## **Characterising the level of crashworthiness for impacts on hard ground and water surfaces for a metallic helicopter under floor structure: What lessons can be learned?**

**K. Hughes**

Crashworthiness, Impact and Structural Mechanics Group (CISM),  
School of Engineering, Cranfield University, Cranfield, BEDS, MK43 0AL, UK

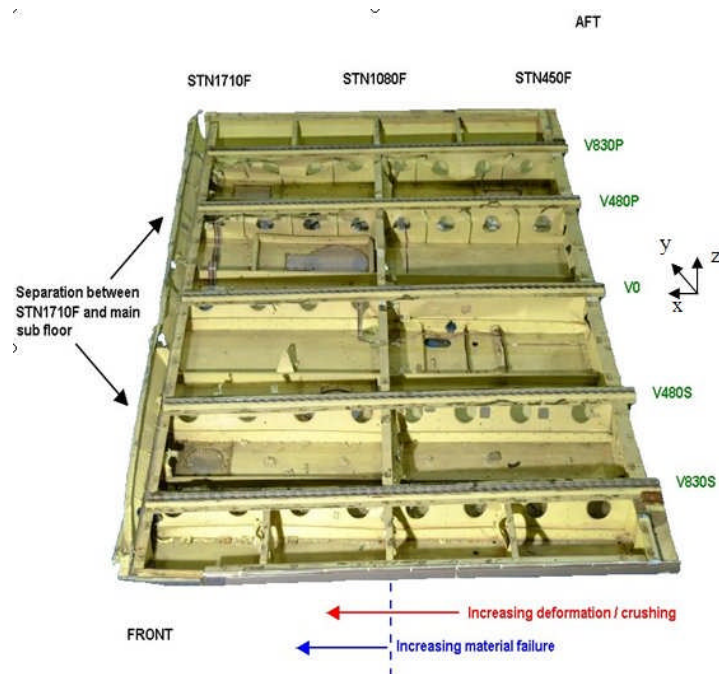
The floor was dropped via a guided descent at  $8\text{ms}^{-1}$ , to which a 1 ton ballast plate was added. Instrumentation included eight accelerometers positioned on the main longitudinal frames, together with strain gauges and three force transducers. The main features of damage can be found in figure 2, where the passenger floor has been removed for clarity. As can be seen, all the frames contribute to energy absorption, as failure in the form of hinge lines in both transverse and longitudinal frames is observed. The skin plays no part in the energy absorbing process. Good agreement was obtained for the locations of frame collapse and force-time histories with the numerical results. The existing structure is capable of absorbing the impact energy, but achieves this in an inefficient manner due to the limited use of the available stroke.

Figure 2 Overall view of the post test specimen, where the floor has been removed for clarity

The first observation concerns limited utilisation of the available frame stroke, so consideration should be given to frame construction to ensure progressive collapse through the careful selection of geometry, material type and possible inclusion of a trigger, and the second is through the redesign of the joints, as progressive joint failure will be critical in order to allow for increased and controlled frame collapse.

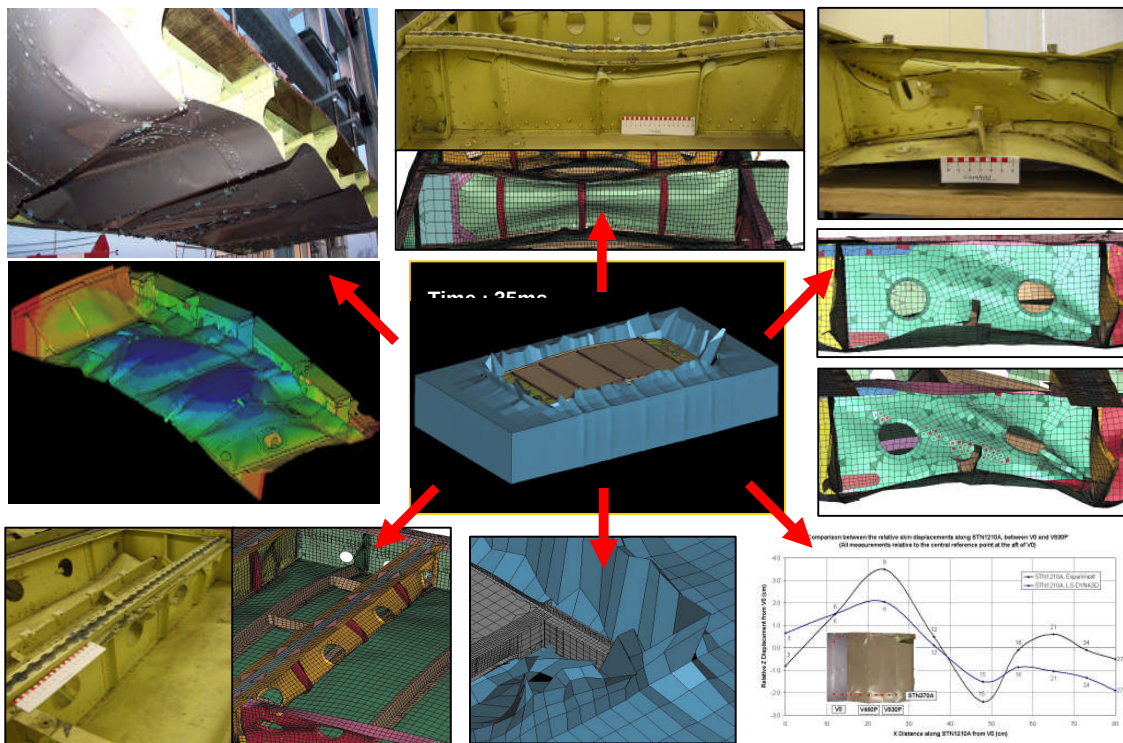
The post impact specimen can be found in figure 3, where the passenger floor has been removed for clarity. As can be seen, the floor retains its global integrity, as the main longitudinal frames remain undamaged, with the skin deflecting quite significantly in between these longitudinal frames. There are two main locations of skin and rivet failure, which would result in the ingress of water and the resulting secondary damage. The curved end sections remain relatively undamaged, as their shape minimises loading at these locations, due to the redirection of the water.

Figure 3 The finite element analysis allowed detailed comparisons with experiment for hinge location, skin deformation and collapsed height of the frames

To recreate numerically, a purely Lagrangian approach was used. The code was able to predict a representative response when compared to test, as good agreement for limited frame collapse, the deflections of the skin (within 10% of test), together with the locations of potential skin failure. Limited joint collapse is predicted, which is also consistent with test. The skin deflects in-between the frames, causing localised material and rivet failure, in the form of tensile pull-out from the surrounding frames.

During a water impact, the dominant membrane behaviour of the skin is the only mechanism to transfer the water pressure to other energy absorbing components. Therefore, skin integrity is essential if the loads generated are to be transferred to enable frame collapse to occur, without the skin failing. This in turn will increase the floatation capabilities and post impact survivability for the occupants. Therefore, the deflection of the skin needs to be encouraged, as this forms a significant passive energy absorber during an impact on water. This will require a move away from conventional metallic skins towards the use of composite materials.
