# Assessment of Coating Performance on Waterwalls and Superheaters in a Pulverised Fuel-Fired Power Station

**Abstract** Protective coatings offer one route to increase the lives of heat exchangers in pulverised fuel power plants. A range of candidate coatings have been exposed on the waterwall and superheaters of a 500 MWe UK power station unit for periods of up to ~4 years (24,880 operating hours), during which time this unit was fired on a mixture of UK and world-traded coals. Both nickel- and iron-based candidate coatings were included, applied using high velocity oxy-fuel or arc-wire process; a selection of these also had a surface sealant applied to investigate its effectiveness. Dimensional metrology was used to evaluate coating performances, with SEM/EDX examinations used to investigate the various degradation mechanisms found. Both the waterwall and superheater environments generated their characteristic corrosion damage morphologies which depended on the radial positions around the tube. Coating performances were found to depend on the initial coating quality rather than composition, and were not improved by the use of a sealant.

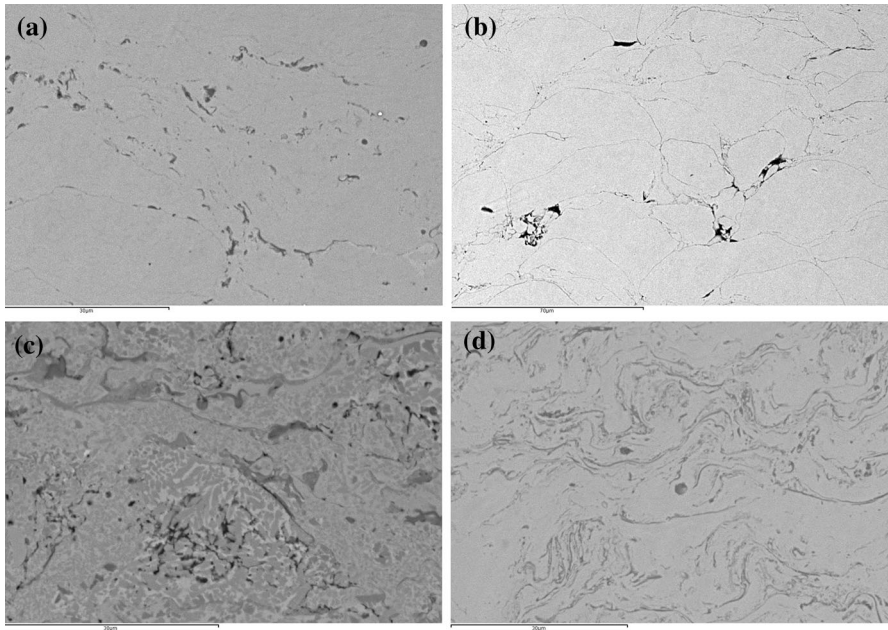
**Fig. 4** Representative microstructures of different as-sprayed HVOF coatings. The images have been selected to illustrate the variations in coating microstructures observed. **a** Ni–50Cr, **b** FeCrAl, **c**  $\text{Cr}_3\text{C}_2$ –NiCr matrix, **d** alloy 625 NiCrMo(Nb+Ta)

1% voidage previously considered necessary to ensure good coating performance. One exception to this was for the alloy 625 coating which was observed to contain an unusually high oxide content (Fig. 4d). The  $\text{Cr}_3\text{C}_2$ -filled NiCr matrix coating contained a considerable amount of the hard, erosion-resistant carbide material as expected (Fig. 4c), although this prevented the assessment of its oxide and porosity content.

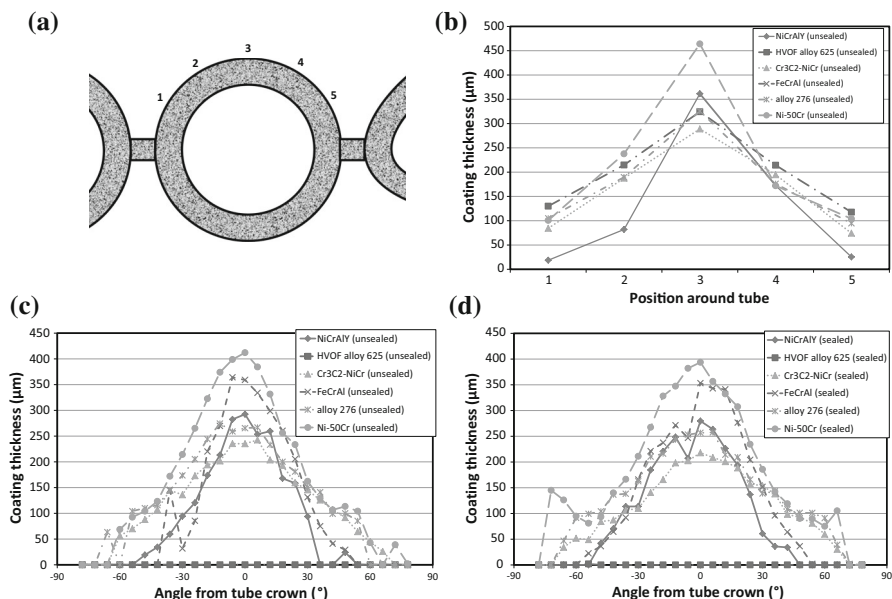
**Fig. 5** Variation in unsealed HVOF coating thickness around waterwall tubes 3 and 8 before and after exposure. **a** pre-exposure measurement positions, **b** before exposure, **c** after exposure—unsealed coatings, **d** after exposure—sealed coatings

Dimensional metrology measurements were carried out on all the coated tubes before and after their exposures. Figure 5b shows the data generated by pre-exposure Elcometer measurements at the five radial locations for each of the unsealed coatings on tube 8. This illustrates the initial variation in the thickness of these coatings around the tubes. After exposures, measurements of coating thicknesses were carried out at 6° intervals around the tube cross-sections. The results of these are shown in Fig. 5c for the same tube 8 coatings and in Fig. 5d for an unsealed version of the same coatings (tube 3).

These data emphasise the much greater coating thicknesses in the ‘crown’ areas (or 12 o’clock positions) which are shown at zero degrees on the  $x$ -axis in Fig. 5c, d, and the tailing off of the coating thicknesses on either side of this peak position. These data should be compared to those generated by the pre-exposure metrology (e.g. Fig. 5b), which showed the coatings becoming thinner away from the ‘crown’ areas (i.e. either side of position 3 in Fig. 5a). It is clear that the areas of thinner coatings have failed during the course of exposures in the plant. Given the variation in coating thicknesses around the tubes that has resulted in areas of total coating loss, to obtain quantitative data on coating performances it is necessary to use the maximum coating thickness measurements (corresponding to the tube ‘crowns’) before and after exposure.

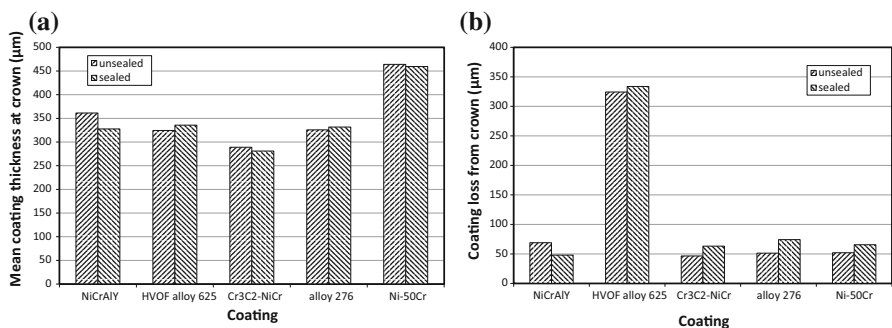
**Fig. 6** Pre- and post-exposure HVOF coating thicknesses on waterwall tubes 3 and 8 (except FeCrAl as no pre-exposure data). **a** Mean coating thicknesses at waterwall tube ‘crowns’, **b** coating losses from waterwall tube ‘crowns’

Figure 6 shows the coating losses calculated for each of the coatings with and without sealant layers. As there is no HVOF IN625 coating left in either case, it has clearly performed the worse, with corrosion damage exceeding the 320–330  $\mu\text{m}$  coating thicknesses. However, all the other coatings have performed similarly with damage levels of  $\sim 50$  to  $75 \mu\text{m}$  during their  $\sim 25$  khour exposure (i.e.  $\sim 2$ – $3 \mu\text{m}$  per 1000 h). There was no obvious benefit from the sealant—for the majority of the coatings the sealed version had apparently corroded a little more than the unsealed version (but this was within the standard deviation of the measurements).

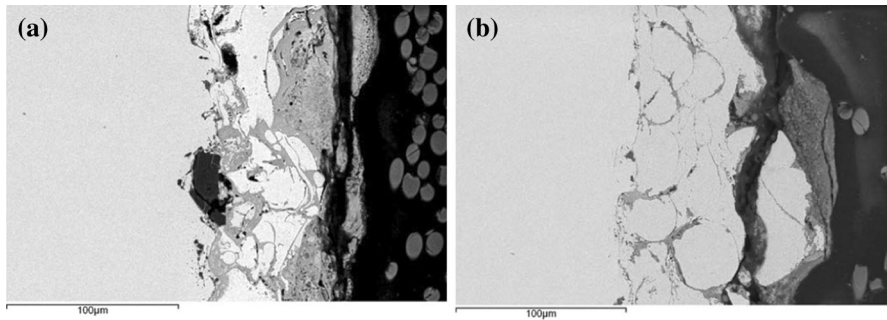
Similar examinations were carried out for the coatings exposed on the superheater tubing. SEM/EDX examinations of the cross-sections through the coatings confirmed the coating compositions. These examinations also characterised the deposit compositions that had formed on the tube surfaces and that the corrosion damage morphologies (e.g. Fig. 8) were consistent with typical superheater corrosion damage for a coal-fired boiler [7].

**Fig. 8** Summary of coating performances on the superheater, **a** arc wire alloy 625 3 o'clock position, **b** HVOF NiCrAlY 3 o'clock position

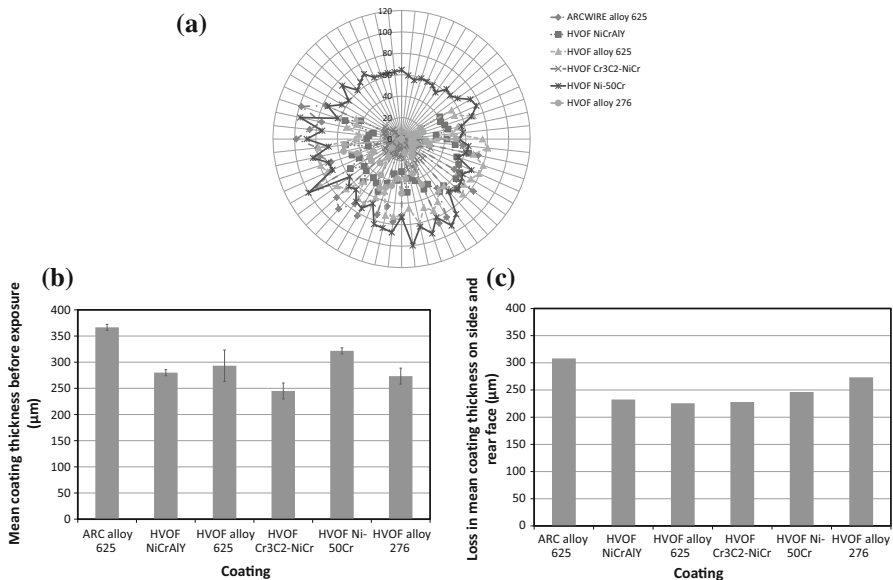
Figure 9a shows the thicknesses of the sealed coatings after their exposure. This shows that only HVOF Ni-50Cr had survived on the upstream surface of the tubes,

**Fig. 9** Examples of coating performances on the superheater. **a** Coating thicknesses (µm) as a function of radial position around superheater (upstream tube face at top), **b** mean coating thicknesses before exposure on the superheater, **c** mean loss in coating thicknesses from the sides and downstream faces during exposure on the superheater

but all the coatings were present around the rest of the tube surfaces. Pre-exposure coating measurements were in the range  $\sim 250$  to  $350\text{ }\mu\text{m}$  (Fig. 9b), with some coatings having initial thicknesses on average  $100\text{ }\mu\text{m}$  less than others (the bars in this figure show the standard deviations of the initial coating measurements). Figure 9c shows the differences between the average coating thicknesses before exposure for these samples and those measured on the sides/downstream surfaces of the samples after exposure. Given the spread in the measurement datasets, the results for the HVOF coatings, with thickness losses of  $\sim 220$  to  $260\text{ }\mu\text{m}$ , indicate similar levels of behaviour (i.e.  $\sim 9$  to  $10\text{ }\mu\text{m}$  per  $1000\text{ h}$ ). However, the arc-wire alloy 625 coating performed worse with an average downstream coating thickness loss of  $\sim 300\text{ }\mu\text{m}$  (i.e.  $\sim 12\text{ }\mu\text{m}$  per  $1000\text{ h}$ ).
