# **Private Sector Participation in Low Cost Water Well Drilling**

**Knowledge and Research (KAR) Project R7126**

**Water Quality Data for Five Pounder Well and Five Hand-  
Augured Wells in Katabi Sub County, Mpigi District, Uganda.  
[Including June 2001 Data for Two Wells in Mukono and Jinja Districts]**

**Rwamwanja R, Danert K and Carter R C  
2001**

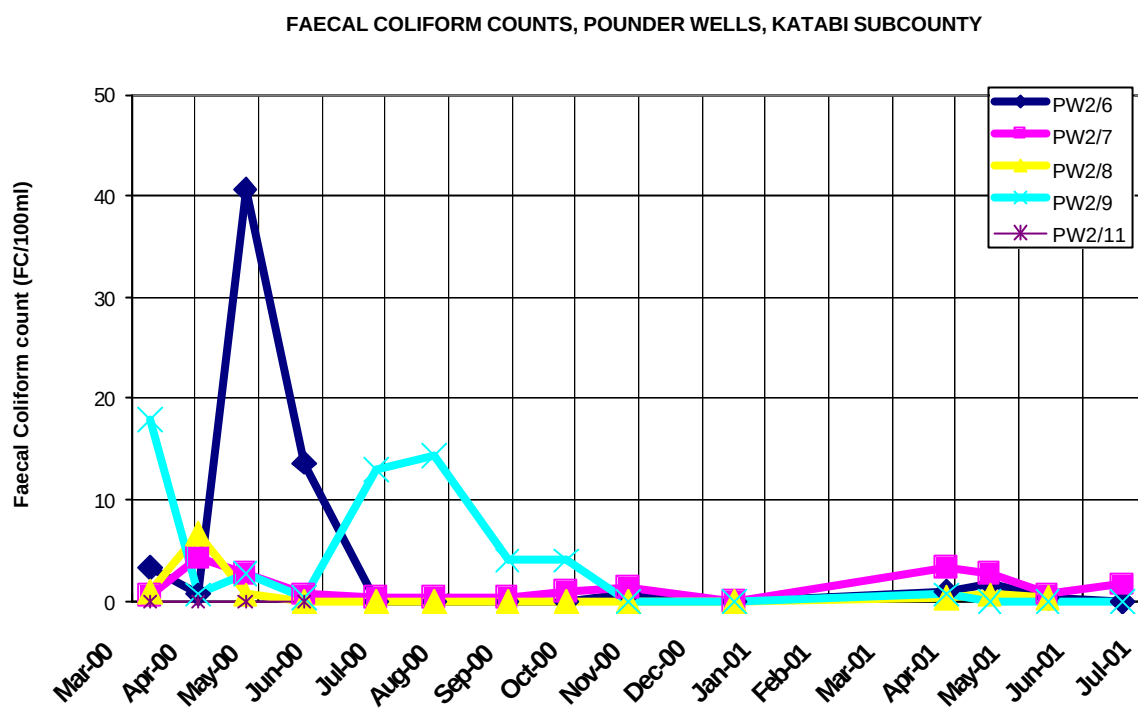
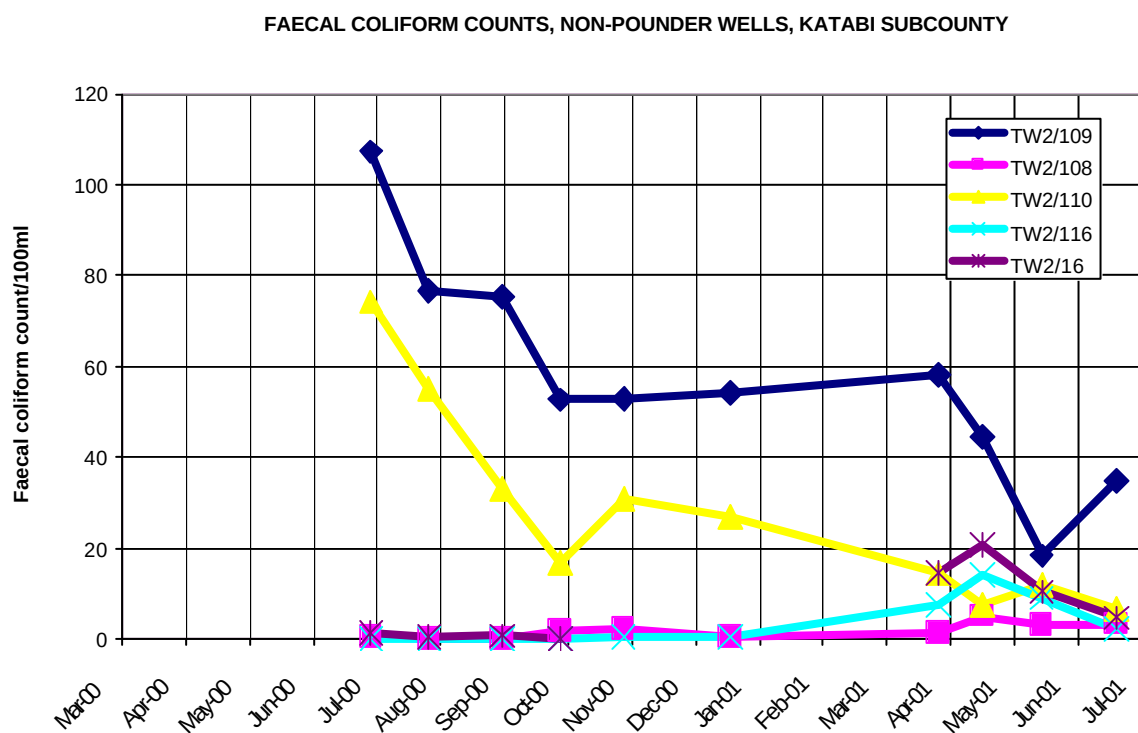
- All Pounder well data gives faecal coliform counts well within the GoU standard.
- Faecal contamination of Pounder wells is no worse than that experienced by other shallow wells. The data in fact show Pounder wells to be better in this regard than their comparison group of hand-augered wells.
- Groundwaters can have quite low pH values, which can cause severe corrosion of galvanised below-ground pump components. This corrosion can lead to rapidly increasing dissolved iron contents. Replacement of GI rods with SS causes iron levels to drop.
- Turbidity values in both groups of wells are generally low, and in this sample give no cause for concern.

**Figure 4.1 Faecal coliform counts of Pounder (upper) and hand augered (lower) wells [Note same time scales, but different y-scales]**

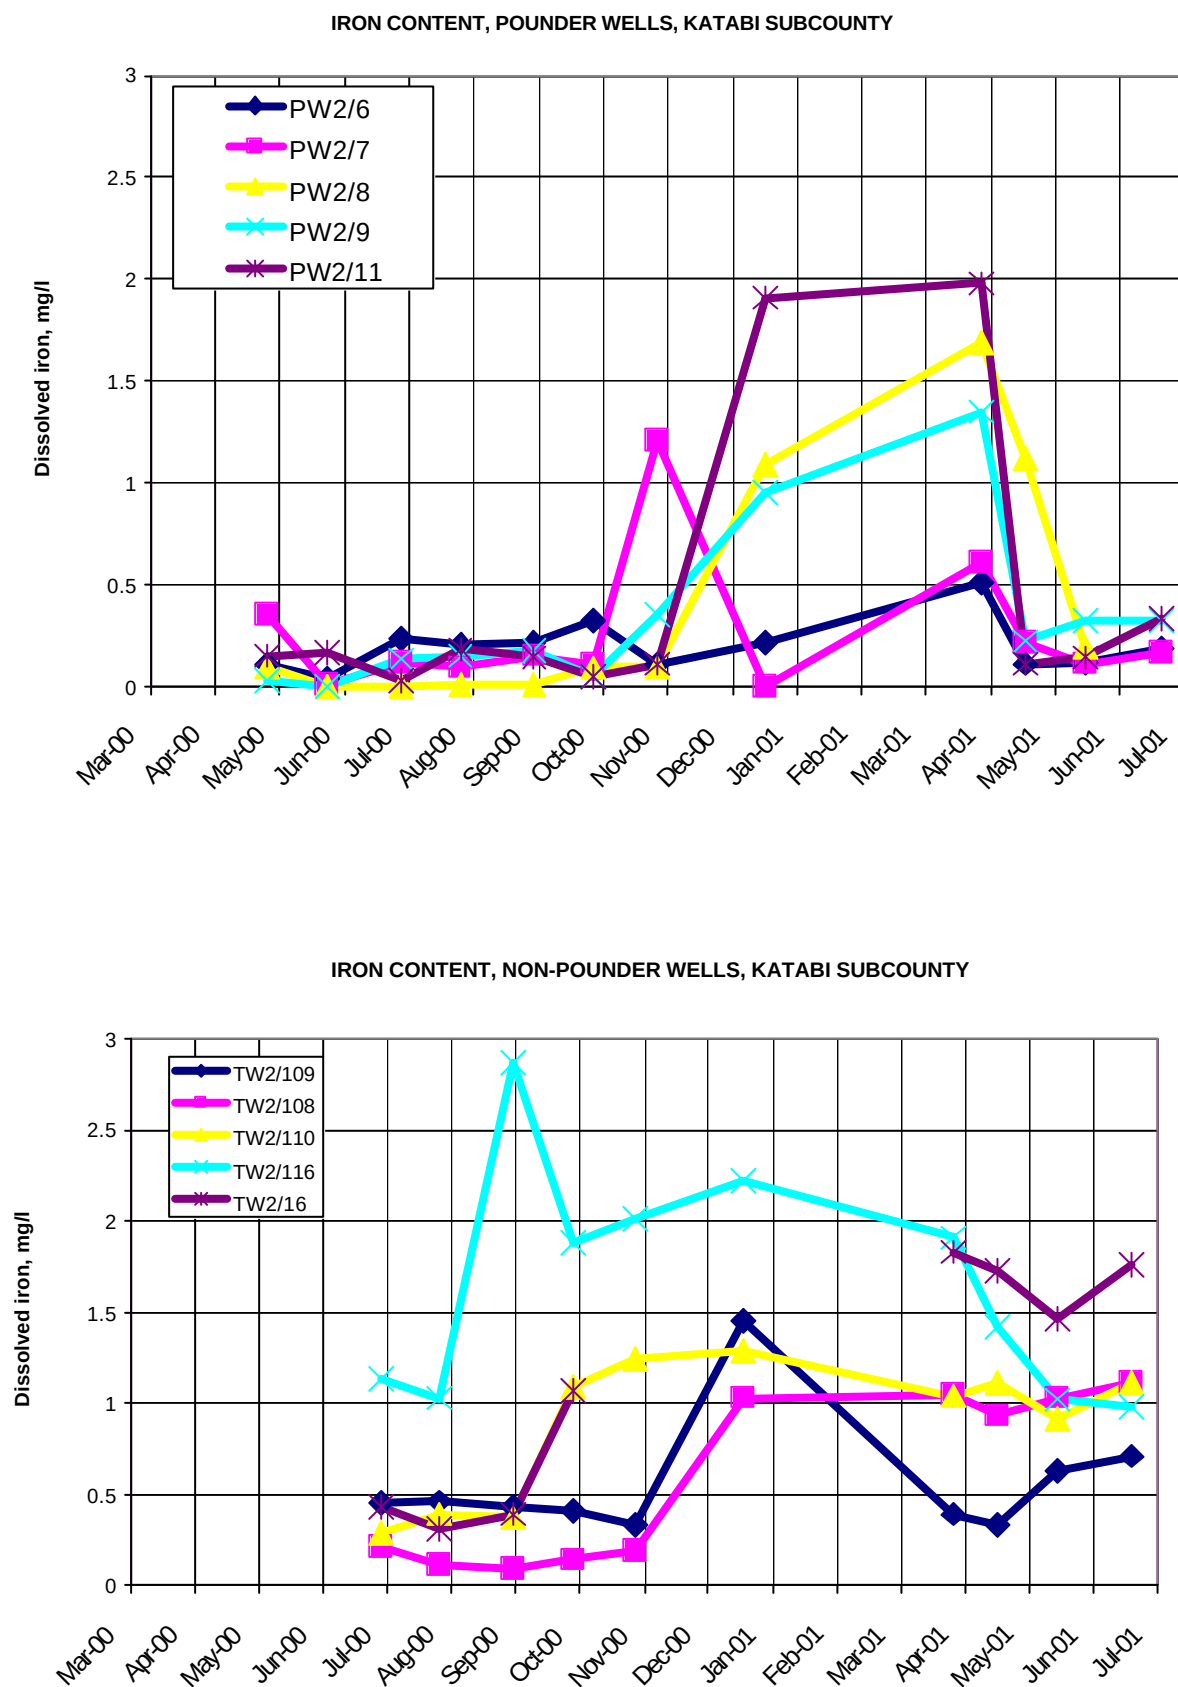
The dissolved iron content of the Pounder wells (Figure 4.2) shows a very interesting pattern. Values are generally low (less than 0.5 mg/l) up to about December 2000, but from January through April 2001 iron levels rise to 1-2mg/l. After April, levels drop again. This pattern is consistent with the fact that heavy corrosion was observed in below ground pump components (galvanised pump rods) in April 2001, when the GI rods were replaced with stainless steel. The April water samples were taken immediately after replacement of the rods, when the borehole still probably contained a lot of iron which had originated from corrosion of the old rods.

**Figure 4.2 Iron contents of Pounder wells (upper) and hand-augered wells (lower)**
