The Fourth International Conference on Through-life Engineering Services

## Degradation study of heat exchangers

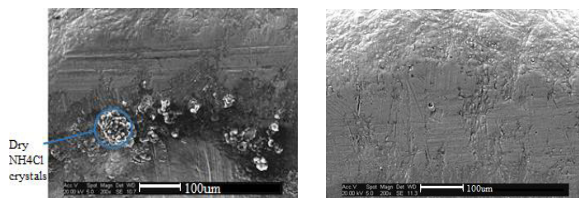
Fig. 3 Oil side coupon with corrosive solution at x200 mag after (left image) ½ day and (right image) 1 day exposure

Fig. 2 shows the SEM image of the as received oil side coupon taken at x25 magnification (mag) after preparing the sample as mentioned in the test plan. The left image as shown in Fig. 3 shows the deposition of ammonium chloride crystals prominently and do not show any indication of corrosion after ½ day exposure. The right image from Fig. 3 shows the SEM image obtained after 1 day exposure and does not show any visible signs of corrosion even at a magnification of x200. However, Fig. 4 shows clear signs of formation of blisters at a magnification of x25 (left image). When the magnification factor was increased to x1000 it was noticed that some blisters have now actually flaked off exposing the material to further corrosion.

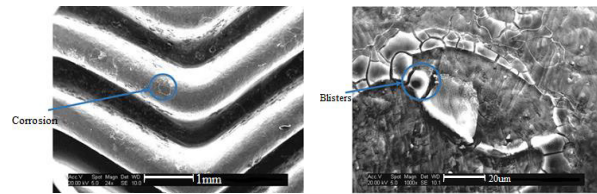
Fig. 4 Oil side coupon with corrosive solution after 2 days exposure (left image) at x25 mag and (right image) at x1000 mag

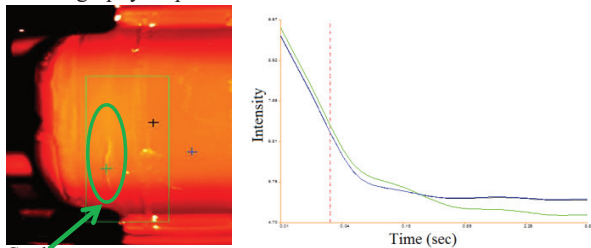
Fig. 7 RAW thermal image of heat exchanger shell (left), log thermal plot of the image on the left (right).

For initial test, several trials were undertaken as the heat exchanger was highly reflective in nature. To increase the surface emission characteristics, it was coated with a removable graphite spray. The above RAW thermal image (Fig.7 left) shows the areas that are sound (blue, black

marker) and have damage (green marker). The black and blue curves show the sound area of the heat exchanger whereas the green marker shows the crack. It can be noted from the log thermal plot that the cooling characteristics of the damage is different confirming the presence of crack.
