## **Detection of shaft-seal rubbing in large-scale power generation turbines with Acoustic Emissions; Case study**

**D. Mba<sup>1</sup>, A. Cooke<sup>2</sup>, D. Roby<sup>3</sup>, G. Hewitt<sup>3</sup>**

### **Abstract**

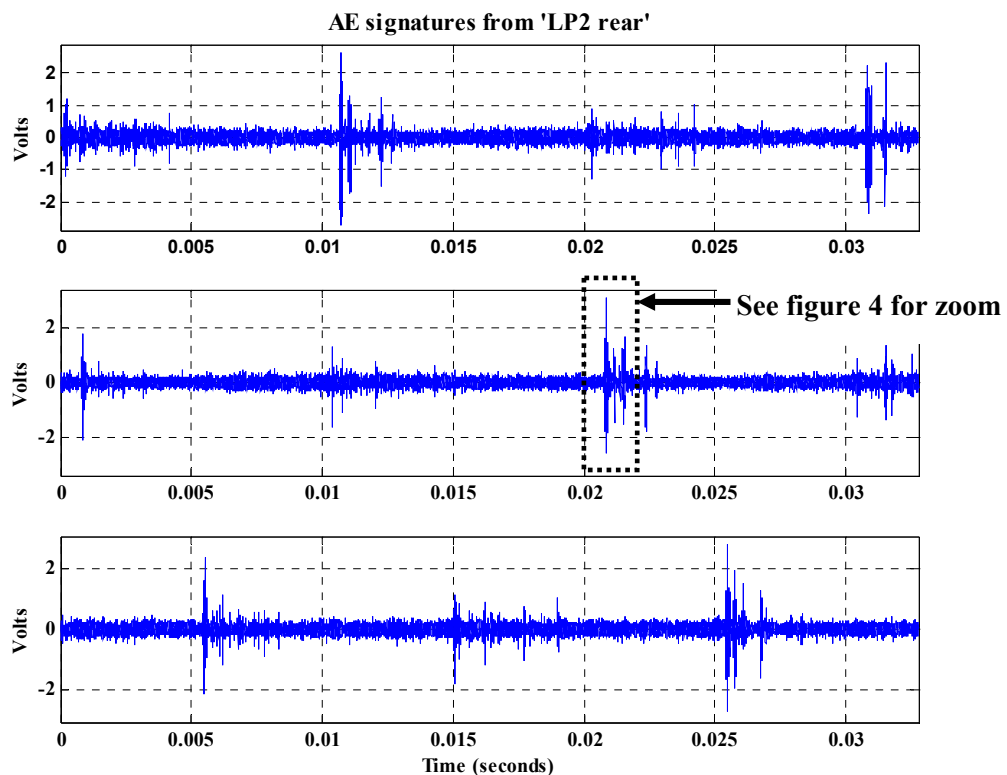
The larger amplitude AE burst signatures detected at this position were generated at 0.02 second intervals, equivalent to the rotational speed of the unit, 50Hz, see figure 3. In addition, smaller amplitude AE burst signatures were emitted between the larger amplitude bursts described above, at a periodicity also equivalent to once-per-revolution, see figure 3. It was noted that the periodicity of all AE transient events was twice the rotational speed. Figure 4 is a close-up view of a selected portion of figure 3 (middle diagram), primarily to show the reader that the transient bursts are not electronic spikes.

**Figure 3** Typical AE signature from 'LP 2 Rear' (sampled at 1MHz)

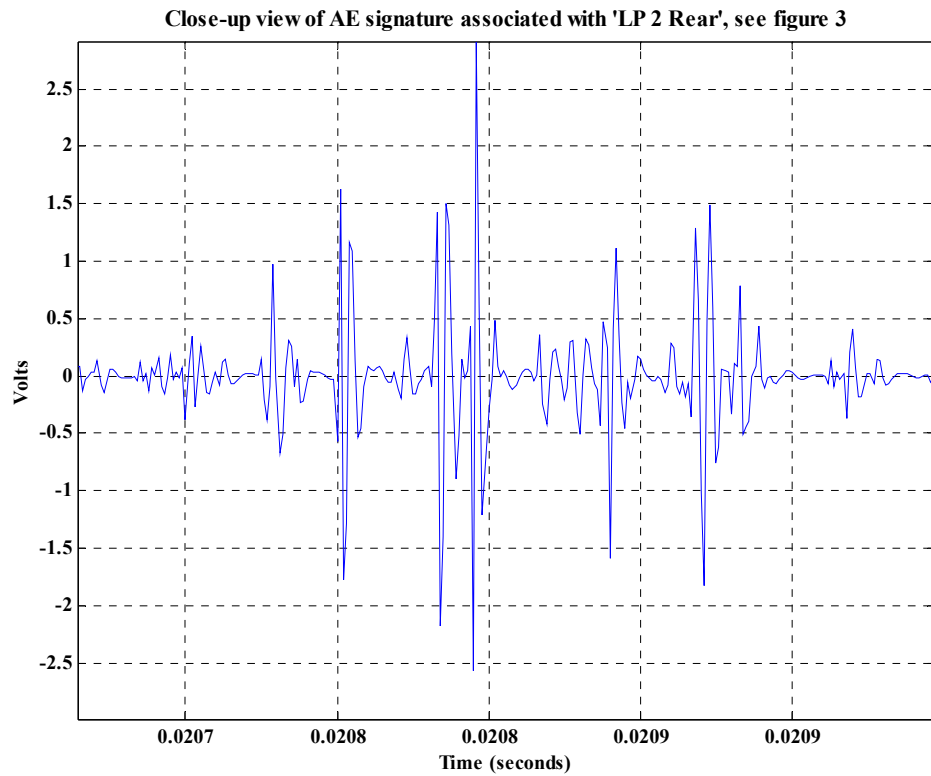
**Figure 4      Close-up view of a selected region in figure 3**

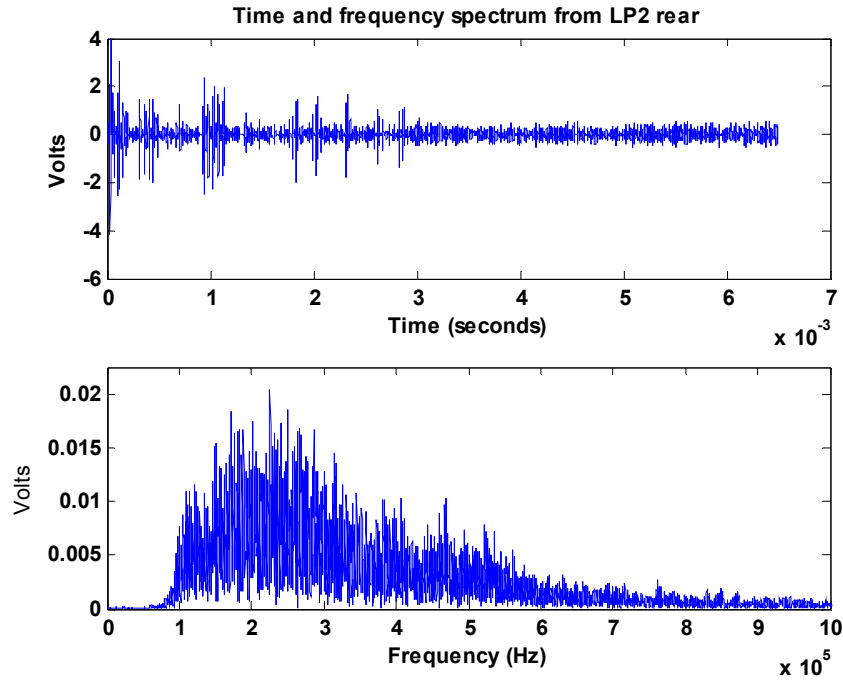
A time signature, with corresponding frequency spectrum, of a typical AE burst signature associated with 'LP2 Rear' can be seen in figure 5. The frequency spectrum ranged from 100kHz to 600kHz.

**Figure 5** AE signature from ‘LP 2 Rear’ with corresponding frequency spectrum (sampled at 4MHz)

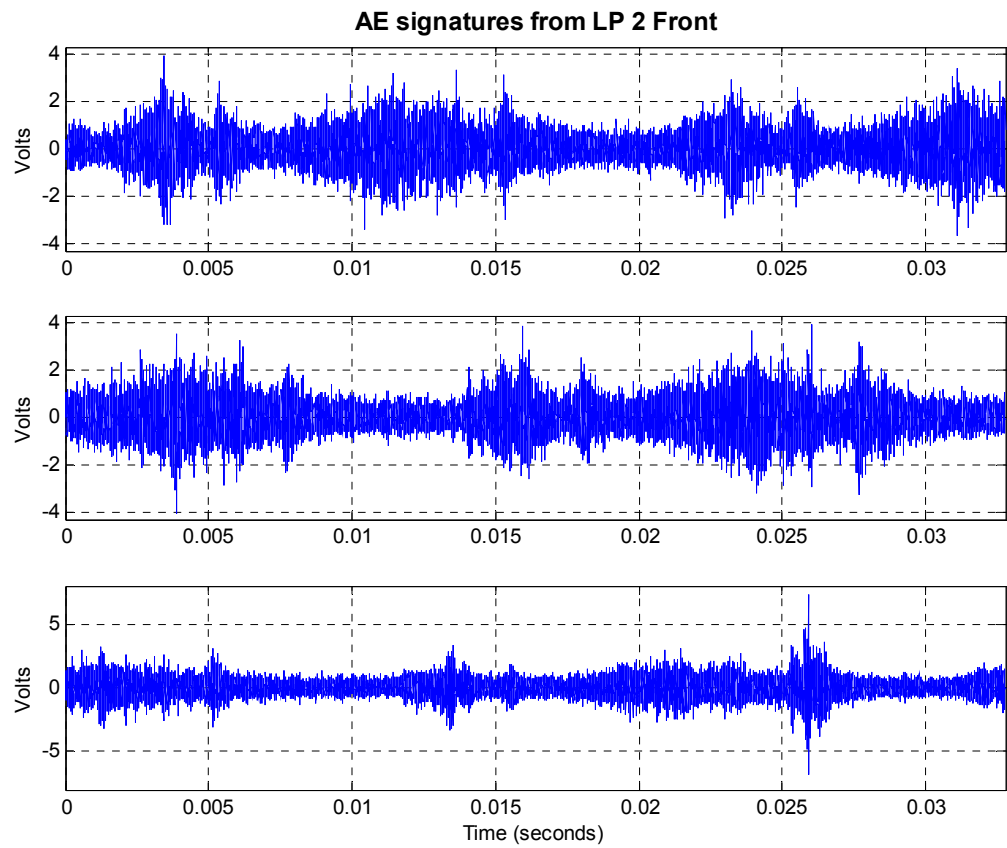
The AE signatures detected at this position were of larger amplitude and energy than at ‘LP2 Rear’. The high frequency AE burst signatures detected were modulated at twice rotational speed of the rotor, 0.01 seconds or 100Hz, see figure 6. An AE time signature with corresponding frequency spectrum of a typical AE burst at ‘LP2 Front’ can be seen in figure 7. The frequency spectrum of these AE signatures ranged from 100kHz to 600kHz.

**Figure 6** Typical AE signature from ‘LP 2 front’, (sampled at 1MHz)

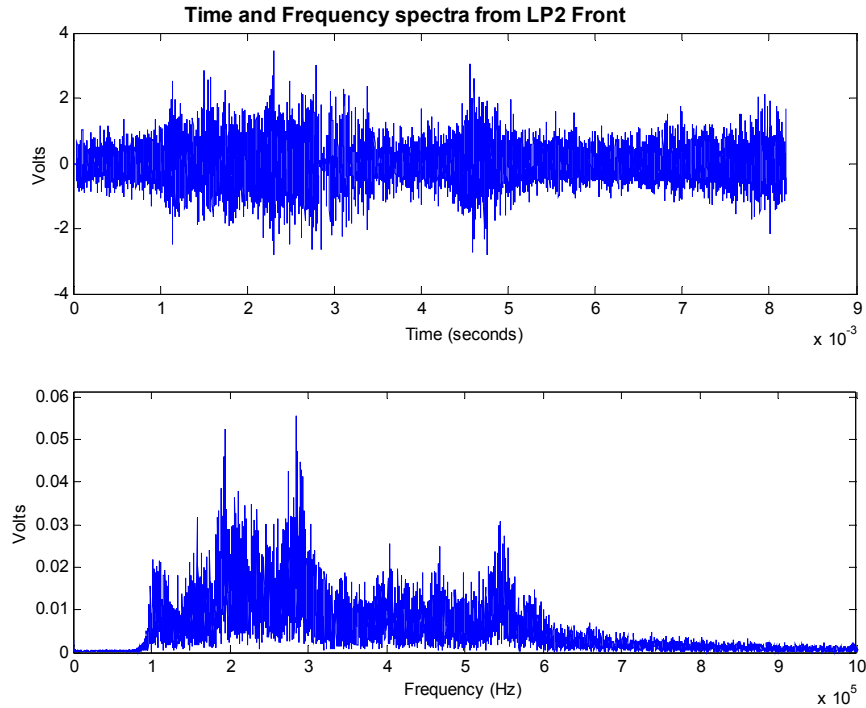
**Figure 7** AE signature from ‘LP 2 Front’ with corresponding frequency spectrum (sampled at 4MHz)

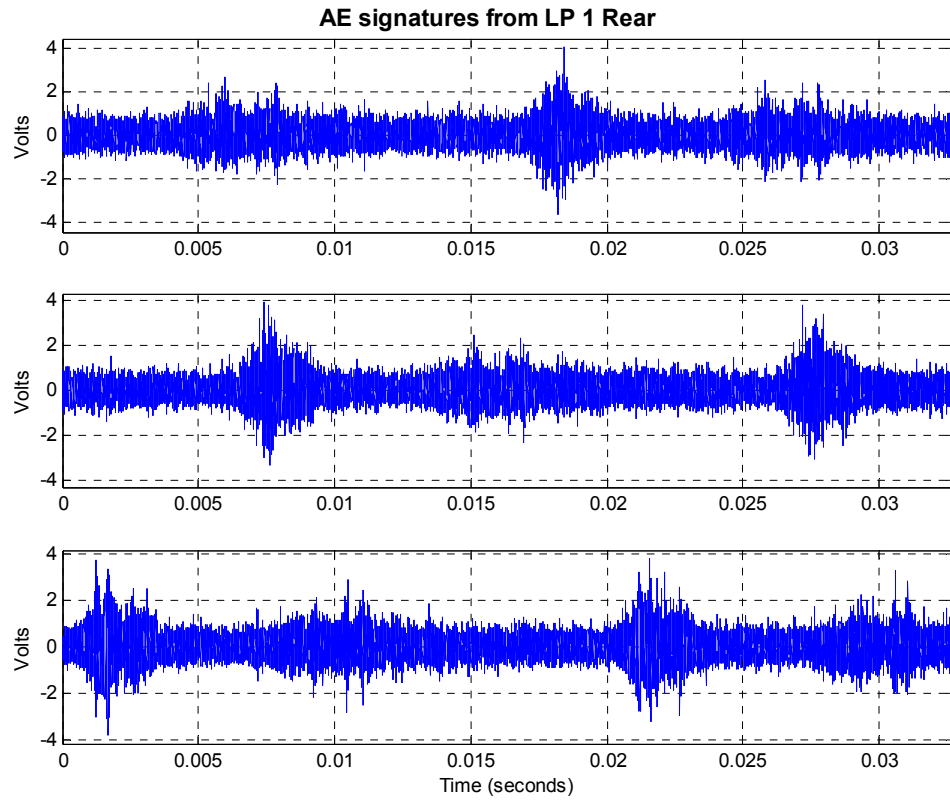
High frequency AE burst signatures were detected at 0.02 second intervals, equivalent to the rotational speed of the rotor, 50 Hz, see figure 8. In addition, AE signatures of relatively lower amplitude and energy were evident between the larger amplitude bursts. This phenomenon was observed at ‘LP2 Rear’, although at much lower AE energy levels.

**Figure 8** AE signature from 'LP 1 Rear', (sampled at 1MHz)

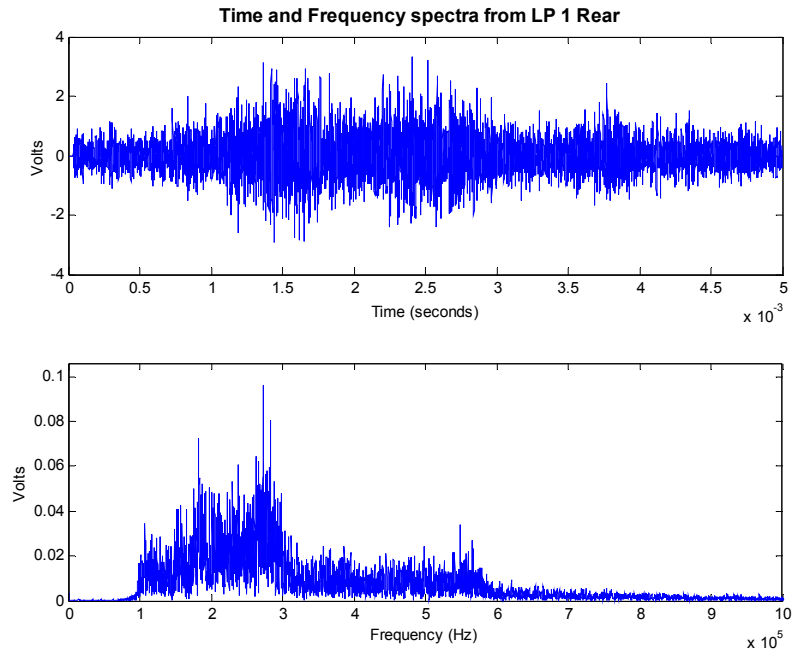
A time signature, with corresponding frequency spectrum, of a typical AE burst signature associated with 'LP1 Rear' can be seen in figure 9. The frequency spectrum ranged from 100kHz to 600kHz.

**Figure 9 Typical AE signature from ‘LP 1 Rear’ with corresponding frequency spectrum (sampled at 4MHz)**

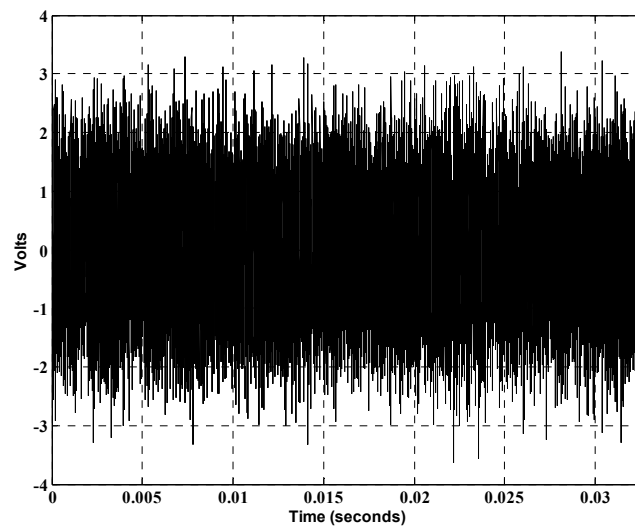
Acoustic Emission signatures captured on the second visit from positions ‘LP1 Rear’ and ‘LP2 Front’ showed neither modulation nor distinct discrete AE signatures as was observed during the period of high vibration, see figures 10 and 11. In addition, the amplitude and energy levels of the AE’s observed at the second visit were higher than those recorded in the first visit. This is attributed to the change in operating background noise characteristics and suggests that AE activity is related to the operating conditions of the turbine unit within its cylinder.

**Figure 10** Typical AE signature detected at ‘LP1 Rear’ after shaft displacement levels had been reduced due to changes in operating conditions.

The operating conditions of the cylinders were modified to reduce the dynamic shaft displacement to acceptable operational levels. This was achieved by reducing the system vacuum thereby causing a rise in steam exhaust temperature and thus an increase in clearance between the seals and the rotor. The performance parameters at this condition included an exhaust temperature of 25°C at a load of 80MW. During the second visit the unit was operating under the conditions detailed above.

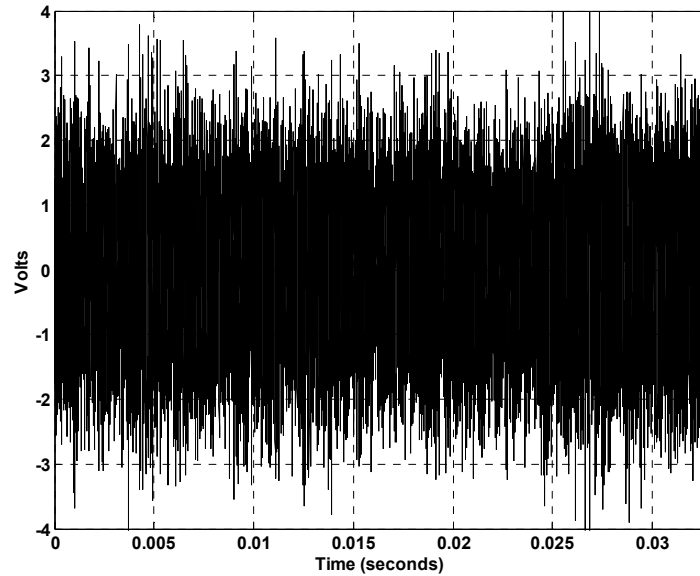
**Figure 11** Typical AE signature detected at ‘LP2 Front’ after shaft displacement levels had been reduced due to changes in operating conditions.

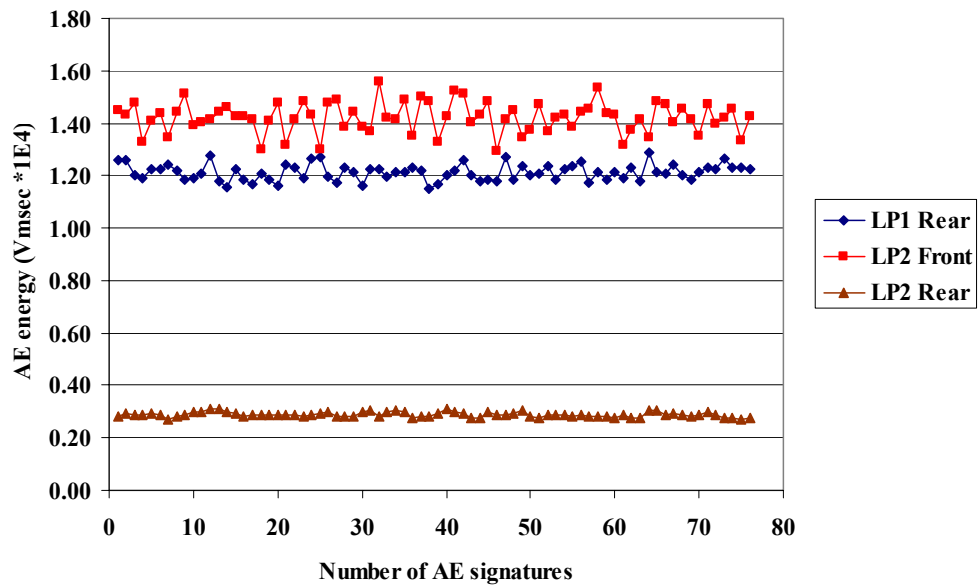
**Comparison of AE energy levels from 'LP 2 Front and Rear'  
and 'LP 1 Rear'**

To aid identification of the main source of rub from the first visit, comparisons of maximum amplitude and energy levels were made on AE signatures from the various seal/gland casings, see figures 12 and 13. A complete breakdown of maximum amplitude and energy values is detailed in appendix A. A total of seventy-six (76) AE data files, each of 0.032 seconds duration, are presented. This was considered sufficient in providing an indication of AE maximum amplitude and energy levels for the three seal casings. Maximum amplitude and energy values were obtained from the entire duration of each data file. The energy was calculated using the trapezoidal numerical integration.

**Figure 12 Comparison of AE energy levels**

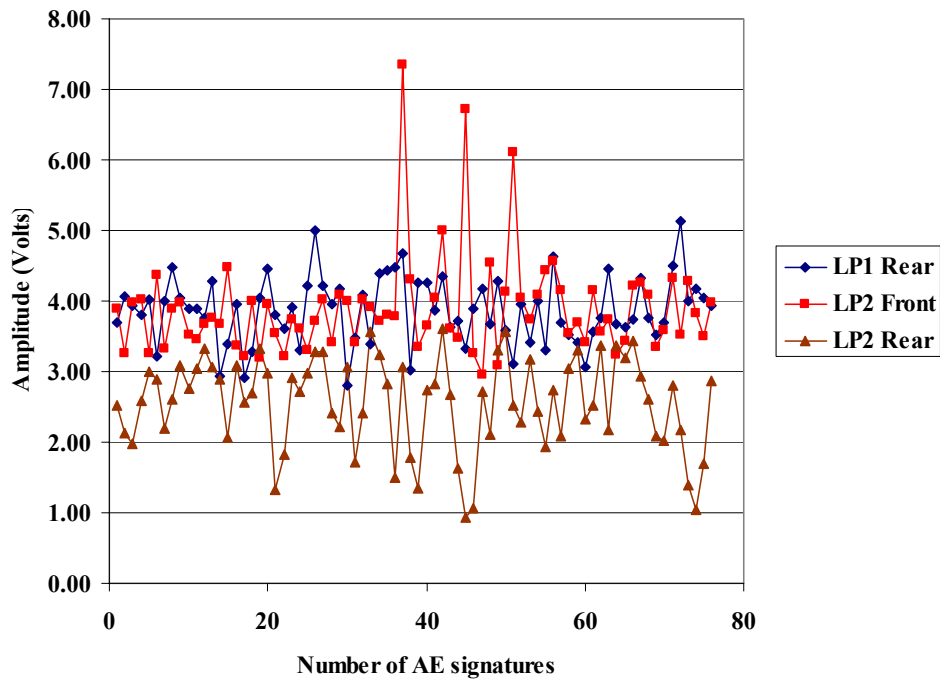
**Comparison of AE amplitude levels from 'LP 2 Front and  
Rear' and 'LP 1 Rear'**

**Figure 13 Comparison of maximum AE amplitude levels**

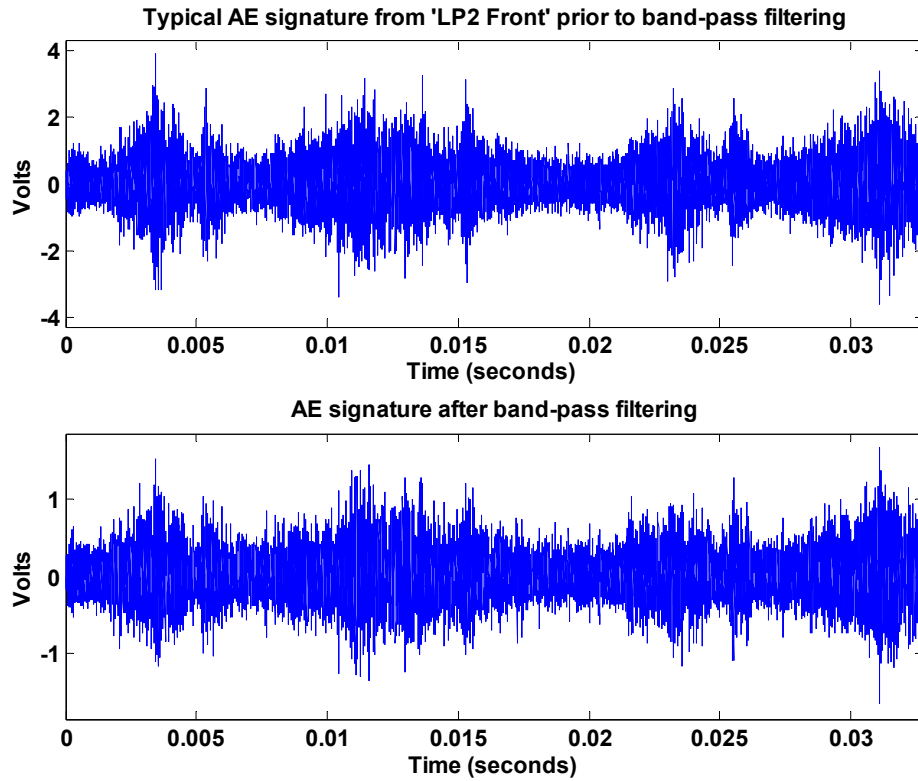
It was thought prudent to filter the AE output signatures to ensure that the high frequency AE signatures, modulated at the rotational speed of the unit, was not attributed to excessively high vibrations overcoming in-built high pass filters of the acquisition system. This has been known to occur during AE diagnostic tests on operational bearing units (16). A digital elliptic filter with a band-pass frequency range of between 100kHz to 750kHz was applied to captured modulated AE signatures. The filter employed a 5dB loss limit in the pass-band and 60dB attenuation in the stop-band. A typical result before and after filtering can be seen in figure 14. It was concluded that the modulation was attributed to the high frequency AE signature.

**Figure 14** Typical AE signature detected at ‘LP2 Front’ before and after band pass filtering.
