# Experimental observations of an 8 m/s drop test of a metallic helicopter underfloor structure onto a hard surface: part 1

**Abstract:** This is the first part of a two-part paper that describes the experimental observations for two similar sections of floor that were dropped onto both hard and water surfaces at 8 m/s, as a part of one experimental campaign. The current paper provides an assessment of a simple box-beam underfloor structure typically found in metallic helicopters and provides an overview of the failure modes and the collapse mechanism observed when dropped onto a hard surface. All findings are supported by quantitative measurements and extensive photographic evidence.

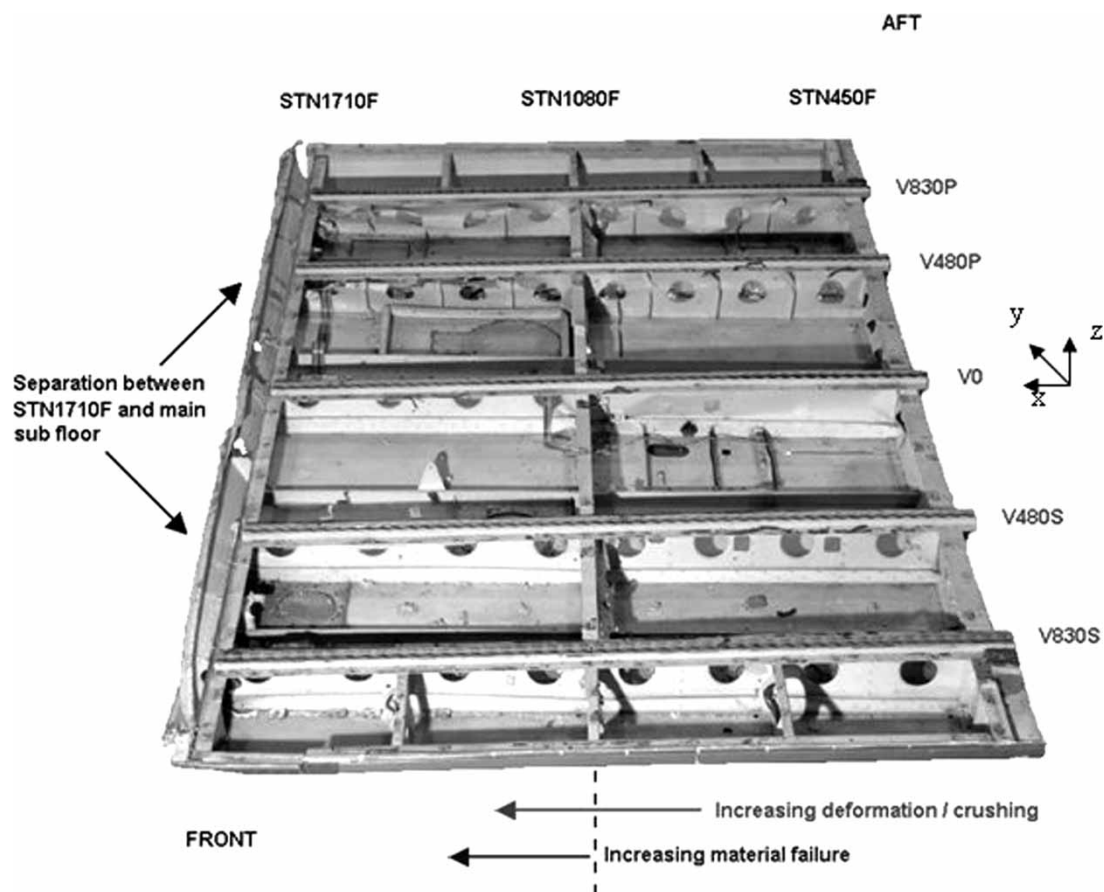
Despite the separation of STN1710F, the subfloor remains intact, with deformation observed in all longitudinal and transverse members, which is consistent with the nature of the distributed loading applied to the cross-section of the floor, due to the presence of the steel ballast plate. The degree of frame deformation is strongly influenced by its construction, as will be discussed in the next section.

One of the main features to note from the global view in Fig. 5 is the fact that the deformation is not uniform, as it is more severe towards the front half of the component between stations 1710F and 1080F. This asymmetry is caused by the separation between STN1710F and the rest of the subfloor. This loss in localized strength reduces the load-carrying ability in this region, permitting more deformation in the form of increased material failure and severity of the magnitude of the plastic hinges. Figures 6 and 7 provide a more detailed view of the damage to the forward and aft sections respectively, where only the port side is considered due to the similarities in the transverse direction either side of frame V0.

**Fig. 5** Global view of post-test article where the instrumentation and passenger floor have been removed for clarity

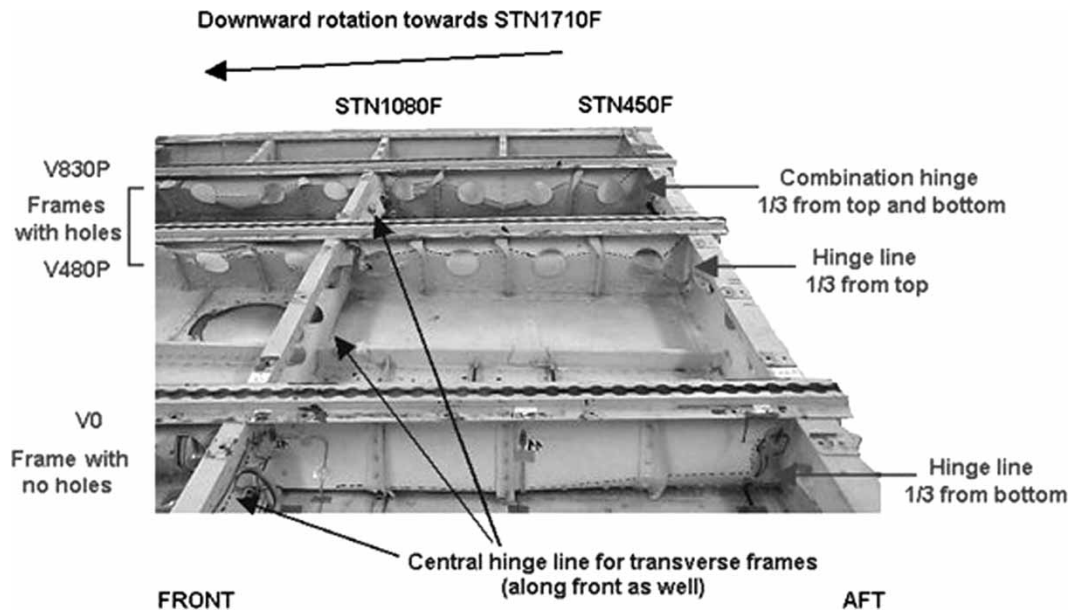
**Fig. 7** Aft port side deformation observed between frames V0 and V830P
