THE COLLEGE OF AERONAUTICS  
DEPARTMENT OF AERODYNAMICS

An investigation of the flow in an axial compressor inlet casing and its effect on the performance of the first stage of the axial compressor

G. M. Lilley, M.Sc., D.I.C., A.F.R.Ae.S.

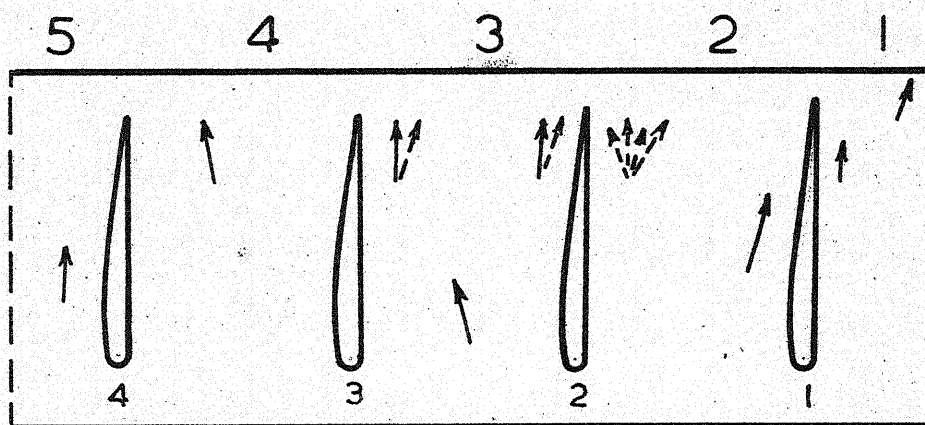
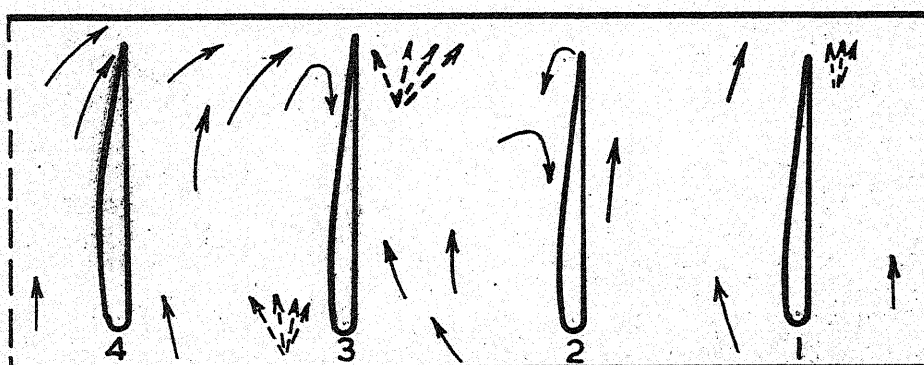
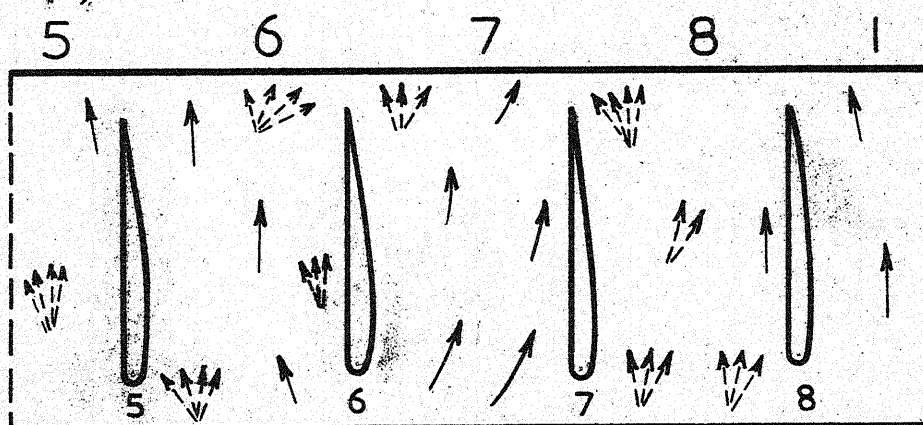
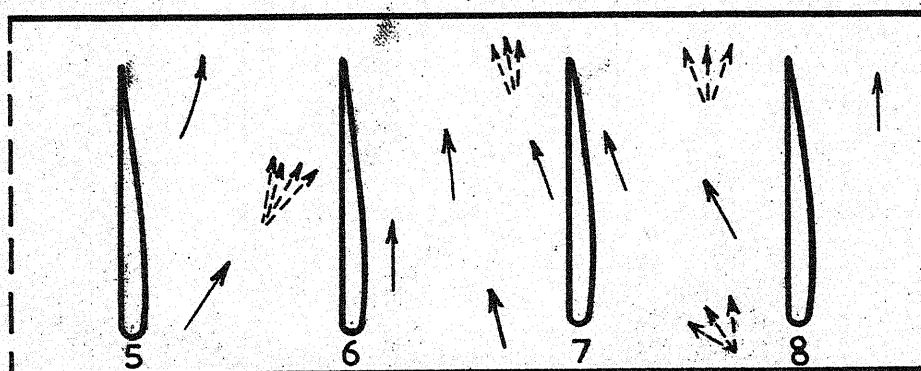
FIG. 2. ORIGINAL CONDITION - MAIN FLOW CLOCKWISE

The positions of the tufts at exit in the clockwise and anticlockwise flow configuration are sketched in figures 2 and 3 respectively. These diagrams show the tufts on the developed surfaces of the outer casing and the central shaft fairing. It is shown that the flow direction is not constant across the annulus and in passages 3 and 7 the flow is under-turned (negative angle) by approximately  $20^\circ$ . Vanes 2,3,6,7 and 8 were partially or completely stalled. Very unsteady flow was present in passages 2,4,5,6 and 8. It is impossible in diagrams of this type to indicate the random and rapid changes about a mean in fluid direction due to the oscillatory nature of the flow and it must be noted that the unsteadiness is much greater than the diagrams show.

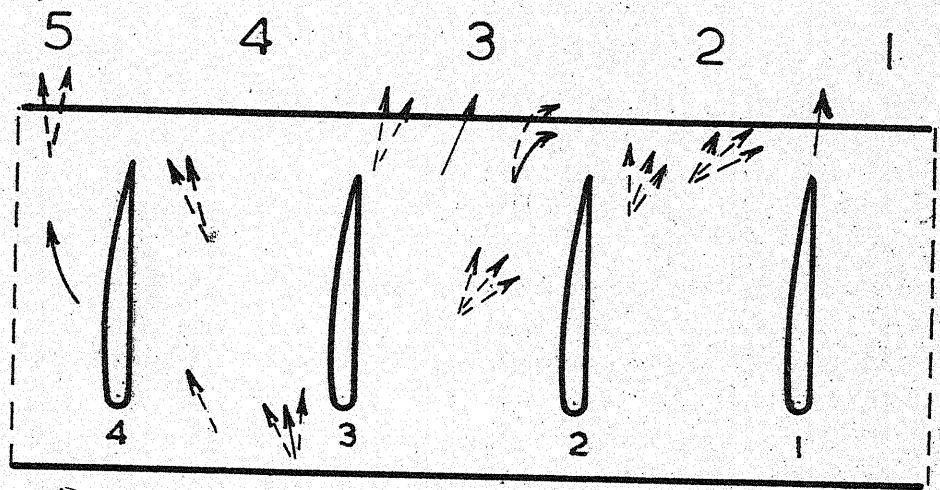
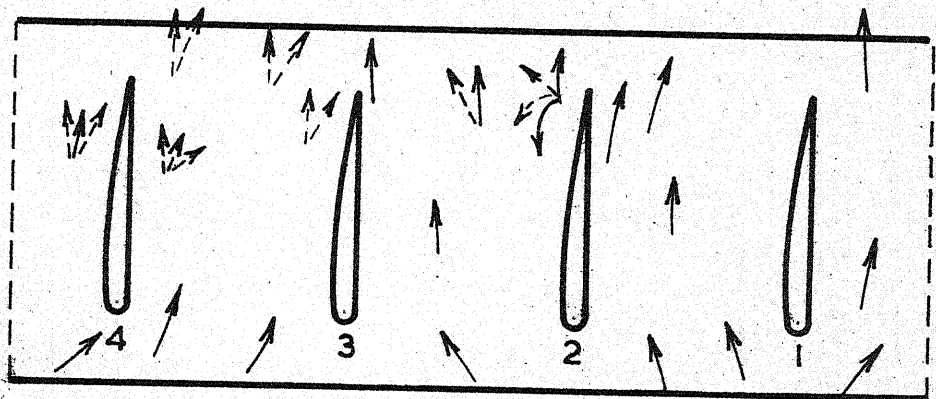
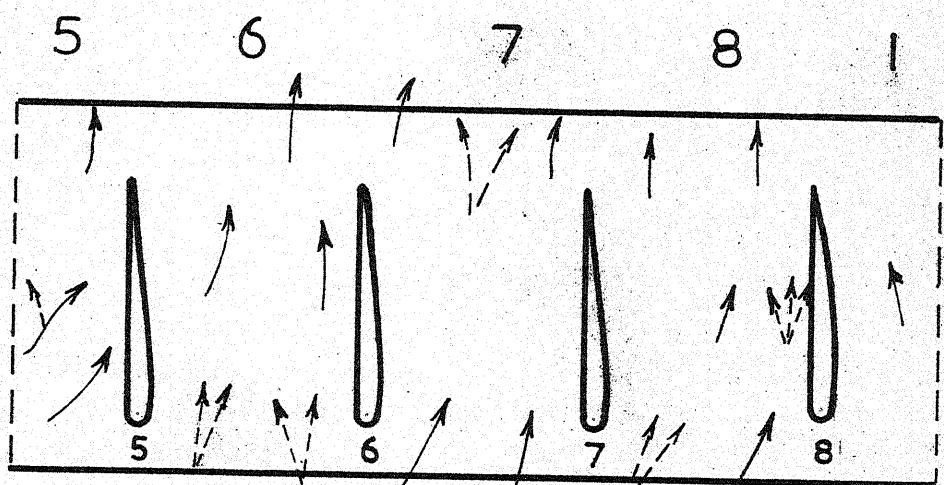
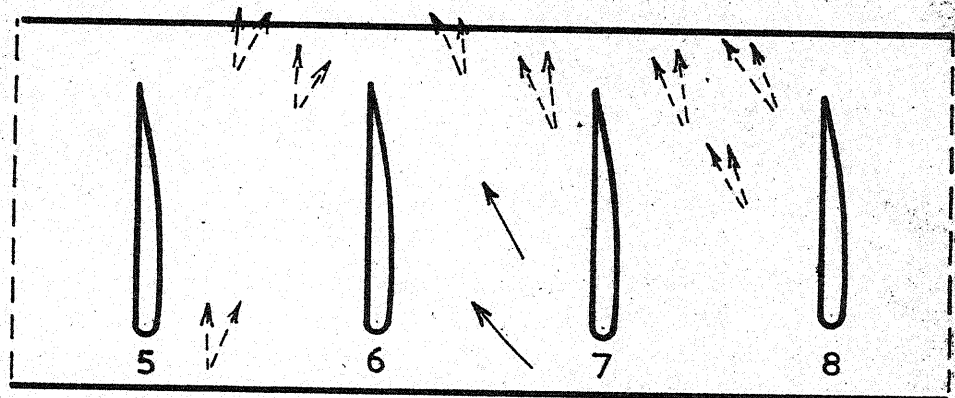
FIG. 4. ORIGINAL CONDITION-PLUS REAR DIVIDING PLATE.

The flow pattern at exit is sketched in figure 4. It is shown that large angular variations in flow direction across the annulus are present and vanes 2, 3, 6 and 7 are stalled. It was noticed that the dividing plate had increased the flow unsteadiness but had eliminated the oscillatory nature of the flow.

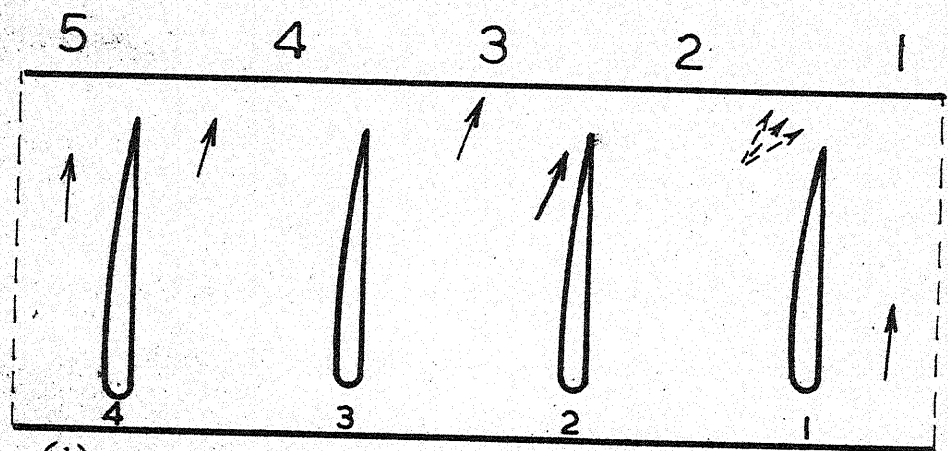
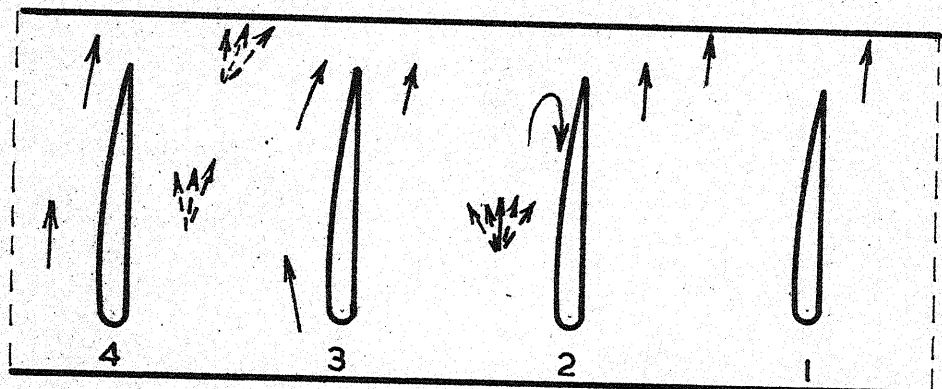
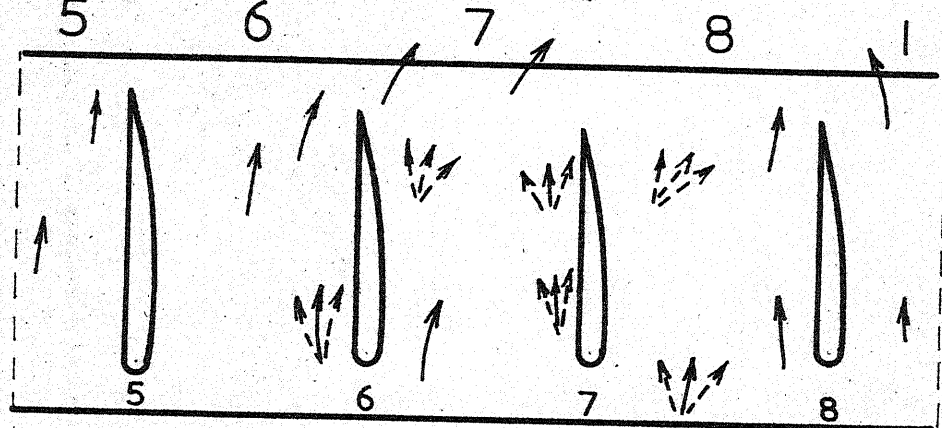
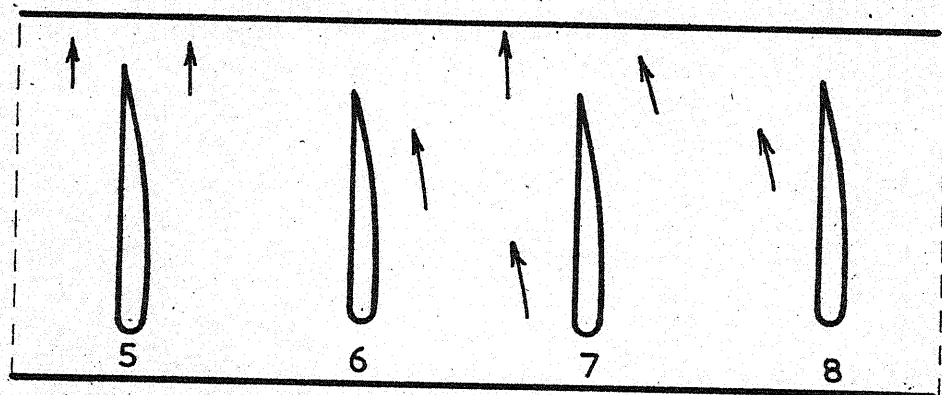
FIG. 5. DOUBLE FAIRING AT REAR OF CASING

The geometry of the curved fairing can be seen in figure 6b and the flow pattern in figure 5. It is shown that the flow has been improved in passages 4, 5 and 6 but vanes 2, 3, 6 and 7 are still stalled. Leading edge slats of small chord fitted upstream of these vanes eliminated the stalling but the large angular variations in the flow direction at exit still remained.

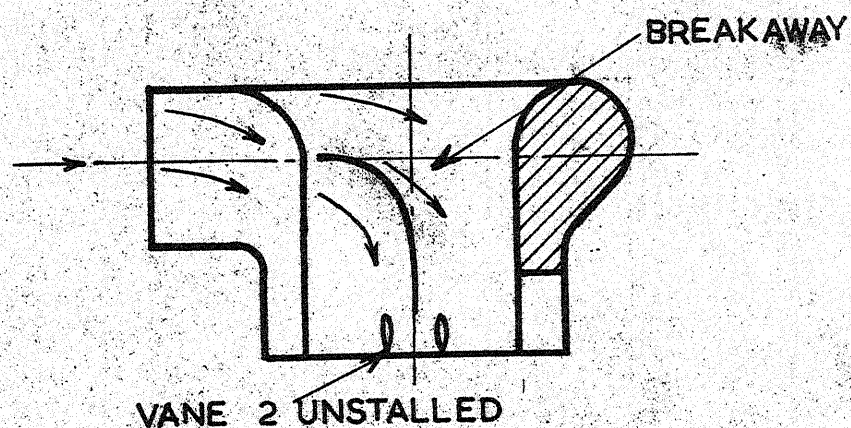
FIG. 7a. FLOW WITH LONG CENTRAL GUIDE VANE.

The position of the vane, in passage 3 only, is shown in figure 7a. It can be seen that the leading edge of the vane was not in the direction of the oncoming flow. This vane was completely stalled. Vane 2 was unstalled although eddying flow was present in passage 2. The flow was very unsteady in passage 4.

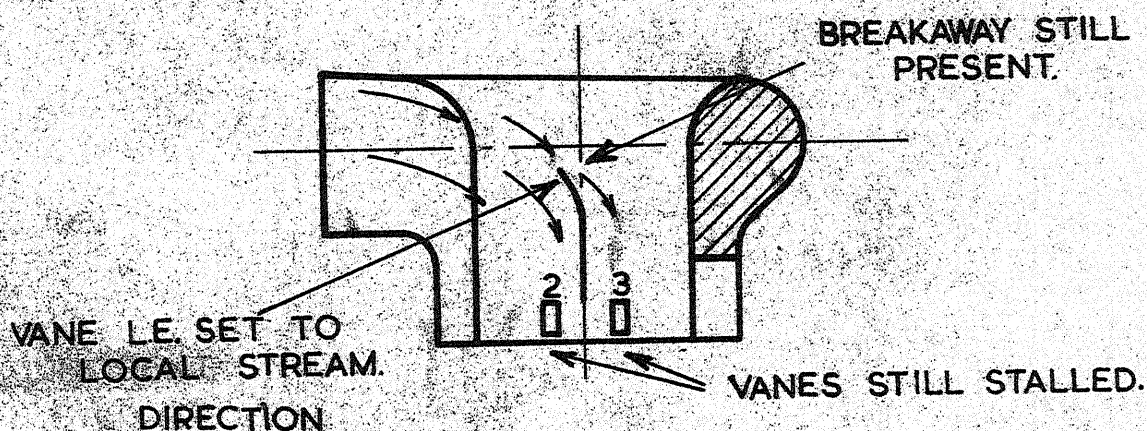
FIG. 7b. FLOW WITH SHORT CENTRAL GUIDE VANE.

The position of the vane in passage 3 is shown in figure 7b. Although the leading edge was now set in the direction of the upstream flow 'breakaway' was present on the upper surface and both vanes 2 and 3 were stalled.

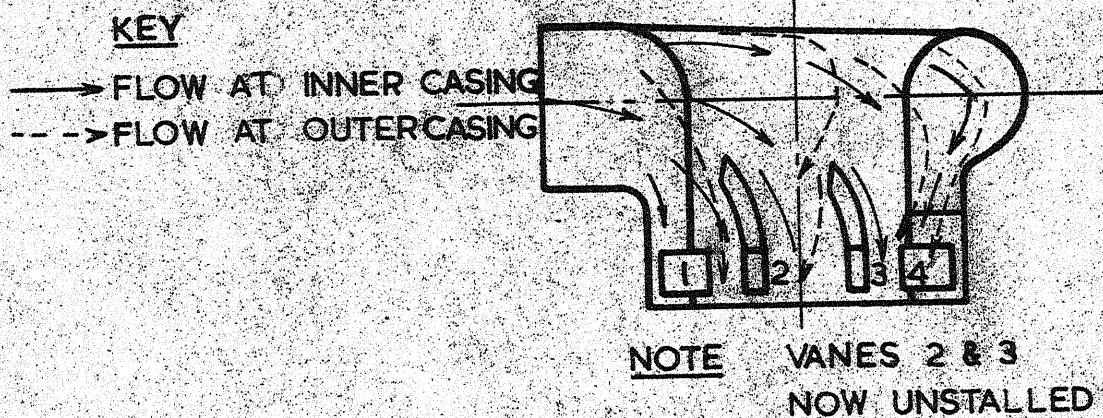
FIG. 8. FLOW WITH EXTENSIONS TO VANES 2 & 3.

The vane extensions to guide vanes 2 and 3 together with the flow configurations are shown in figure 8. The leading edge of the extension to vane 2 had to be carefully set to prevent stalling. The change in flow direction across the annular passage in section 3 was still approximately  $20^\circ$  and a standing eddy could not be eliminated by local movements of the guide vane extensions. The guide vanes were now in turn lengthened and shortened but the exit flow configuration could not be changed.

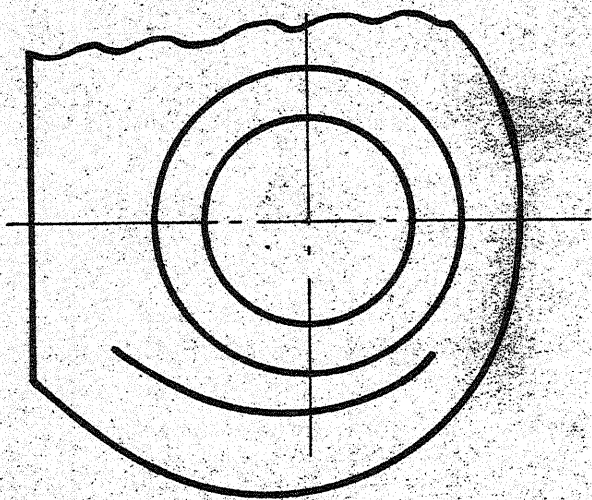
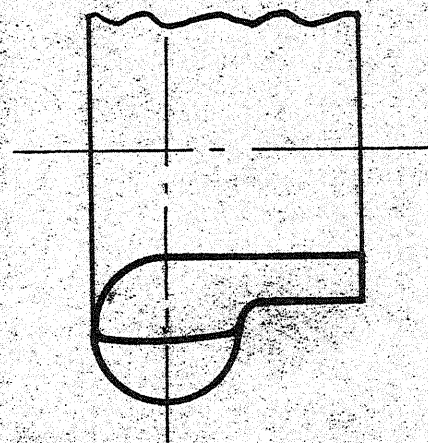
FIG. 11. LONG SPLITTER PLATE.

The plate is shown in figure 11. It was hoped to feed passages 1, 8 and 7 from the 'inner' and passages 6 and 5 from the 'outer' flows. Observations showed that disturbed flow in passage 7 was caused by a partial breakaway from the sharp radius between the external casing and the outlet annulus. Disturbed flow in passage 8 was due to uneven mixing at the trailing edge of the splitter plate as well as a reversal in the direction

of the flow in the outer channel.

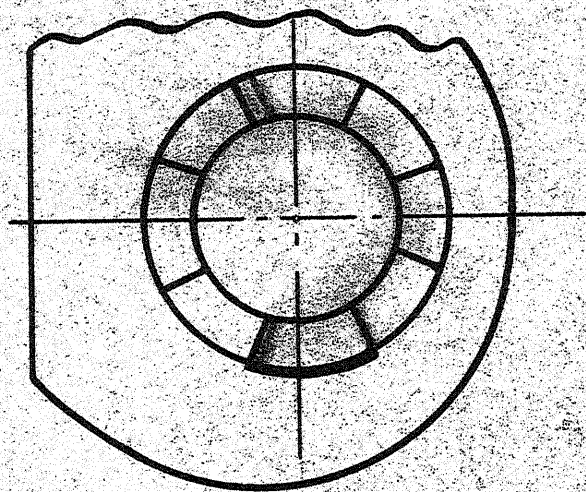
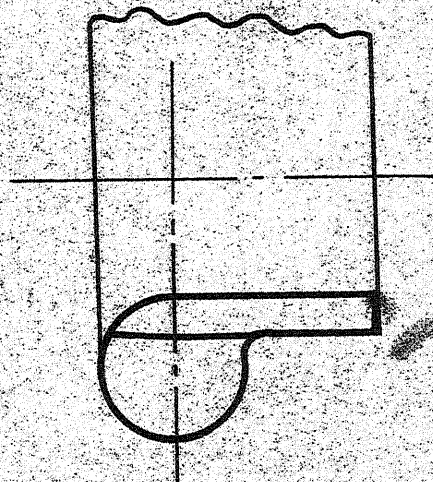
FIG. 12. SHORT SPLITTER PLATE.

The plate is shown in figure 12. It was shown that little change in flow direction occurred across the annulus at passage 7. This decided improvement had therefore been obtained by suppressing the small radius on the external casing (see para. 3.15). The flow was, however, disturbed in passages 8 and 6 owing to interference of the upper and lower flows at the ends of the plates.

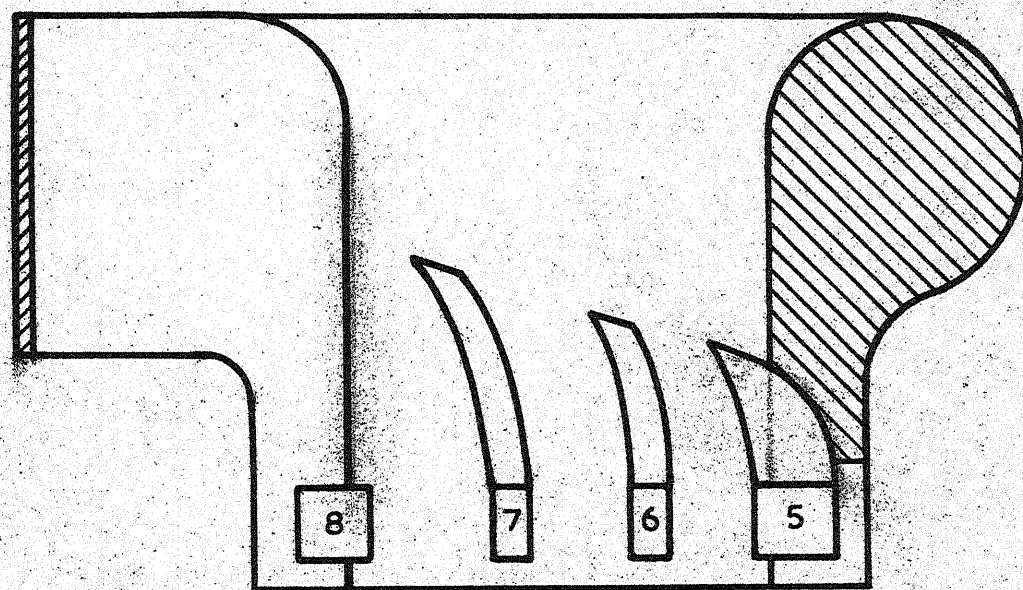
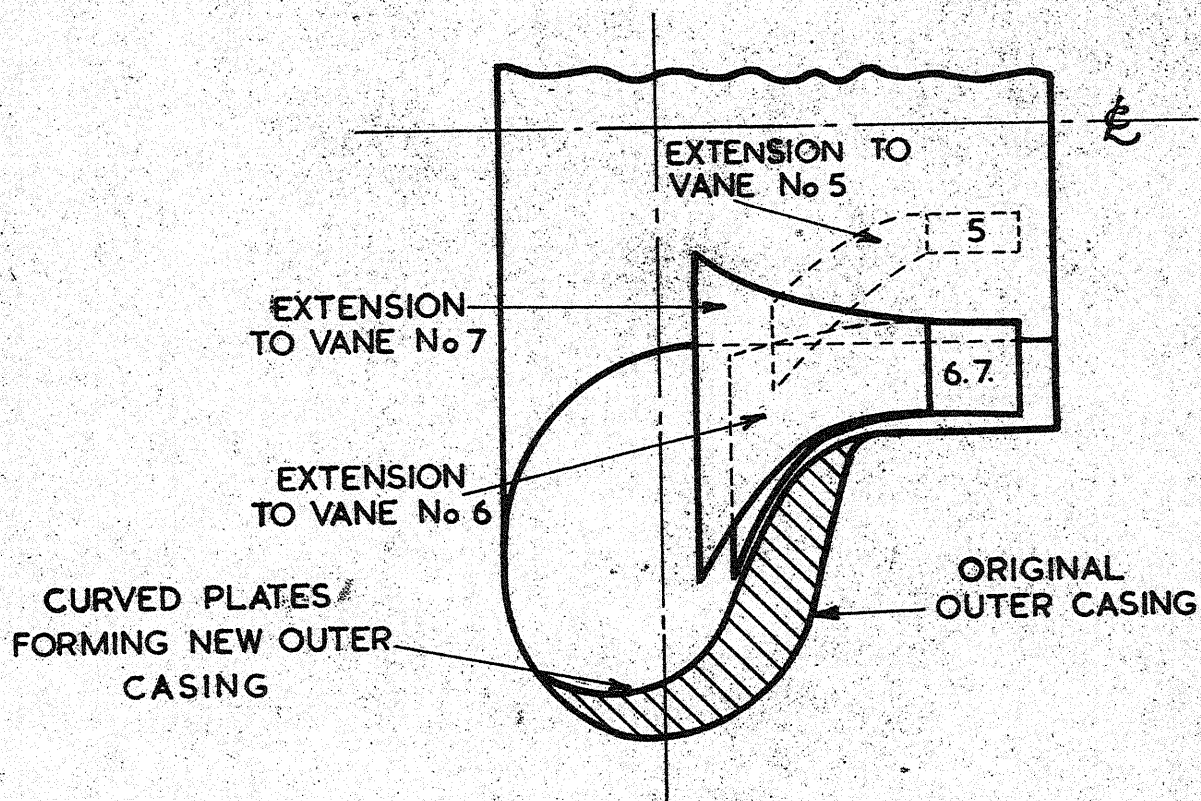
FIG. 13. FINAL CONFIGURATION.

Observations showed that the angle distributions across the annulus in passage 7 were uniform within  $5^\circ$ , but guide vanes 6 and 7 were stalled. A surprising feature, in this condition, was the steadiness of the flow in section 8 whereas the flow in section 6 showed a tendency towards reversal.

The size and shape of the vane extensions were changed until vanes 6 and 7 were unstalled. The geometry of the vanes is shown roughly in figure 13. The tendency to flow reversal was still present in section 6.

This vane extension is also shown in figure 13. This modification prevented the flow reversal in section 6 by diverting the flow in the outer sections of the casing through the lower part of section 5.

The outer casing (lower half only) was modified as shown in figure 13. The new inner surface provided a smooth entry at its forward end, and joined the rear plate curved fairing at its downstream end. In addition the sharp radius in the outer casing was eliminated.

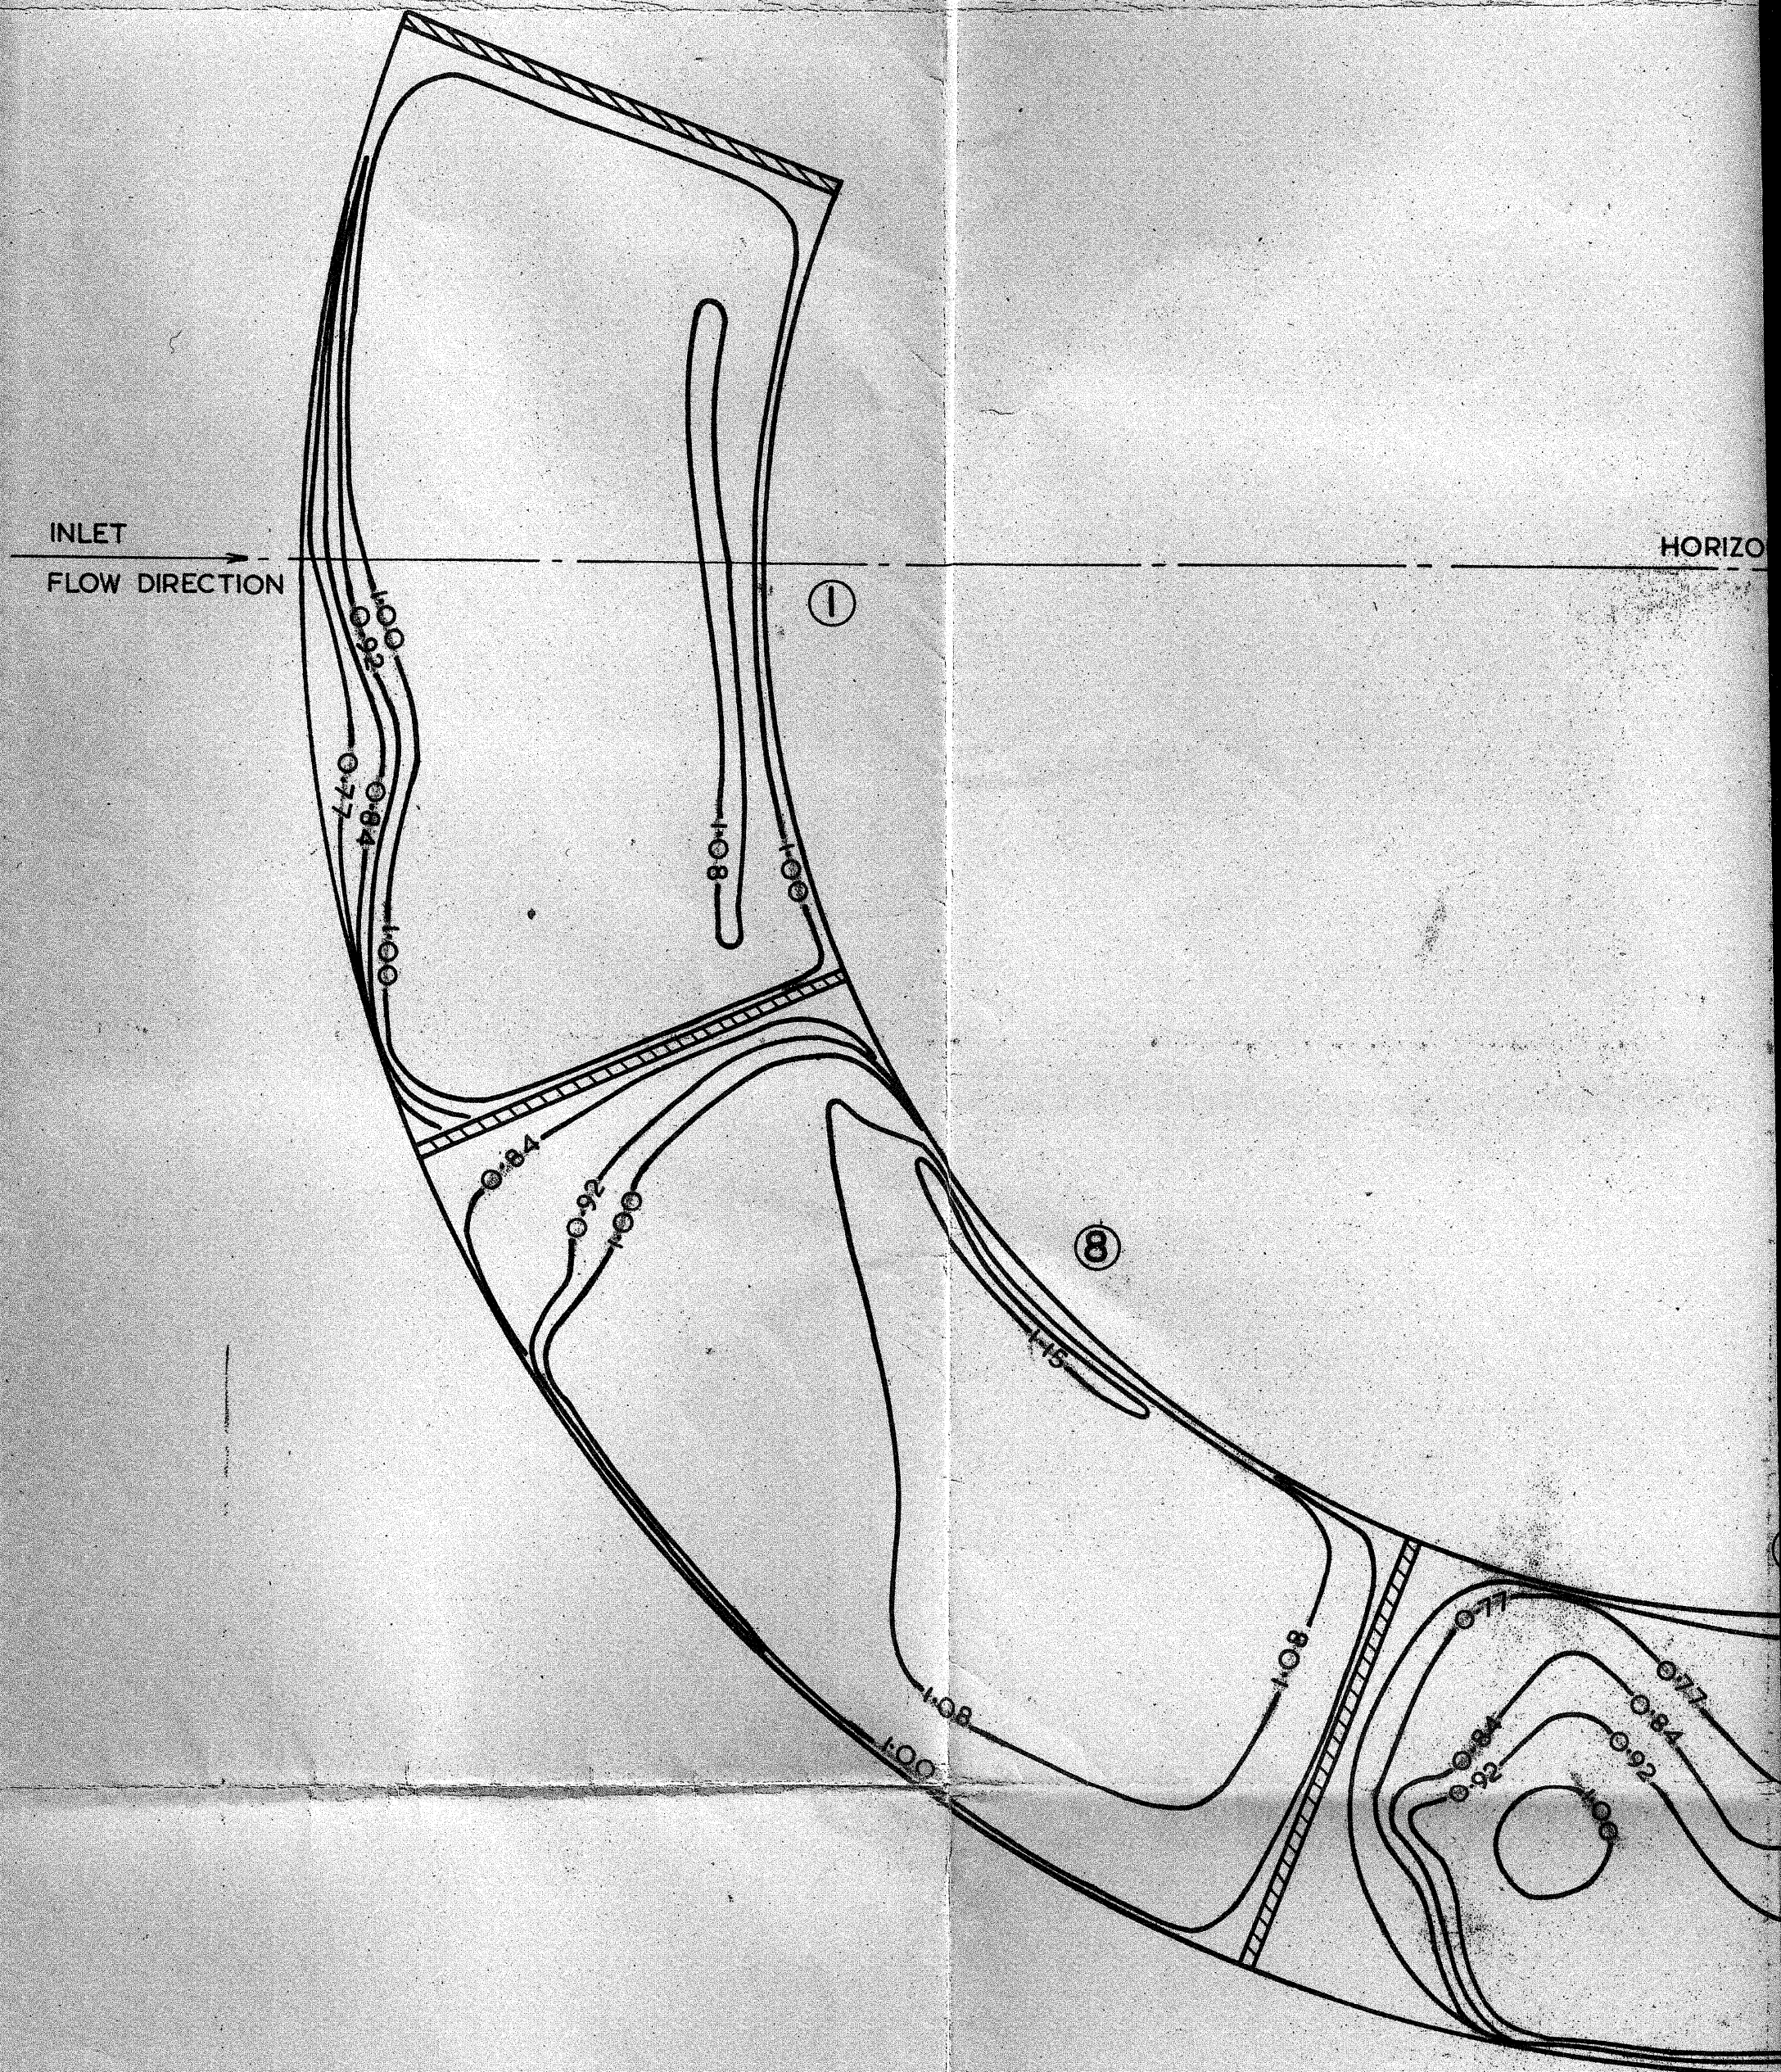
Accurate total head distributions at exit could not be obtained in the basic condition owing to the flow unsteadiness. In the final condition (see para. 3.21) the total head distribution is given in figure 14. This contour diagram shows clearly that secondary flows between the guide vane annular passages are responsible for the slight non-uniformity.

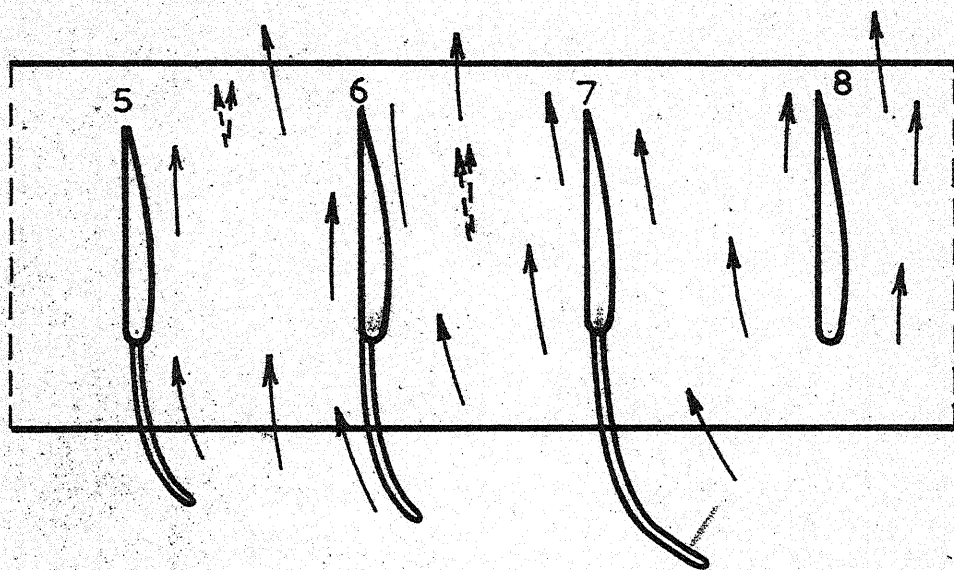
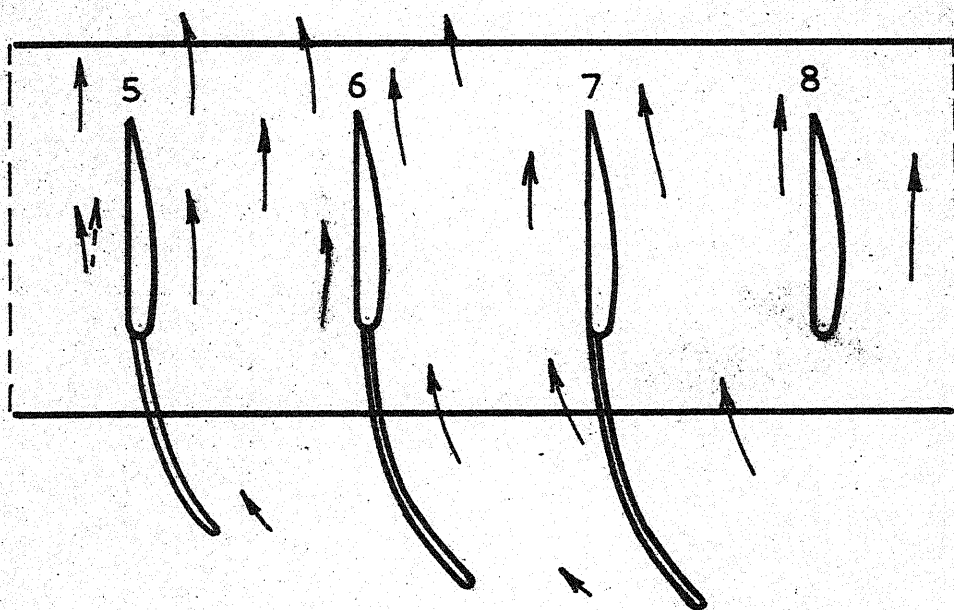
FIG. 15. FINAL FLOW CONDITION.— LOWER CASING.

The disturbed flow in passages 5 and 6 was now reduced by the addition of this curved fillet. The flow configuration is shown in figure 15.

Further modifications were now considered unnecessary as the flow at exit satisfied approximately the conditions of uniform steady flow and the angle distribution varied from  $+5^\circ$  to  $+10^\circ$  outside the wakes from the guide vanes. Total head distributions confirmed that the flow was approximately uniform (see paragraph 4).

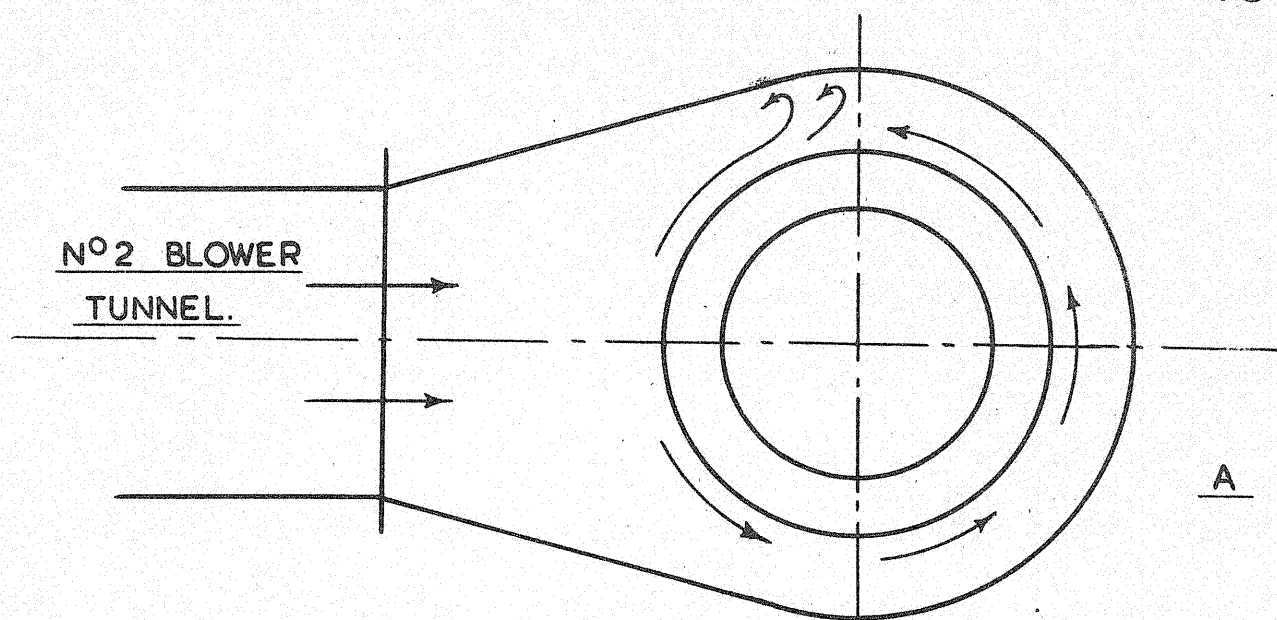
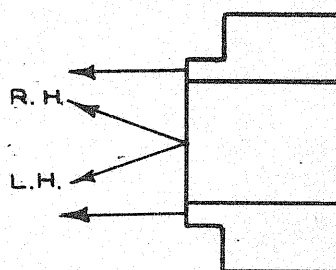
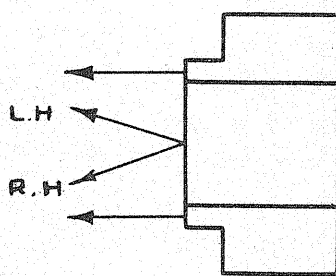
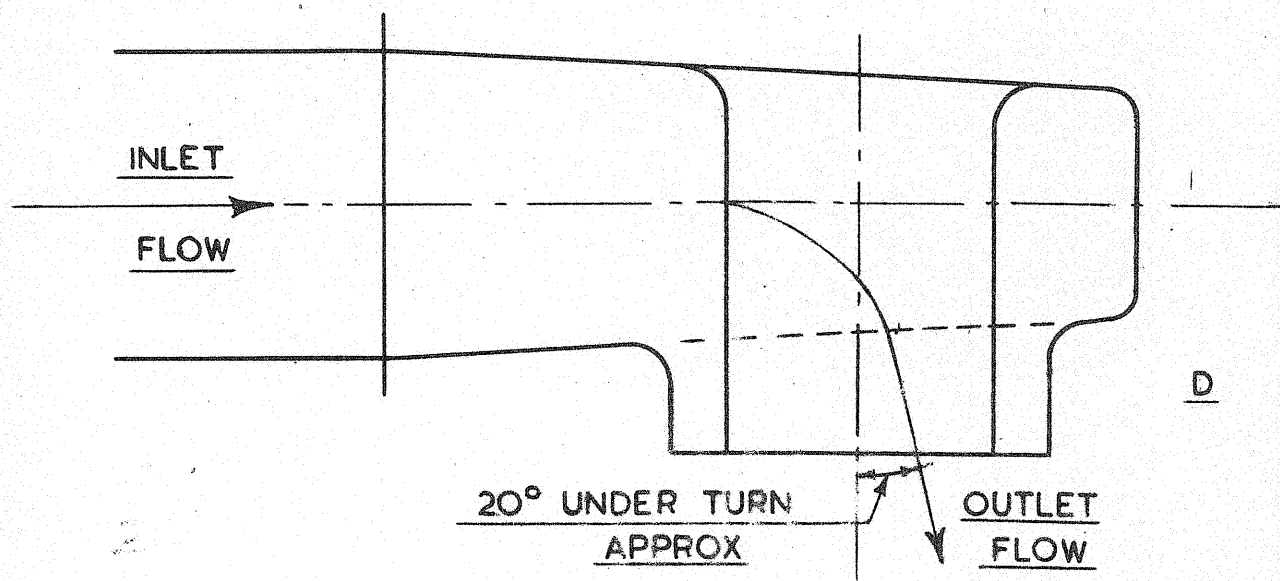
FIG 2

This flow condition is represented in figures 2a, 2b and 2c.

The remainder of the inlet flow was under-turned by approximately  $20^\circ$  in passing through the casing, as shown in figure 2d. The combination of the radial oscillatory flow and the under-turning caused an instability of the flow at the outlet from the casing as shown in figures 2b and 2c.

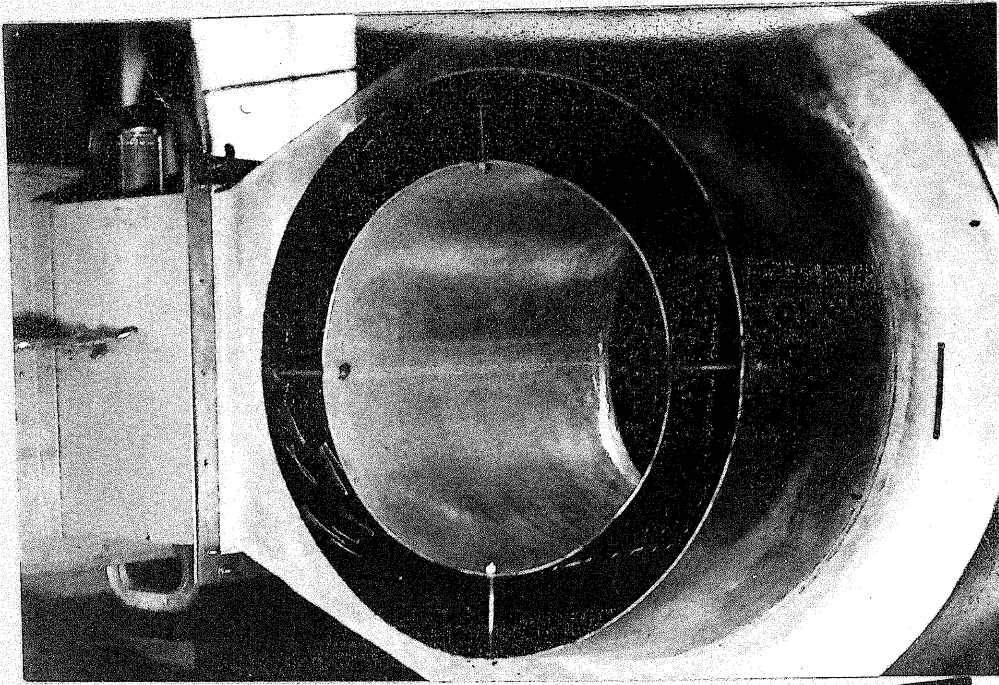
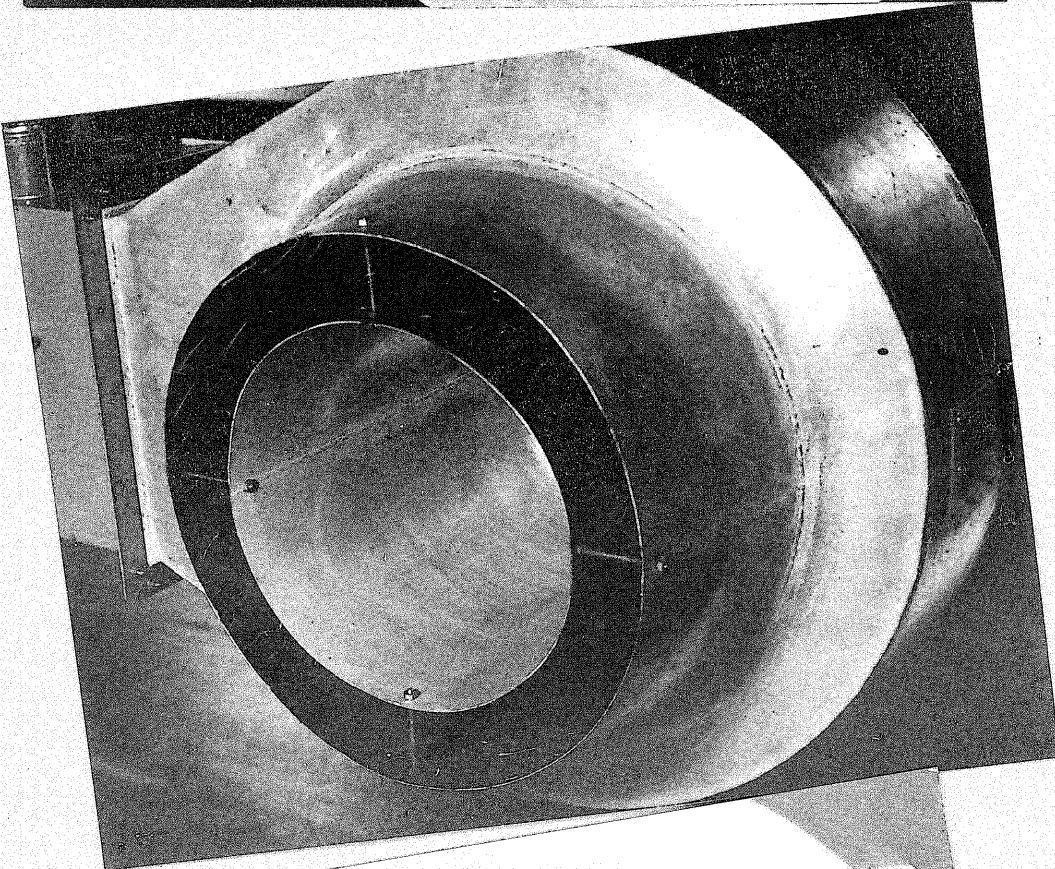
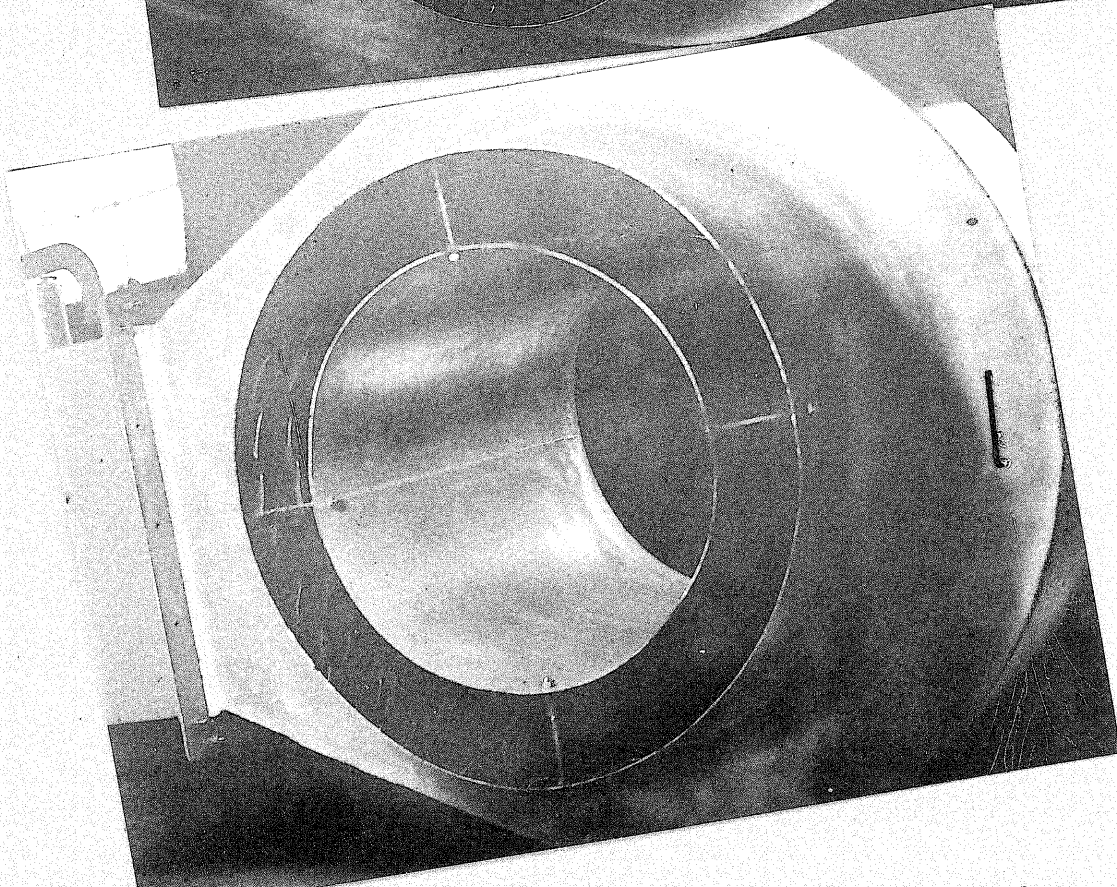
FIG. 3.

Photographs of the nylon threads around the outlet are shown in figures 3a, b and c. Figure 3a shows the tufts on the left hand side of the outlet are pointing  $60^\circ$  upwards from the horizontal whilst figure 3c shows the tufts pointing similarly but in a downwards direction. Figure 3b shows the tuft configuration in an intermediate condition.
