# **Private Sector Participation in Low Cost Water Well Drilling**

**Knowledge and Research (KAR) Project R7126**

## **Contractor Drilling with Pounder II**

**Danert K and Carter R C  
December 2000 – June 2001**

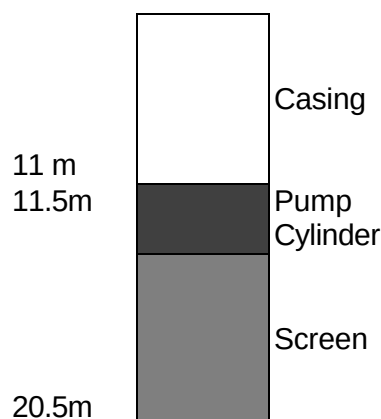
### ***Well Profile***

The RWL on day five was 2.2 and the hole had collapsed back to 16.5m. The reaming proceeded slowly due to the hard layers at the bottom. Installation of the screen, pump cylinder and casing along with 1 1/2 bags of gravel pack was undertaken followed by a rough pump test using the drill pipe pump test arrangement. The drawdown was rapid and considerable fine sand was pumped out.

A return visit was made to Ntunda to undertake a pump test. The well was pumped to the suction limit with the treadle pump, after which a DC pump was used. The test indicated that, after one hour of pumping at a rate of 0.15 l/s, the water level was at 9.4m and still drawing down at a rate of approximately 4 cm in 5 minutes. However, the recovery was very rapid and recovered to 8m in 23 seconds, and to 7m in 54 seconds. It was estimated that a hand pump at this site was unlikely to be in constant use, due to the low population density, giving the well sufficient time for recovery. Thus, it was decided that this was a suitable hand pump site and the installation was completed.

The complete installation was undertaken without the full supervision of the Low Cost Drilling Project staff, and upon inspection, a number of changes had to be made to prevent long term problems with the pump. In particular, the centralises had to be replaced for those in the specification Annex 2 / 3 in the Final Report, the seal had to be adjusted and glued, the top rod altered, and the plunger and foot valve replaced (worn components had been utilised). In addition, the well was pumping significant quantities of sand causing high turbidity (NTU 2000).

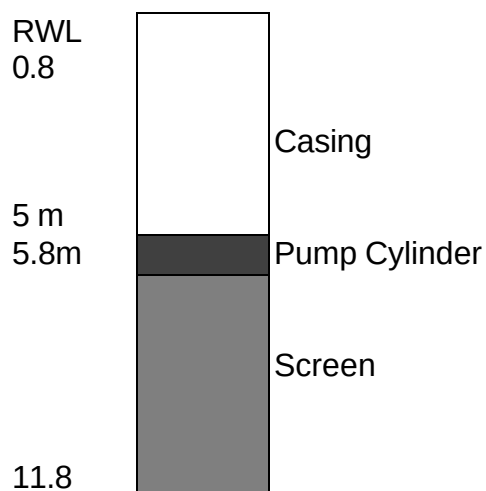
#### **Well Profile**

The community complains that the water is salty, although they say that is better than the water from another well constructed in the area earlier. The other well was vandalised by thieves who were interested in the pipes. As the Pounder well components plastic and are fixed in the ground, the pump is not likely to be vandalised.
