# Experimental observations of an 8 m/s drop test of a metallic helicopter underfloor structure onto water: part 2

K Hughes\*, R Vignjevic, and J Campbell

Crashworthiness, Impacts and Structural Mechanics Group, School of Engineering (CISM), Cranfield University, Cranfield, Bedfordshire, UK

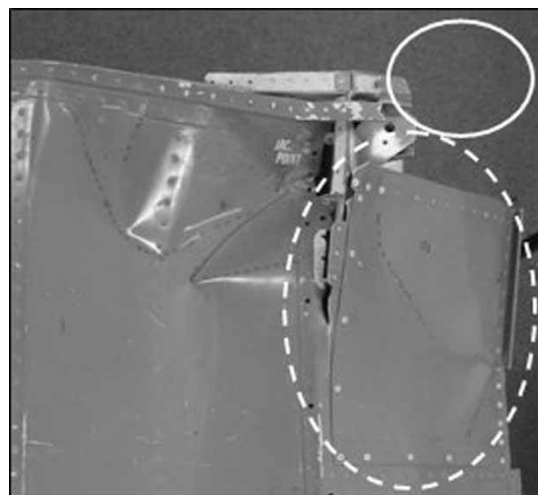
**Fig. 3** Underside view of the starboard landing gear assembly that shows the location of the replaced skin panel (dashed circle) and the missing landing gear attachment (solid circle)

in the post-test report, as a replacement panel was riveted to this section as shown in Fig. 3, together with the removal of the port landing gear attachment. This changed the localized stiffness at this location, so damage to this side of the floor was neglected.

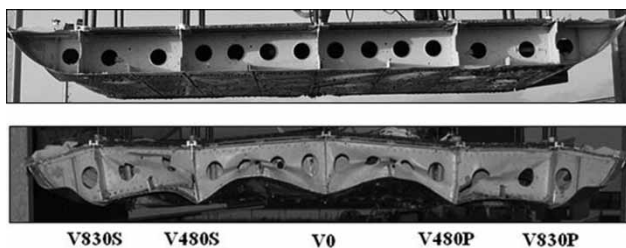
**Fig. 5** Pre- and post-test response showing the degree of deformation along STN370A at the forward section of the subfloor

Due to the distortion of STN370A, inward and outward deflections are also evident, which can be clearly seen in Fig. 5. The degree of skin deformation decreases in magnitude as one moves closer to V830P, due to the increase in strength of the construction and the lack of deformation observed. The midspan deflection is larger than STN370A when one compares locations 20 and 21. This difference is attributed to the fact that the increase in water pressure only has to overcome the structural rigidity provided by the reinforcing z-stringer, whereas frame collapse is required for STN370A.

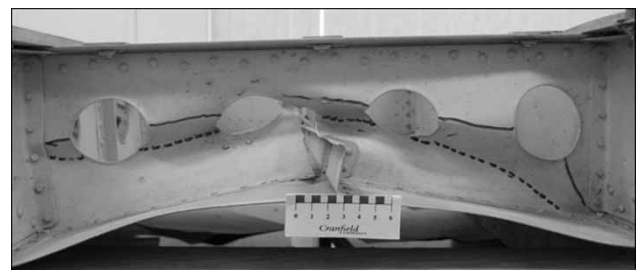
Due to the inward deflection of the skin, the single frame buckles at the midpoint, as shown by the continuous and dotted lines in Fig. 6, which represent an inward and outward hinge, respectively. The upward movement of the skin causes the central z-stringer to cut into the frame, causing localized material failure in Fig. 7.

**Fig. 6** The location of plastic collapse of STN370A located between V480S and V0

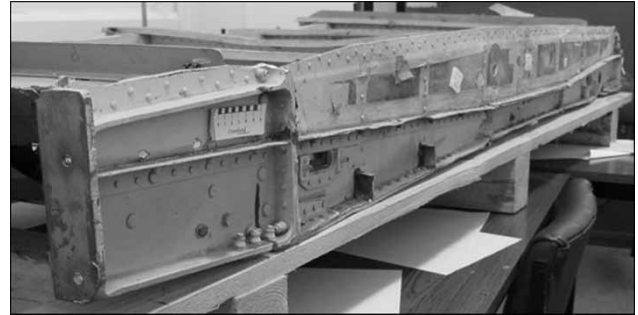
STN1210A forms part of lower aft bulkhead and is a substantial component due to the attachment of the port and starboard landing gear assemblies, and the reinforcing rail that runs along its length, as shown in Fig. 9. As expected, no significant deformation is observed as this frame retains its structural integrity, with only slight damage observed at the base of the z-stringers, together with slight plastic hinge lines forming at the intersections with the longitudinal v-frames.

**Fig. 9** Due to the high strength construction of STN1210A, no deformation is observed

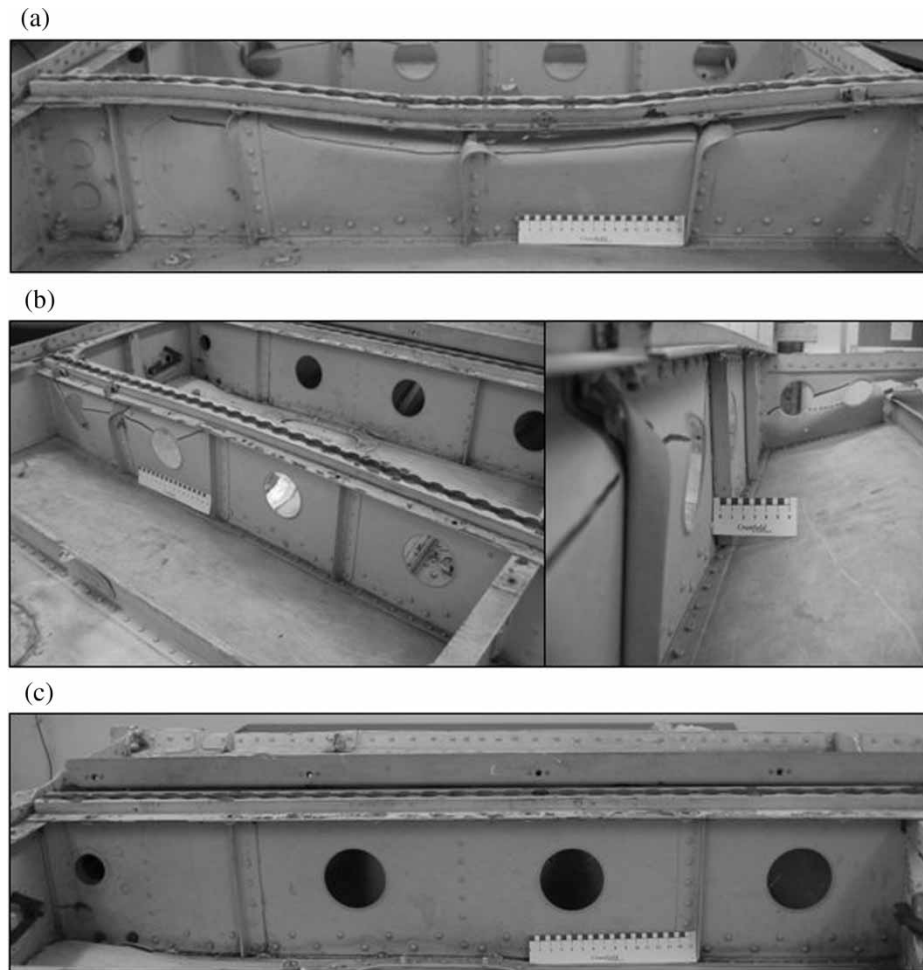
The aft part of V0, situated between stations STN-1210A and 370A, consists of a single metallic sheet that is reinforced by three evenly spaced L-section stringers. The failure mode for this frame consists of single hinge line that forms in the upper part of this frame as shown in Fig. 10(a), which is a direct consequence of the proximity of the applied loading that was attached either side of the central stringer. The outward buckle results in the stringers adopting this failure mode, causing small localized material fractures at the peak of this deflection.

This frame configuration can be found in Fig. 10(b) and is the most common, as it consists of a single metallic sheet reinforced with evenly spaced L-stringers and also contains four circular cut outs that act to reduce the weight of the frame. Limited deformation is observed, which is consistent with current understanding, as the current construction is not able to transfer the increase in water pressure to these energy absorbing components. Therefore, the available stroke is not utilized and very little energy is absorbed.

The deformation observed towards the aft part of this frame is caused by the failure of the upper seat track and STN1210A, due to the proximity of one of the pairs of attachment points located at the last two seat track positions shown in Fig. 11. This separation results in an upper hinge line that spreads to the mid-point of V480, as this frame now solely supports the loading. Also shown in Fig. 10(b) is the severity of the skin in relation to the height of the undamaged V480P,

**Fig. 10** Comparison between the different failure modes observed for (a) V0, (b) V480P, and (c) V830P. (The frame orientations are normal to the water surface)

which demonstrates quite succinctly the dominant behaviour of the skin for an impact on water.

The final frame configuration shown in Fig. 10(c) is similar in construction to configuration #2, except the frame does not have a vertical stringer located at the midpoint. Instead, this frame is directly riveted to a curved transverse end frame, which provides the vertical support. Due to the high strength nature of this construction in relation to the flexible skin, no deformation is observed.

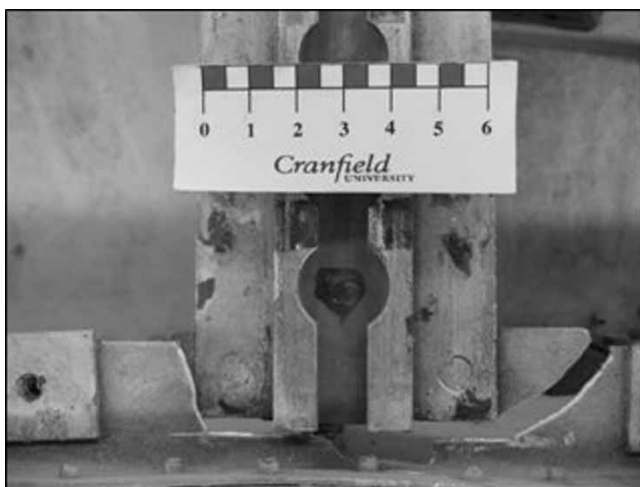
**Fig. 11** Top down view of the shear failure of the upper seat track at the intersection between V480 and STN1210A

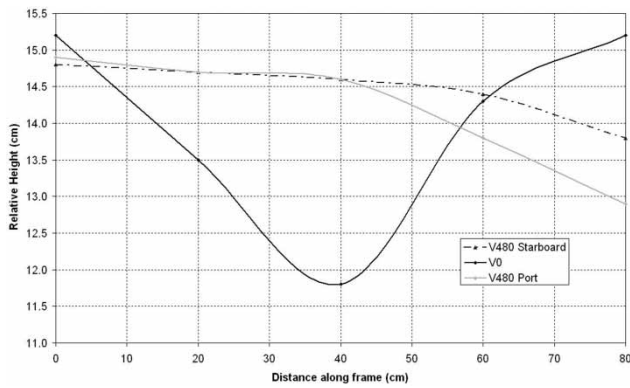
To conclude, due to the high strength nature of the construction and the inability to transfer the membrane loads generated in the skin, the forces generated are insufficient to initiate collapse in the longitudinal frames. This lack of deformation means that their contribution to energy absorption will be small, as demonstrated by the comparison presented in Fig. 12 for the relative heights at different points along these frames. This infers that the failure strength of the structure is a critical parameter for a water impact and indicates that the current construction exhibits too high a failure strength, due to the inefficient use of structural collapse as an energy absorbing mechanism.

**Fig. 12** Graph of compacted heights for the longitudinal frames which shows that the lack of collapse demonstrates that the membrane loads generated are insufficient to trigger collapse

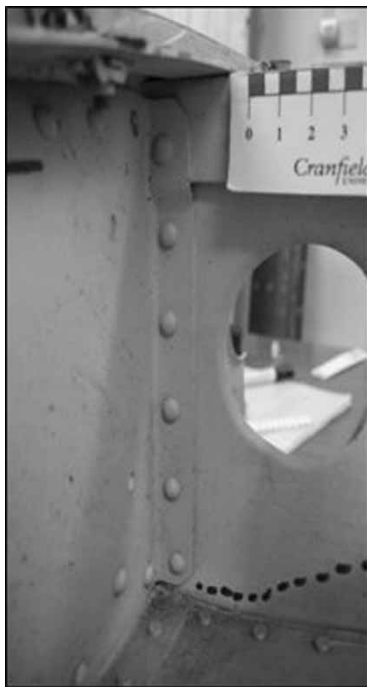
The collapse of a box section is heavily dependant upon the behaviour of the supporting frames, together with the collapse of the intersection joints. These joints are extremely strong, due to the plies that are riveted together and the reinforcing brackets that are used. As the loads encountered during a water impact are less than those that are generated during a hard

**Fig. 13** A lack of intersection joint collapse is a common feature observed during a water impact, as the intersection between STN370A and V0 orientated normal to the water surface demonstrates

surface impact, the membrane loads generated are insufficient to cause collapse as no deformation is observed [18]. The stabilizing effect of these joints will reinforce and support the frames, resulting in very little energy being absorbed, as shown in Fig. 13. Progressive collapse needs to be encouraged for the water impact case, if improvements in energy absorption are to be gained.

The first recommendation concerns the very stiff sections of the subfloor that are too strong from a water impact point of view. This includes the intersection joints that form between the frames and the frames themselves. Consideration should be given to encourage frame collapse at lower loads through the use of geometry, material type, and the inclusion of triggers. The caveat with this approach is that if the failure strength is optimized for a water impact, a poor crashworthy response may occur during an impact onto a hard surface.

The second area for improvement concerns the development of the stiff intersection joints, as the collapse of a typical box-section is heavily dependant upon the failure of these joints. A proposed concept demonstrator solution to this problem can be found in reference [18]. This area of research is closely linked with the development of the skin, as successfully transferring the water pressure will be essential to encourage progressive collapse.

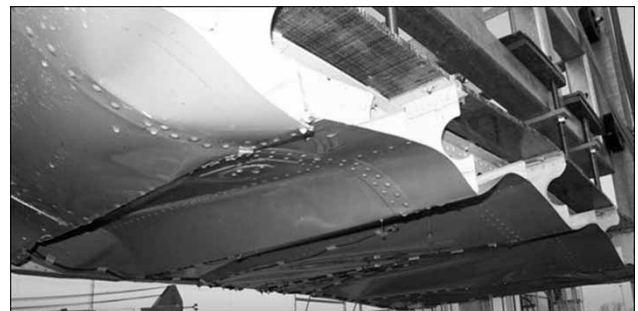
The membrane behaviour of the skin is of paramount importance for an impact on water, as the deflections form part of the energy absorbing process, due to the kinetic energy imparted to the water. An underside view of the skin response can be found in Fig. 14, which shows the port deformation in the region surrounding STN370A.

**Fig. 14** Underside view of the port side taken after the drop test. Picture courtesy of CIRA [10]

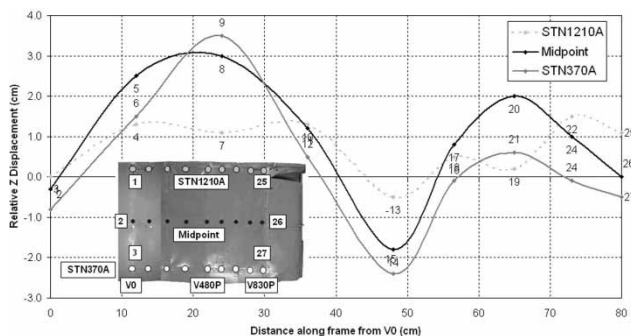
The measurements can be found in Table 3 and are presented graphically in Fig. 15. A positive relative displacement means that the point is higher than the reference point (i.e. it has moved inside the internal structure of the subfloor), whereas a negative value indicates that the point is lower than the reference point.

As no frame collapse is observed for STN1210A, the displacement of the skin at these locations is

**Fig. 15** Comparisons between the relative skin deflections near STN1210A, located between V0 and V830P. All measurements taken relative to aft of V0

small and is typically of the order of 1.5 cm. The skin deflections along the midspan and STN370A are comparable, which peaks at the midpoints in-between the longitudinal frames V0 and V480P. The deflections are of the order of 3 cm and correspond to the failure of the single skinned STN370A at this location, due to the interpenetration of the central z-stringer shown in Fig. 7.

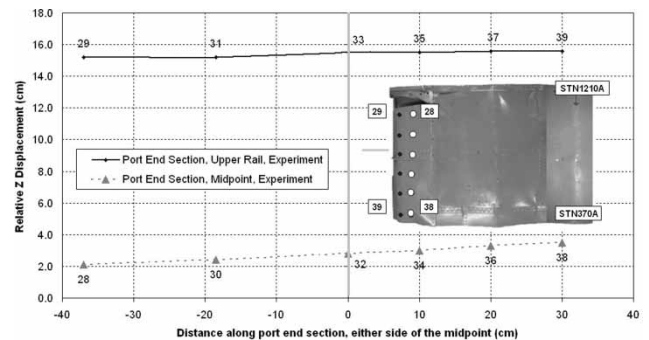
Table 4 provides a comparison between the relative displacements for the skin at various port side locations for the curved end section, using the same reference point at the intersection of V0 and STN1210A. Due to the limited relative deformation presented in Fig. 16, the results demonstrate how the shape can cause the redirection of the water surface, which can be beneficial in minimizing the loading at these locations.

**Fig. 16** Comparisons between relative skin deflections along lower and upper part of port curved end section. All measurements taken relative to the intersection of V0 and STN1210A
