# Dynamic investigation on the Mirandola bell tower in post-earthquake scenarios

**Abstract** After the seismic events of the 20th and 29th of May 2012 in Emilia (Italy), most of the monumental and historic buildings of the area were severely damaged. In a few structures, partial collapse mechanisms were observed (e.g. façade tilting, out-of-plane overturning of panels...). This paper presents the case-study of the bell tower of the Santa Maria Maggiore cathedral, located in Mirandola (Italy). The dynamic response of the structure was evaluated through operational modal analysis using ambient vibrations, a consolidated non-destructive procedure that estimates the dynamic parameters of the bell-tower. The dynamic tests were carried out in pre-intervention and post-intervention conditions in order to understand the sensitivity of dynamic measurements to safety interventions. Furthermore, a comparative study is made with similar cases of undamaged masonry towers up to the 6th mode. Finally, an investigation on the state of connections and of the building itself is carried out via FE model updating.

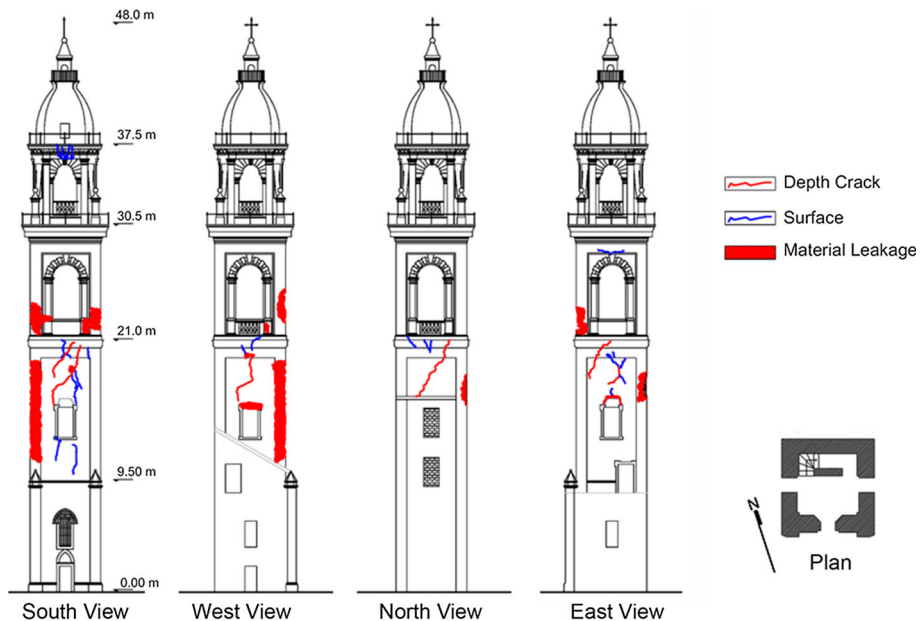
The May 2012 Emilia earthquake sequence severely damaged the cathedral, with two events on May 20th and 29th. The epicentre of the May 29th event was less than 1 km far from the site of the bell tower, which led to massive destruction to the historical city centre of Mirandola. It resulted in the collapse of the aisle, the side aisle, the roof and in several cracks on the bell-tower (Fig. 2).

An exterior laser scanner survey of the cracking patterns, carried out by the INGV (Istituto Nazionale di Geofisica e Vulcanologia) within the ILRIS 3D project (Pesci et al. 2012), highlighted the activation of a twisting mechanism leading to a rotation of about 1 degree of the building portion located between 20 and 32 m. The structural damages are mainly concentrated in this section of the bell tower, where deep diagonal cracks right below the first order of openings on all four sides can be noted, extending down to the openings of the underlying level. Furthermore, various lintels failed on the South, West and East fronts. The twisting mechanism and the high local stresses caused the crushing of masonry near the area of the tower in contact with the adjacent building, especially at the

**Fig. 2** Post-earthquake damage survey of the Mirandola bell-tower

The maximum displacements values are obtained for the CH-7 position, located in a higher, thus more flexible region of the tower, where the most severe damages were assessed (see Fig. 2). Observing the time-history responses in Fig. 16 and the results in Table 6 it is possible to notice how the amplitude of the response in the PR-I and PS-I configurations is quite similar with all the three aftershocks. As shown in Fig. 16, the response in the direction of the x and y reveals quite similar results between PR-I and PS-I differing only by the time of occurrence of the peak displacement. Only the responses to AS1 and AS3 aftershocks show an improvement of global behaviour when considering the maximum response in terms of displacement.

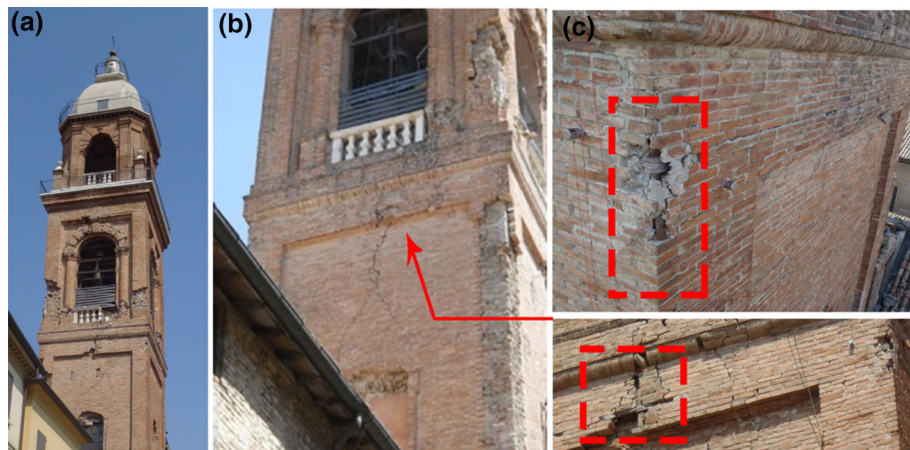
height of 21 m (Fig. 3a, b). Metal chains were revealed by the occurred damages inside the masonry layer around the perimeter at the base of this level of the structure, as shown in (Fig. 3c). The visual and laser scanner surveys did not confirm for the other levels.

**Fig. 3** Damage at the level of the belfry of the bell-tower (a, b) and the metal chains (c) at 20 m

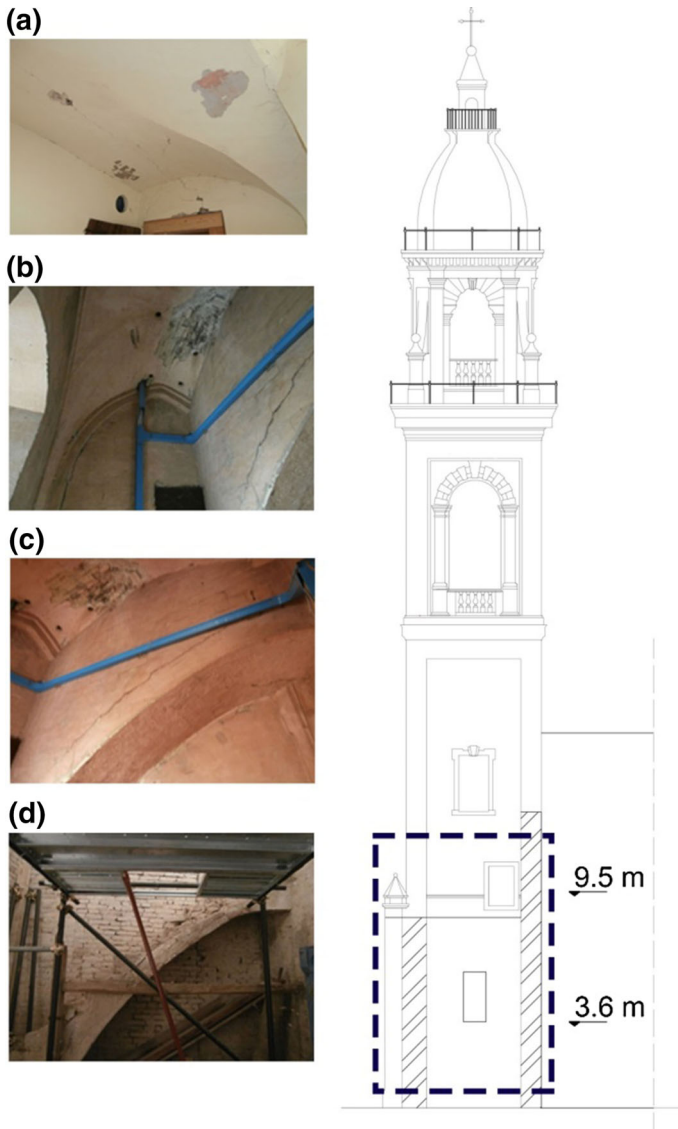
The internal state of the bell tower was assessed by visual inspection and this was compared to the laser scanner survey. Only two masonry vaults in the basement are still standing with clearly visible cracks (Fig. 4a, b). The internal staircases are partially collapsed and only the flight between 0 and 9.5 m (Fig. 4c) is still accessible. From this level up to the belfry all ceilings and stairs are collapsed as can be seen in Fig. 4d which depicts the remains of a flight of stairs at 9.5 m of height.

**Fig. 4** Damage on vaulted slabs at 3.6 m (a) and at 9.5 m (b) and internal staircase (c, d)

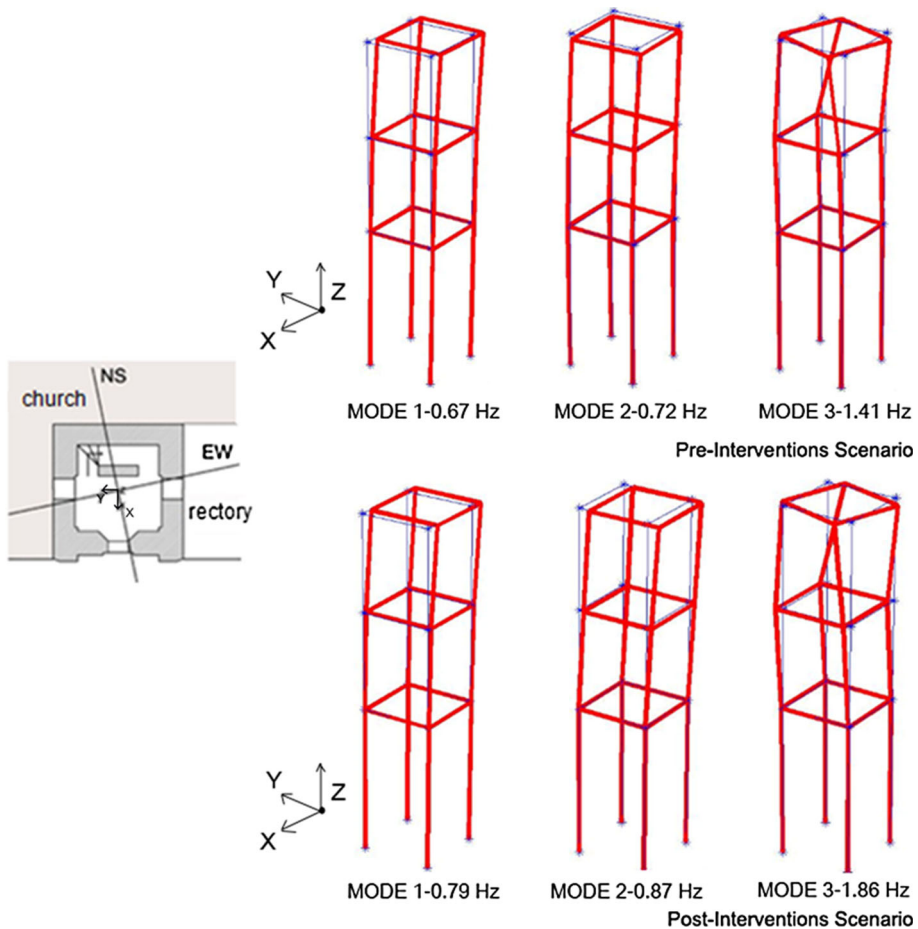
It is also worth noting that, in the PR-I condition, the first and the second flexural modal shapes, directed along E–W and N–S directions respectively, show a coupled behaviour and a value of Modal Assurance Criterion (MAC) of 0.495, whereas after the strengthening interventions they appear almost perfectly aligned with the principal axes of the tower, the MAC decreases to 0.001 (Fig. 9).

**Fig. 9** Bell-tower identified frequencies and modal shapes in the PR-I scenario and the PS-I scenario

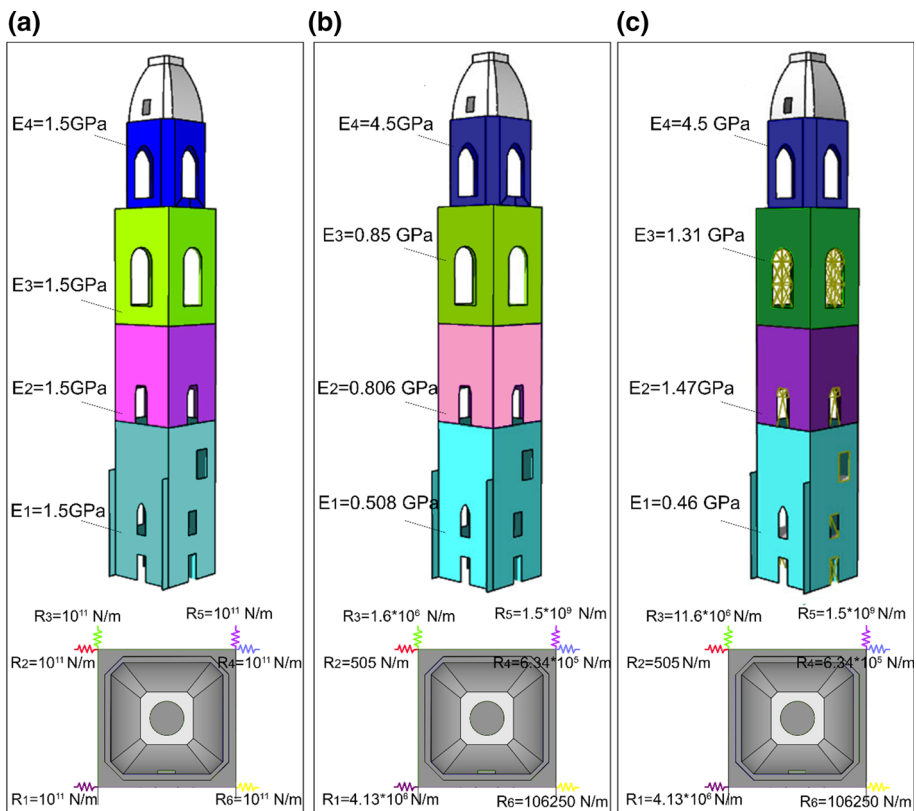
The results of the updating procedure provide further information about the bell-tower damage state (Fig. 14b): the value of 0.508 GPa for the Young modulus of the first sub-part and the others of the upper levels, 0.806 GPa for the second level and 0.85 GPa for the third one, refer to heavily cracked regions of the building. Moreover, these results suggest that the first sector is strongly influenced by adjacent bodies, that have stiffened the basement of the tower, especially on the west side, where the spring-element  $R_1 = 4.13 \times 10^6$  N/m represent the external wall of the church's nave; and on the east-side where  $R_5 = 1.5 \times 10^9$  N/m,  $R_4 = 6.34 \times 10^5$  N/m,  $R_6 = 106,250$  N/m model the rectory building.

**Fig. 14** Model updating results: initial values (a) and the updated values for the pre-intervention scenario (b) and in the post-intervention scenario (c)
