# Signal Processing of Acoustic Data for Condition Monitoring of an Aircraft Ignition System

Umair Ahmed \*, Fakhre Ali and Ian Jennions

Integrated Vehicle Health Management Centre, School of Aerospace, Transport, and Manufacturing, Cranfield University, Bedfordshire MK43 0AL, UK

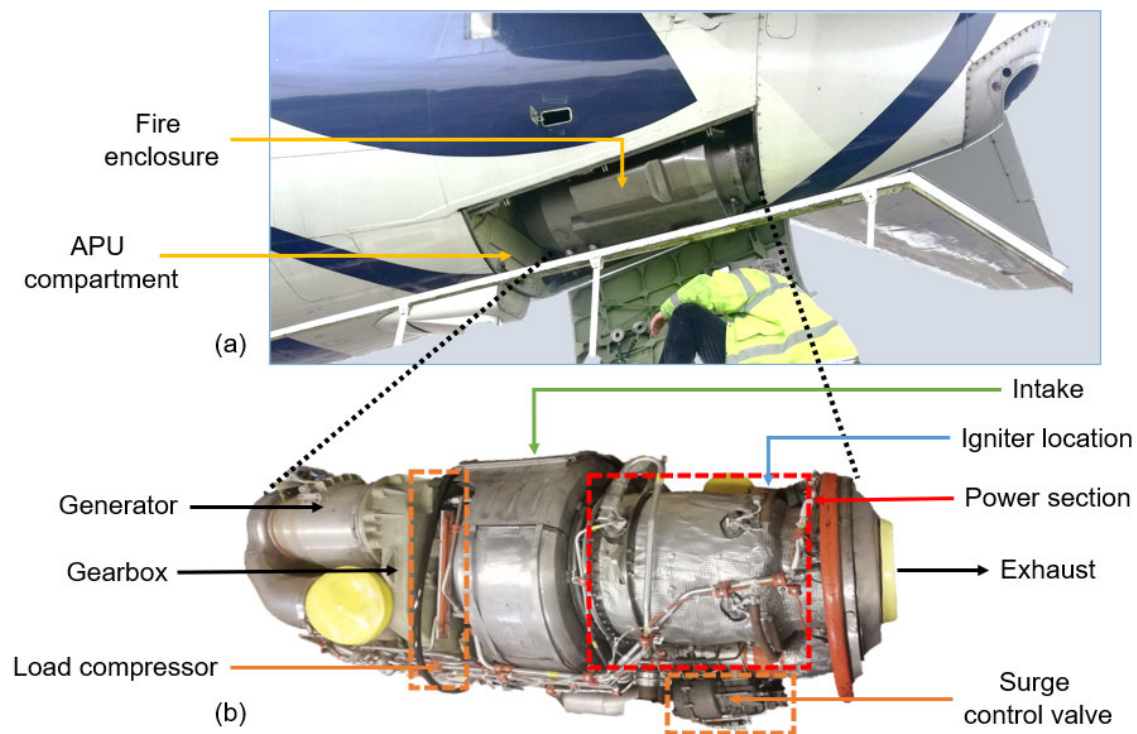
**Figure 1.** The APU of a Boeing 737-400 (a) aircraft tail section and APU compartment; (b) components of the APU.

The APU's startup system consists of a starter motor assembly and ignition system (ignition exciter, igniter, and igniter lead). Aircraft DC power is required to start the APU, which can either be provided externally or by using onboard batteries. This power is utilized by the starter motor to spool up the APU so that the fuel and air mixture reaches the combustor. As per the AMM, from 7–95% of the rated rpm (7768–60,638 rpm), the ignition system is energized using the same DC power to produce a series of sparks that initiates combustion. In the case of a fault or degradation in any of the components of the ignition system, the combustion process will not initiate. Under such conditions, the FADEC terminates the startup sequence, and a 'No Flame' error is displayed.

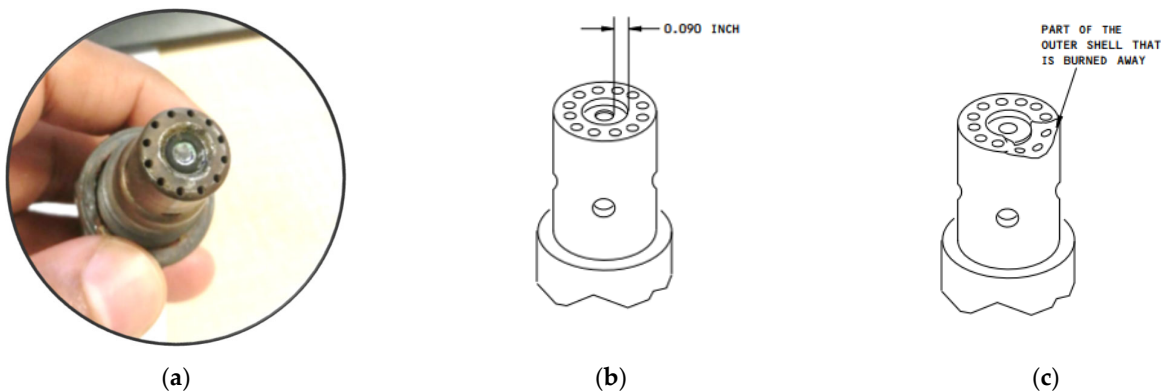
**Figure 2.** APU igniter and faults: (a) actual igniter with eroded tip; (b) nominal limit of erosion; (c) burnt outer shell fault, adapted from [10].

The most common type of degradation that is associated with the igniters stems from their tips being exposed to water or ice, as well as due to their intrinsic wear and tear. As per the AMM, as illustrated in Figure 2, the wear can appear as erosion or damage to the outer surface. This can increase the gap between the electrodes to such an extent that the supplied voltage is unable to produce a spark, consequently leading to the loss of sparks during the startup sequence. On the other hand, a faulty ignition exciter will not produce a series of sparks at the desired frequency, or may not generate the desired voltage to produce a spark. Furthermore, a degraded igniter cable can also lead to a reduction in the amount of electrical energy that is supplied to the igniter, which can result in similar effects.

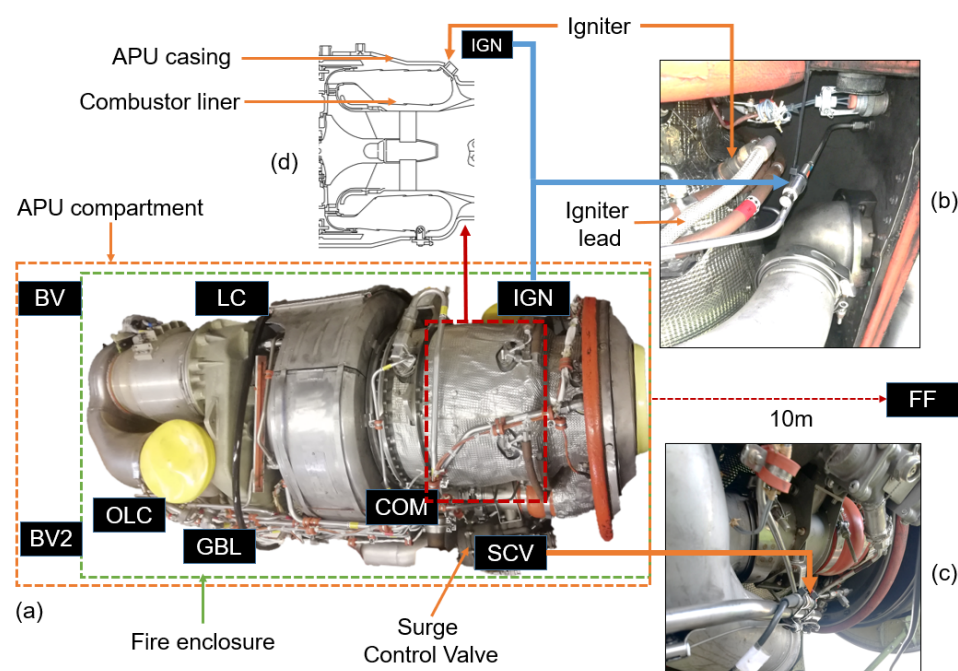
**Figure 3.** Experimental setup: (a) APU and sensor locations; (b) IGN microphone location; (c) SCV microphone location; (d) cross-sectional view of the APU combustor, adapted from [10].

For this study, experimental data were acquired from Cranfield University's Boeing 737-400 aircraft APU. Multiple PCB Piezotronics 130F20 ¼ inch IEPE microphones were installed around the APU, as shown in Figure 3a. The microphones had a sensitivity of 45 mV/Pa, and a flat frequency response in the 20 Hz–20 kHz range. They were integrated with NI-DAQ using NI-9234 modules which sampled the acoustic data at 51.2 kHz for each channel. The sensitivity of the selected microphones and voltage limit of  $\pm 5$  V of the NI-9234 modules allowed noise data acquisition with peak noise levels up to 111 Pa or 134 dB. Six of the nine microphones were placed inside the fire enclosure, two were installed outside but inside the APU compartment, while one microphone (shown as FF in Figure 3) was placed 10 m away in the far-field of the APU exhaust. Initially, vibration sensors were also considered for this study, but it was found that they were unable to detect any sparks, and were therefore excluded from the detailed study. The low energy produced by sparks is unlikely to induce considerable vibrations in the APU structure, and thus cannot be picked up by vibration sensors.

The acoustic data were acquired for APU startups on eight different occasions (represented as a day for the purposes of analysis demonstration), out of which six startups utilized the internal aircraft battery, while the remaining startups used external ground power. On six of these occasions, the aircraft was parked on a taxiway, while the other two experiments were conducted inside a partially enclosed hangar near the runway. Initially, the acoustic data were manually analyzed in order to identify the microphone locations where the spark noise was clear and remained audible for longer durations as the APU spooled up and the background noise increased. In the far-field of the APU, the spark signal was found to degrade sharply as soon as the combustion process initialized, making it impossible to detect the presence of a spark for a longer duration of time. This observation remained the same for all microphone locations where the background noise was high compared to the spark-generated noise. On the other hand, microphones that were placed closest to the igniter (the locations denoted by IGN and SCV in Figures 3b,c) were found to be the most suitable locations to capture spark characteristics, and therefore remained the primary focus of discussion in this paper. The IGN sensor location indicates that the microphone is near the igniter, while SCV specifies the sensor's proximity to the surge control valve. These two sensor locations are the closest to the igniter, with the SCV being on the opposite side compared to the IGN's location. Between the igniter and the microphones, there are multiple layers that may incur a shielding effect on the acoustics. These layers can be identified as, amongst others, combustor liner and APU casing (see zoomed-in cross-sectional view of the combustor in Figure 3d).

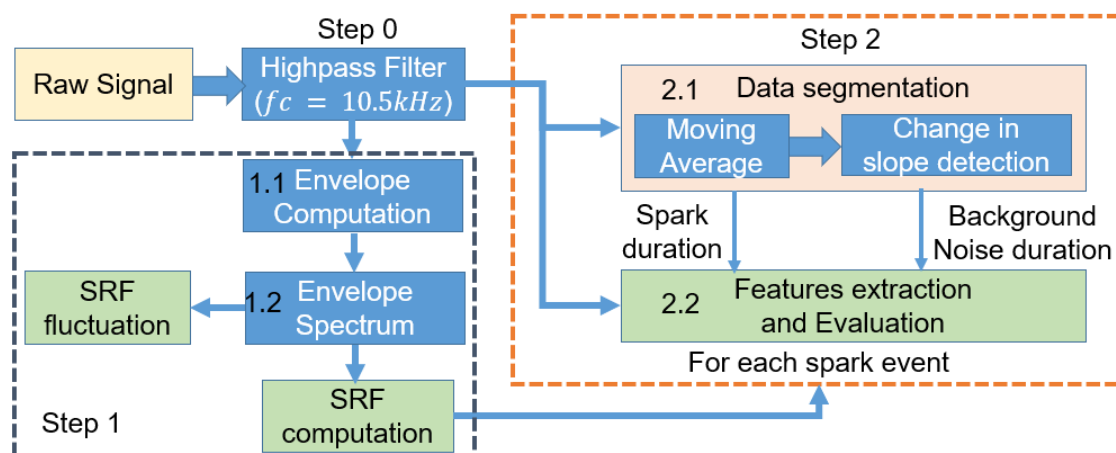
**Figure 4.** Flow chart of the employed methodology.

The employed approach to investigate the spark characteristics from the aircraft's APU startup is presented in Figure 4. There are two steps involved: Step 1 deals with the estimation of spark repetition frequency (*SRF*), while Step 2 is related to the evaluation of various feature extraction techniques on the acquired spark signals. The initial application of a high-pass filter (Step 0) to suppress background noise was a precursor for each step. For *SRF*, the envelope spectrum was analyzed to enable visualization of the degree of fluctuations for a given day of operation.

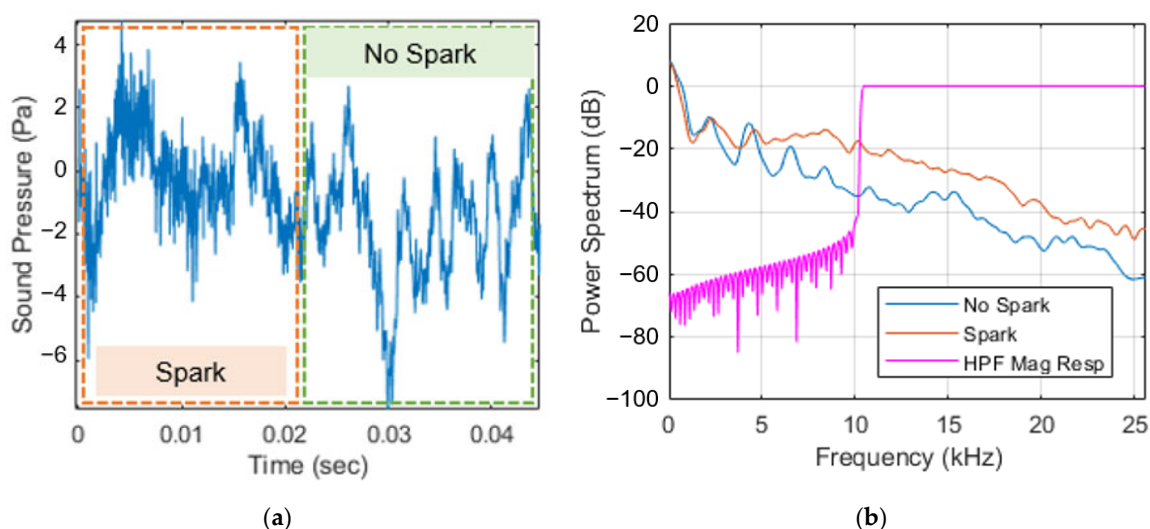
**Figure 5.** Comparison between spark and no spark signal: (a) time domain representation; (b) frequency domain analysis and magnitude response of the high-pass filter.

The noise generated during the spark event can be masked by the background noise. For an APU operating in situ, the background noise is a complex phenomenon. In general, a major part of the background noise stems from the superposition of tonal noise generated by the shaft, compressor blades, cooling fan blades, gears, the broadband noise produced by the combustion process, and acoustical reflections taking place within the APU compartment. The resultant overall background noise during APU startup is non-stationary, which is due to variations in the APU rpm and gradual build-up of the combustion process. The tonal noise dominates the lower frequencies because the rpm is low (e.g., APU shaft frequency is in the range of 75–210 Hz for 7–20% rpm). The combustion noise is also present at low frequencies [9]. Figure 5a shows a portion of one cycle of the sparking sequence; initially, a spark occurs and then gradually fades away into the background noise. In Figure 5b, the power spectrum of these two signals demonstrates that the noise generated by the spark is present for frequencies greater than 5 kHz. This observation is in agreement with the analysis reported in [31].

The application of a high-pass filter with a cut-off frequency of 5 kHz can be a good choice to suppress the no spark characteristics. However, the figure only shows the spark taking place at a very early stage of the startup sequence where the tones generated by the shaft, compressor blades, cooling fan blades, and gears are at lower frequencies. As the APU spools up, these frequencies also increase and begin to overlap with the spark noise frequencies. The impulse noise generated by a spark discharge is almost broadband in nature and peaks at around 10.5 kHz, with a 6 dB/octave drop on either side of the peak [27]. A high-pass filter with an  $f_c$  at around 10.5 kHz represents an appropriate filter for suppressing the background noise at the lower frequencies. Therefore, a high-pass filter was applied to the raw acoustic data using MATLAB's 'highpass' function with an  $f_c = 10.5$  kHz transition band steepness and stop-band attenuation of 0.98 and 80 dB, respectively. The filter produced by this function is a FIR filter with 829 coefficients and a stop-band frequency of 10.19 kHz (magnitude response of the filter is shown in Figure 5b).

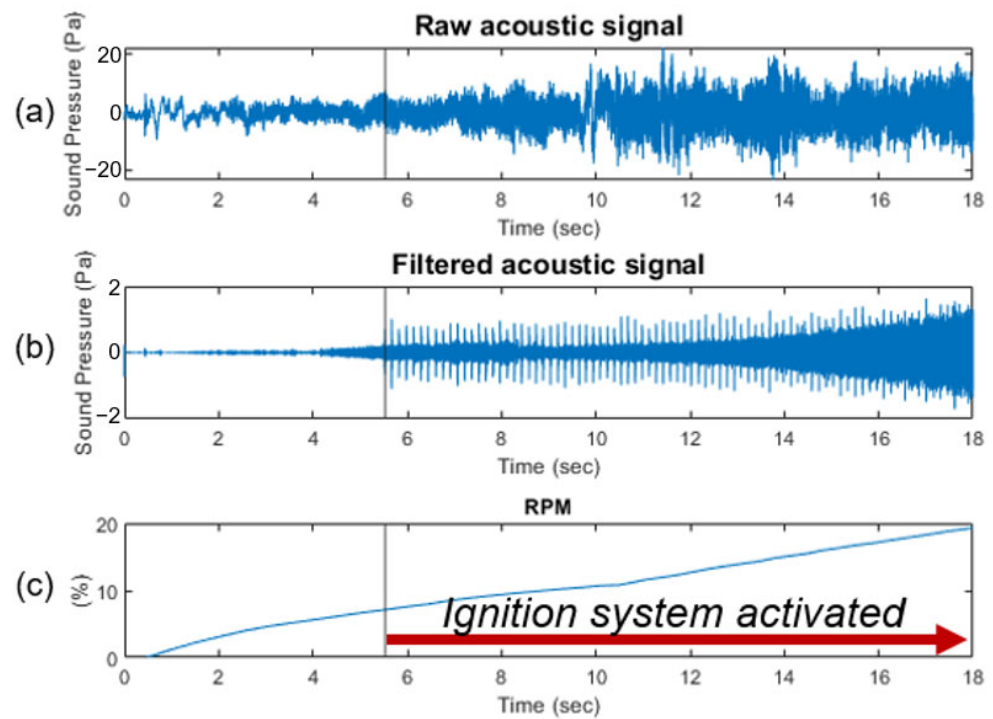
**Figure 6.** Results of the application of high-pass filtering on acquired data: (a) raw acoustic data; (b) filtered acoustic data; (c) APU RPM.

The acquired results are shown in Figure 6; part (a) of the figure shows the raw signal for the selected duration, as well as how the noise levels progressively increase as the APU spools up. The weak spark signals are not observable in the graph; however, with the application of the high-pass filter, a series of impulse signals emerge after 7% RPM as illustrated in Figure 6b. The instances where the sparking sound was generated are noticeable, and the gradual increase in the background noise level in between these instances is also visible. After 20% of the rated RPM (at 18 s—see Figure 6c), the background was found to significantly increase, which resulted in it completely masking the sparking sound.

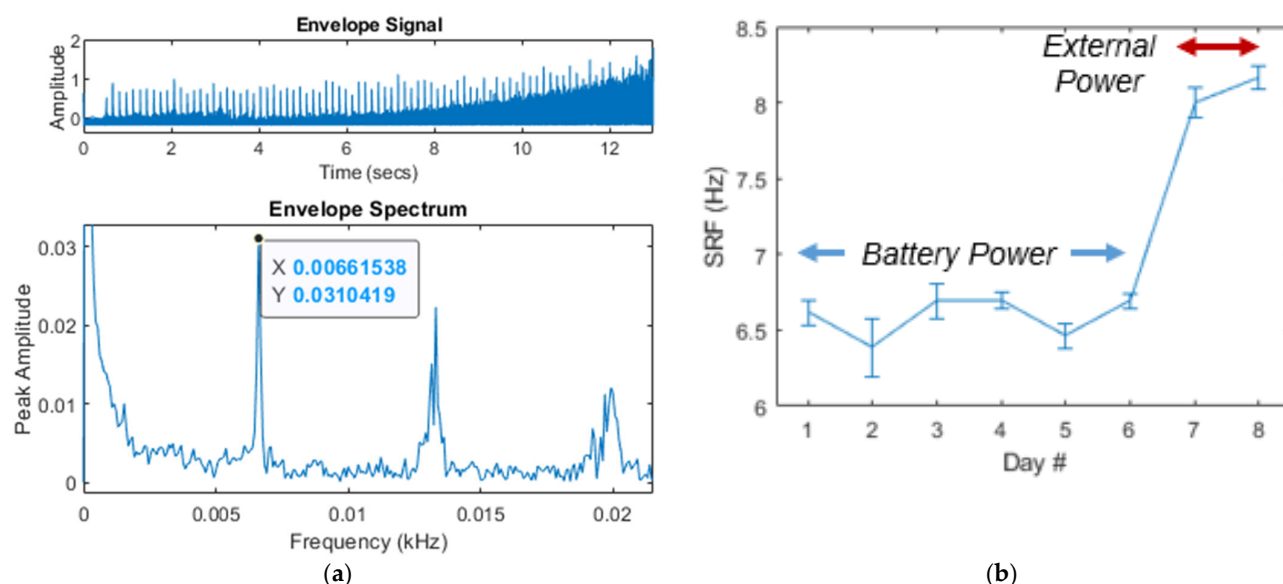
**Figure 7.** Results of *SRF* computation: (a) envelope signal and envelope spectrum for acoustic data from Day#1; (b) computed *SRF* and their fluctuations across all days of experimentation.

Envelope analysis was performed on the filtered acoustic signal to estimate the average *SRF*. MATLAB's '*envspectrum*' function was used for this purpose. It initially computes the envelope of the input signal by taking the absolute of the analytic signal, and then takes the FFT of the envelope. For Day#1 of the operation, the results are shown in Figure 7a for the acquired acoustic data corresponding to location IGN (for location SCV, the results are identical and are not presented to avoid repetition). It can be seen that multiple peaks occurred in the envelope spectrum. The first peak is at 76  $\mu$ Hz, and does not correspond to the time period of the peaks occurring in the envelope signal. The next peak, which occurs at 6.6 Hz, is in line with the periodic spikes in the time series data, and can therefore be regarded as the repetition frequency (*SRF*) of the high-energy impulse signals.

The same analysis was repeated for the complete data set, and the results are presented in Figure 7b. The variation in the source of aircraft power modifies the *SRF*; 6.6 Hz on battery, and 8 Hz with external power. A similar variation in the *SRF* can also occur if there is degradation in the components (resistances and capacitances) that control the repetition frequency; hence, the *SRF* can be regarded as an appropriate metric to monitor the health of the ignition system. Moreover, the approximate number of sparks ( $N_{sparks}$ ) can be estimated for a given startup, even if all of the sparks have not been detected by knowing the *SRF* and the time required to transition from 7–95% rpm ( $t_{7-95\%rpm}$ ); that is, the estimate can be obtained as follows:

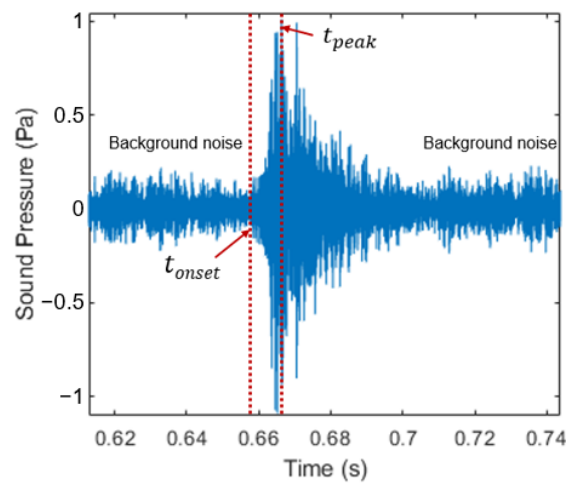
**Figure 8.** Time series data around a spark event.

Having successfully estimated the *SRF*, each corresponding impulse signal could be individually analyzed to extract the acoustic features from the region where the spark characteristics were dominant. Each spark signal is composed of background noise, the onset of spark, peak acoustic pressure, and the gradual decay in energy which eventually diminishes due to the presence of the background noise, as shown in Figure 8. The region of significant interest occurs between the onset of the spark ( $t_{onset}$ ), and the time ( $t_{peak}$ ) where peak pressure is observed. Within this region, spark characteristics are found to be dominant, and less affected by background noise.

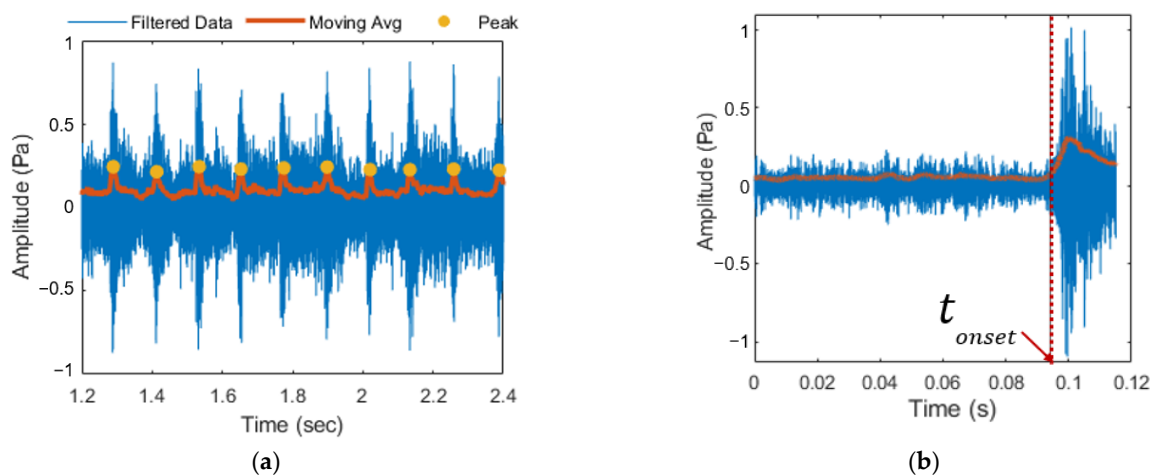
**Figure 9.** Moving average filter results: (a) series of sparks; (b) single spark with identified location of  $t_{onset}$ .

In order to estimate  $t_{onset}$ , a change detection strategy based on slope values was applied to the moving averaged version of the filtered acoustic signal. In order to do this, an averaging filter with window size = 256 was applied after taking the absolute of the filtered signal; this allowed for the reduction in the background noise while preserving the spark event locations, as shown in Figure 9a. MATLAB's 'ischange' function was then utilized to provide the time location ( $t_{onset}$ ) for each spark event where the highest positive change occurred in the slope of the averaged version of the signal. Figure 9b shows the time ( $t_{onset}$ ) where the rise in acoustic pressure is taking place, which was identified by the function. Using  $t_{onset}$  and  $t_{peak}$ , the high-pass filtered acoustic data was segmented around each of the spark events, as follows:

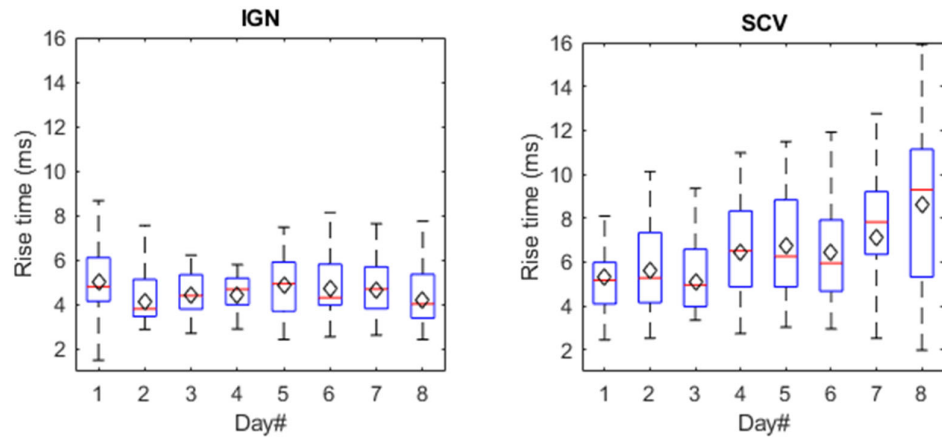
**Figure 10.** Rise times computed for the complete data set at sensor locations IGN and SCV.

$t_{peak} - t_{onset}$ ). Figure 10 presents the acquired values of  $t_{rise}$  for all 8 test days at sensor locations IGN and SCV; the overall variation is captured in the form of boxplots. Each plot shows the range, median (red solid line), and mean (labeled as a black unfilled diamond symbol) values of the rise times on each day at a given sensor location. The median and mean values of  $t_{rise}$  remained stable (4–5 ms) for location IGN throughout the data set. For location SCV, large deviations (5–9 ms) were observed. The  $t_{rise}$  values also varied, due to the change in surroundings (see plots for SCV for Day#7 and Day#8, where the aircraft was parked inside a semi-enclosed hangar that led to high values of  $t_{rise}$ ). Based on the analysis,  $t_{rise}$  values were found to be an inappropriate feature to be observed for condition monitoring due to their inconsistent behavior. However, the samples existing between  $t_{onset}$  and  $t_{peak}$  were useful for characterizing the spark using various features.

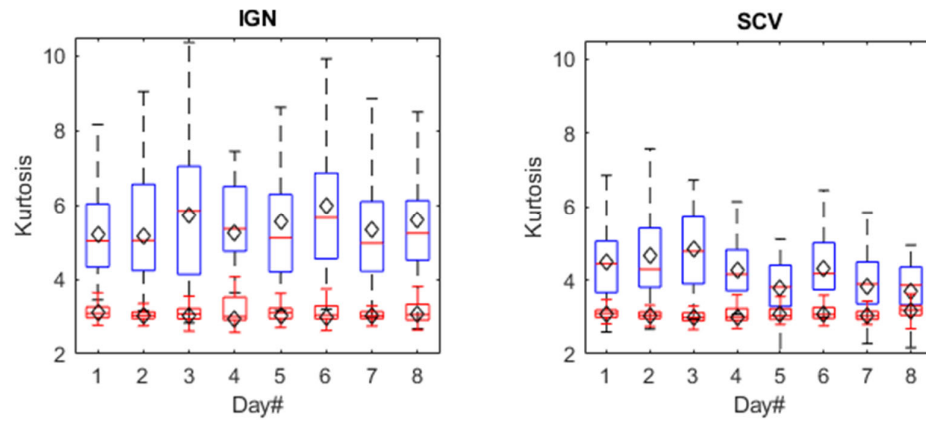
**Figure 11.** Kurtosis values computed for spark and noise data at sensor locations IGN and SCV.

The ZCR values for the sparks and the background noise were found to be similar (very high values for  $\Delta_{Noise}^{IGN}$  and  $\Delta_{Noise}^{SCV}$ ), which shows that the feature is sensitive to the noise present within the spark duration, and is unable to capture any unique characteristics of the spark. Similarly, the kurtosis value was found to be highly sensitive to sensor location, and also indicated the level of Gaussian behavior in the data. Figure 11 shows the box plots for kurtosis values that were computed for the spark and background noise duration for the two sensor locations. The background noise can be seen to have a Gaussian response (kurtosis  $\approx 3$  [34]). For IGN, the mean kurtosis value is around 5–6, while for SCV it is less than 5, and falls as low as 4 for Day#7 and Day#8 (leading to a high value of  $\Delta_{Noise}^{SCV}$ ). This behavior indicates that the background noise corrupted the acoustic data, even during the sparking event. The low value of 0.62 for  $\Delta_{IGN}^{SCV}$  is also an indicator of the high level of dissimilarity that existed between the feature values at the two sensor locations.

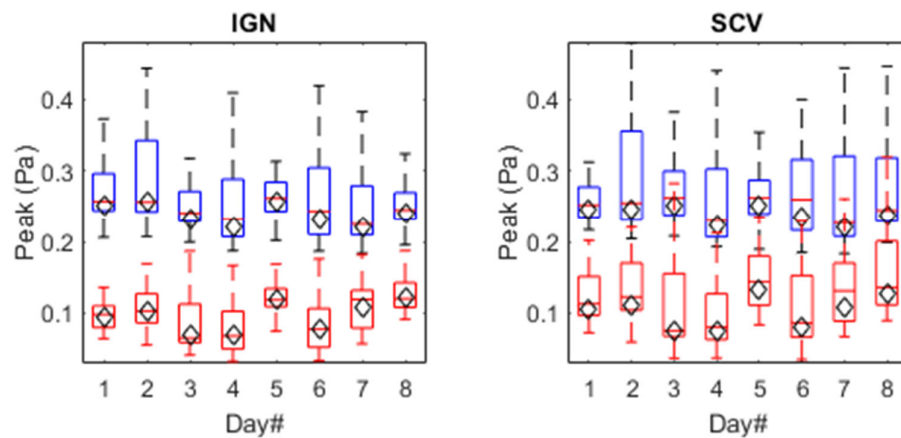
Figure 12. Peak values computed for spark and noise data at sensor locations IGN and SCV.

In terms of similarity with the background noise, the SF and RMS features were the worst performing. The values of  $\Delta_{Noise}^{IGN}$  and  $\Delta_{Noise}^{SCV}$  are 0.07 and 0.13 for SF and 0.10 and 0.19 for RMS. These numbers indicate the degree to which the feature values for spark and noise resemble one another, thus making them prone to noise. Similarly, the Sp. Crest feature is also susceptible to background noise. Lastly, the Peak feature is also slightly affected by background noise if the sensor is far from the igniter ( $\Delta_{Noise}^{SCV} = 0.1$ ). However, for this feature, the value of  $\Delta_{IGN}^{SCV}$  is 0.81, which indicates that it does not significantly vary with a change in the acoustic path, and can therefore be a direct consequence of the variations in spark discharge characteristics. Figure 12 shows how the peak values vary for spark and noise duration for the two sensor locations under different days of operation. Several useful observations can be made through the figure: the peak values are higher than the background noise if the sensor is close to the igniter; the mean values are similar (~0.25) across the two sensors; and there is a gradual decrease in the peak values as the time progresses from Day#1 to Day#8. The gradual decrease in these values may be an indicator of the level of degradation in the ignition system. It is to be noted that there was a five-month delay between the first day and the last day of operation, during which it is probable that atmospheric effects may have degraded the igniter. A similar trend was also observed for the  $\delta_{RMS}$  feature (see Figure 13), which surpassed all of the other features in displaying a very high value for  $\Delta_{SCV}^{IGN}$  (0.84). The  $\delta_{RMS}$  appears to gradually decrease after each day of operation. This feature corresponded to the energy that was added into the acoustic channel by the spark discharge, and can be an appropriate parameter to ascertain the health of the system.

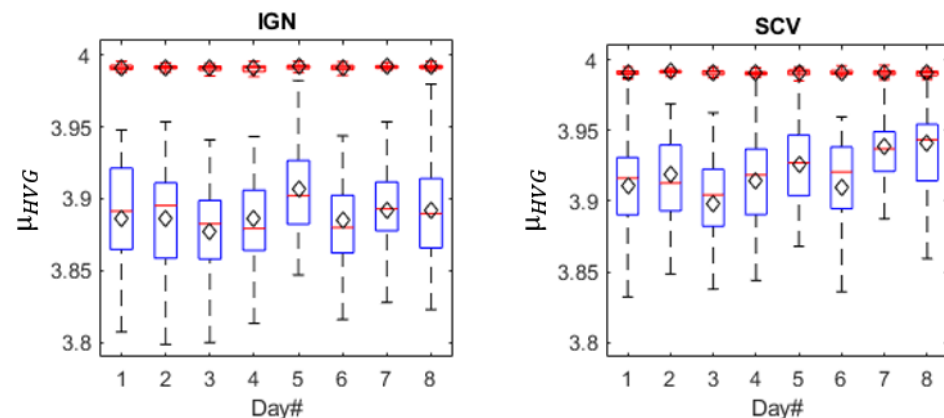
Figure 14.  $\mu_{HVG}$  values computed for spark and noise data at sensor locations IGN and SCV.

The  $\mu_{HVG}$  feature performed well in terms of its resistance against background noise (see Figure 14). This value refers to the mean number of samples which are horizontally visible in a time series data set. For the background noise, the mean value for the feature was 3.99, while for spark, the values ranged between 3.8 and 0.94. Although  $\mu_{HVG}$  had very low values for  $\Delta_{Noise}^{IGN}$  and  $\Delta_{Noise}^{SCV}$ ; however, it was sensitive to the sensor location ( $\Delta_{SCV}^{IGN} = 0.73$ ). For SCV, the values reduced for Day#8, which may have been attributed to the increase in the rise times at location SCV (see Figure 10), when more samples of background noise were captured and analyzed within the spark duration.

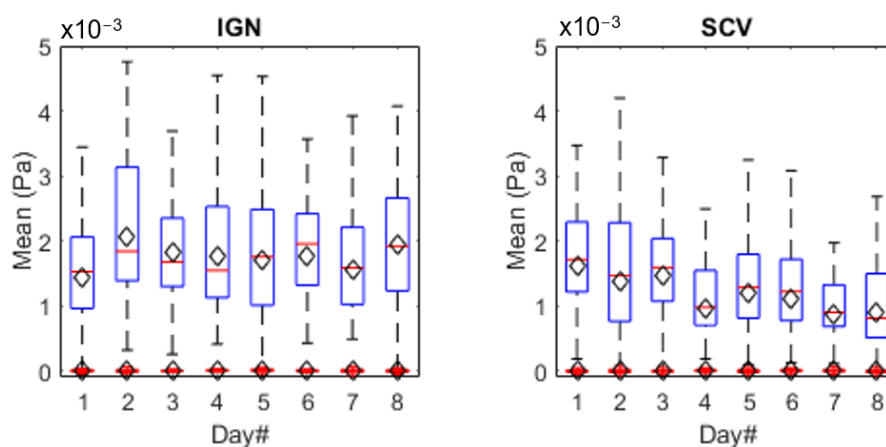
Figure 15. Mean values computed for spark and noise data at sensor locations IGN and SCV.

The results for feature  $\mu$  are also interesting (see Figure 15). The value of  $\mu$  for noise is zero, while for the spark it is positive for the majority of the data set. The wave that originated from the spark discharge took the shape of an N-wave, which has more energy towards the positive side [7], making the mean  $> 0$ . During the propagation of such a wave through a multi-path channel, it is likely that the outcome will also have a positive mean. Variations in the spark discharge characteristics due to ignition system degradation will lead to changes in the shape of the N-wave, which can be manifested in the change in the mean value of the samples taken during the spark duration. The remaining features (*Sp.AM*, *Sp.GM*, and *Sp.Flatness*) were also found to be highly robust against background noise, regardless of the sensor location ( $\Delta_{Noise}^{IGN} \sim 0$  and  $\Delta_{Noise}^{SCV} \sim 0$ ). These features, therefore, present strong potential for capturing the characteristics desired to support the development of an online condition monitoring solution. It is noted that, in order to fully comprehend the sensitivities of the acquired features, experimentation should be conducted under an actual degraded/faulty ignition system.
