# Exploring the potentialities of thermal asymmetries in composite wind turbine blade structures via numerical and thermographic methods: a thermophysical perspective

## Abstract

**Keywords** Composite · Turbine blades · Defect · Thermography · Thermophysical properties · Heat transfer

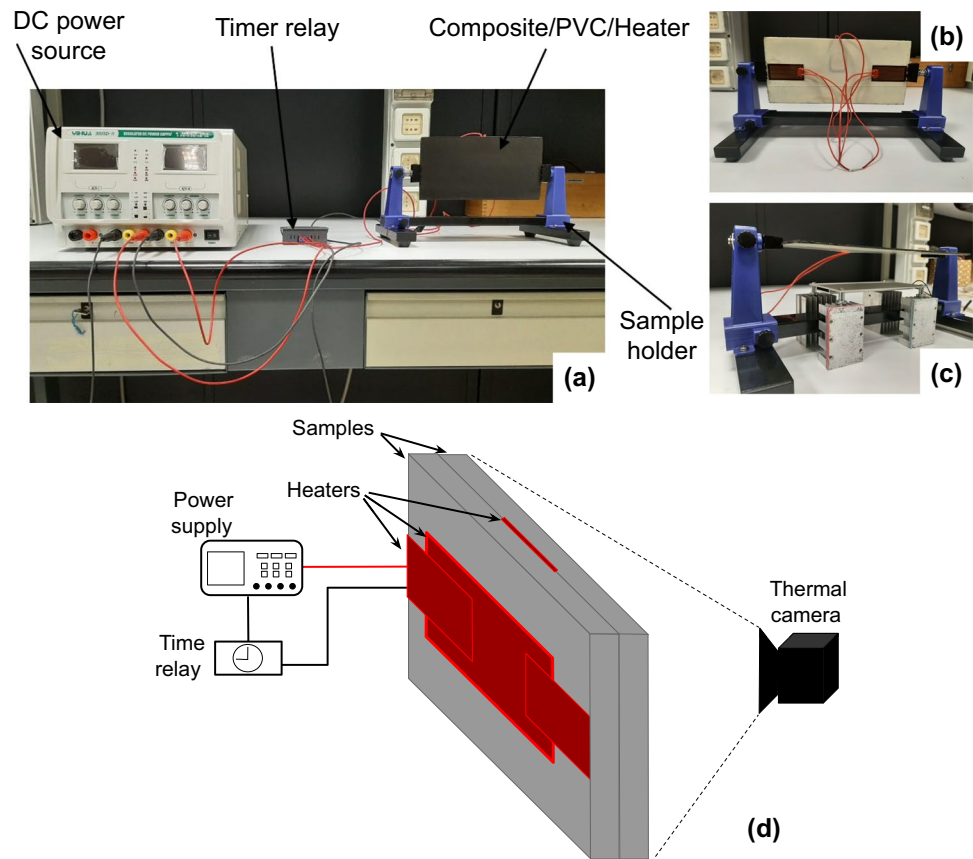
**Fig. 1** Experimental setup with IR camera in the laboratory: **a** overview, **b** two heaters, **c** heater plate, and **d** schematic setup

Figure 1 shows the configuration of the experiments performed, where the sample was characterized by two glass fiber/epoxy matrix composite plates and an artificial polyvinyl chloride (PVC) inclusion was considered a defect. Figure 1a shows an overview of the experiment, highlighting the power source that powered the heaters, the timer relay to control the heating duration, and the composite sample along with its holder. Figure 1b shows the scenario where two heaters were utilized on the rear surface, while Fig. 1c shows the heater plate employed in transmission mode. Figure 1d shows a schematic configuration of the experiment. A FLIR T1020 thermal camera (1024 x 768 pixels resolution) was used to record thermal images from the front surface.

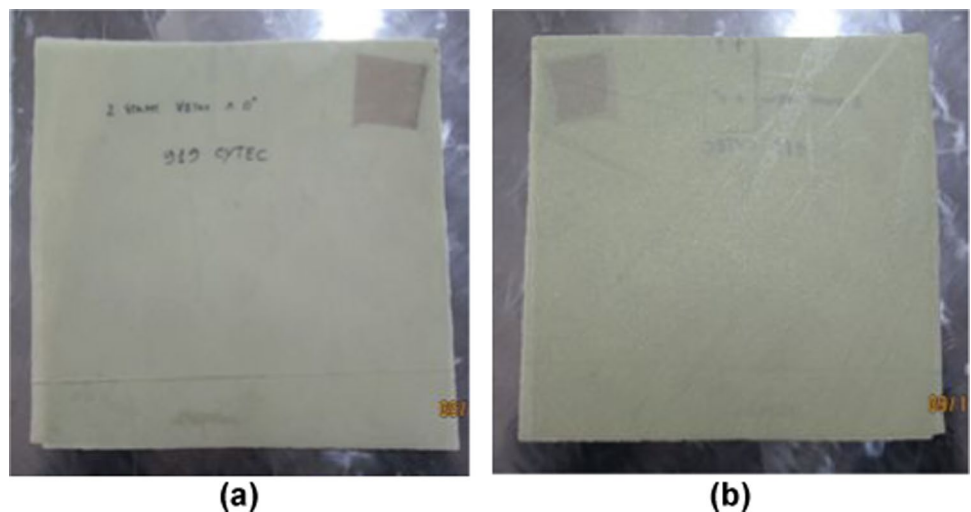
**Fig. 2** Cytec 919 specimen: **a** front side of the specimen and **b** back side of the specimen

defect (inclusion). The initial specimen (from which the final specimen described thereafter was realized) is shown in Fig. 2. To evaluate the thickness of the sample, it was decided to acquire at least 4 thicknesses in different points. Figure 3a shows the thickness measurement points within the areas marked with red circles. It is possible to see the composite slab on the rectified surface of the Fanuc brand 18i-MB gantry milling machine. The cylindrical steel mass

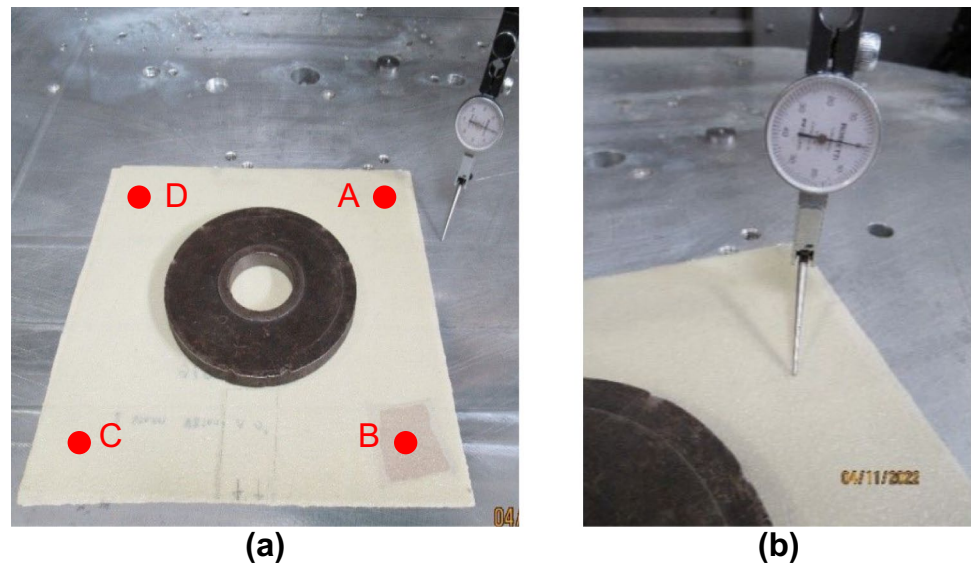
**Fig. 3** Position of the composite plate on the measuring plane: **a** general view and **b** detail of the measuring probe on 0 to allow the piece zero procedure

visible in Fig. 3b has the task of keeping the entire surface of the sample in contact with the milling machine surface. It is possible to see an enlargement of the Borletti brand comparator with thousandth accuracy, in contact with the workpiece table centered at 0 to allow the Z-axis of the machine to be zeroed.

and positioned as shown in Fig. 3a. Note that the particular symmetry of the heater-composite assembly built in scenario 1 not only allow the numerical modeling to be simplified, but also it represents the best practice for building the experimental apparatus used for thermal property estimation of solid materials in case of the plane source method is used [31, 32]. Indeed, the analysis here reported can also be considered preliminary to the design of the experiment aimed at estimating the thermal properties of the composite material. In scenario 2, two heaters with the same dimensions were inserted into the rear surface and positioned as shown in Fig. 3b; it is observed that in this scenario there is a small region in common between the heater and the defect, but there is no contact between the two. Scenario 3 shown in Fig. 3c is the combination of scenarios 1 and 2, i.e., there is the central heater between the composites and two heaters on the rear surface. In scenarios 1, 2, and 3, the resistances of 20.92  $\Omega$  were powered by a voltage of 4 V, generating power in each heater of 0.76 W. In scenario 4, a heat source of 400.00 W heating power with dimensions equal to 120.00, 70.00, and 2.00 mm was placed 37.00 mm away from the rear surface, as shown in Fig. 3d. It is worth noting that in each scenario analyzed, a symmetric heating is applied to the sample to localize the inclusion without thermally stimulate all regions of the composite. This is a key point of the present work.

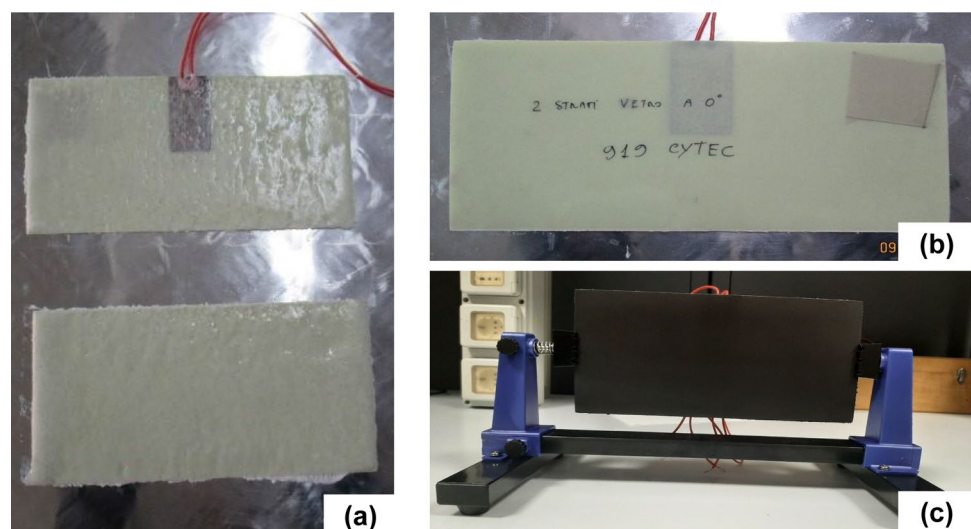
**Fig. 4** Final stages of sample manufacturing: **a** adhesive deposited on sample surfaces, **b** Specimen glued with the electrical resistance present between the two pieces and **c** final painted sample

bench where squaring and trimming are carried out until a rectangle is obtained. Then, the specimen was split into equal parts as depicted in Fig. 4a. An electrical resistance was juxtaposed on one of the surfaces of the specimen, through its adhesive layer, with the aim of generating a local thermal load. This resistance is of a commercial nature and the thickness was measured (given the regularity of the product) in a single point with the aid of a twentieth caliper. After having made the electrical resistance (i.e., the electric heater) integral to the specimen, the surfaces having a higher roughness were sprinkled with a very high-temperature resistant glue (sprayed on the surface), creating a homogeneous and regular layer. The two segments were juxtaposed, both on the surfaces covered by the glue, thus forming the final specimen shown in Fig. 4b. Figure 4c illustrates the final painted sample mounted on the sample holder.

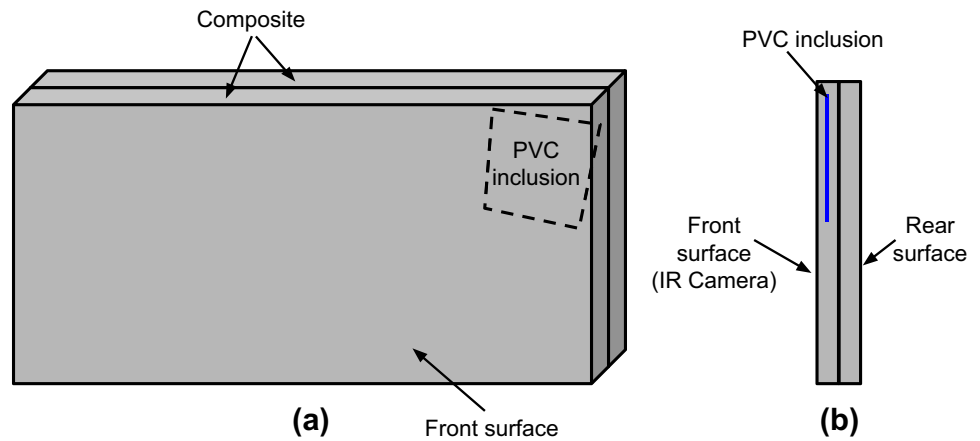
**Fig. 5** Schematic drawing of composite material geometry and defect: **a** front surface and **b** side view

Figure 5 shows a schematic drawing detailing the sample used in the experiments, where each composite plate has width, height measured with a common metric rod with precision in the order of mm equal to 203 and 101, respectively, while the thickness was measured with a millesimal dial comparator, and it is equal to 0.765 mm. The PVC inclusion has a thickness of 0.17 mm and is located 0.30 mm away from the front surface (surface monitored by the thermal camera). As the thickness of the inclusion inserted into the composite is very thin, this minimizes the existence of lateral flows in the thermographic images, limiting the blurring effect and thus facilitating the analysis of the results.

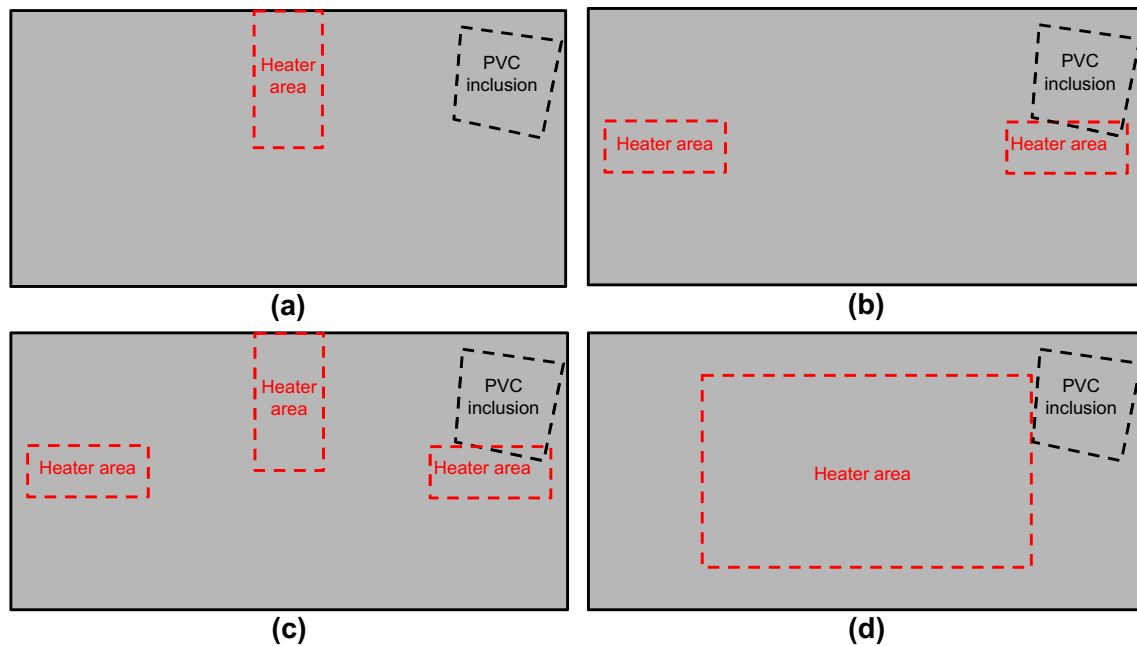
**Fig. 6** Four different scenarios for sample heating: **a** scenario 1, **b** scenario 2, **c** scenario 3 and **d** scenario 4

Four different heating scenarios were designed to apply a thermal excitation to the sample. In scenario 1, a heater covered with polyimide layers of dimensions 44.00, 19.00, and 0.10 mm was inserted between the two composite plates

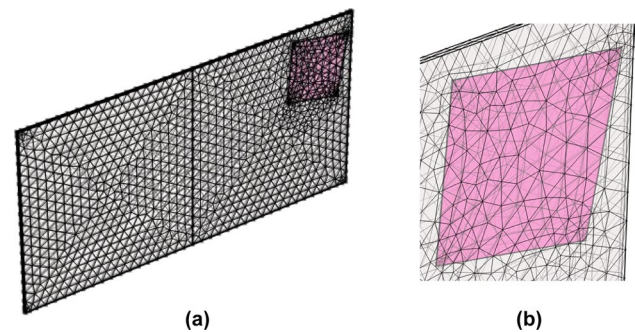
**Fig. 7** Mesh used in numerical simulations: **a** overview and **b** details on the composite/inclusion interface

Numerical simulations were performed using the commercial software COMSOL® to solve the heat transfer problem using the same boundary conditions as the experiments [39]. Initially, the transient problem was solved during the sample heating phase, and then, the transient analysis was simulated for the cooling period. Additionally, the PVC inclusion was modeled numerically without considering the thermal contact resistance with the composite, i.e., only the thermal properties of the materials were characterized as different. Figure 7 shows the numerical mesh composed of 25,479 tetrahedral elements that was considered ideal after a mesh convergence study. The detail of the mesh refinement in the region of the inclusion

can be observed in Fig. 7b, where a greater quantity of elements was necessary.

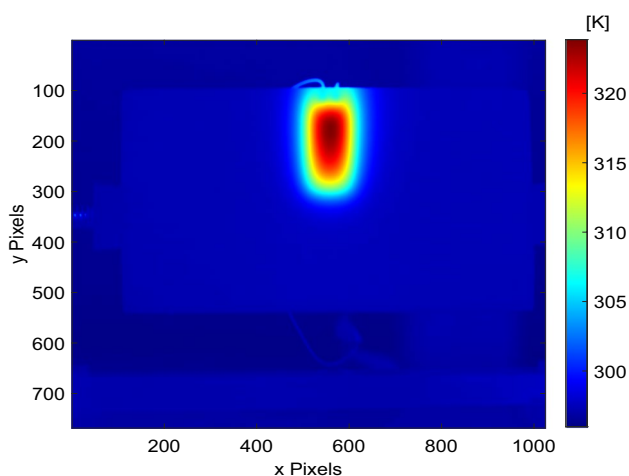
Fig. 8 Thermal image inherent to scenario 1 at 344 s

The first experiment refers to the use of scenario 1 where only a single heater was used to try to detect the defect using active thermography (Fig. 3a). A heating time of 360 s was used followed by 344 s of natural convection cooling at the laboratory ambient temperature of 297 K. The acquisition rate was 1 s, totaling 704 images acquired during the experiment. Figure 8 shows the thermographic image at the

final stage of heating, where the central region can be seen with a maximum temperature of approximately 323 K due to the presence of the heater. No difference can be seen in the image between the region with the defect and the surrounding area. At all other times analyzed, it was also not possible to observe any difference in the thermal images that would characterize the presence of a defect in the sample. Indeed, the low thermal conductivity of the composite material (see Table 1) does not allow the heat to be easily diffused throughout the sample. And the distance between the heater and the defect proved to be large enough to render the detection of the inclusion impossible.

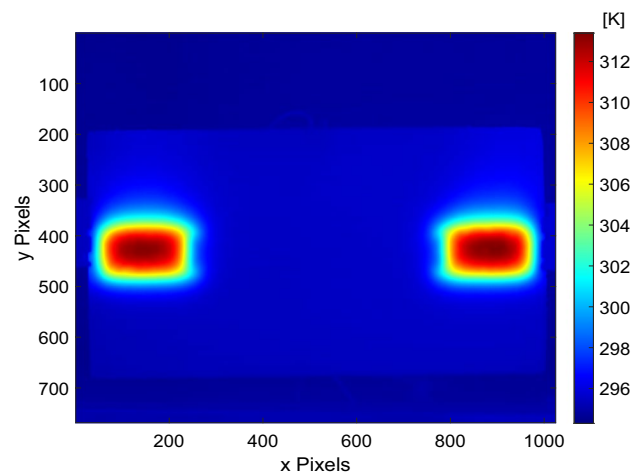
Fig. 9 Thermal image inherent to scenario 2 at the end of heating [K]

For scenario 2, the sample was heated for 120 s and the cooling time was 300 s. Figure 9 shows a thermographic image obtained at the end of heating using the heating configuration of scenario 2 (Fig. 3b). A symmetrical heating can be observed in the image, and the maximum temperature obtained was approximately 313 K. However, no significant thermal changes that would characterize the defect were observed.

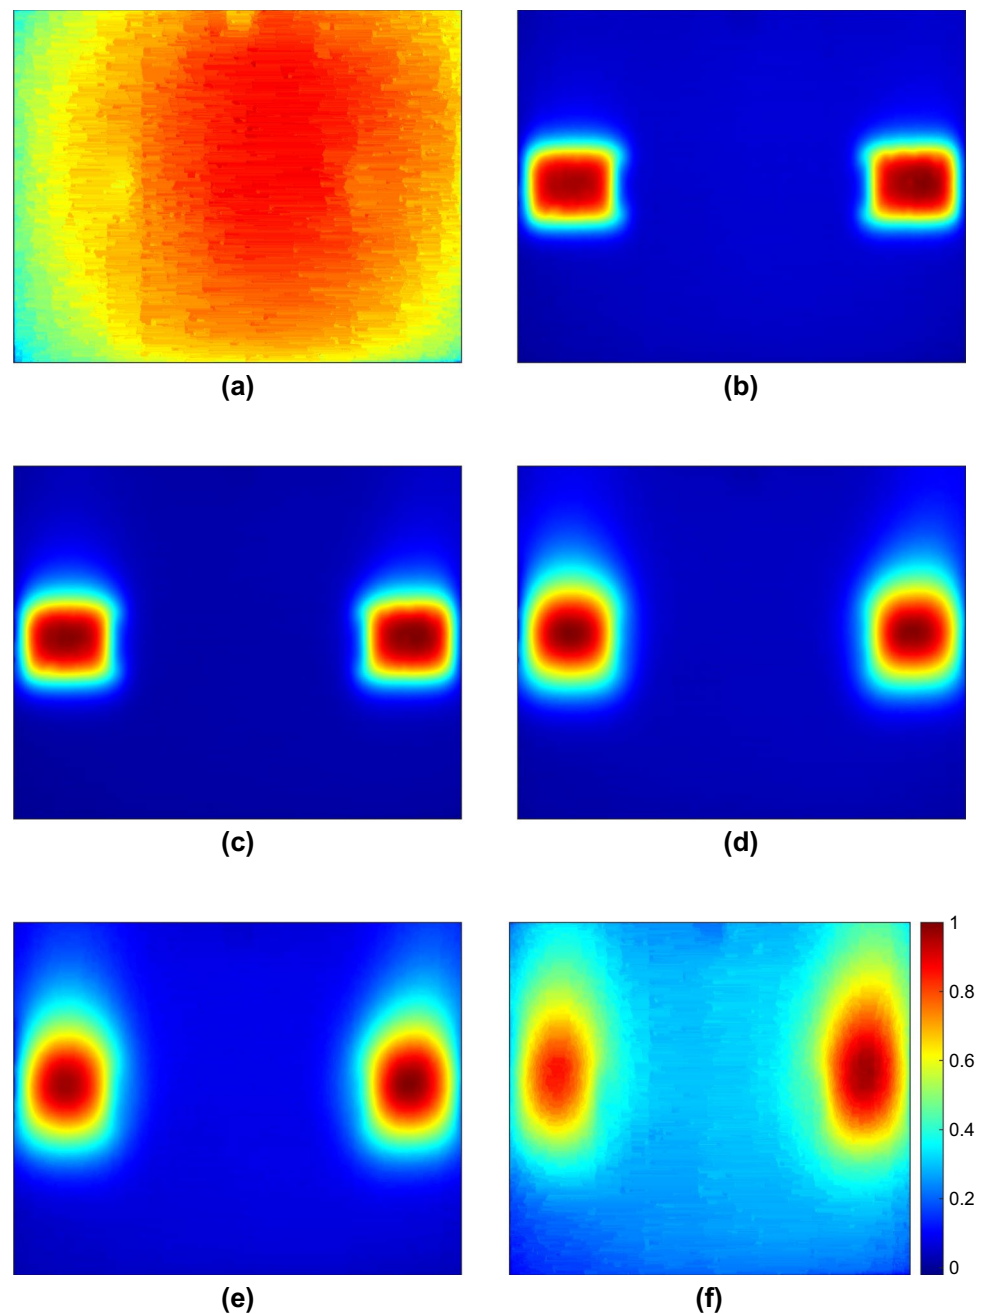
**Fig. 10** Thermal images of excess temperature normalized for scenario 2: **a** 0 s, **b** 60 s, **c** 120 s, **d** 180, **e** 240 s, and **f** 420 s

Figure 10 shows the normalized thermographic images with only the sample surface selected for scenario 2 at times 0, 60, 120, 180, 240, and 420 s. At time 0 s, an almost uniform distribution on the composite surface can be observed. During heating, Fig. 6b and c is unable to clearly reveal the

presence of the defect. During the cooling phase, mainly at 420 s, the temperature of the defect area (right side) was higher compared to the left side.

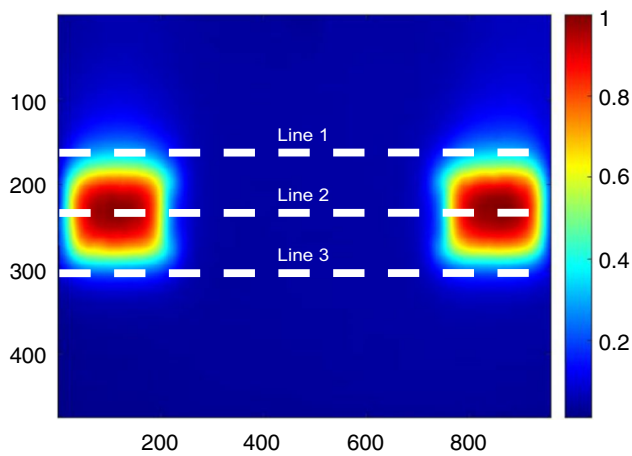
**Fig. 11** Cut lines in the normalized thermographic image

Figure 11 shows three lines in the normalized thermographic image that were created to analyze the temperature curves on the sample surface. Line 1 intersects the defect region, line 2 covers the two heaters, and line 3 does not intersect the defect and the heat source. The justification for analyzing the temperature distribution from these lines stems from the low sensitivity of the problem, thus necessitating a more specific verification to ascertain whether there are more pronounced asymmetries between the side of the component with and without defect.

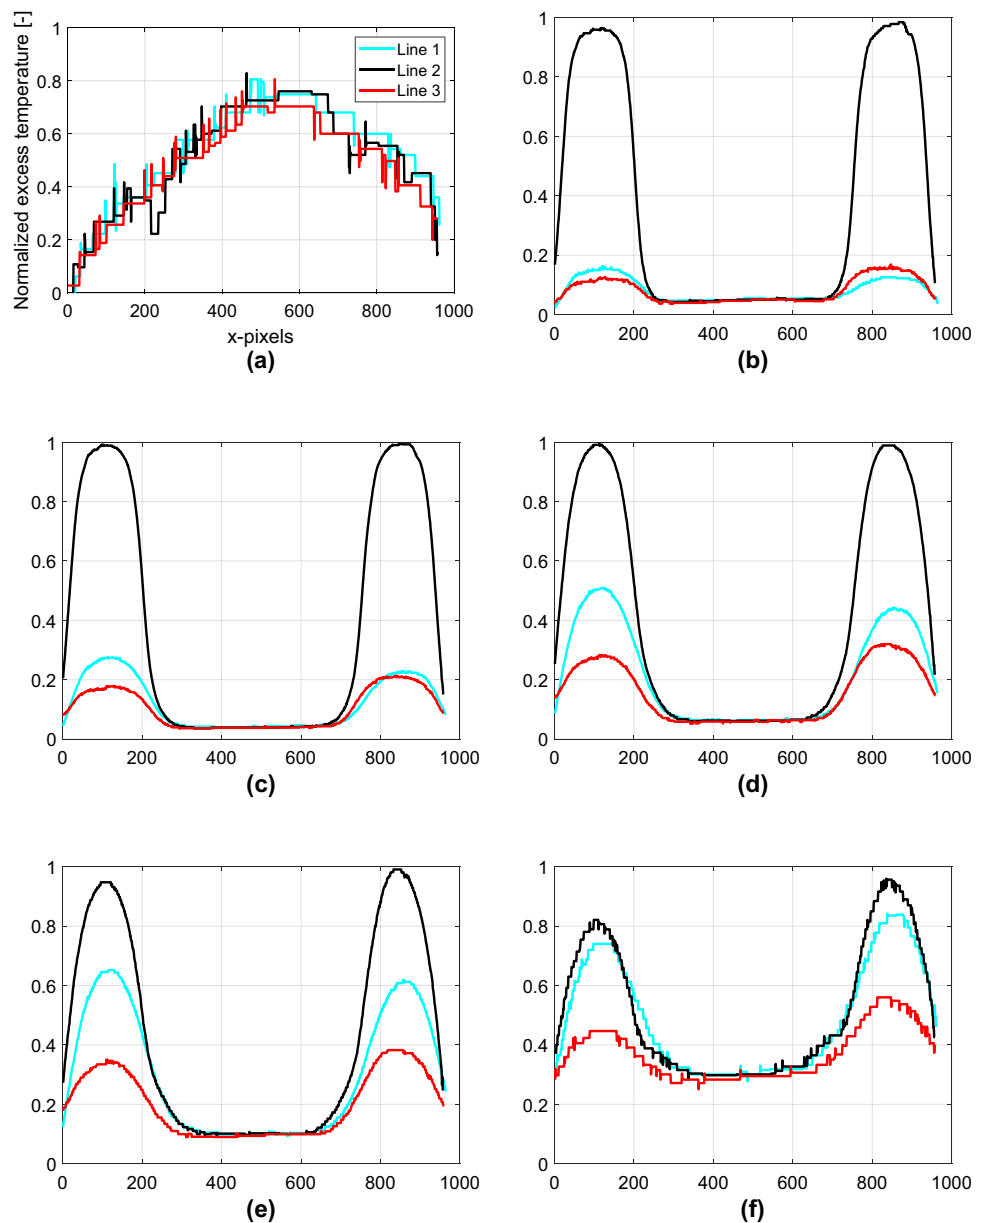
**Fig. 12** Normalized excess temperature lines for scenario 2: **a** 0 s, **b** 60 s, **c** 120 s, **d** 180, **e** 240 s, and **f** 420 s

Figure 12 shows the three normalized excess temperature lines for six different times. At the time of 60 s during heating, a non-symmetrical behavior in lines 1 and 3 can be observed, as shown in Fig. 12b. The temperature curve in line 2 at 120 s (Fig. 12c), the end of heating, shows symmetry between the sides of the sample, thus showing that equal heating occurred in both heaters during the experiment. Line 1 showed that the right side, the defect region, had a lower temperature gain than the non-defective side during heating and part of the cooling; this is due to the low conductivity of the material. The increase in thermal resistance makes heat transfer difficult, resulting in a lower temperature in this region. In line 3, the opposite is observed, that is, there was a greater temperature gain on the right side compared to the left. Therefore, part of the amount of heat that should have been transferred upwards (where the PVC was) went downwards (less thermal resistance), causing more heat to accumulate in relation to the left side. At the end of heating,  $t = 120$  s, the right side of line 1 showed 20% less increase in temperature compared to the left side; in line 3, there was 10% more increase in temperature. At the end of cooling,  $t = 420$  s, the defect region had 10%, 20%, and 25% higher

temperatures compared to the non-defect side for lines 1, 2, and 3, respectively. Thus, scenario 2 was able to identify the presence of PVC inclusion due to the non-symmetrical thermal behaviors observed in the temperature gain lines.

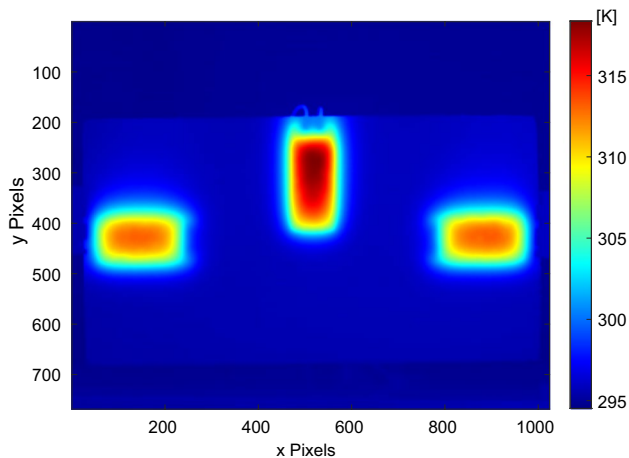
**Fig. 13** Thermographic images for scenario 3 at the end of heating

Figure 13 shows the result of the experiment using scenario 3 (Fig. 3c), which had the same heating and cooling time as scenarios 1 and 2. The thermographic images obtained presented results similar to previous scenarios. The temperature curves analyzed did not present different results in relation to scenario 2. Therefore, it was not necessary to present further results for this scenario. The advantage of this third configuration is having an

additional heater, which can help locate more defects due to the increased chances of the heat source being closer to a PVC inclusion.

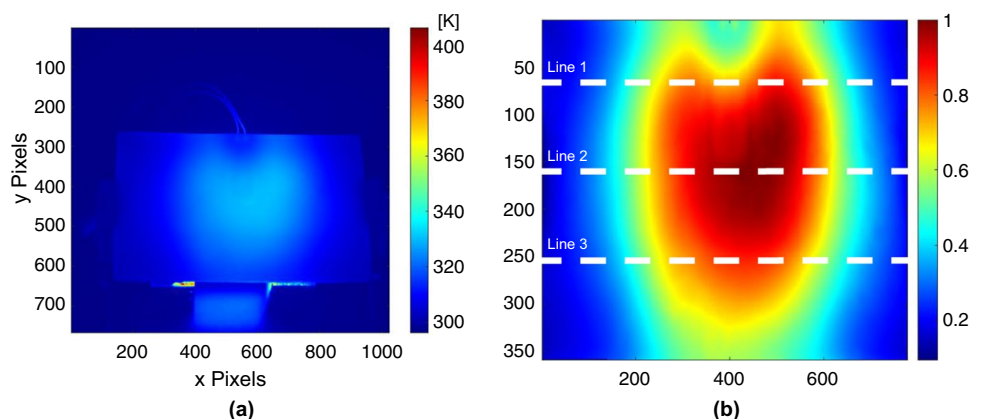
**Fig. 14** Thermographic images for scenario 4 at the end of heating: **a** temperature distribution [K] and **b** normalized excess temperature distribution [-]

For what regards the configuration of the last scenario analyzed (see Figs. 3d), Fig. 14 shows the thermographic images for the final heating time. In particular, Fig. 14a shows the general image of the experiment, and Fig. 14b shows only the composite with three lines created to analyze the temperature curves. The region on the right side heated more compared to the left side. This must have occurred because the PVC-inclusion increased the thermal resistance on the right side of the sample, resulting in

the accumulation of heat in the region between the center of the composite and the defect.

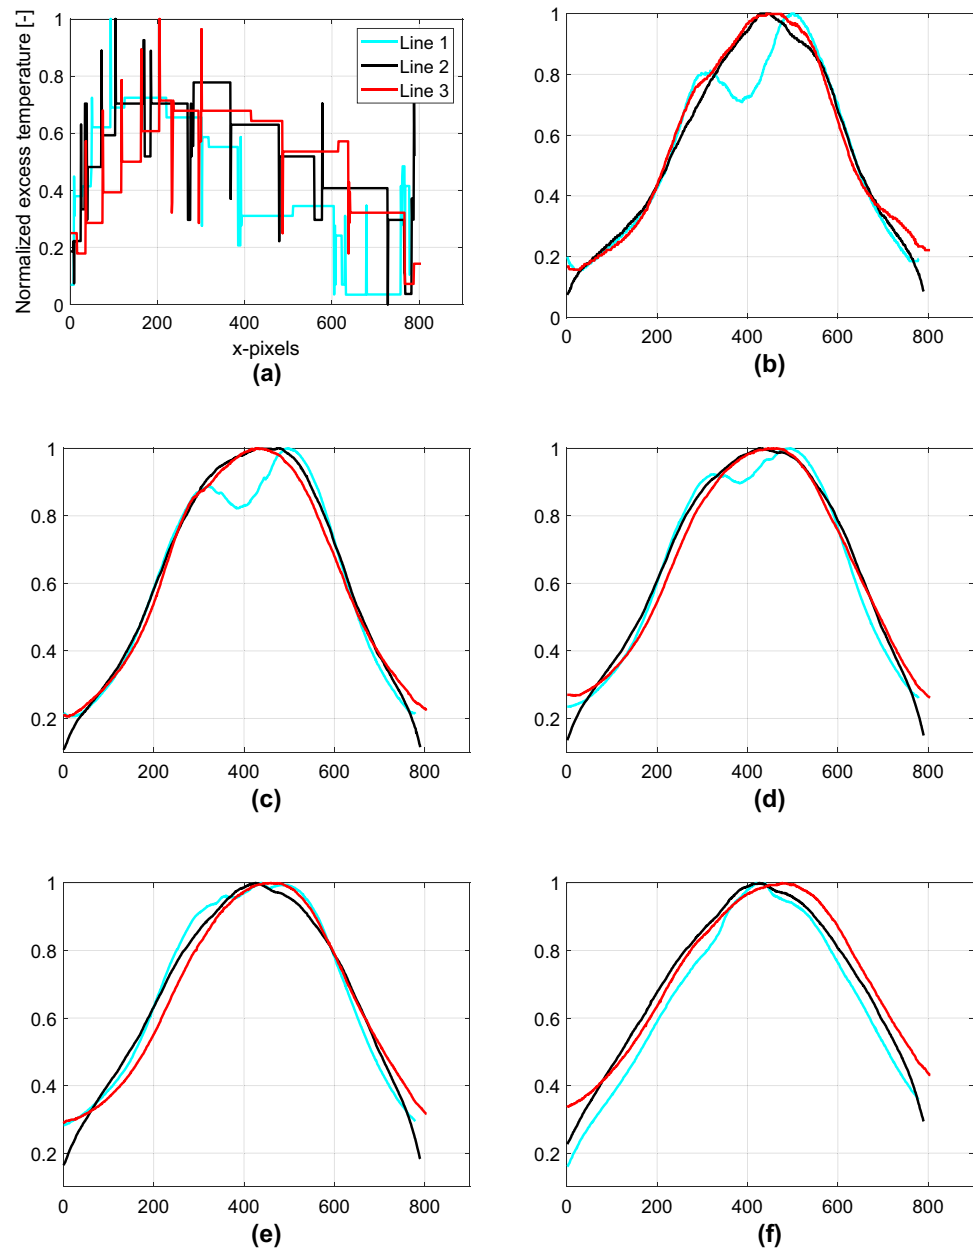
**Fig. 15** Normalized excess temperature lines for scenario 4: **a** 0 s, **b** 60 s, **c** 120 s, **d** 180, **e** 240 s, and **f** 420 s

Figure 15 shows the excess temperature curves obtained from lines 1, 2, and 3 shown in Fig. 14b. Lines 2 and 3, which do not pass through the defect, showed thermal symmetry between the left and right sides for all times analyzed. The times of 60, 120, and 180 s showed a significant asymmetry between the two sides of the surface for line 1. Halfway through the heating time, 60 s, a 20% greater temperature accumulation was observed on the right side (between the composite center and the PVC-inclusion). For times of 120 and 180 s, the asymmetry between temperatures decreased to 15 and 10%, respectively. During the remainder of the cooling time, no significant thermal asymmetries were observed, probably

due to the heating method that was non-contact with the sample, resulting in more uniform heat dissipation in the composite. Therefore, scenario 4 proved to be capable of capturing the presence of PVC inclusion from active infrared thermography. This method has an advantage over others due to the larger heating area reached in the sample, being able to detect defects in different locations using the same experiment.

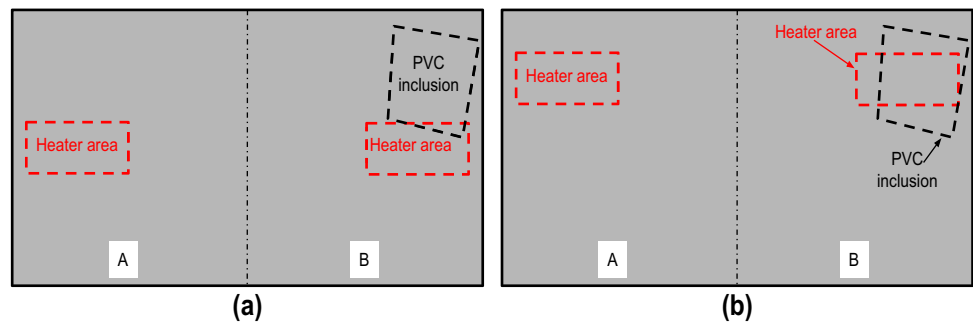
**Fig. 16** Front view of numerical model: **a** scenario 2a and **b** scenario 2b

Numerical analyses were performed using COMSOL® software. From experimental scenario 2, two different configurations were numerically simulated. Figure 16a shows the front view with two heaters arranged in the same way as in the experiments—scenario 2a. Alternatively, in Fig. 16b, the heaters were placed to overlap the defect—scenario 2b. Figure 16 includes a center line that divides sides A and B of the analyzed surface. All parameters and properties set in the simulation were the same as in the experiments, with the

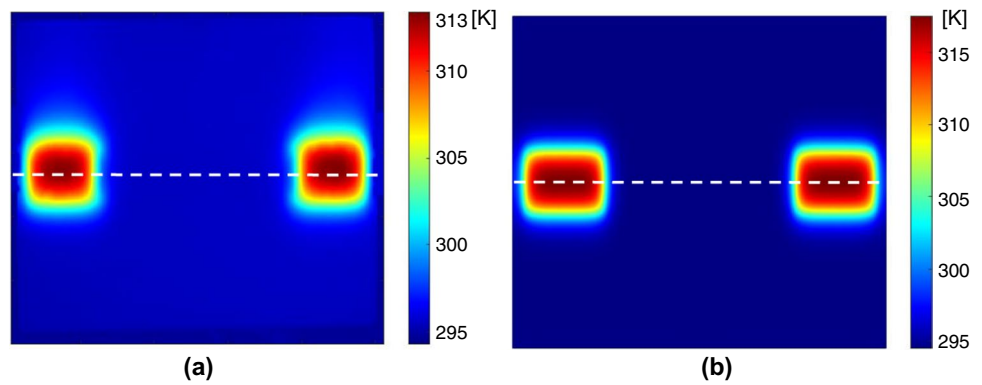
**Fig. 17** Thermal image at the final instant of heating (120 s): **a** experiment and **b** numerical simulation

Initially, a model validation study was carried out based on scenario 2a, comparing the results on the frontal surface at the final heating instant (120 s) of the experiment (Fig. 17a) and numerical simulation (Fig. 17b). The behavior of the temperature distributions are similar; however, a difference was observed among the maximum temperatures obtained, that in the experiment was 313 K and in the numerical simulation was 315 K. This difference may be due to the heat losses that occur in the experiment due to the thermal contact resistance existing between the heater and the composite, and also between the layers of the sample. A horizontal cut line was created on the surface center to analyze the temperature curves and provides a better comparison among numerical and experimental results.

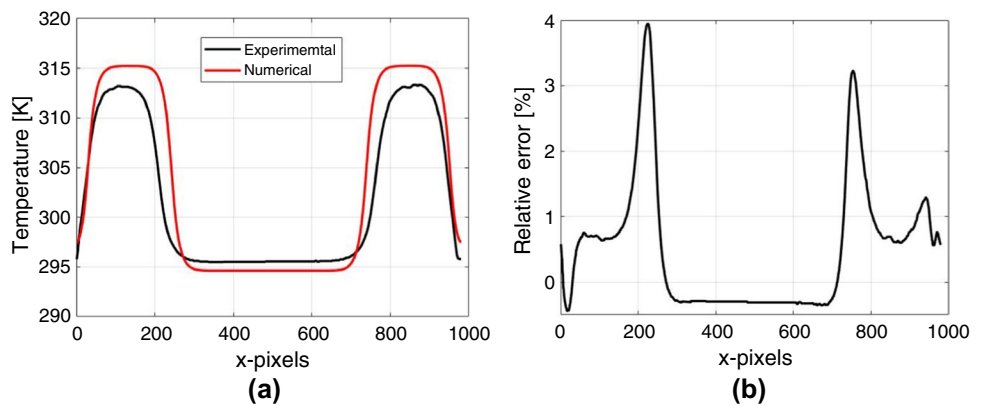
**Fig. 18** Error between experimental and numerical temperatures: **a** absolute error and **b** relative error

Figure 18a shows the experimental and numerical temperature distributions on the dotted white line drawn in Fig. 17, where temperature differences exist mainly in the heater region. Figure 18b shows the relative error between the experimental and numerical temperatures, with the maximum value of 4 %, thus validating the numerical model developed in COMSOL®.

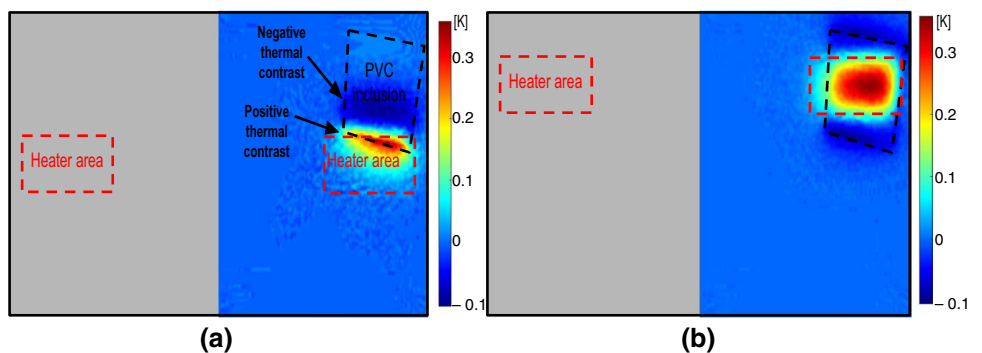
**Fig. 19** Numerical thermal contrast at the end of heating ( $t = 120$  s): **a** scenario 2a and **b** scenario 2b

Subtracting the images from sides B - A (Fig. 16a), Fig. 19a shows the thermal contrast of this scenario, where regions of positive and negative thermal contrasts were observed. A contrast of 0.3 K was obtained at the interface region between the heater and the PVC inclusion, that is, side B heated more than side A due to the existence of increased thermal resistance in this location. A thermal contrast of  $-0.1 \text{ K}$  was obtained in the defect region, because the heat could not be transferred with the same efficiency on side B compared to side A. From the simulated results for scenario 2a, it was possible to obtain quantitative markers that indicate the presence of a defect in the composite. However, low thermal contrast values make it difficult to obtain the same results from the experiments.
