# Research and Development on Coatings and Paints for Geothermal Environments: A Review

Francesco Fanicchia\* and Sigrún Nanna Karlsdóttir

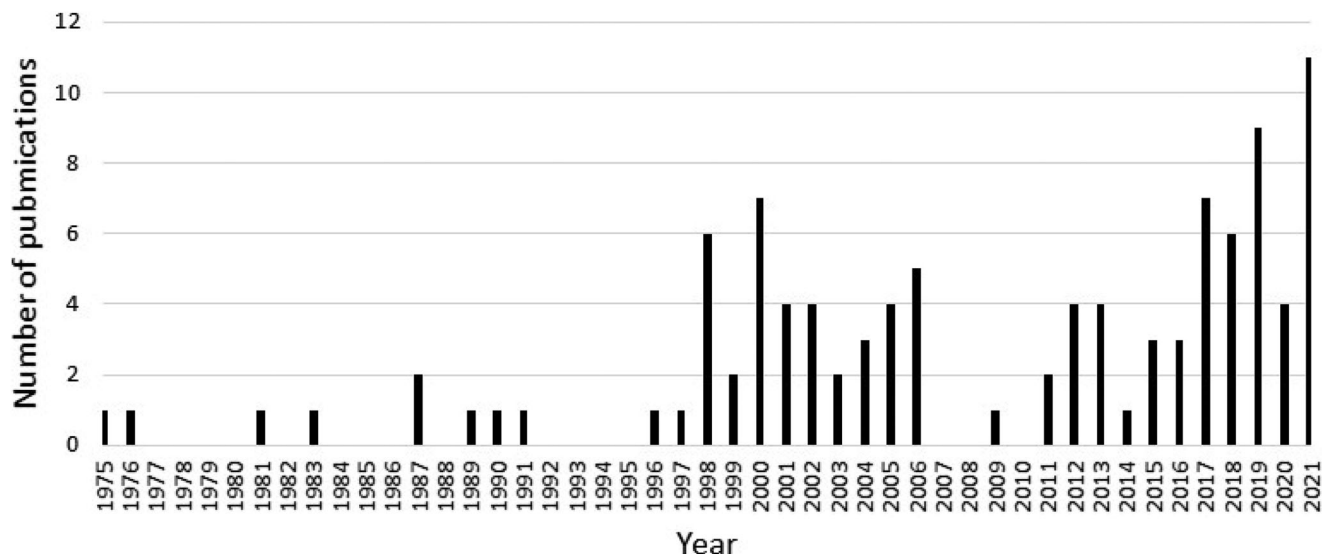
**Figure 1.** Breakdown of the 103 publications identified on coatings for geothermal applications per year (including peer-reviewed journal papers, conference transactions and reports), showing an increasing trend to date.

Figure 1 clearly shows an increasing tendency in the years reported. It is worth noting that the publications identified here only include work aimed at developing coatings tested specifically in geothermal conditions, either simulated or in field tests. Although in fact coatings developed for other harsh environments (e.g., hydrothermal power resources, biomass power production, etc.) could also represent promising candidates to mitigate degradation in geothermal systems, these have not been included in this review. The lack of papers up to the late 1990 s is observed since a significant amount of research in this area was performed privately within industrial research programs, with the consequence that novel developments would not be made publicly available. A deviation from this trend is observed from the early 2000s, where the global trend for geothermal energy development has triggered an increase of public investment in technologies facilitating the development of this renewable energy source. The present review paper is broadly subdivided into two sections: a first theoretical overview of the material degradation phenomena linked to material interaction with geothermal fluid (Section 2) and the actual review on coatings for geothermal applications (Section 3).

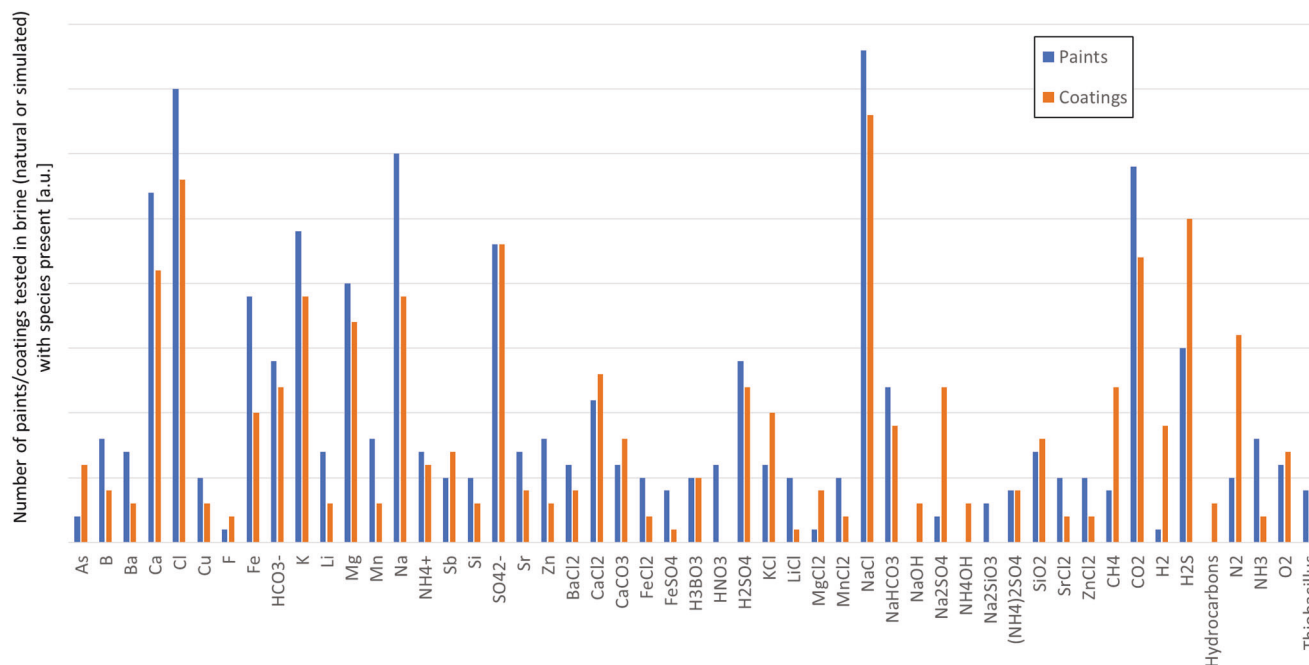
**Figure 2.** Number of paints and coatings tested in brine where a specific species was present, as summarized from 103 publications identified in this work. Only species appearing more than twice have been presented in the graph. A complete list of all the species can be found in the table in Supplementary Information.

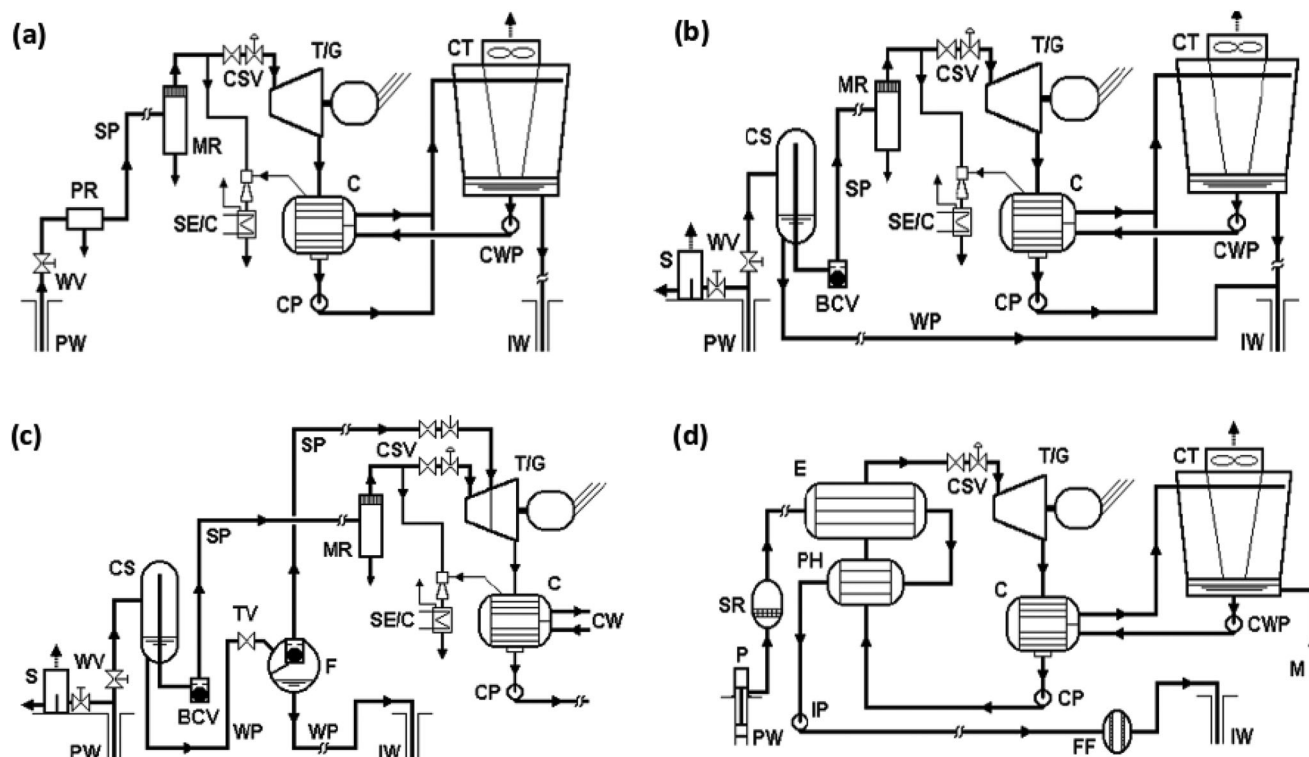
**Figure 3.** Schematics of geothermal power plant configurations: a) dry steam, b) single-flash, c) double-flash, and d) binary. In the figure: BCV (ball check valve), CP (condensate pump), CSV (control and stop valve), CW (cooling water), E (evaporator), FF (final filter), IW (injection wells), MR (moisture remover), PH (preheater), R (recuperator), SE/C (steam ejector/condenser), SP (steam piping), T/G (turbine/generator), WP (water piping), C (condenser), CS (cyclone separator), CT (cooling tower), CWP (cooling water pump), F (flasher), IP (injection pump), M (make-up water), P (well pump), PR (separator), PW (production wells), S (silencer), SH (superheater), SR (sand remover), TV (throttle valve), WV (wellhead valve). Reproduced with permission.<sup>[23]</sup> Copyright 2011, Geo-Heat Digital Library, Oregon Institute of Technology Library. Klamath Falls, Oregon.

the turbine, several particulate removal systems are placed (e.g., separators, (PR)) together with moisture removal systems (MR). Moreover, due to the common presence of non-condensable gases (NCG) within the steam, steam ejectors with pre-and after-condenser systems (SE/C) are generally used. The "single-flash" configuration is depicted in Figure 3b. This represents the most common type of geothermal power plant as most reservoirs are liquid-dominated.<sup>[24]</sup> In this case, the steam necessary to drive the turbine/generator is separated from the liquid geothermal fluid by a rapid evaporation (i.e., flash). This latter operation is performed by the cyclone separator (CS). The separated brine from the cyclone separator is generally re-injected within the reservoir, carried via a water piping system, (WP). Ball check valve (BCV) and moisture removal systems are placed after the cyclone separator to insure against any possible slug entering the steam line. The after-turbine system in this type of plant essentially mirrors the one for the dry-steam one. The "double-flash" configuration is depicted in Figure 3c. The cycle is fundamentally like the single-flash plant, with the exception that the brine obtained from the cyclone separator is not directly re-injected back into the reservoir but withstands further flashing within a second flasher (F). The low-pressure steam ejected from the secondary brine is then fed either into a separate low-pressure turbine or to a separate stage of the main turbine. The re-usage of the primary brine generally allows for 20–25% more power to be generated as compared to single-flash plants.<sup>[24]</sup>

Within "binary" configurations (Figure 3d), the geothermal fluid is not directly employed to rotate the turbine, but its thermal energy is transferred instead, via a heat exchanger, to a secondary working fluid. The working fluid can be a mixture of hydrocarbons (e.g., isopentane and isobutene) or water and ammonia. The geothermal fluid is generally maintained in the liquid state throughout the cycle, maintained below its flash level by down-hole pumps (P) to raise its pressure. The working fluid steam required to rotate the turbine is generated at the evaporator (E) as opposed to the cyclone separator typical of flash plants. A preheater (PH) is also present prior to the evaporator to provide the working fluid with additional thermal energy, possibly still available from the geothermal fluid. The preheater-evaporator ensemble is generally referred to as a heat exchanger. Finally, *hybrid* systems (not depicted in Figure 3), are composed of combinations of the above-described four basic systems. In fact, a hybrid plant is designed to achieve an optimized efficiency to suit the specific set of working conditions experienced by the plant site (in terms of pressure, temperature, NCGs, dissolved solids, pH, scaling, and corrosion potential). Examples of this type of plant are dry-steam/binary,<sup>[25]</sup> single-flash/binary,<sup>[25]</sup> single-/double-flash,<sup>[26,27]</sup> and hybrid fossil-geothermal systems.<sup>[28]</sup> Additionally, geothermal combined heat and power (GCHP) plants exist (e.g., additions to single and double flash) which include additionally heat exchangers to the systems to heat up cold water with the geothermal fluid (liquid) from the separators. The heated water

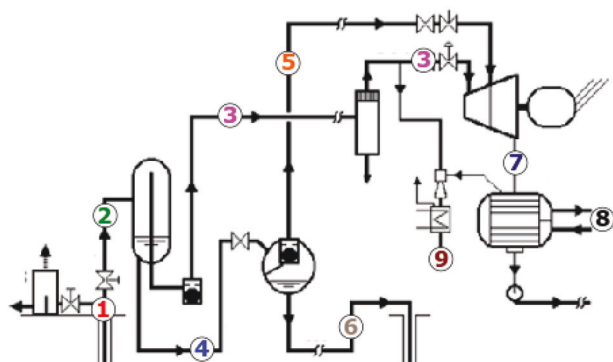
**Figure 4.** The schematic diagram of the double-flash power plant configuration from Figure 3c<sup>[23]</sup> adapted with areas of significant geothermal fluid properties variation highlighted with numbers. These properties are reported, for a class III fluid (according to the classification in Table 3), in Table 4. Reproduced with permission.<sup>[23]</sup> Copyright 2011, Geo-Heat Digital Library, Oregon Institute of Technology Library, Klamath Falls, Oregon.

fluid properties corresponding to the numbered areas in Figure 4, is given in **Table 4**, together with the corresponding degradation mechanisms and affected components.

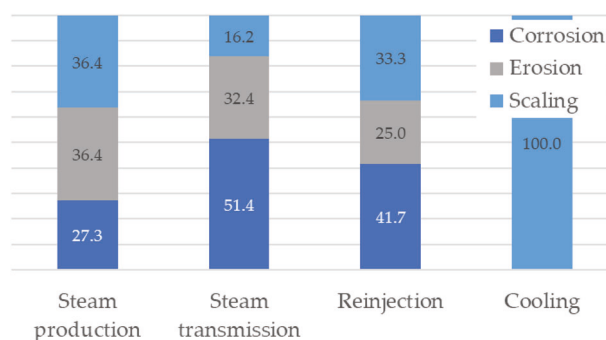
**Figure 5.** Probability (%) of occurrence of corrosion, erosion, and scaling mechanisms in the main four systems of a geothermal power plant, obtained as a summary of the table in ref. [32], where critical components, principal damage mechanisms and their effects compiled from FMEA analysis from 12 different geothermal power plants were analyzed.

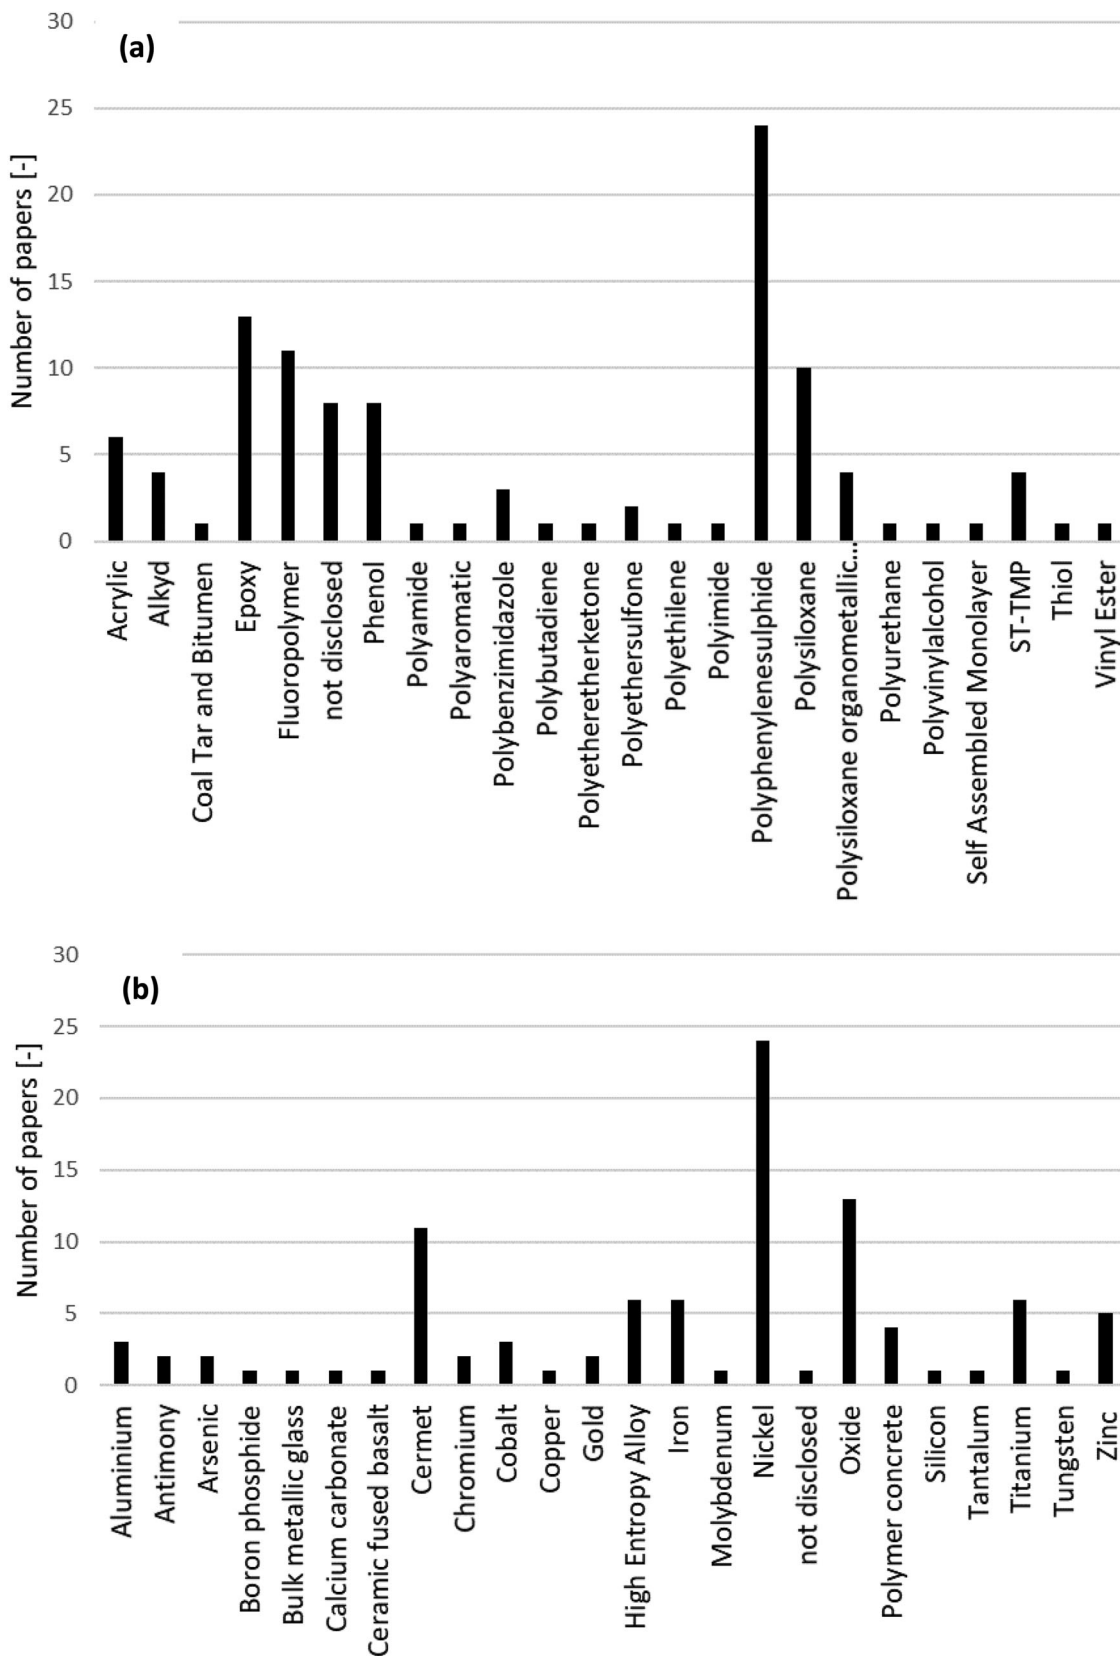
**Figure 6.** Number of papers, identified in this work, reporting the testing of a) paint and b) coating systems for mitigation of damage in geothermal components. Summarized from the table in the Supplementary Information.

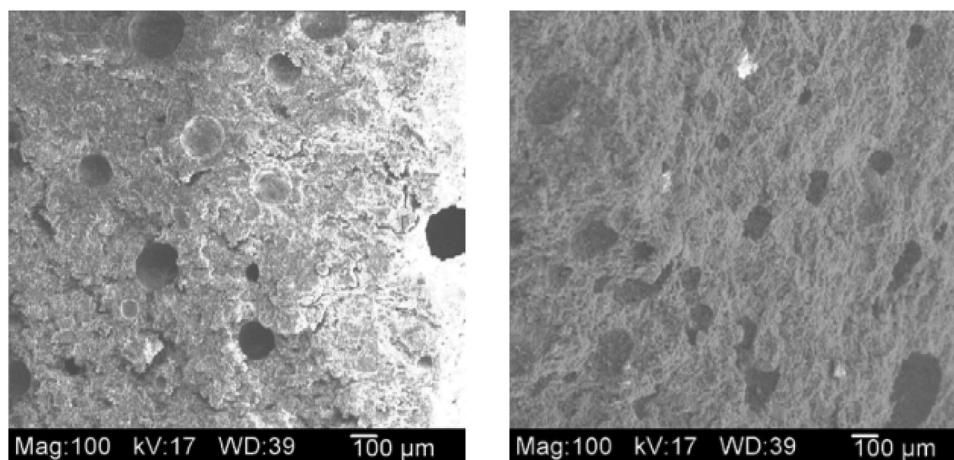
**Figure 7.** SEM micrographs of fractured surfaces for styrene acrylic latex (SAL)/calcium aluminate cement (CAC) at 30/70 ratio in (left) non-exposed and (right) exposed to 21 days simulated geothermal conditions. Pores originally identified on the as-deposited specimen (left) were observed to be filled with boehmite and calcite phases during the exposure (right). Reproduced with permission.<sup>[64]</sup> Copyright 2006, Brookhaven National Laboratory.

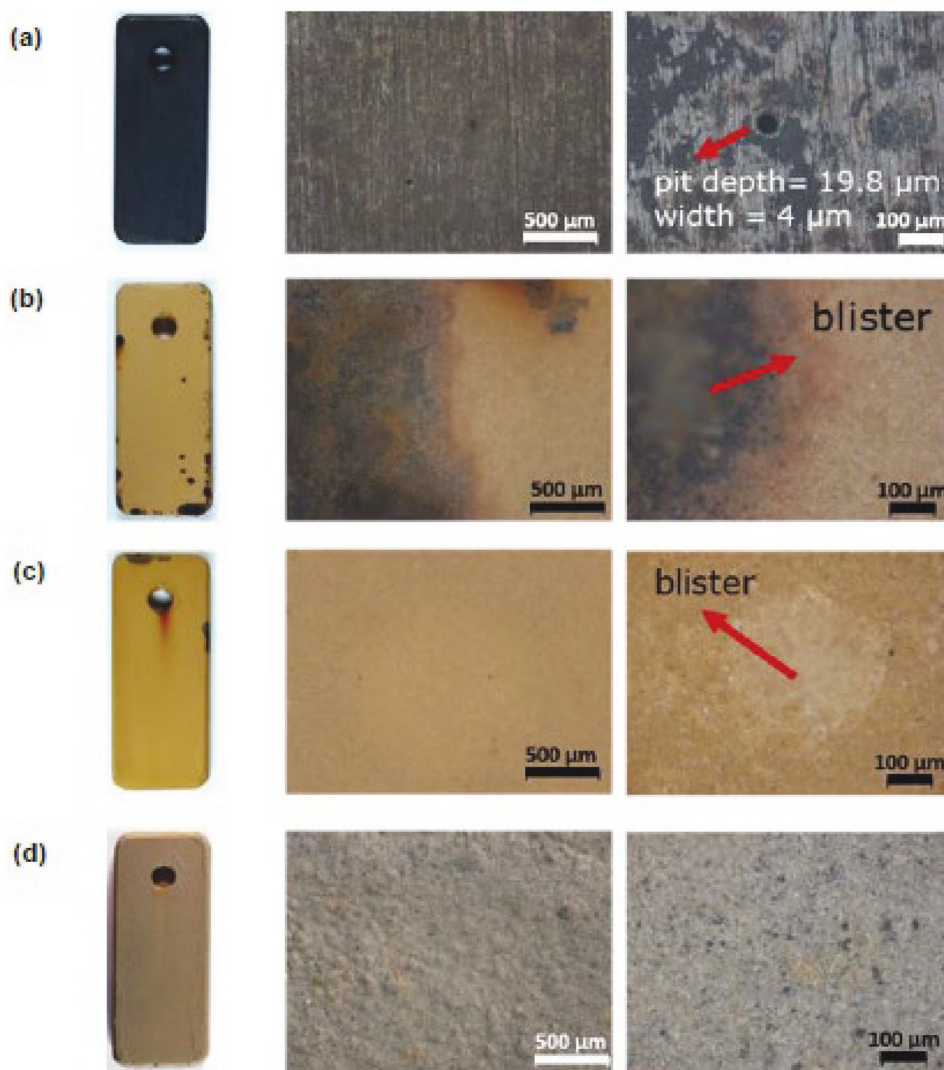
**Figure 8.** Overview (left), stereo picture (center), and light microscope images (right) of specimens exposed at 150 °C and 1 MPa for 7 days of a) carbon steel, b) binder, c) Si15, and d) PS. Reproduced with permission.<sup>[66]</sup> Copyright 2018, Association for Materials Protection and Performance.

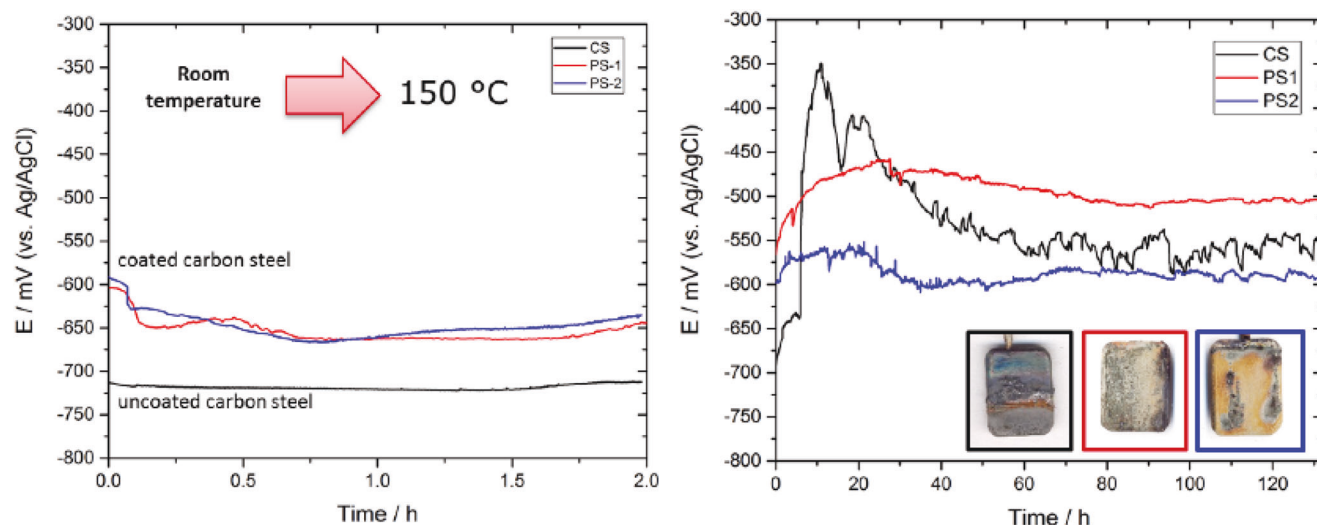
**Figure 9.** Open Circuit Potential (OCP) of carbon steel, PS1, and PS2 paint systems in artificial geothermal water and oxygen free environment at 150 °C and 1 MPa for 132 hours. Reproduced with permission.<sup>[67]</sup> Copyright 2019, Association for Materials Protection and Performance.

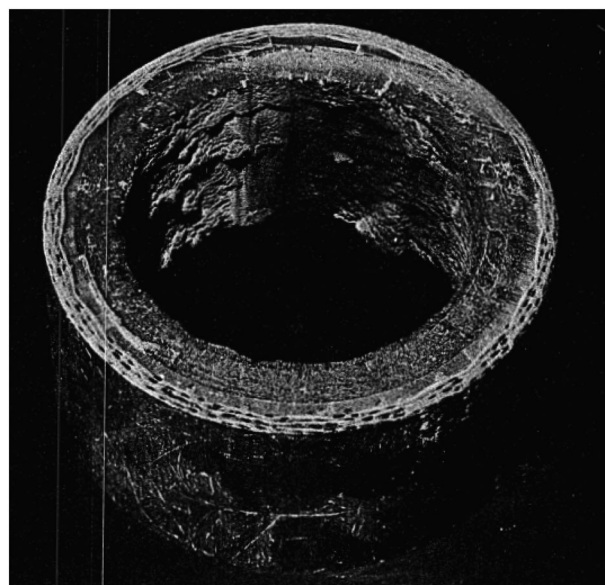
**Figure 10.** Epoxy fiberglass pipe after 72 h exposure to a synthetic hypersaline brine (24 wt.% NaCl) at 300 °C, showing clear presence of scale on the internal diameter. Reproduced with permission.<sup>[63]</sup> Copyright 1975, Lawrence Livermore National Laboratory.

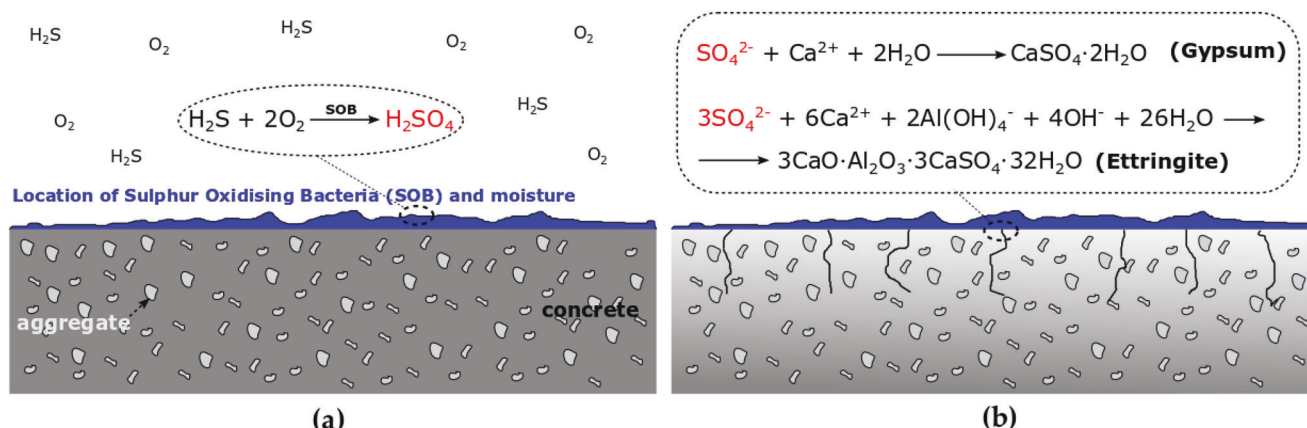
**Figure 11.** Microbiologically Induced Corrosion (MIC) of concrete due to sulfur oxidising bacteria (SOD) is due to the formation of a) sulfuric acid ( $H_2SO_4$ ) from hydrogen sulfide ( $H_2S$ ) and oxygen ( $O_2$ ) in the atmosphere and b) sulfuric acid attack with formation of hydrated gypsum and ettringite compounds, causing substrate cracking and disintegration.

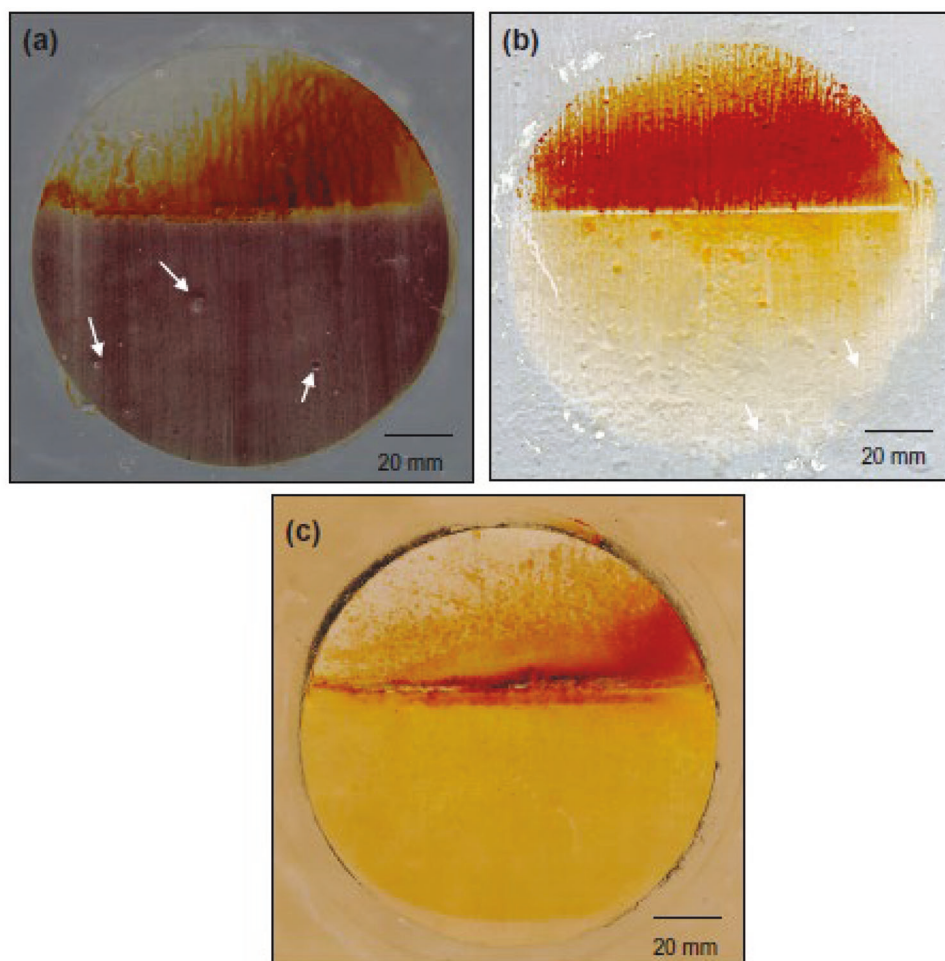
**Figure 12.** Appearance of a) Amercoat 351, b) Amercoat 385, c) Sikagard 62 after 60-day exposure to *T. ferrooxidans*. All the epoxy coatings show good condition, except for Amercoat 351 where blisters were observed (white arrows). Reproduced with permission.<sup>[80]</sup> Copyright 2011, Elsevier.

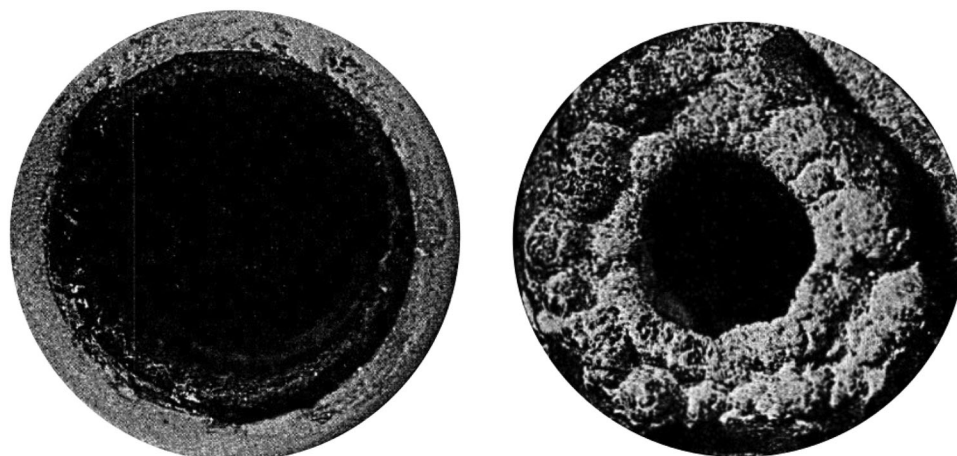
**Figure 13.** Teflon PFA (left) and Ployphenylquinoxaline (right) nozzle exits after field tests showing considerable difference in amount of mineral scaling. The Teflon PFA paint system demonstrated the least scaling and highest resistance to erosive wear among the tested systems by Lorensen et al. Reproduced with permission.<sup>[63]</sup> Copyright 1975, Lawrence Livermore National Laboratory.

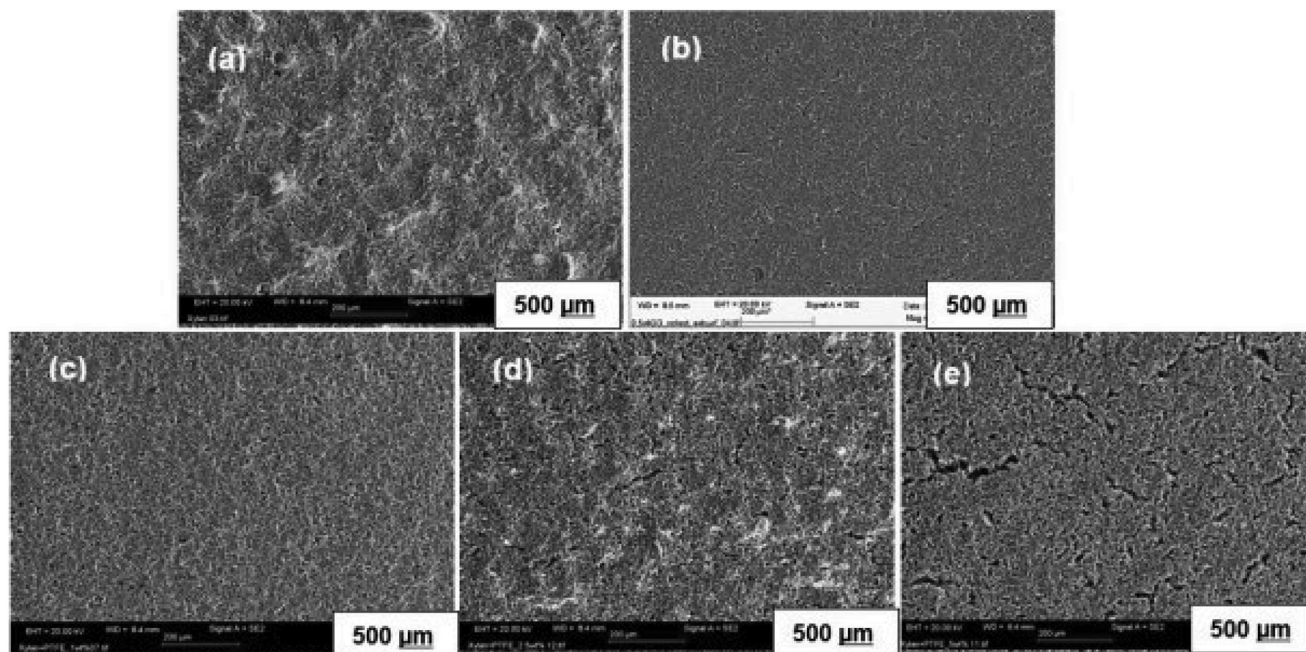
**Figure 15.** SEM micrographs of the surface of Xylan-based coatings a) pure Zylan, b) Xylan+0.5 wt.%Graphene Oxide(GO), c) Xylan+1 wt.%GO, d) Xylan+2.5 wt.%GO, e) Xylan+5 wt.%GO. Reproduced with permission.<sup>[94]</sup> Copyright 2021, International Geothermal Association.

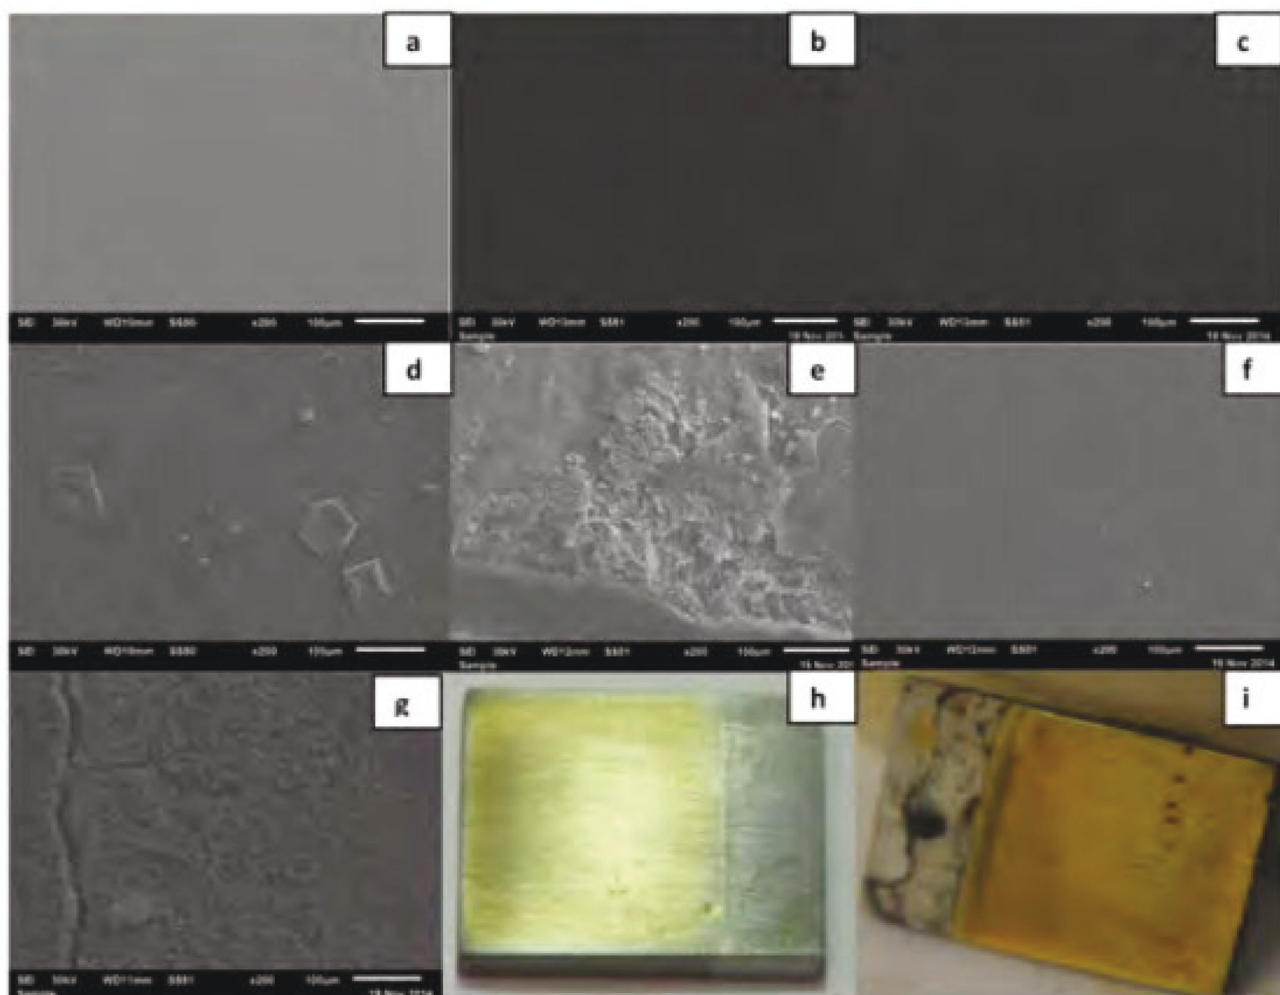
**Figure 16.** SEM micrographs before and after exposure tests of polybenzoxazine (PBZ) and rubber-modified (PBZ-R)/montmorillonite (MMT) nanoclay composites: a) bare carbon steel, b) PBZ-R, c) PBZ-R-5MMT before immersion in geothermal brine, d) bare steel immersed in 0.5 M NaCl, e) bare steel, f) PBZ-R, g) PBZ-R-5MMT immersed in geothermal brine for 7 days, and optical images of PBZ-R-5MMT, h) before immersion, i) after immersion in simulated geothermal brine for 7 days. The smooth surface appearance of the sample PBZ-R-5MMT in panel (i) shows no clear signs of corrosion or damage. Reproduced with permission.<sup>[97]</sup> Copyright 2019, Association for Materials Protection and Performance.

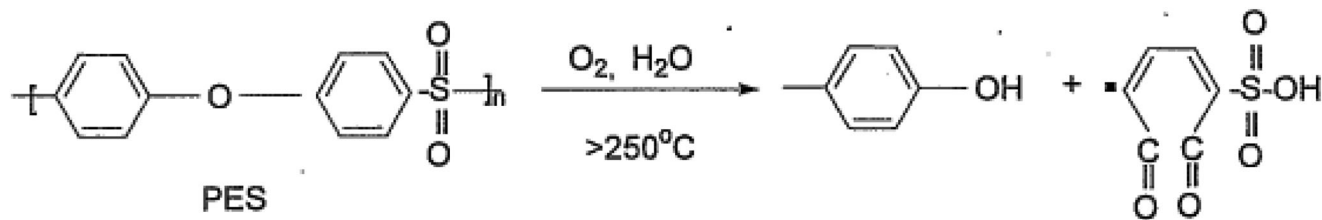
**Figure 17.** As suggested by Sugama,<sup>[102]</sup> hydrothermal oxidation of polyethersulfone (PES) exposed to artificial brine at temperatures  $>250$  °C leads to the formation of hydroxyl and carbonyl groups, with consequent enhancement of moisture susceptibility. Reproduced with permission.<sup>[102]</sup> Copyright 2005, Brookhaven National Laboratory.

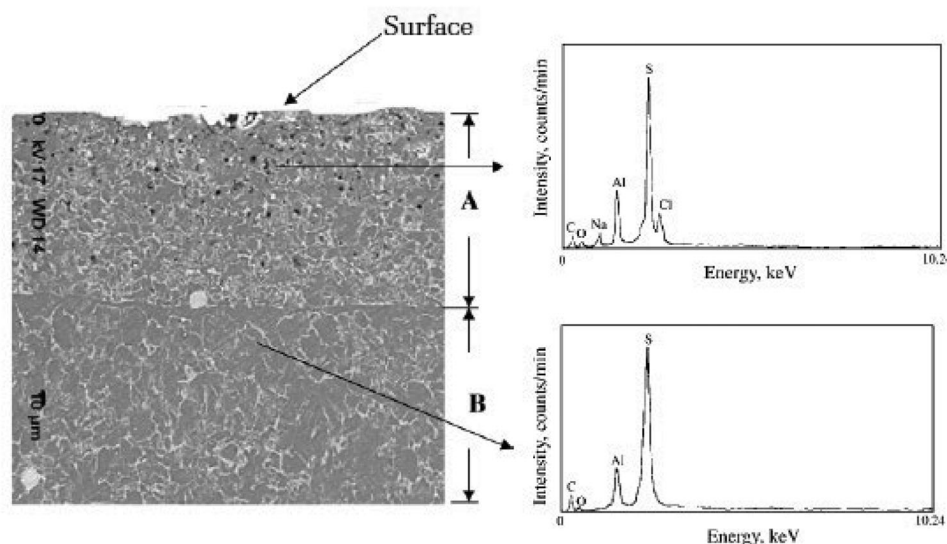
**Figure 18.** Backscattering SEM image and EDX spectra for the cross-sectional area of 15wt% boehmite-filled PPS paint system after exposure for 15 days in 300 °C brine. Porosity is generated within the paint layer in contact with the exposure medium, which was linked to an excessive amount of boehmite phase. Reproduced with permission.<sup>[113]</sup> Copyright 2004, SAGE Publications Inc.

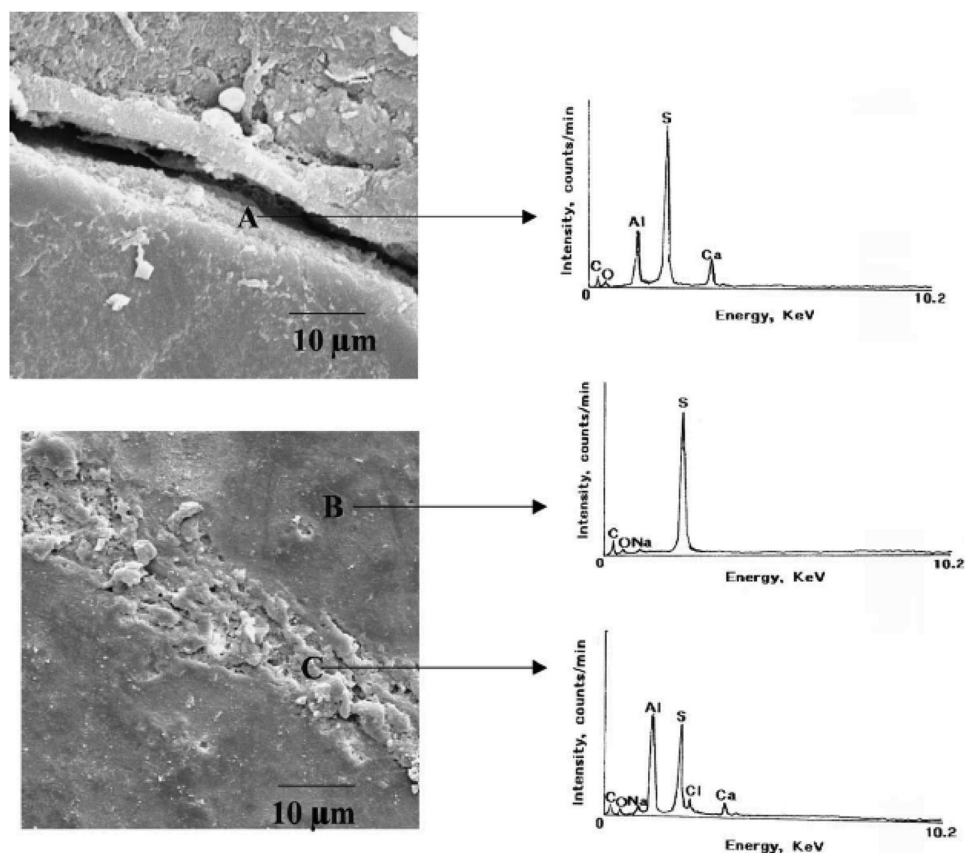
**Figure 19.** SEM images coupled with EDX spectra for cleaved PPS coatings with 5 wt.% CA fillers before (top) and after (bottom) exposure for 24 h to CO<sub>2</sub>-laden brine at 200 °C, clearly indicating that crack filling with block-like crystals has occurred. Reproduced with permission.<sup>[115]</sup> Copyright 2003, Elsevier.

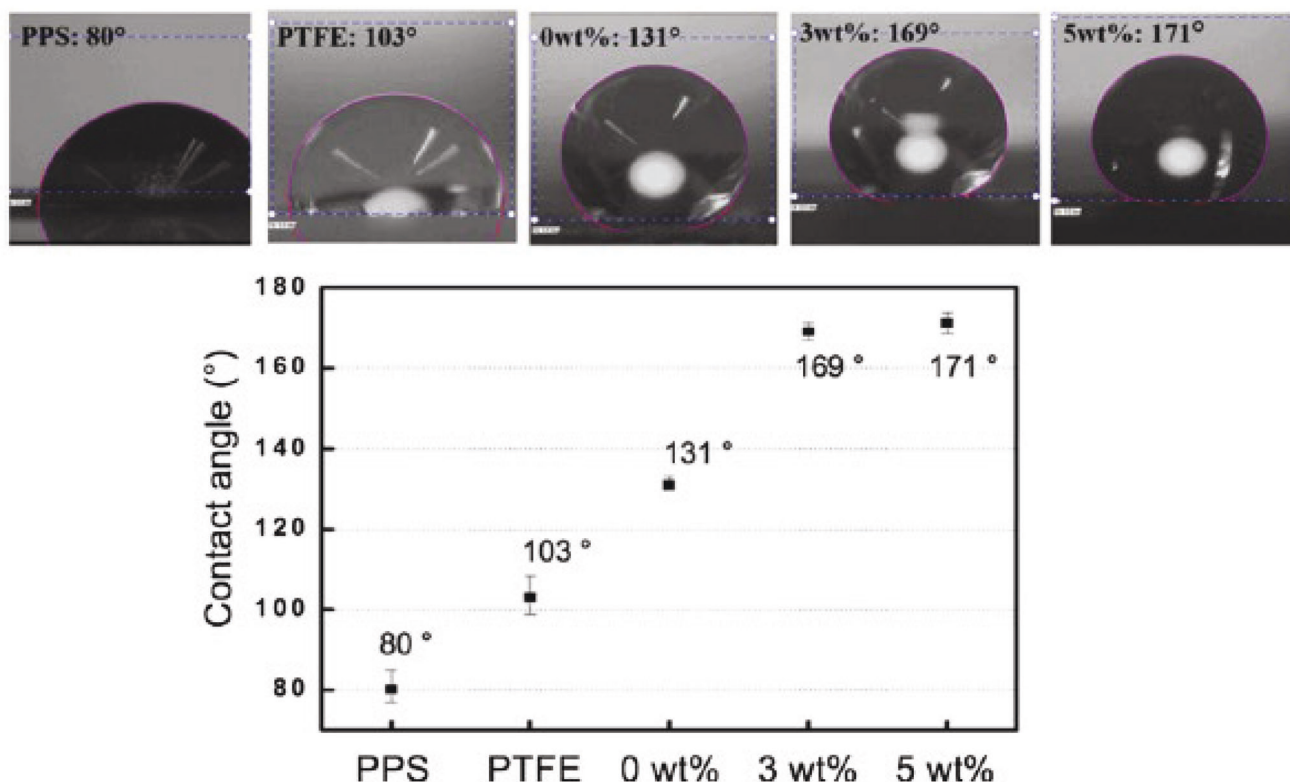
**Figure 20.** Water contact angle measured for PPS, PPS/PTFE and PPS/PTFE/MWCNT paint systems at different MWCNT loading levels. Reproduced with permission.<sup>[121]</sup> Copyright 2016, Wiley-VCH GmbH.

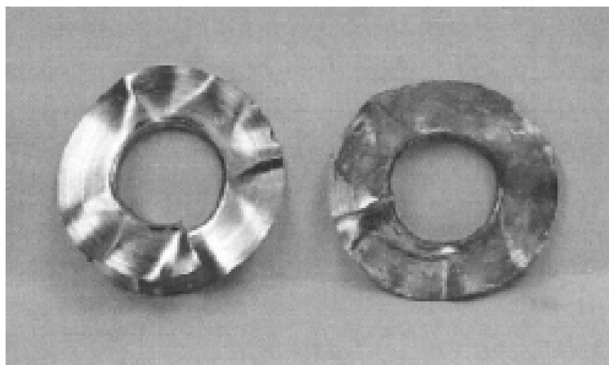
**Figure 21.** Organometallic polymer-coated (left) and uncoated (right) aluminum fin after 30 days salt spray test in 3.5 wt.% NaCl and 35 °C. No corrosion products developed on the coated component. Reproduced with permission.<sup>[122]</sup> Copyright 2002, Geothermal Rising.

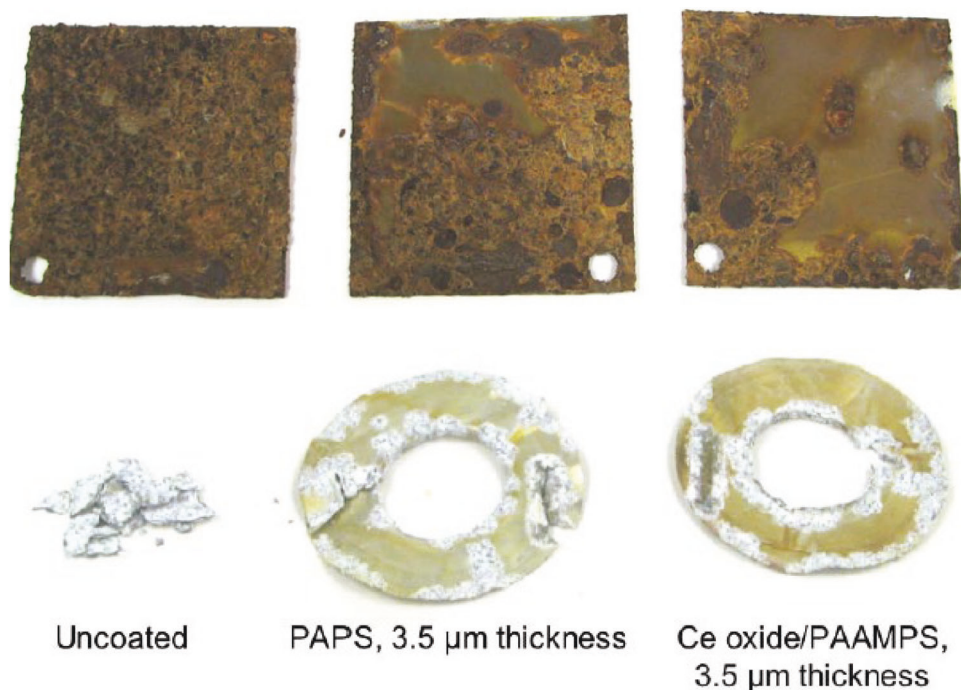
**Figure 22.** Uncoated, undoped PAPS and Ce oxide/PAAMPS-coated carbon steel coupons (top) and aluminum fins (bottom) after the 24 500-cycle test, showing significant improvements in corrosion performance for the latter. Reproduced with permission.<sup>[124]</sup> Copyright 2006, Geothermal Rising.

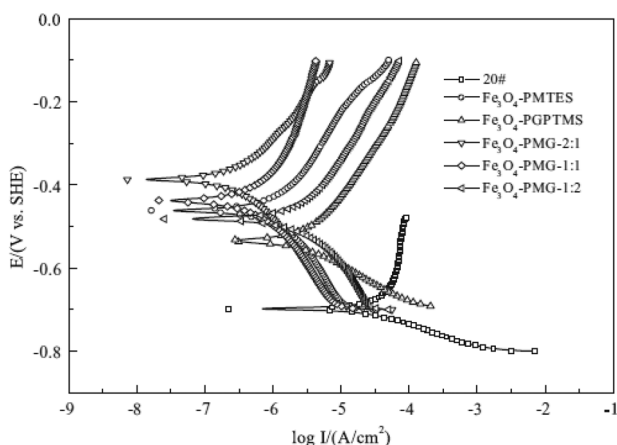
**Figure 23.** Potentiodynamic polarization curves of different ferric oxide polysiloxane-based composite coatings in 3.5 wt.% NaCl solution. The best performance was demonstrated by specimen  $\text{Fe}_3\text{O}_4\text{-PMG-2:1}$ . Reproduced with permission.<sup>[125]</sup> Copyright 2017, Elsevier.

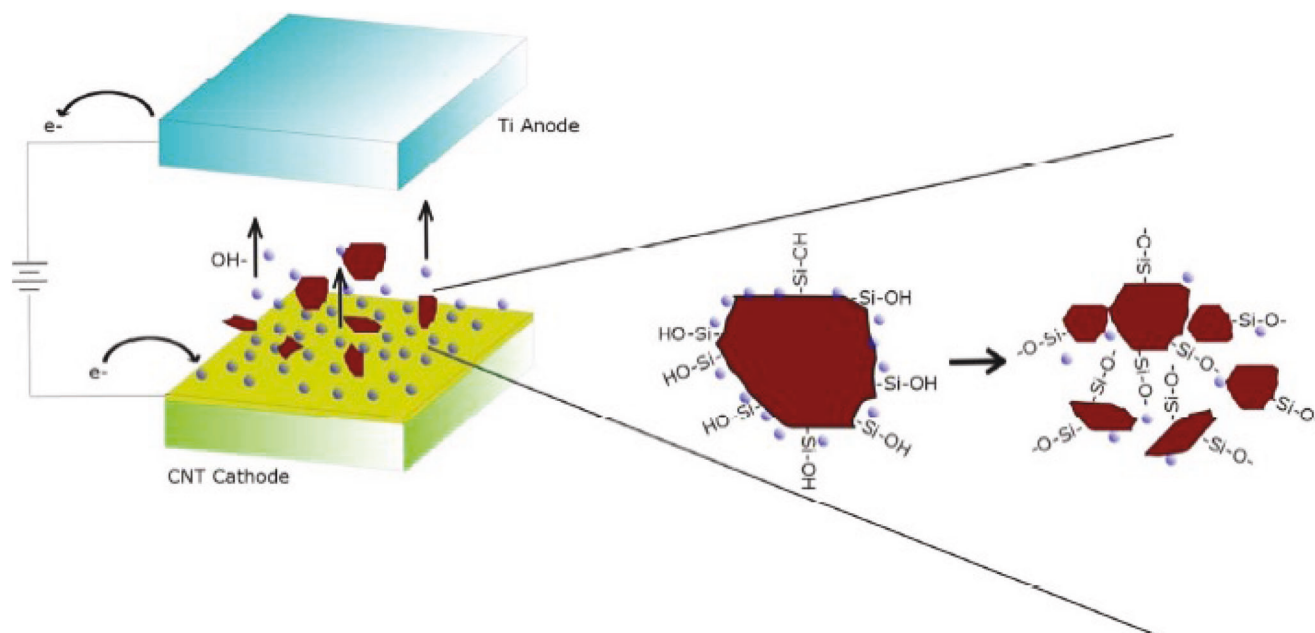
**Figure 24.** Graphical description of proposed electrochemically induced silicate dissolution cleaning mechanism provided by the carbon nanotubes(CNT)/polyvinylalcohol(PVA) paint for the membrane distillation (MD) process. Reproduced with permission.<sup>[126]</sup> Copyright 2017, American Chemical Society.

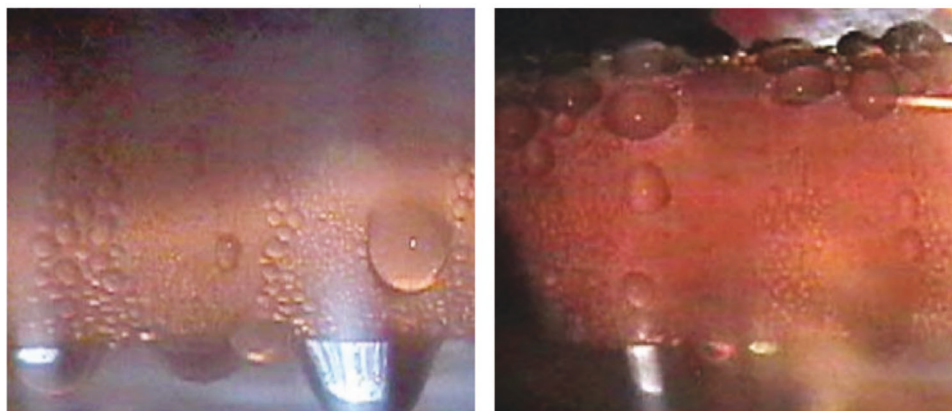
**Figure 25.** Surface photograph of condensation onto a self-assembled monolayer paint-coated tube (SAM-2) after 100 h (left) and 3600 h test (right), demonstrating an increase in drop size with exposure time. Reproduced with permission.<sup>[128]</sup> Copyright 2006, Geothermal Rising.

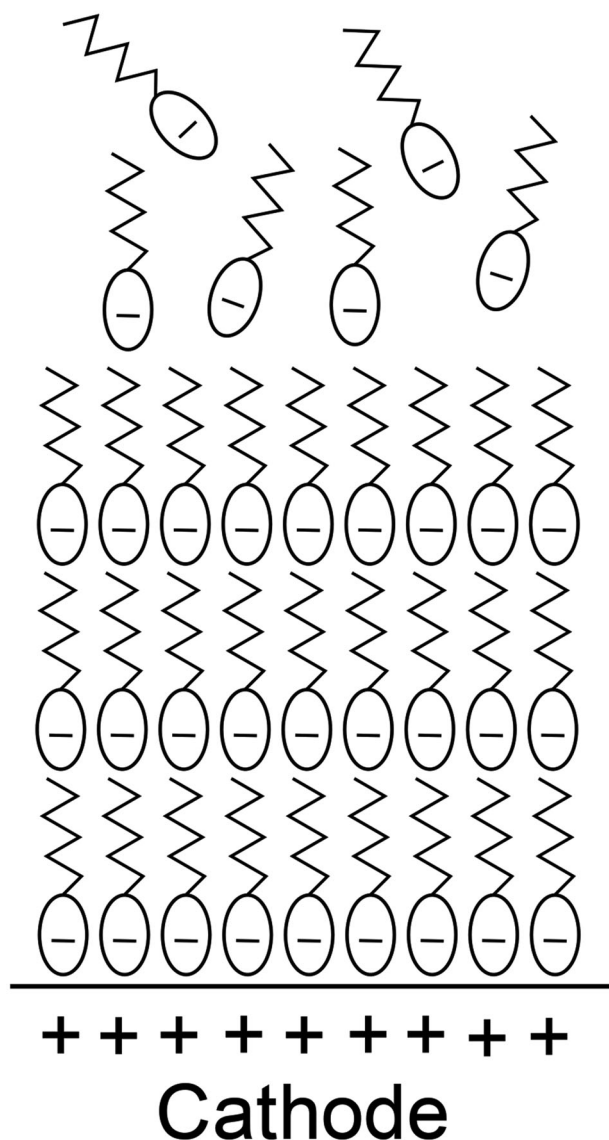
**Figure 26.** Monomer thiolate ions could arrange in an electric bilayer fashion after voltage application.

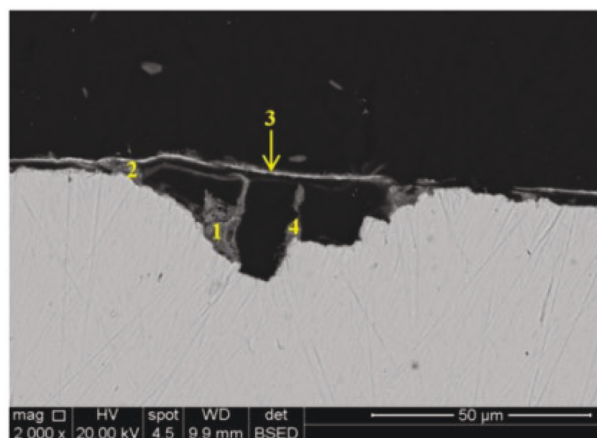
**Figure 27.** SEM micrograph of a corrosion pit formed under antimony-coated carbon steel coupon after exposure to aerated pH 5.4 solution. Reproduced with permission.<sup>[133]</sup> Copyright 2015, International Geothermal Association.

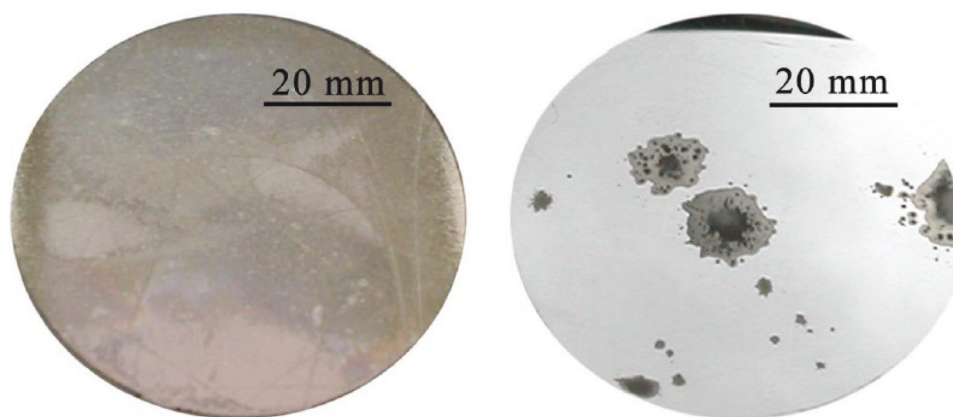
**Figure 28.** Surface photographs of (left) BP-coating and (right) 304 L stainless steel after potentiodynamic polarization test in 5.7 M NaCl solution at 25 °C. Pitting is observed on the un-coated stainless-steel substrate. Reproduced with permission.<sup>[135]</sup> Copyright 2014, Elsevier.

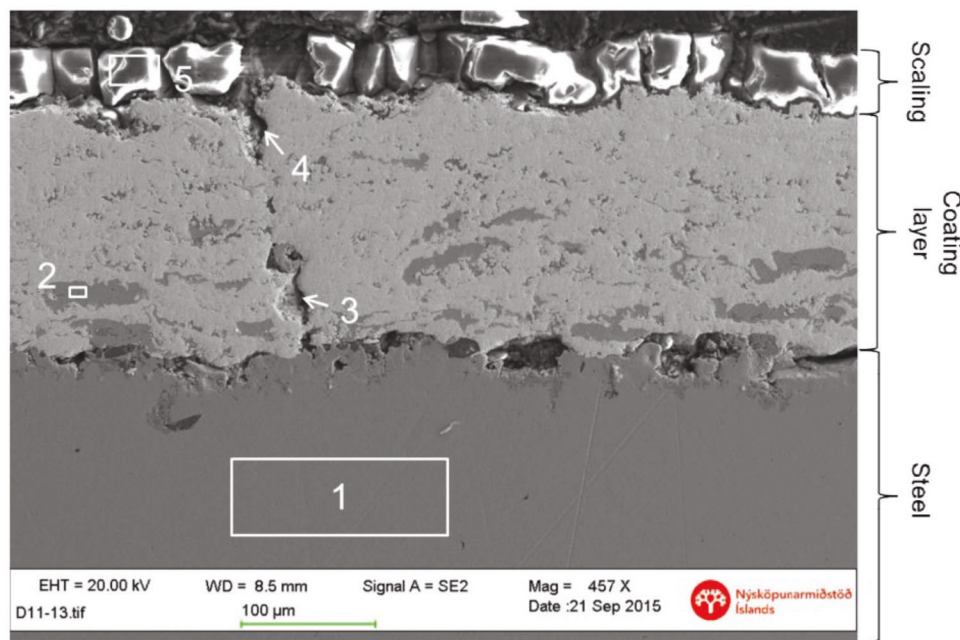
**Figure 29.** Cross-sectional SEM micrograph of HVOF WC-Co-Cr cermet coating deposited onto carbon steel, showing vertical cracks and voids at the interface after in-situ exposure test at the Hellisheiði geothermal power plant. Reproduced with permission.<sup>[141]</sup> Copyright 2017, Association for Materials Protection and Performance.
