# Research and Development on Coatings and Paints for Geothermal Environments: A Review

Francesco Fanicchia\* and Sigrún Nanna Karlsdóttir

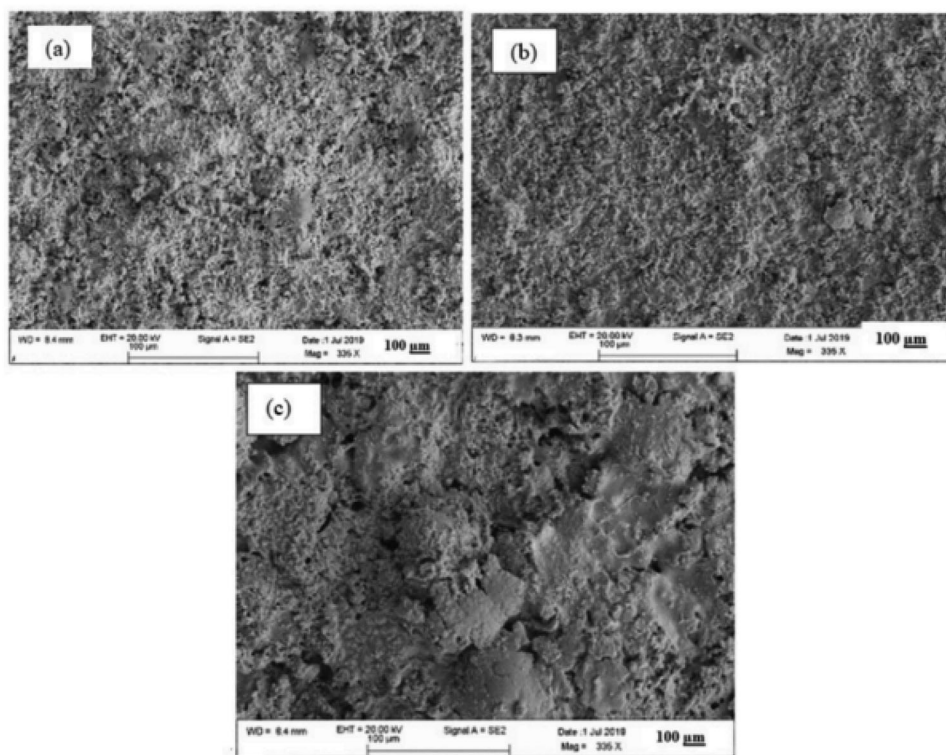
**Figure 30.** Surface SEM micrographs of the HVOF-deposited cermet coatings, tested against sliding wear behavior by Boakye et al.: a) WC-Co-Cr, b)  $\text{Cr}_3\text{C}_2$ -NiCr, and c) CA3 – Ni-Cr-Fe-Si-B-C. Reproduced with permission.<sup>[144]</sup> Copyright 2021, International Geothermal Association.

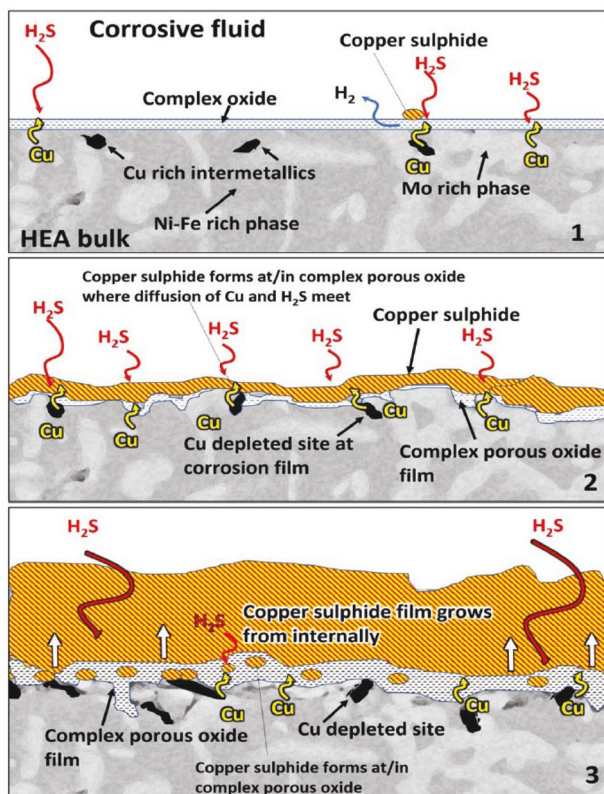
**Figure 31.**  $\text{Cu}_2\text{S}$  formation mechanism proposed by Thorhallsson et al., for Cu-containing HEAs after exposure to hot geothermal brine resembling the IDDP1 chemistry (Krafla region, Iceland). Reproduced with permission.<sup>[152]</sup> Copyright 2021, Elsevier.

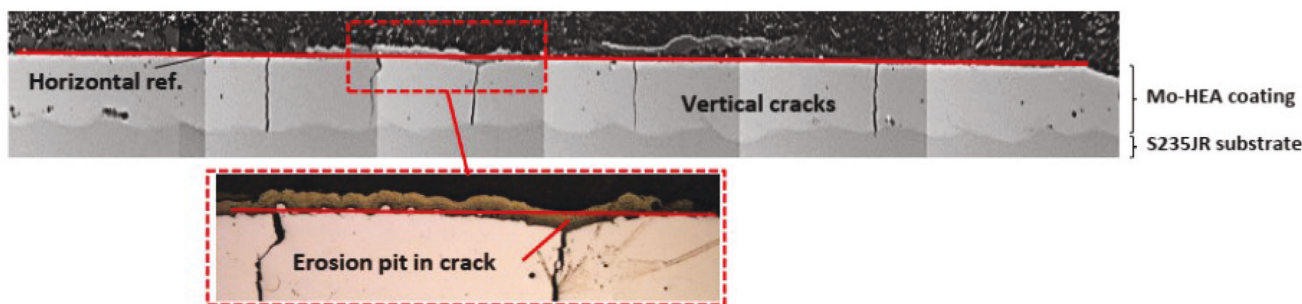
**Figure 32.** The laser metal deposited CoCrFeMo<sub>0.85</sub>Ni coating onto carbon steel revealed manufacturing cracks, which were considered responsible for a locally enhanced erosion damage after erosion in-situ exposure at the Hellisheiði geothermal power plant. Reproduced under the term of CC-BY license.<sup>[155]</sup> Copyright 2021, The Authors, published by MDPI.

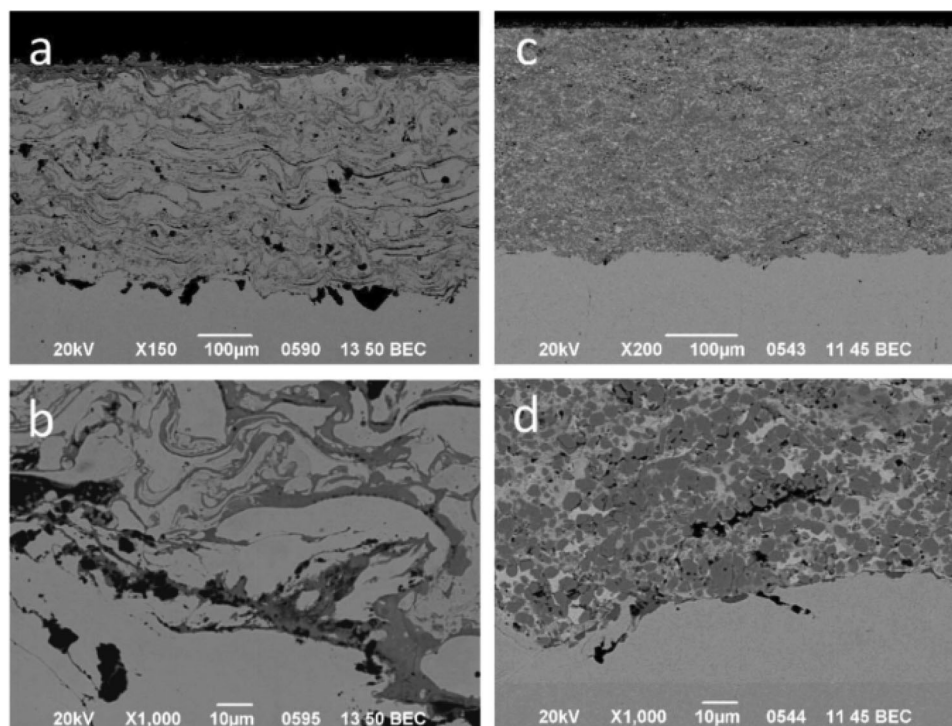
**Figure 33.** Cross-sectional SEM micrograph of a,b) TWAS-deposited  $\text{Cr}_{13}\text{Fe}_{87}$  and c,d) HVOF-deposited  $\text{Ce}_2\text{C}_3$ -NiCr (cermet) coatings after 3 months exposure to simulated geothermal fluid. Corrosion damage is observed, particularly with the Fe-based alloy. Reproduced with permission.<sup>[142]</sup> Copyright 2021, Tanger Ltd.

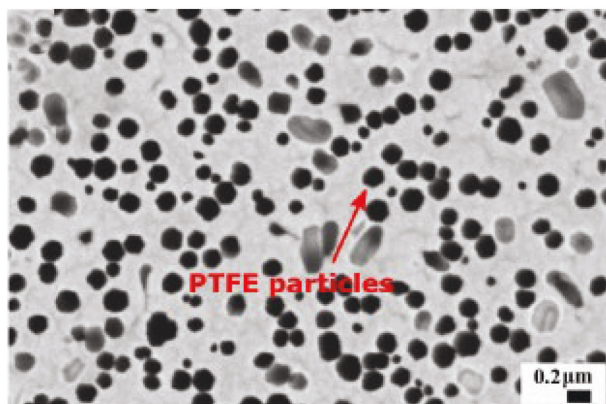
**Figure 34.** Sem micrograph of electroless plated Ni-P-PTFE layer as reported by Fanicchia et al. Reproduced with permission.<sup>[143]</sup> Copyright 2021, International Geothermal Association.

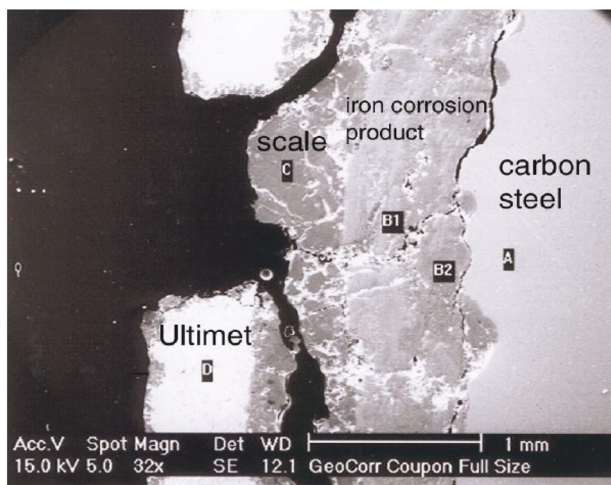
**Figure 35.** SEM micrograph of Ultimet-coated (Co-based alloy) carbon steel coupons after exposure for 1200 h within a wellhead in the Salton Sea geothermal area. Scale and corrosion products are observed at the interface between coating and substrate because of brine permeation through defects in the coating. Reproduced with permission.<sup>[146]</sup> Copyright 2002, Geothermal Rising.

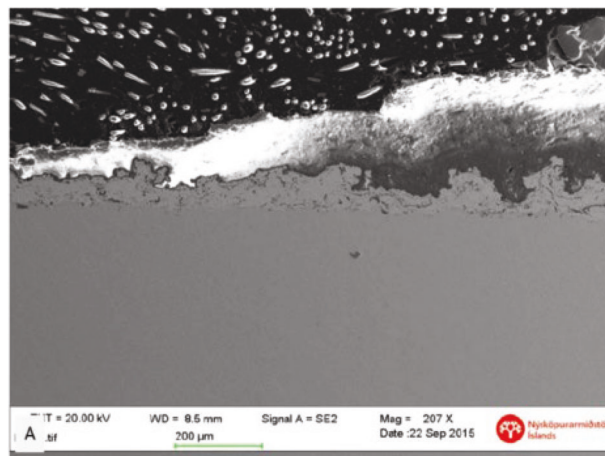
**Figure 36.** Cross-sectional SEM micrograph of  $\text{Al}_2\text{O}_3/\text{TiO}_2$  coating after 38 days in-situ exposure at the Hellisheiði power plant (Iceland), showing no cracks nor delamination, but significant erosion wear. Reproduced with permission.<sup>[141]</sup> Copyright 2017, Association for Materials Protection and Performance.

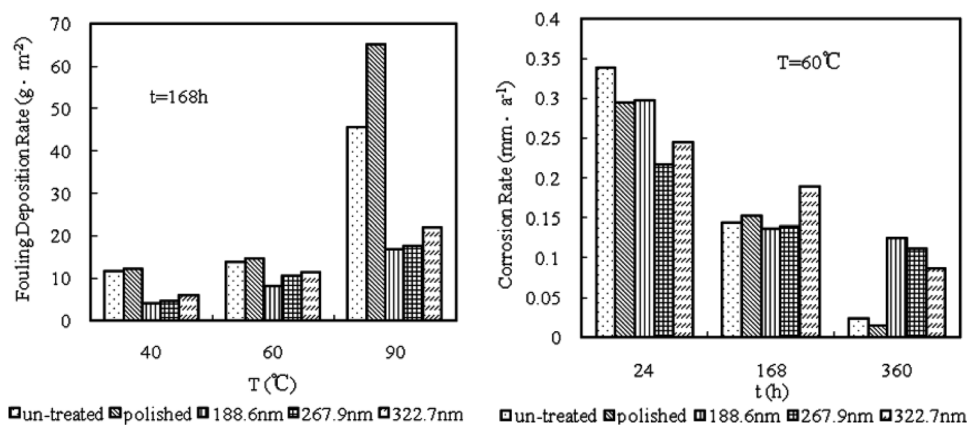
**Figure 37.** The performance of bare and SiO<sub>2</sub> coated copper substrates, at different coating thicknesses, was assessed against (left) fouling and (right) corrosion performance by Chen et al. Results showed improved fouling performance but corrosion mitigation only at short exposure times, due to worsening of the coating mechanical properties. Reproduced with permission.<sup>[168]</sup> Copyright 2021, American Chemical Society.

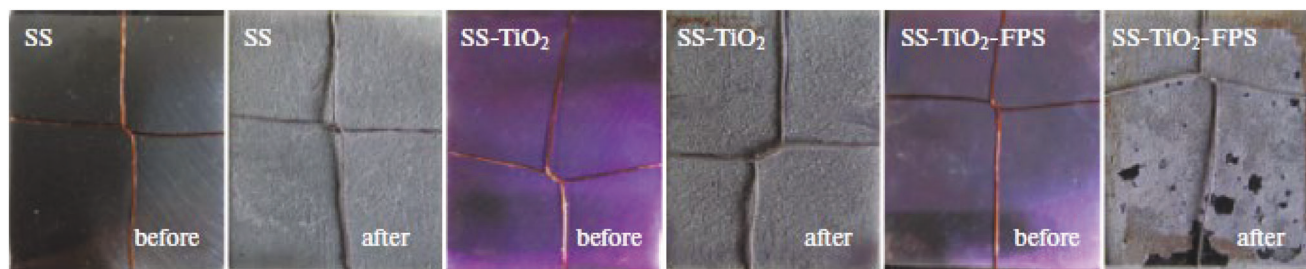
**Figure 38.** Surface photographs of the un-coated 304 stainless steel coupons and coated coupons before and after immersion for 720 h in simulated geothermal water at 80 °C. Reproduced with permission.<sup>[172]</sup> Copyright 2018, Springer.

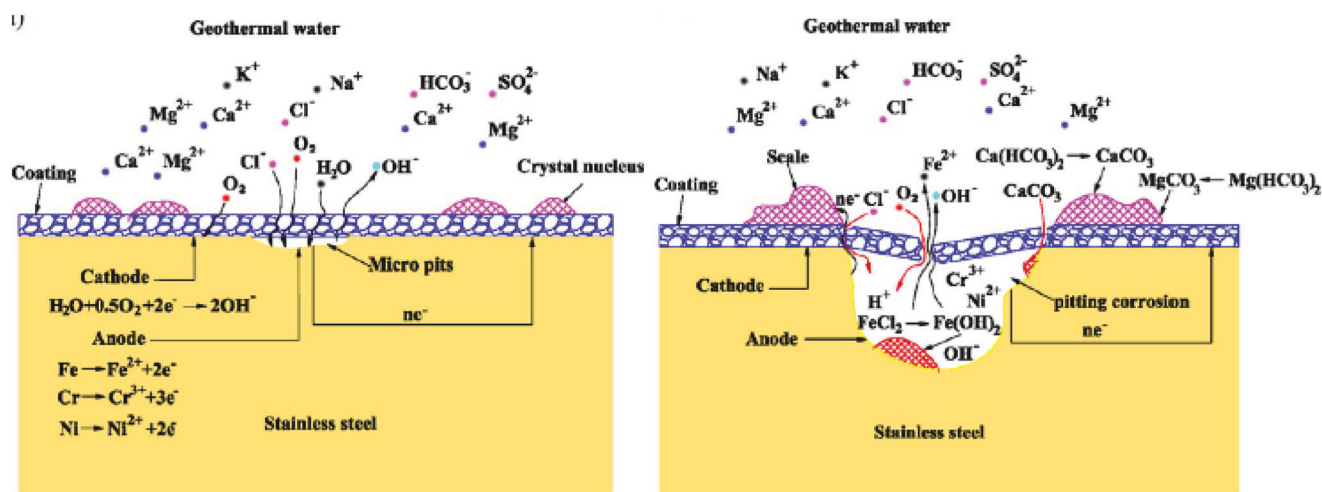
**Figure 39.** Schematic representation of corrosion and scaling mechanisms proposed by Cai et al. involving composite  $\text{ZrO}_2\text{-TiO}_2$  coatings deposited onto AISI 304 stainless steel and exposed to NaCl-rich simulated geothermal water at 20 °C. a) The tortuous path of  $\text{O}_2$  and  $\text{Cl}^-$  through the protected coating at the initial stage and b) coating damage and scale formation processes after prolonged immersion time. Reproduced with permission.<sup>[174]</sup> Copyright 2016, American Chemical Society.

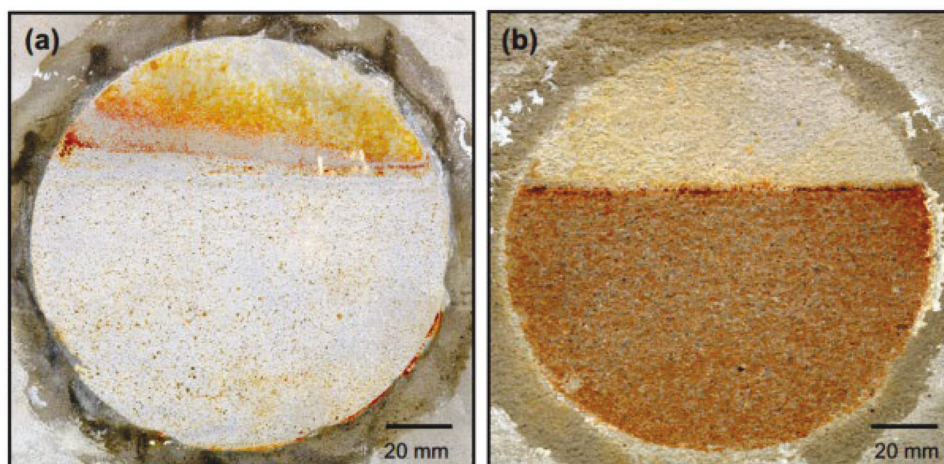
**Figure 40.** Surface photograph of a) Sikagard 75 EpoCem mortar and b) latex-modified mortar after exposure to *Thibacillus ferrooxidans* showing very slight etching in immersed zone. Reproduced with permission.<sup>[80]</sup> Copyright 2011, Elsevier.

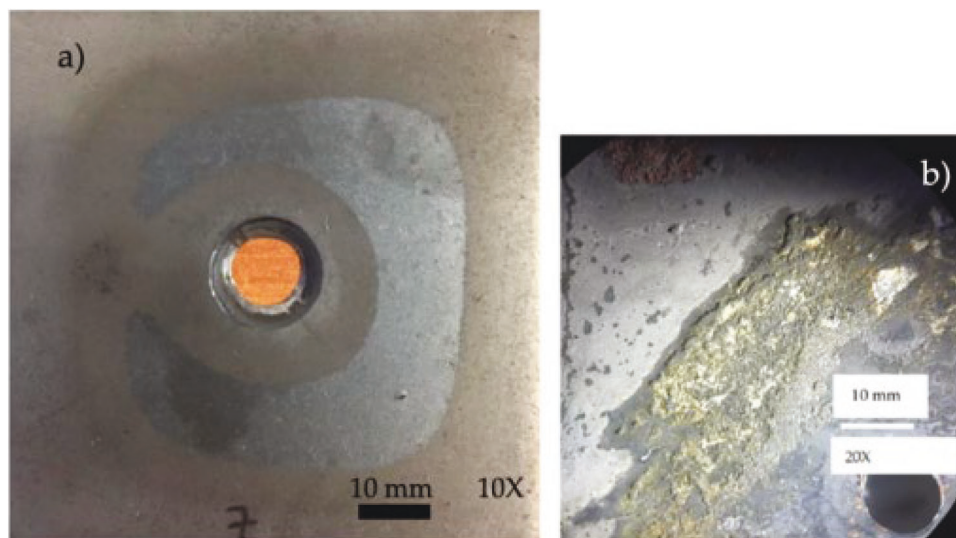
**Figure 41.** Surface photographs of a)  $\text{TiB}_2\text{-Ni}_3\text{B}$  nanocomposite coating and b) uncoated stainless-steel type 304 specimens after 1 month in situ exposure to geothermal fluid at the Geothermal Unit Los Hornos (Mexico); no clear corrosion products are visible on the coated coupon as opposed to the steel substrate. Reproduced with permission.<sup>[183]</sup> Copyright 2021, Institute of Physics.
