## Application of NDT Thermographic Imaging of Aerospace Structures

# Application of NDT Thermographic Imaging of Aerospace Structures

**Abstract.** This work aims to address the effectiveness and challenges of Non-Destructive Testing (NDT) inspection and improve the detection of defects without causing damage to the material or operator. It focuses on two types of NDT methods; pulsed thermography and vibrothermography. The paper also explores the possibility of performing automated aerial inspection using an unmanned aerial vehicle (UAV) provided with a thermographic imaging system. The concept of active thermography is discussed for inspecting aircraft CFRP panels along with the proposal for performing aerial inspection using the UAV for real time inspection. Static NDT results and the further UAV research indicate that the UAV inspection approach could significantly reduce the inspection time, cost, and workload, whilst potentially increasing the probability of detection.

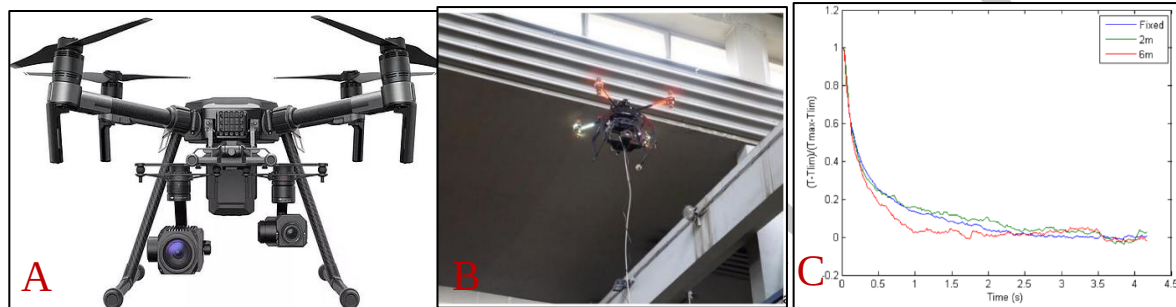
**FIGURE 20 A:** DJI M210 equipped with thermal camera [27]. **FIGURE 20 B:** UAV equipped with thermal camera [12]. **FIGURE 20 C:** Comparison of front face temperature responses to flash heating in the case of a large uniform irradiation with a fixed camera and a stabilized camera with UAV at two distances (2 m and 6 m) [12] [5].

Along with the liquid penetrant NDT method as mentioned in the introduction, a UAV thermographic inspection was tested for civil engineering applications (see Figure 20B). The UAV is equipped with a FLIR A320, this IR camera is connected to a computer via a cable, one is a power cable and the other provides real time radiometric thermal images, which will reveal heat patterns and thermal anomalies [12]. Transient thermography with flash and step heating where the methods used in this inspection. An inspection took place and gathered data on different distances between the camera and the samples (2, and 6 metres). Along with the UAV equipped with the IR camera, there was a fixed IR camera, therefore two sets of data could be acquired and compared. A thermally uniform area of a sample is delimited, and the IR cameras captured the data [12] [5].
