# Non-destructive thickness measurement of thermal barrier coatings using terahertz radiation

Luis Isern<sup>1</sup> · Andrew J. Waddie<sup>2</sup> · Christine Chalk<sup>1</sup> · Andrew J. Moore<sup>2</sup> · John R. Nicholls<sup>1</sup>

Received: 3 May 2021 / Accepted: 21 July 2021 / Published online: 6 August 2021  
© The Author(s) 2021

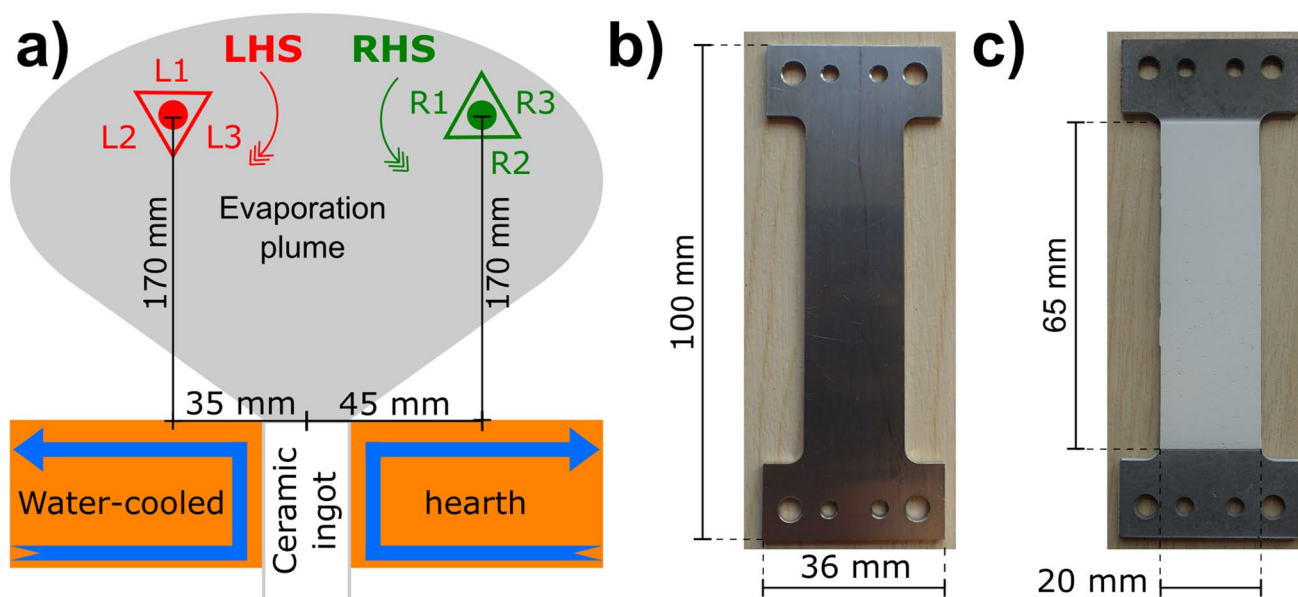
**Fig. 1** a Schematic plan view of the EB-PVD deposition chamber where up to three samples can be mounted on each holder (left-hand side — LHS for samples L1, L2, L3, and right-hand side — RHS for samples R1, R2, R3). The dog-bones are mounted to the sample

holder with their long dimension perpendicular to the plane of the schematic. Image of dog-bone substrates **b** before and **c** after TBC deposition (bondcoat and 7YSZ)

Sample substrates were nickel alloy Nimonic® 75, machined to a dog-bone shape, 100 mm long and 36 mm wide. In previous experiments, similar dog-bones were pulled to investigate strain-induced birefringence in the TBC with GHz illumination [13, 14]: in the experiments reported in this paper, the dog-bones were not tensioned but were used to take advantage of existing mounts for the specimens during coating and the THz measurements. A  $\beta$ -NiAl bonding layer, 25–40  $\mu\text{m}$  thick, was deposited onto grit-blasted substrates using Cranfield University's chemical vapour deposition facilities. For aging purposes that will be covered in a future publication, an intentional defect was introduced on the bondcoat of samples R1 and L1. The defect was created by masking-off the central region (around  $x=0$  mm,  $y=0$  mm, and of 5–10 mm in diameter) during the bondcoat deposition process to provide a region with low aluminium content. Finally, the aluminised samples were grit-blasted again and a ~300- $\mu\text{m}$ -thick, 7 wt.% yttria-stabilised zirconia (7YSZ) layer was deposited using electron beam physical vapour deposition (EB-PVD) in Cranfield's custom-modified Electrotech CL680 vacuum coater (8 kW gun). The coater's loading chamber, described in Fig. 1a, can accommodate six substrates distributed around two triangular sample holders that are continuously rotated during deposition as per the figure. The long dimensions of the samples are laid perpendicular to the perspective of Fig. 1a and have a top–bottom orientation: top is closer to the viewer's perspective. Coating deposition took place at 1030 °C, in a 90% O<sub>2</sub>/10% Ar atmosphere at  $6 \cdot 10^{-3}$  mbar. The sample holders are designed to mask the end of the dog-bones and restrict the coating deposition to a narrower area of ~65 mm × 20 mm, as shown in Fig. 1b and c.

to the ingot (Fig. 1). There seem to be small thickness variations within the L samples, as well as within the R samples, with L3 and R2 being the thickest of the groups. This is likely a consequence of the holders not being

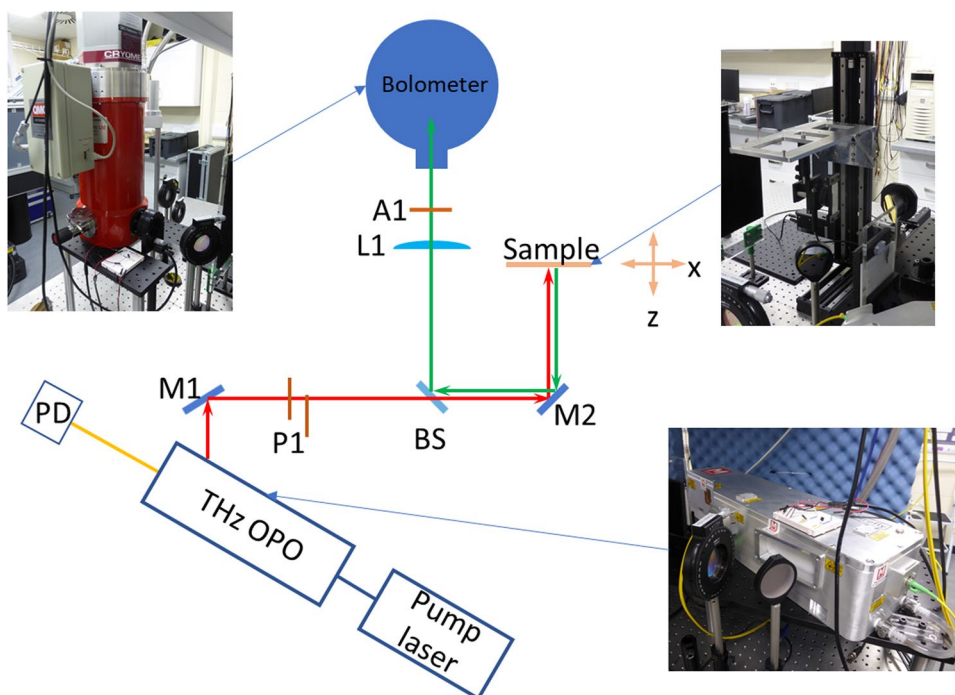
**Fig. 2** Schematic of experimental setup. M1, flat mirror; P1, linear polariser; BS, Si beam splitter; M2, parabolic mirror; L1, PTFE lens; A1, linear analyser; PD, photodiode

Figure 2 presents a schematic of the THz experimental setup. The THz idler beam output, produced by the M2 Firefly OPO, under pump illumination supplied by the 1064 nm M2-ICE laser, is passed through a linear polariser (P1) to ensure that

the illumination entering the system is vertically polarised. Due to the observed ~10% pulse-to-pulse THz intensity variation, the near-IR signal beam from the OPO was monitored by an InGaAs photodiode (PD) to allow compensation for this variation to be made. Each measurement point presented in this paper is the average of 50 pulses to further

improve the overall SNR of the data. The parabolic mirror M2 ( $f=152.4$  mm) focuses the incident THz beam (shown in red) on to the sample and the reflected beam (shown in green) is then transmitted back along the incident beam path and reflected by the Si beam splitter (BS) into the detection arm of the instrument. The PTFE lens L1 ( $f=100$  mm) is then used to focus the reflected THz beam onto the THz detector. In this paper, a cryostatically cooled superconducting bolometer (QMC Instruments Ltd QNbTES/X) was used but the Firefly system is of sufficient brightness that a lower-specification detector, such as a pyrometer, could equally well be used. The sample is translated in X, Y and Z directions by means of a set of motorised translation stages (Zaber Technologies Inc. X-LRQxxxBL-E01; x-,y- 450 mm; z- 75 mm) allowing a scan of the whole sample to be made at a maximum resolution corresponding to the measured focal spot diameter of 1 mm on the TBC specimen. Currently, the overall measurement speed of the system is relatively slow due to the low repetition rate of the THz laser (50 Hz), the need to mechanically translate the samples with each translation point taking approximately 1.5 s and each of the four frequencies approximately 1 s, and the large amount of measuring points (1,200 per sample), leading to a total measurement time per sample of around 5 h.

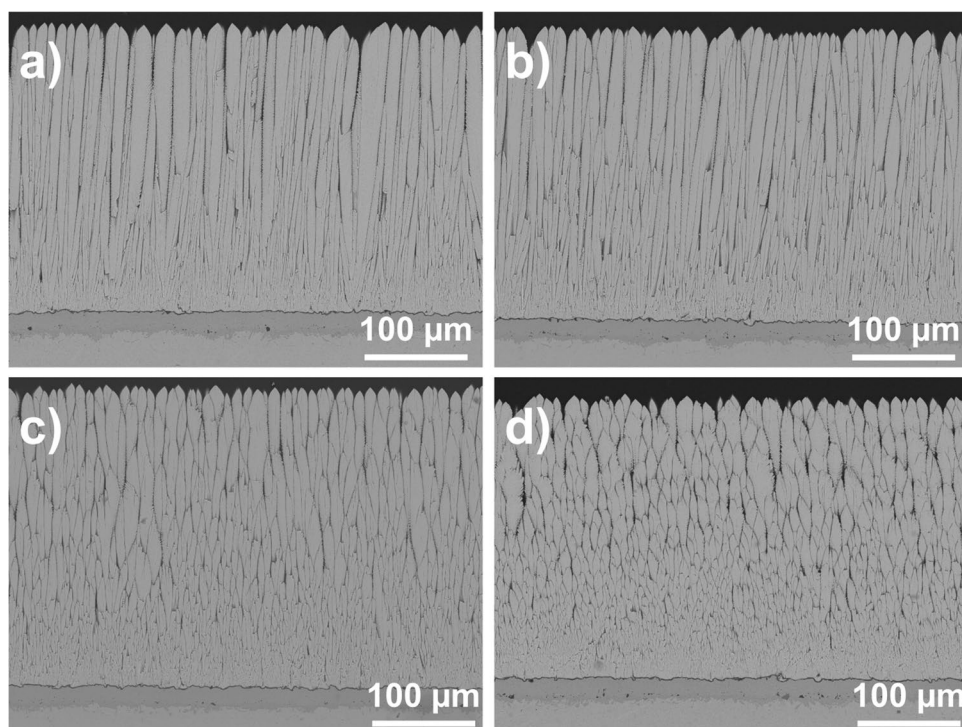
**Fig. 4** TBC images from sample R2 at  $y$ -sections of **a** +21 mm, **b** +14 mm, **c** 0 mm and **d** −21 mm

Sample R2 was selected as a reference sample to validate the THz technique for thickness measurement. R2 was physically sectioned at 7-mm intervals transversally as per Fig. 3 and inspected by optical and electronic microscopy. Representative examples of the cross-sections are shown in Fig. 4, where back-scattered SEM imaging reveals atomic number contrast of the distinct coating layers of the TBC. All images show the columnar microstructure of the TBC growing on the thin  $\text{Al}_2\text{O}_3$  oxide (thin black line,  $< 2 \mu\text{m}$  thickness), which in turn is on top of a  $\sim 25\text{-}\mu\text{m}$   $\beta\text{-NiAl}$  layer that appears slightly darker than the underlying Nimonic75® substrate. The thickness of the TBC is relatively homogeneous and there are no major defects present, except for the occasional minor defects known as “carrot growths”, 50–300  $\mu\text{m}$  wide, which are discussed in detail in a later section. The “carrot growths” are produced during regular evaporation in EB-PVD and their presence is tolerated if small-sized and in small quantities. The columns nucleate very finely at the bondcoat interface but grow much wider towards the coating surface. Column inclination changes perceptibly across the longitudinal direction of the sample. Columns in sections  $y = +21$  and  $+14$  mm (i.e. near the “top” of the sample) are almost perfectly parallel to the  $xz$ -plane of the cross-section and the full columns are shown in their entirety (Fig. 4a and b). Near the “bottom” of the sample, the columns have some perceptible tilt with respect to the plane of the cross-section at  $y = 0$  mm (Fig. 4c), and this is much more accentuated at

$y = -21$  mm where the column intersections with the polished cross-section now appear as small ellipses (Fig. 4d). This variation in the growth direction of the columns is due to the expansion of the evaporation plume and is discussed further in a later section.

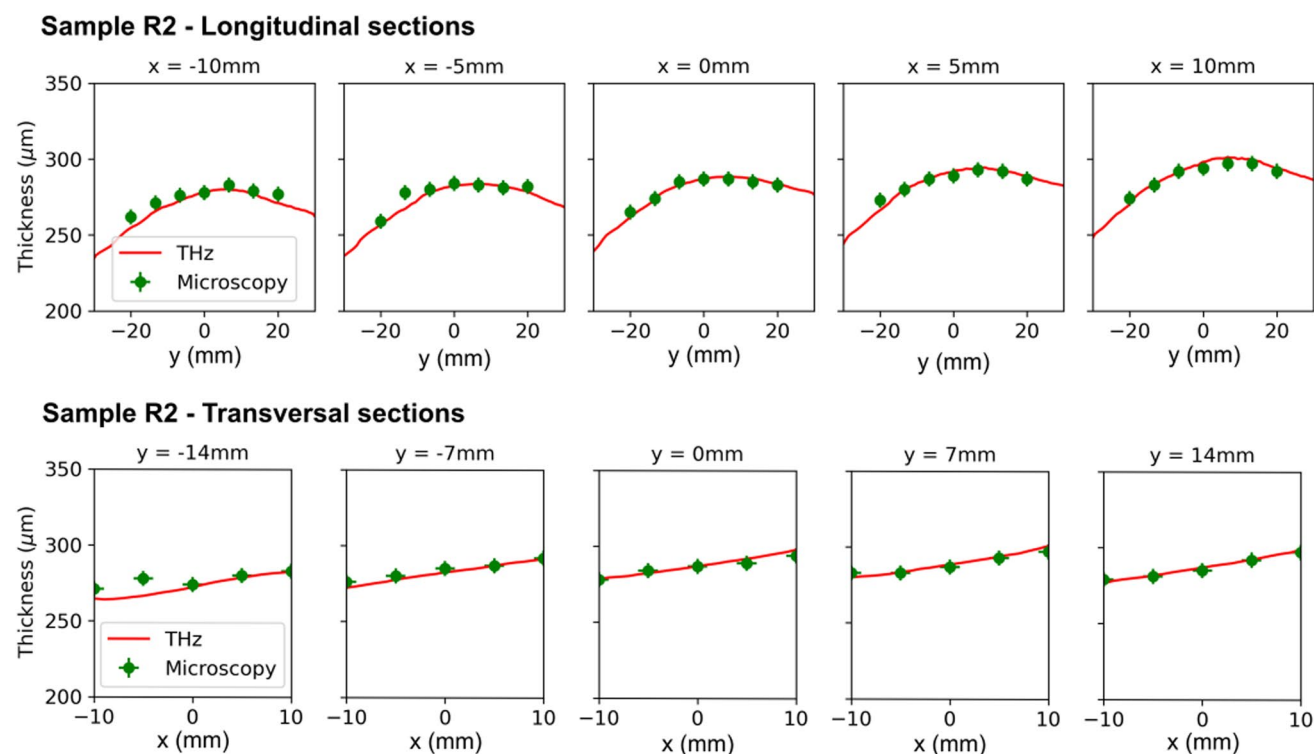
**Fig. 5** Comparison of thickness measurements by microscopical inspection of cross-sections (green dots) with THz imaging calculations (red curves) for longitudinal sections at different x positions,

and transversal sections at different y positions on sample R2. Microscopic measurements are only plotted every 5 mm on the transversal sections to enhance clarity

At each transversal section, optical microscopic measurements were taken every 1 mm, the same spatial resolution as THz imaging. The microscopic measurements mostly agree with the thickness curves calculated from THz radiation as shown in Fig. 5. The experimental error considers both the limitations of the measuring device, positioning and the peak-to-valley distance of the columns at the surface. Less than 5% of THz measurement points fall outside the error bars of the microscopic measurements; these are mostly related to “carrot growth” defects and are explained in a subsequent section. Moreover, the graphs reveal different trends for the longitudinal and transversal directions on the samples. Longitudinally, the thickness fits a spherical shape with an absolute maximum at around section  $y = +5$  mm. Transversally, the

thickness increases from left to right. Both trends are related to the “point-source evaporator” characteristic nature of the EB-PVD deposition as reviewed in the discussion.

Another minor defect is the change in column inclination across the length of the sample, as observed in Sect. 3.1. The inclination is related to the relative position of the sample with respect to the ingot being evaporated. This does not seem to affect the value of  $n$ , deduced through the good agreement of the THz thickness maps and the cross-sections (Fig. 5).

In principle, THz imaging could be deployed as a non-destructive technique for quality control during the manufacturing process of TBCs on industrial scale. Our results show that the method is reliable within a sample (Fig. 5) and within a coating batch (Figs. 6 and 7). This is because any changes in the refractive index caused by column inclination and other minor defects such as “carrot growth” defects are too small to affect the thickness measurement by THz radiation. Moreover, the THz method averages the thickness of the area irradiated, which is less sensitive to the presence of “carrot growths” (Fig. 8) and even column tip variation than direct inspection of the cross-section. Potentially, this method could be applied to batches of samples produced using the same coating technique and deposition conditions, perhaps with the use of one sample per batch to correct for variations in the refractive index value. However, this method cannot be applied as a universal solution, using a single  $n$  value, for coatings produced by different deposition methods and with different parameters, because the refractive index is too sensitive to larger variations in coating microstructure. For example, the difference between EB-PVD columns and plasma-sprayed splats is significant: at similar THz frequencies, the refractive index obtained here (3.977) is similar to other EB-PVD 7YSZ coatings measured in the literature (3.73 [9]), but is smaller than for plasma-sprayed 7YSZ coatings, which are in the range of 4.0–5.2 [7, 10, 12, 15]. Even for coatings deposited using the same deposition technique, other factors, such as porosity, stress or density, affect the value of  $n$ . Watanabe et al. [15] studied the effect of porosity on plasma-sprayed 7YSZ coatings

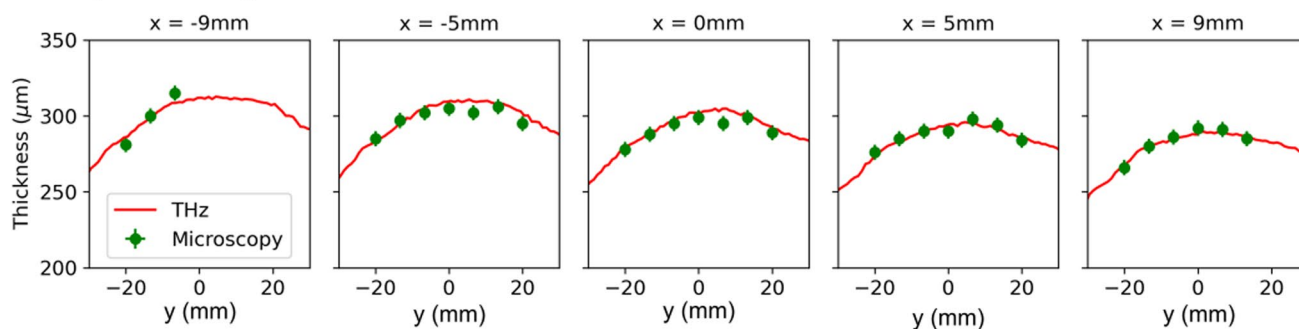
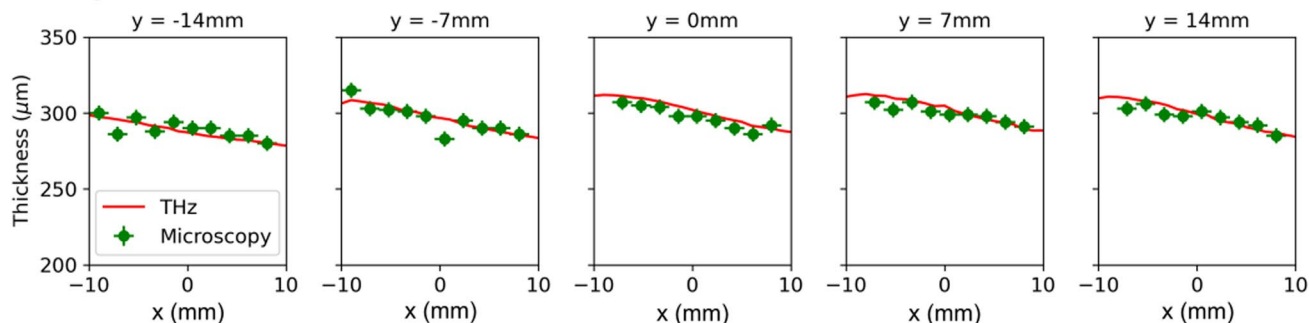
**Fig. 6** Comparison of thickness measurements by microscopical inspection of cross-sections (green dots) with THz imaging calculations (red curves) for longitudinal sections at different  $x$  positions, and transversal sections at different  $y$  positions on sample L2. Only half of the microscopic measurements are plotted on the transversal

sections to enhance clarity. Some longitudinal sections near the edges of the sample ( $x = -9$  and  $+9$  mm) miss points of microscopical inspection due to chipping on the sample edges after the heat treatment cycles

Sample L2 was also sectioned to validate THz thickness measurements, calibrated using the refractive index from sample R2. In this case, sectioning happened after the sample had been thermally cycled between room temperature and 1100 °C for 20 × 1-h cycles with a short period of forced air cooling, to study the impact of aging to be reported in a further publication. The microstructure of the coating has been little altered for the short thermal cycling and both THz and direct inspection thickness measurements seem unaffected by this cyclic heat treatment. The results from both measurement techniques are in agreement (Fig. 6), which demonstrates that THz imaging using a single refractive index can be used to estimate TBC thickness on the same coating batch. The main source of disagreement (error) between microscopy and THz measurements is due to “carrot growth” defects, as detailed in the subsequent section “3.3. Effect of defects”.

columns and reducing their growth as seen in Fig. 8d. This shadowing effect also produces some discrepancies where direct observation produces lower values than THz counterparts, such as the low outlier in  $(x, y) = (0, -7)$  in Fig. 6. In general, discrepancies between direct observation and THz radiation correspond to local effects of “carrot growths”.

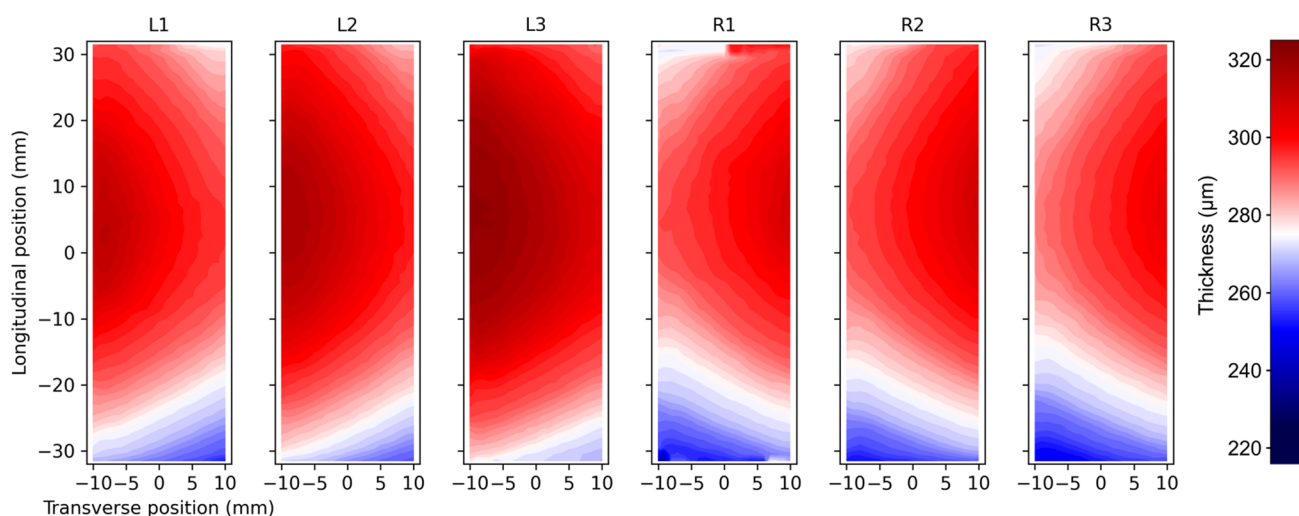
**Fig. 7** Thickness maps for all samples constructed from THz reflectivity measurements. Each sample (R1, R2, R3 and L1, L2, L3) is labelled above the corresponding thickness map

Applying the previously obtained refractive index of 3.977, the reflectivity maps can be converted into thickness maps as shown in Fig. 7. These maps reveal a strong handedness of the samples, with all R samples having the local maximum on the right-hand side, whereas all L samples having the local maximum on the left-hand side. This is explained by the direction of rotation of the samples, described in Fig. 1, and their orientation on the holder, perpendicular to the Fig. 1 schematic and considering the sample “top” as closer to the point of view of the reader. The leading edge (i.e. the foremost edge on the direction of rotation) of L samples is the left-hand side, whereas for R samples is the right-hand side. Therefore, the local-maximum side is the leading-edge, as expected. Longitudinally, this local maximum occurs at approximately  $y = +5$  mm as noted previously, which corresponds to the small vertical offset of the ceramic ingot with respect to the rotating sample holders. The minimum thickness is located on the bottom corner opposite to the maximum (trailing-edge of the rotation), and the thickness variation across each sample is  $\sim 40$   $\mu\text{m}$ . Samples coated on the left-hand side holder have a greater thickness across their whole surface, which is expected due to the asymmetric position of the two substrate holders in the chamber with the left being closer

perfectly horizontal, so one of the faces of the triangle is closer to the ingot. In summary, the thickness distribution on the samples corresponds well with the distance

to the ingot and the direction of rotation, as predicted by a “point source” evaporation model.

Finally, the bondcoat of four samples (R1 and L1) had an intentional defect around the central area, as described in the methodology. It is noted that the thickness maps of those samples (Fig. 7) are not influenced by the presence of these macro-defects. The THz radiation, at the current frequencies used, is reflected by the metallic nature of the bondcoat and therefore does not see these bondcoat defects. Therefore, the defect induced in the bondcoat (which results in aluminium deficiency) does not change its metallic nature and hence does not affect its reflectivity. The only effect that THz radiation could detect is changes in the thermally grown oxide (TGO). However, the TGO thickness of all samples examined is too small ( $< 2$   $\mu\text{m}$ ) after this short time of aging to show any effect on the thickness maps.

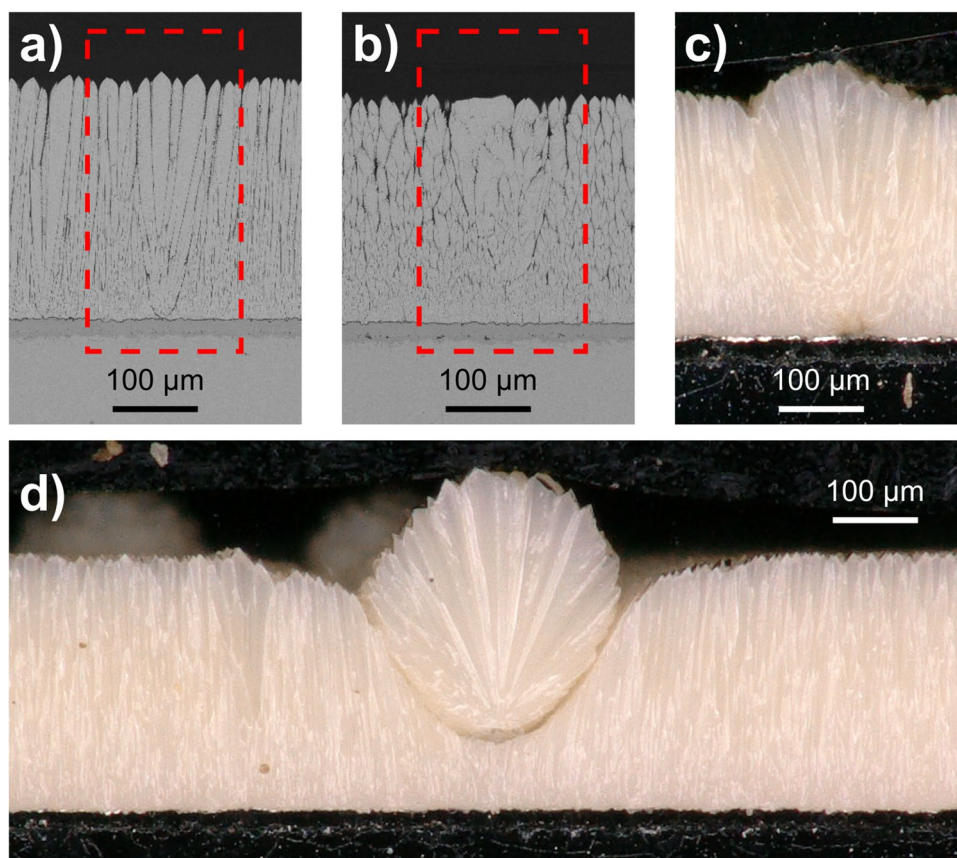
**Fig. 8** **a** and **b** Cross-sectional back-scattered SEM image from sample R2 highlighting “carrot growth” defects. **c** and **d** Dark field digital microscope images of “carrot growths” in sample L2

There are no major defects present within the ceramic layer of the studied TBCs. Some minor defects produced by the nature of EB-PVD deposition are present, but do not seem to affect THz mapping. One example of such defects is the clusters of thicker columns known as “carrot growth” defects, as illustrated in Fig. 8. These are associated with local re-nucleation on a foreign particle that are produced in small numbers as part of nominal EB-PVD evaporation. The “carrot growths” are usually 50–300  $\mu\text{m}$  in diameter and comprise multiple columns; hence, they are smaller than the  $\sim 0.5$  by 1.0 mm diameter irradiated by the THz laser. Consequently, THz measurements give the average of the thickness across the irradiated area and do not resolve “carrot growths”. By contrast, direct examination of the cross-sections produces point measurements at a given position that are affected by the local presence of “carrot growths”. As observed in Fig. 8d, some “carrot growths” can be up to 100  $\mu\text{m}$  taller than the average of neighbouring columns. Moreover, the presence of a tall “carrot growth” creates a shadow around it, partially masking neighbouring
