# A scanning electron microscopy study of projectile entry fractures in cortical bone; genesis and microarchitectural features

The present paper presents a scanning electron microscope (SEM) analysis of the genesis and microarchitecture of experimentally induced cortical entry fractures in porcine scapulae impacted at velocities ranging from 54 to 897 m/s. SEM observation was conducted on polyurethane replicas cast from negative silicone moulds. Analysis of the sequence of fracture processes operative during projectile impact revealed the presence of ring cracks at the site of impact, confirming that penetration in sandwich bones is achieved by cone crack propagation. Despite impulsive loading, two forms of plastic deformation were identified in the cortical bone surrounding the entry fracture up to a maximum velocity of 871 m/s. Microscopic radial and concentric cracks were associated with projectile impact, and the role of pores and pits as stress concentrators was captured. Possible underlying mechanisms for the observed plastic deformation are described, and the diagnostic utility of SEM analysis is presented.

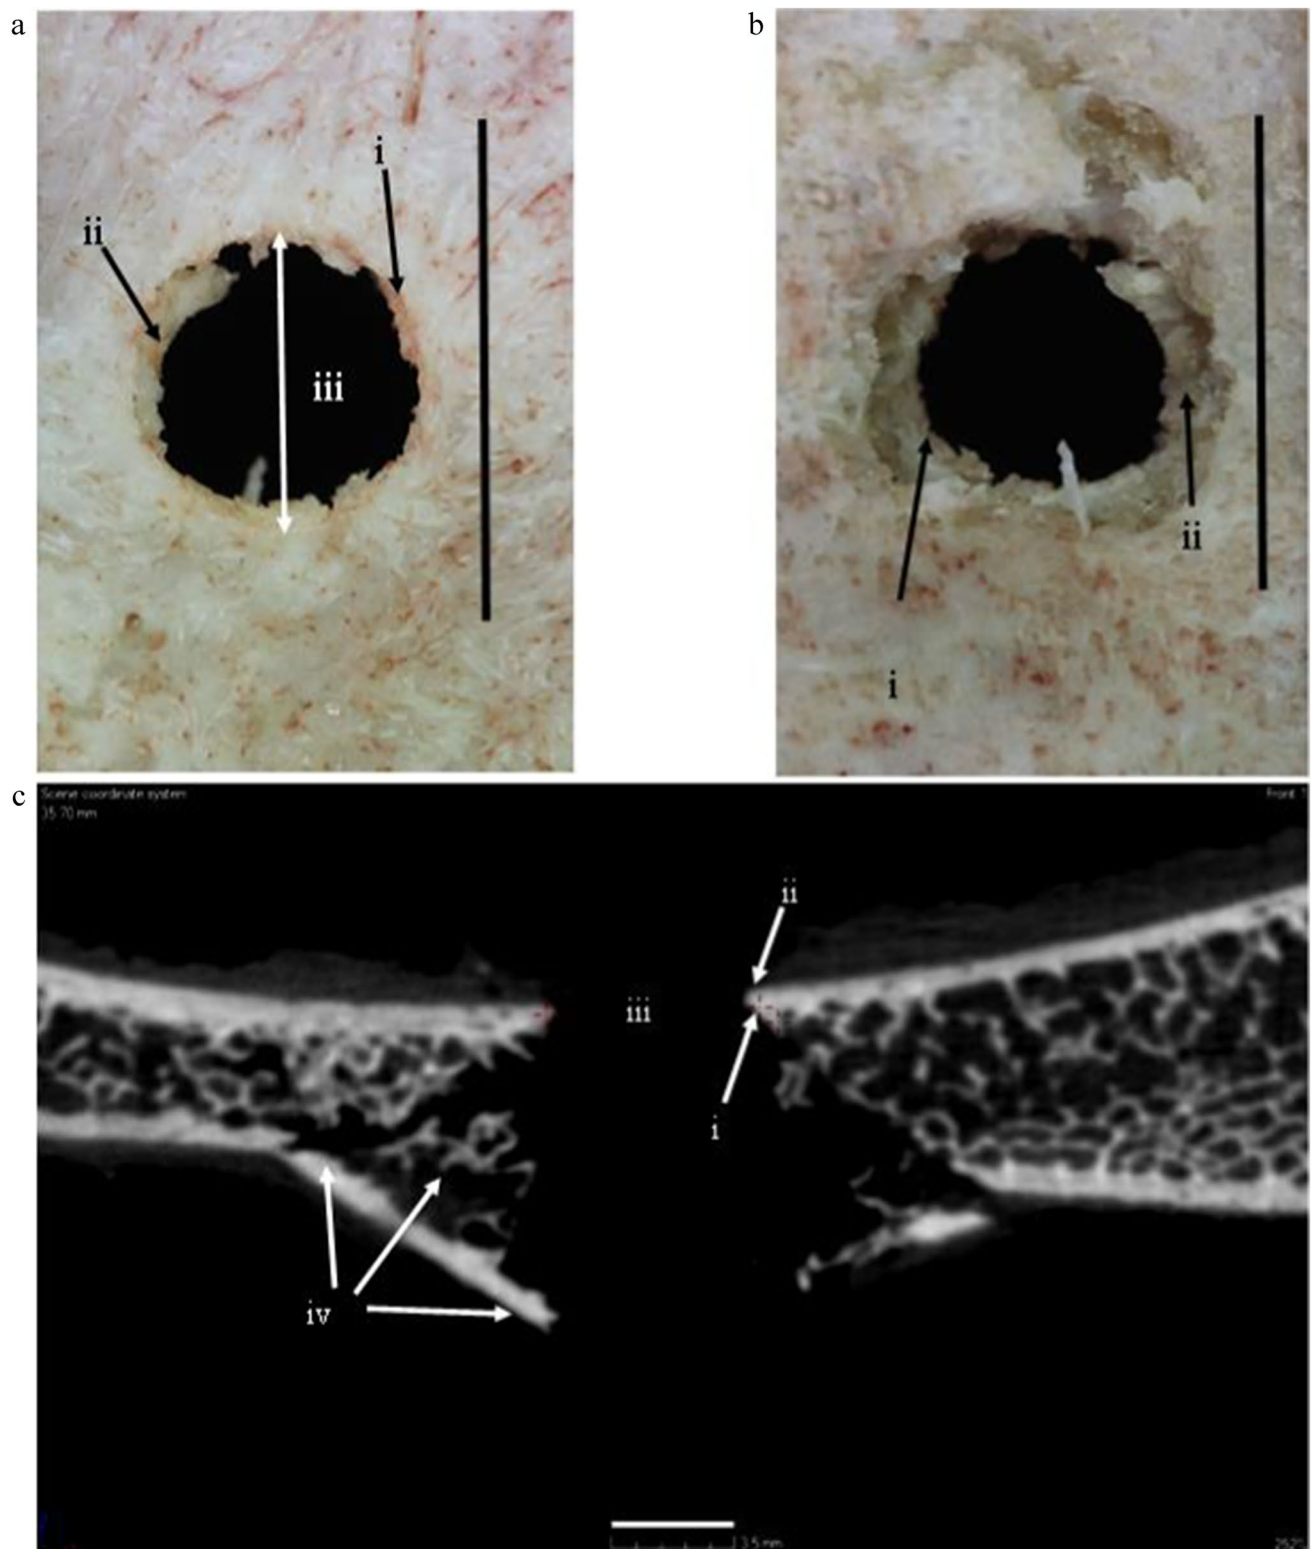
**Fig. 1** Key nomenclature for the components of a bevelled fracture in sandwich bones; **a–b**, 163 m/s perforating impact ( $E_i$  11.78 J,  $E'$  0.42 J/mm<sup>2</sup>; scales bars 10 mm); **a**, **i**, apex of the entry cortical fracture edge (EnCF); the top edge of EnCF where the cortical fracture edge and cortical surface meet; the EnCF itself runs under the apex and is not visible from above; **ii**, cortical roof fragment; fragmentary component of the conoid roof remaining in situ after fragmentation and ejection of the bulk of the conoidal volume; the distal edge faces the cortical entry and the medial edge the cortical surface; **iii**, cortical entry; delineated in cross section by the EnCF and in surface view by the apex of the EnCF; **b**, same cortical entry as in seen in **a** but from the bevel side; **i**, EnCF angling away from the apex; **ii**, underside of the cortical roof fragment seen in **a**; **c**, 158 m/s perforating impact ( $E_i$  11.05 J,  $E'$  0.39),  $\mu$ CT cross-sectional view showing internal structure; (scale bar 3.5 mm) **i**, EnCF, **ii**, apex of the EnCF, **iii**, cortical entry; **iv**, fragment of conoid

To accurately convey the orientation of structural features in the SEM images, the nomenclature presented in Fig. 1 is utilised for analysis. The *entry cortical fracture edge* (EnCF) meets the cortical surface at the *apex* (Fig. 1a, c), which defines the cortical entry when viewed from above. When viewed from below (Fig. 1b) and in cross section (Fig. 1c), the cortical entry is circumscribed by the EnCF. The tri-layered conoid formed by impact consists of a *cortical roof* and *cortical floor* with the trabeculae in between [4]. This conoid typically undergoes comminution but can leave behind traces in the form of cortical roof and floor fragments. When present, the *medial edge* of cortical roof fragment faces the EnCF, whilst the *distal edge* faces into the cortical entry.

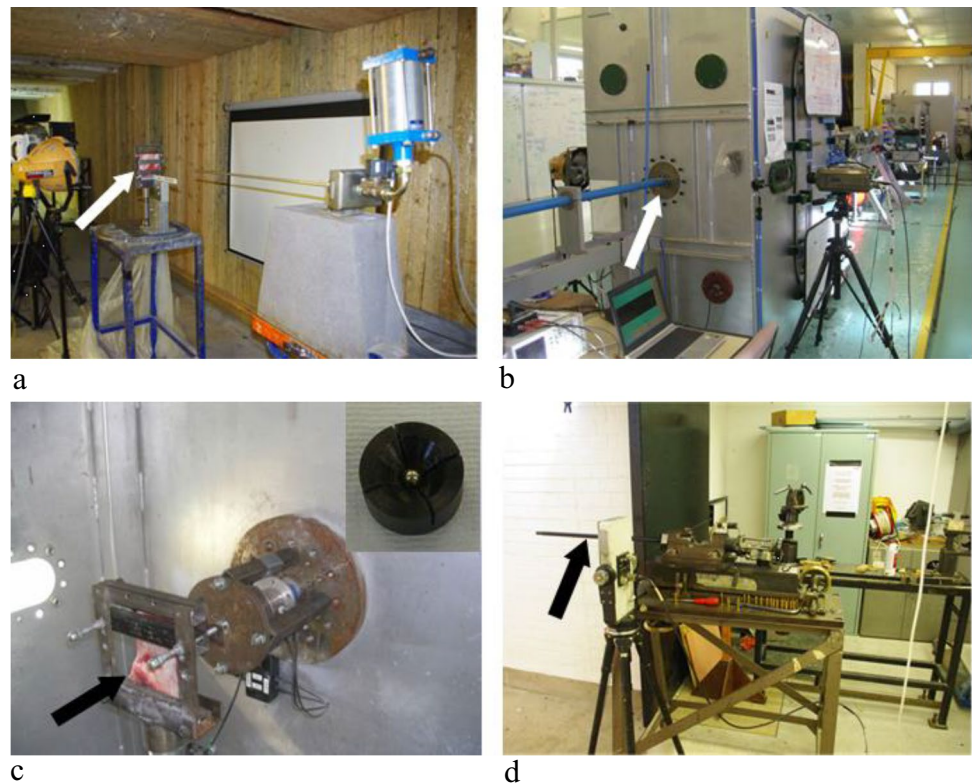
**Fig. 2** Projectile delivery systems; **a**, compressed air gun with 6 mm barrel situated in front of a clamped specimen (arrow); **b**, 21.3 mm calibre gas gun chamber with high-speed camera located on a tripod at the viewing window; the 21.3 mm barrel enters the chamber at left (arrow); **c**, view inside the 21.3 mm gas gun chamber showing specimen clamped in front of the barrel (arrow); part of the viewing window is illuminated at left; inset shows a 6 mm projectile housed in a plastic sabot; **d**, image of Enfield number three proof housing with barrel located at left (arrow)

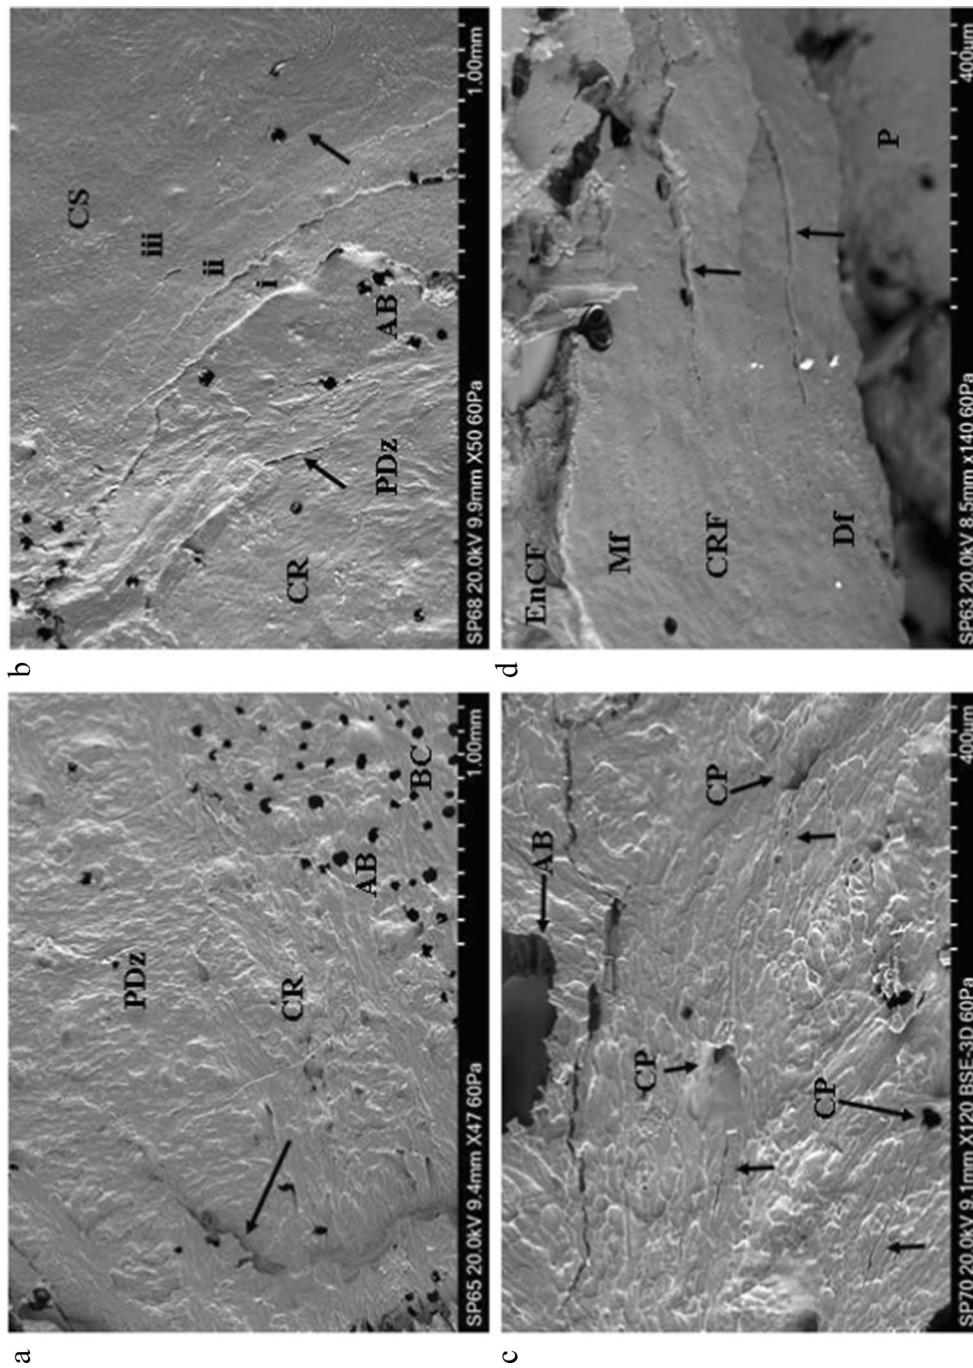
**Fig.3** Genesis of the cortical entry in sandwich bones; plastic deformation and ring cracks (BC, base of compressed region; CS, cortical surface; CR, cortical roof; CRF, cortical roof fragment; MF, medial fracture edge of cortical roof fragment; Df, distal fracture edge of cortical roof fragment; P, putty used to seal the floor of the entry; AB, air bubble artefact); **a** 54 m/s rebound impact, fleshed specimen ( $Ei$  1.30 J;  $E'$  0.05 J/mm<sup>2</sup>), CS located just out of view top left and across the top of the micrograph; micrograph indicates extensive plastic deformation is involved in formation of the concavity (PDz); a ring crack is visible at left (arrow) with the base of the concavity located at the bottom right (BC); **b** 57 m/s rebound impact, fleshed specimen ( $Ei$  1.44 J,  $E'$  0.05 J/mm<sup>2</sup>); micrograph of the right edge of a depressed fracture showing three generations of larger ring cracks (annotated i–iii) and two smaller cracks (arrowed); deformation forming the cavity occurs both along the ring crack fracture margins and in plastically deformed zones without visible fracture; **c** ~57 m/s impact (defleshed specimen) showing cortical surface adjacent to impact site (located along top of micrograph); concentrically orientated nascent ring cracks (white arrows) can be seen arising from cortical pores (CP); **d**, 96 m/s perforating impact ( $Ei$  4.08 J,  $E'$  0.14 J/mm<sup>2</sup>); cortical roof fragment with the distal edge displaced downwards into the cortical entry and displaying concentric fractures consistent with ring cracking during the initial stages of impact (arrows)

Fracture in the compressed region in 3 of the 4 rebound impacts took the form of distinct circumferentially orientated *ring cracks* which occupied parts of the circumference, rather than completely encircling it (Fig. 3, a–b). Impact resulted in multiple generations of ring cracks extending from inside to outside of the cortical discs (Fig. 3b), with each ring crack formed successively at the widening contact radius of the projectile as it penetrated deeper into the cortex. In the fourth specimen, nascent concentric ring cracks less than 400 microns in length were observed emanating from cortical pores near the edge of the compressed region, indicating these had acted as stress concentrating flaws during impact (Fig. 3c). Separation of cortex at the ring cracks contributed to the observed compression of the cortical roof. Apparent ring cracks were also preserved on a section of cortical roof fragment resulting from a 96 m/s perforating impact (Fig. 3d, black arrows at right). Radial cracks arising normal to the apex of the EnCF were observed in one fleshed 54 m/s rebound impact (5 cracks) and one defleshed ~57 m/s impact (2 cracks). All were less than 500  $\mu$ m in length apart from one large, approximately 1 mm crack in the cortex peripheral to the EnCF in the defleshed impact.

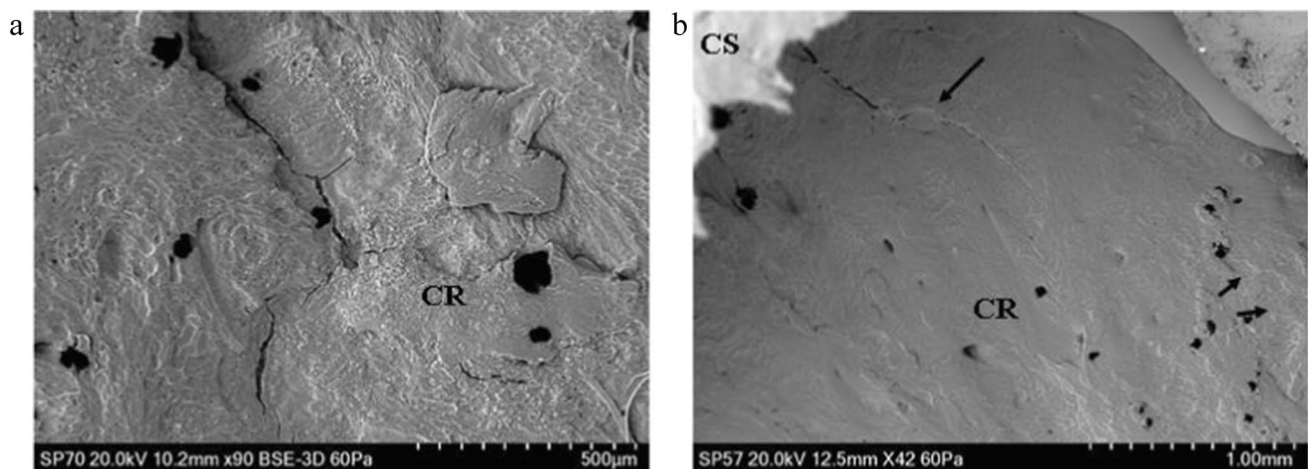
**Fig. 4** Genesis of the cortical entry in sandwich bones; failure of the cortical roof (CS, cortical surface; CR, cortical roof); **a** ~57 m/s rebound impact (defleshed specimen); surface of cortical roof showing vertically orientated fracture dividing the roof into two halves; fracture resulted from tensile failure of the inner surface of the cortical plate under compressive loading; **b** 75 m/s perforating impact

( $Ei=2.47$  J,  $E'=0.09$  J/mm<sup>2</sup>), view of the cortical roof of a nearly intact conoid displaced downwards so it is beneath the cortical surface and protruding from the inner cortical plate; the surface has not been modified by impact but bears a fracture ending before the mid-section (arrow)

Initial failure of the cortical roof in both rebound and perforating impacts occurred via a fracture arising normal to the free fracture margin of the roof; this process was observed in both a rebound impact (Fig. 4a) and in the cortex of a relatively intact tri-layered conoid. In the latter case, the conoid had been displaced downwards and tilted so that the cortical

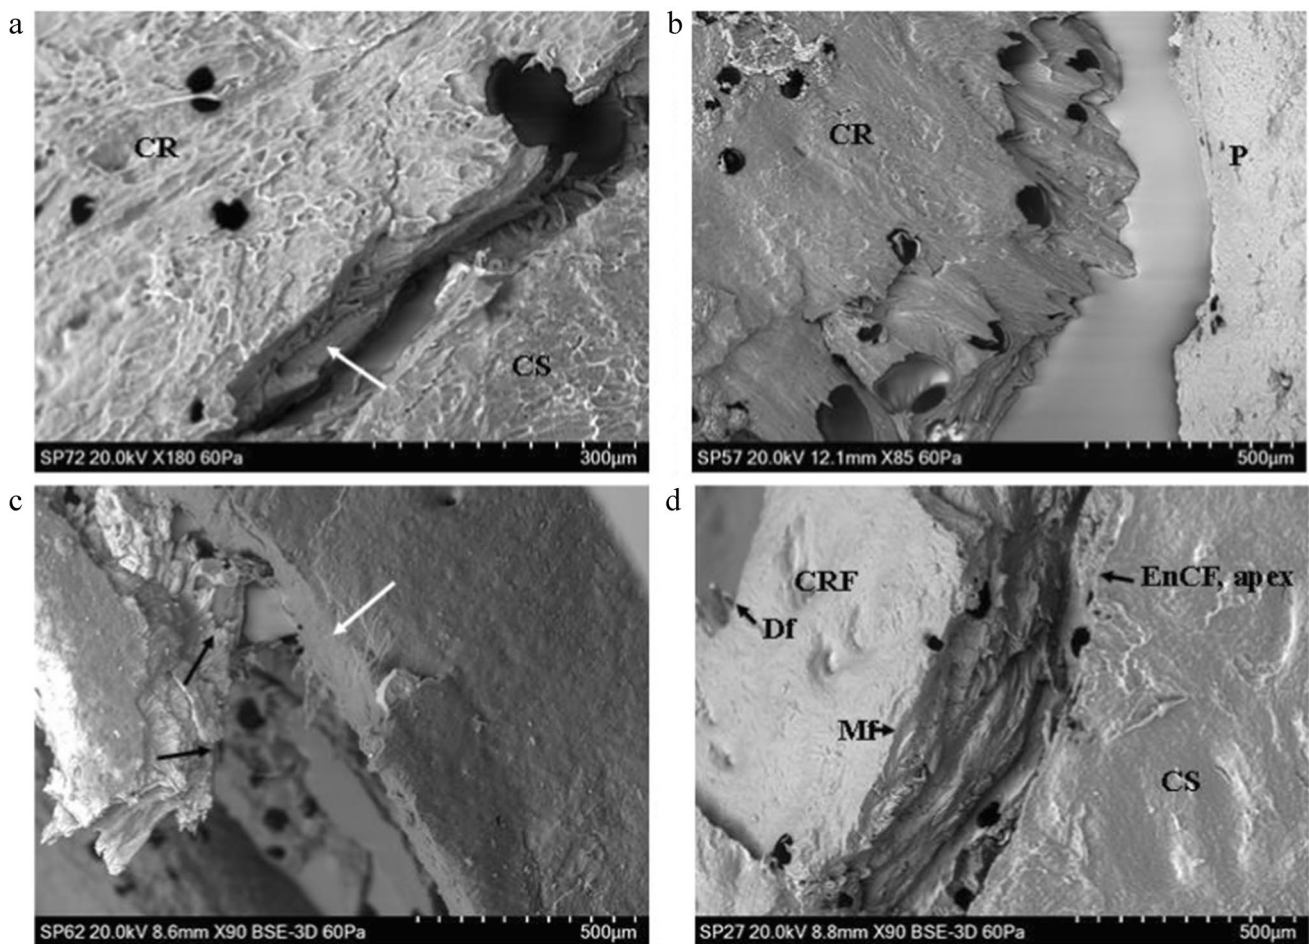
**Fig. 5** Genesis of the cortical entry in sandwich bones; stepping of the cortical roof (CS, cortical surface; CR, cortical roof; CRF, cortical roof fragment; Mf, medial fracture edge of cortical roof fragment; Df, distal fracture edge of cortical roof fragment; P, putty used to seal the cortical entry for negative moulding; EnCF, entry cortical fracture edge); **a** ~57 m/s rebound impact (defleshed specimen), mode I (tensile, crack opening) fracture mode indicated by stepping of the fracture edge across lamellar planes inside the cortical roof (arrow); **b** 75 m/s perforating impact ( $E_i=2.47$  J,  $E'=0.09$  J/mm<sup>2</sup>) showing right fracture edge of the cortical roof of the nearly intact conoid

seen in Fig. 4b, complex stepped morphology resulting from mode I fracture across lamellae; fracture edge is angulated to match the corresponding angulation of the EnCF; **c** 94 m/s perforating impact ( $E_i$  3.94 J,  $E'$  0.14 J/mm<sup>2</sup>), cortical roof fragment with the distal surface facing upwards and displaying internal lamellae on the medial side orientated in different planes (highlighted by the small arrows); large arrow indicates an area of smooth bone consistent with being surface-modified plastic deformation; **d** 161 m/s perforating impact ( $E_i$  11.44 J,  $E'$  0.40 J/mm<sup>2</sup>) showing cortical roof fragment with pronounced stepping across the lamellae of the medial fracture margin

components (Fig. 5, b–c) or presented a more uniform stepped morphology (Fig. 5d). The pointed lamellar morphology is illustrated in Fig. 5b, which shows the lower right margin of the cortical roof of the intact conoid seen in Fig. 4b. In this part of the conoid, the stepped region was angled to match the corresponding angulation of the EnCF, and the overlapping pointed lamellar fracture edges produced a complex fracture surface. This morphology may have resulted from the plane of the crack in relation to the lamellar structure in that region or from a pull-out process as the conoid was compressed downwards. Stepped fracture margins with pointed fracture edges were also observed on a smaller scale in a fragment of cortical roof resulting from a 94 m/s impact; in this specimen, the pointed ends of the

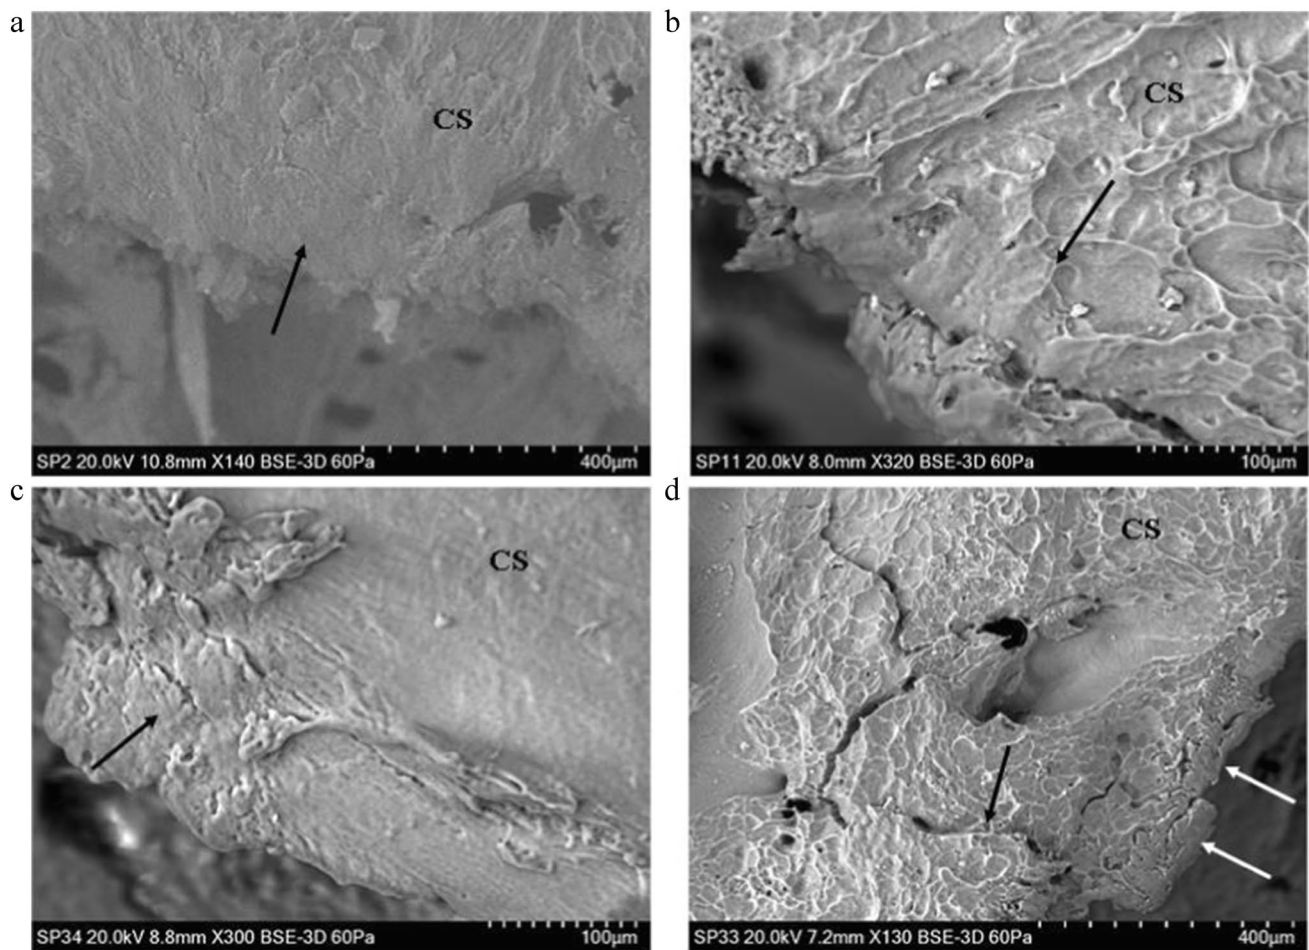
**Fig. 7** Surface modified plastic deformation (SPD), 149–609 m/s perforating impacts (CS, cortical surface); **a** 149 m/s impact ( $E_i=9.78$  J,  $E'=0.35$  J/mm<sup>2</sup>) showing loss of surface detail (arrow); **b** 333 m/s impact ( $E_i=49.07$  J,  $E'=1.74$  J/mm<sup>2</sup>) showing SPD with transition of cortical sculpturing (arrow); **c** 591 m/s impact ( $E_i=154.37$  J,

$E'=5.46$  J/mm<sup>2</sup>) showing SPD (black arrow) with small transverse fractures; **d** 609 m/s impact ( $E_i=163.89$  J,  $E'=5.80$  J/mm<sup>2</sup>) showing SPD along the apex of the EnCF (lower white arrows) in relation to the immediate cortical landscape; note the radial crack emanating from the EnCF (black arrow)

This transition zone is illustrated in specimens impacted at 74–75 m/s Fig. 6, a–b and in specimens impacted at 149–333 m/s in Fig. 7, a–b. Additional features of SPD, present to varying extents in each affected region, were a compressed, deformed cortex and down-bending in the absence of visible fracture. These features are illustrated in a 96 m/s impact in Fig. 6c and in a 591 m/s and 609 m/s impact in Fig. 7 c–d, respectively. The down-bending associated with SPD resulted in a ductile morphology at the apex of the EnCF. Figure 6d shows a cortical roof fragment where bending was extensive enough to allow it to descend into the cortical entry without visible fracture at the top edge (B in the image). Areas of SPD sometimes showed circumferential fractures running along the modified cortical surface (Fig. 7c); these were indistinguishable from ring cracks when they were of large size. The contrast between the cortical surface in the immediate cortical landscape and SPD

along the apex is illustrated in Fig. 7d. In this example, the cortical surface adjacent to the apex was markedly sculpted; this morphology contrasted greatly with the region of SPD which showed complete loss of sculpturing, bending without visible fracture and a compressed, smoothed appearance.

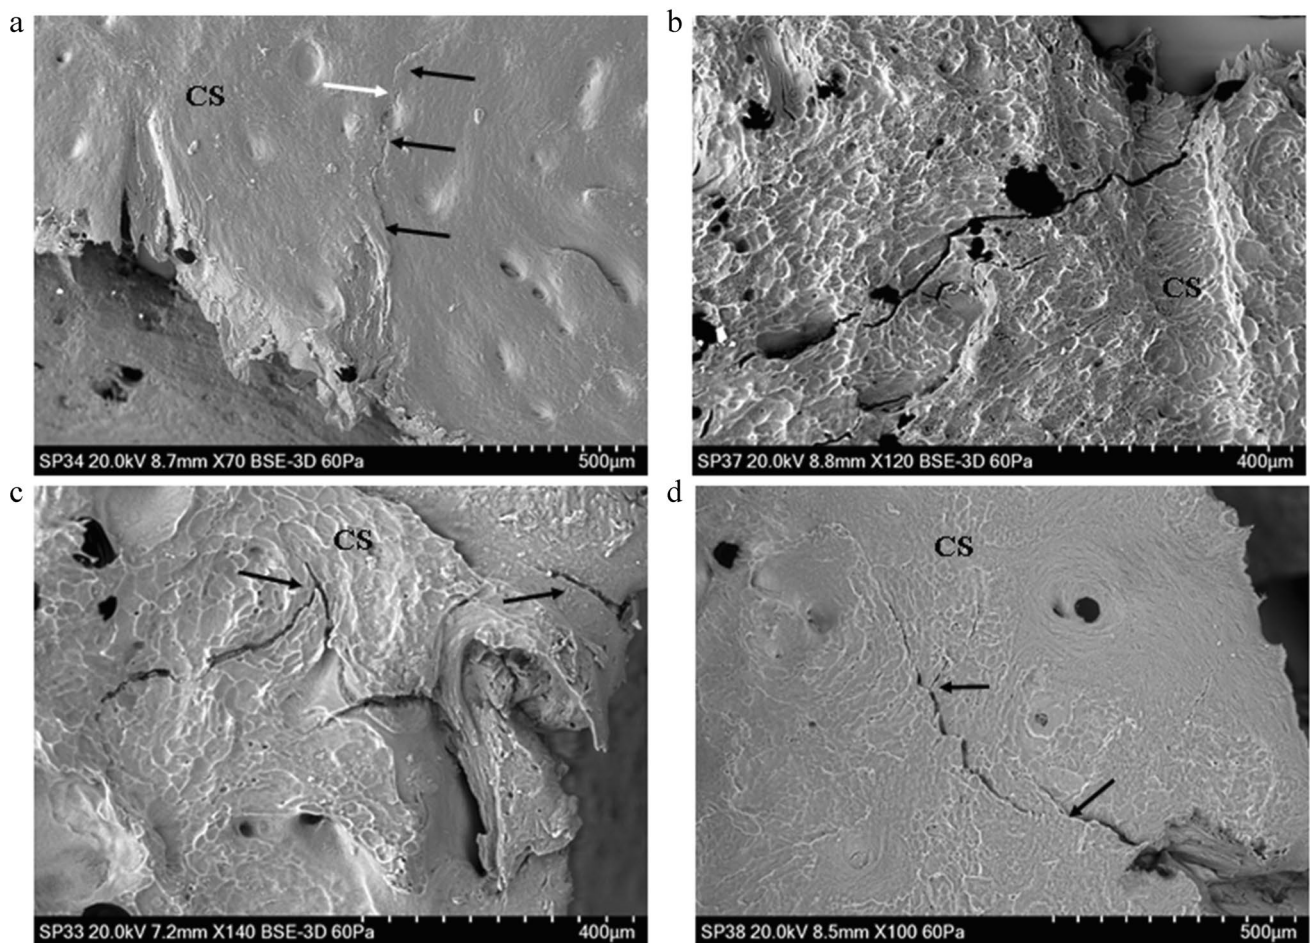
**Fig. 10** Radial cracks originating from the entry cortical fracture edge, perforating impacts (CS, cortical surface); **a** 591 m/s impact ( $Ei=154.37$  J,  $E'=5.46$  J/mm<sup>2</sup>), narrow crack crossing cortical pit and showing a small ligament bridge (white arrow); **b** 850 m/s impact ( $Ei=319.60$  J,  $E'=11.31$  J/mm<sup>2</sup>) showing large, wide radial crack

crossing cortical furrow; **c** 609 m/s impact ( $Ei=163.89$  J,  $E'=5.80$  J/mm<sup>2</sup>), showing crack with a bifurcation (left arrow) and a separate straight radial crack inside a cortical furrow (right arrow); **d** 871 m/s impact ( $Ei=335.71$  J,  $E'=11.88$  J/mm<sup>2</sup>), long radial crack with two points of bifurcation (arrows)

Radial cracks were observed in 19 of the 21 perforated specimens across the velocity series (illustrated for impacts from 591 to 871 m/s in Fig. 10, a–d). Radial cracks were identified in 12 of the 14 impacts between 58 and 168 m/s and in all 7 impacts between 333 and 897 m/s. Radial cracks followed both relatively straight (Fig. 10, a–b) and tortuous (Fig. 10c) paths. Tortuosity is not clearly associated with velocity; for example, the tortuous crack in Fig. 10c is associated with a 609 m/s impact, whilst the straight crack in Fig. 10b is created by an 850 m/s impact. Some of the radial cracks exhibited uncracked ligament bridging despite high impact velocity (e.g., white arrow in Fig. 10a). Radial cracks ranged from being narrow (Fig. 10a) to open (Fig. 10, b–d) and occasionally exhibited bifurcations along their path (Fig. 10, c–d, arrows). Estimates of crack length using the scale in the images indicated that radial cracks  $> 1$  mm in length were more common in high-velocity impacts. Of the 14 perforated specimens impacted between 58 and 168 m/s, only three possessed radial cracks longer than 1 mm (impacted at 58 m/s, 165 m/s and 167 m/s, respectively). In contrast, a total of 4 out of 6 specimens impacted between 333 and 897 m/s had radial cracks greater than 1 mm in length (impacted at 591 m/s, 850 m/s, 885 m/s and 897 m/s).

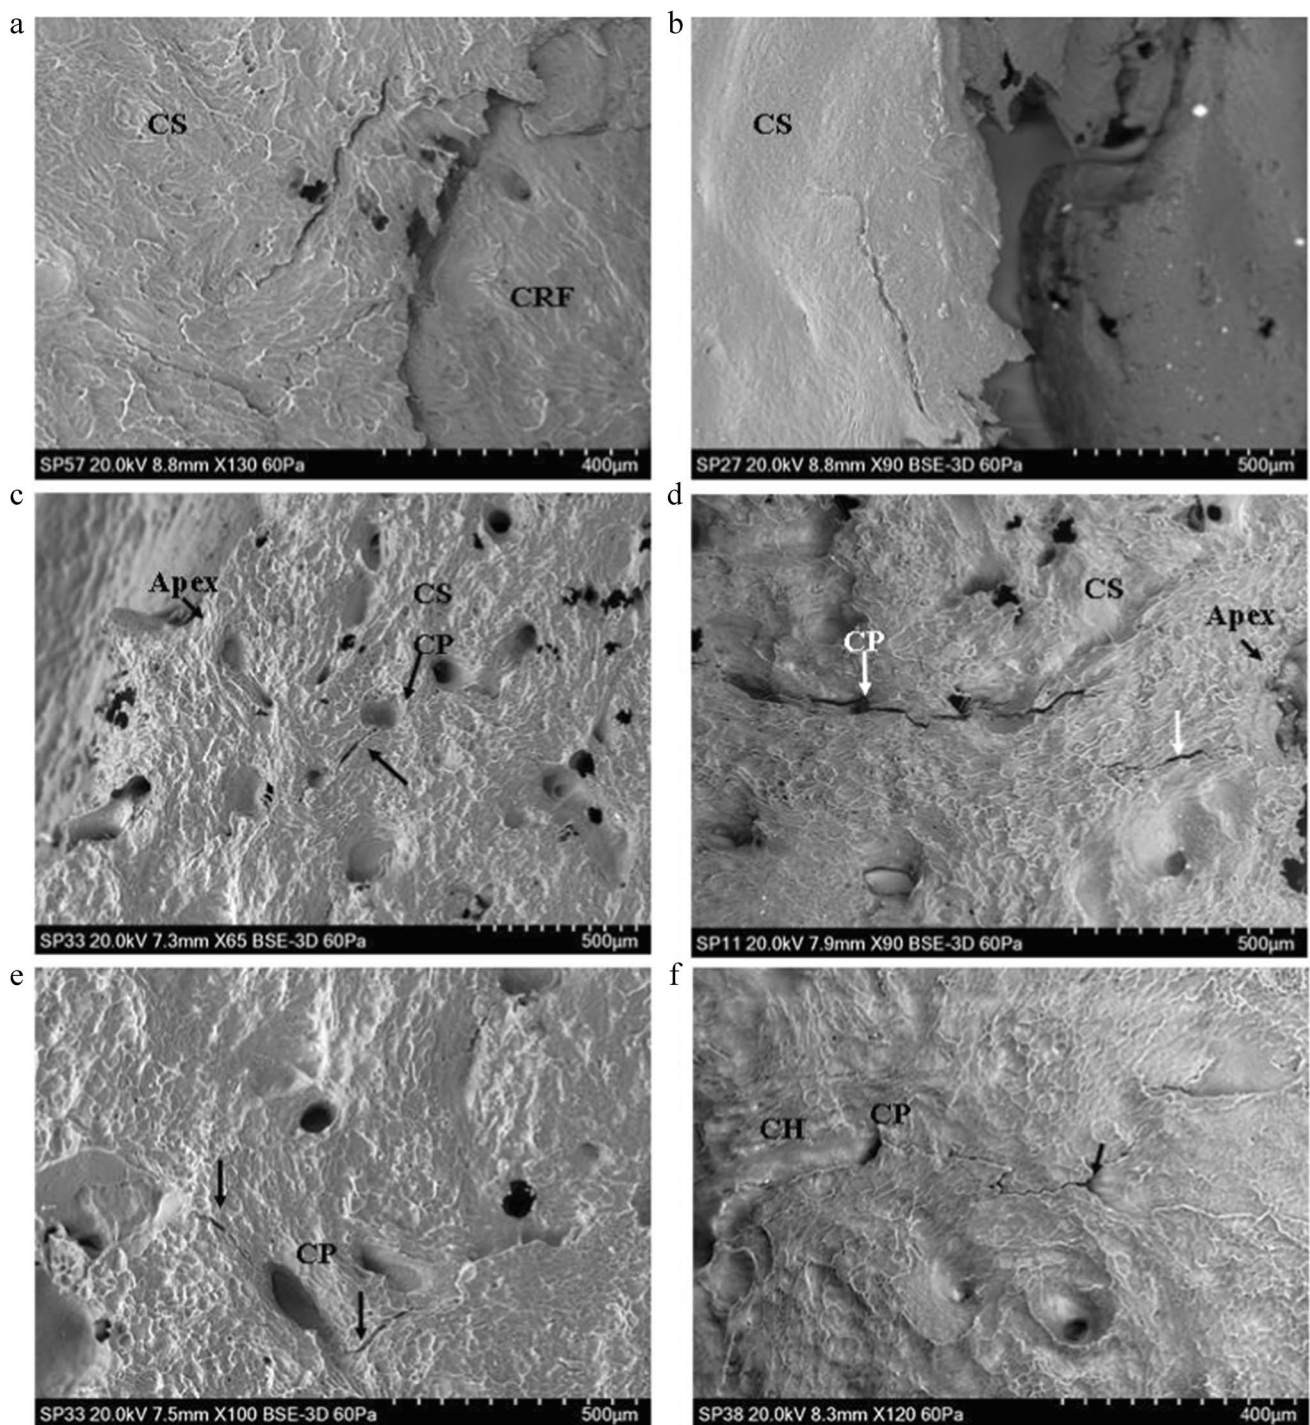
**Fig. 11** Concentric cracking and cracks arising from cortical stress concentrators, perforating impacts (CS, cortical surface, CR, cortical roof; CRF, cortical roof fragment, CP, cortical pore; CH, channel); **a** 75 m/s impact ( $Ei=2.47$  J,  $E'=0.09$  J/mm<sup>2</sup>), showing concentric crack adjacent to a fragment of cortical roof; **b** 161 m/s impact ( $Ei=11.44$  J,  $E'=0.40$  J/mm<sup>2</sup>) with concentrically orientated crack near the EnCF; **c** 609 m/s impact ( $Ei=154.37$  J,  $E'=5.46$  J/mm<sup>2</sup>) showing concentric crack arising from cortical pit adjacent to the apex of the EnCF; **d** 333 m/s perforating impact ( $Ei=49.07$  J,  $E'=1.74$  J/mm<sup>2</sup>), large radially orientated crack adjacent to the apex and associ-

ated with a cortical pore; note the smaller radially orientated crack (lower arrow) that arises within the cortex not a pore; **e** same specimen as in **c**, showing elliptical cortical pore with the major axis running upwards from right to left; stresses acting normal to this axis resulted in stress concentrating at the tips of the elliptical cavity and resulted in cracking at both ends [34]; **f**, 871 m/s perforating impact ( $Ei=335.71$  J,  $E'=11.88$  J/mm<sup>2</sup>) showing figure crack associated with a cortical pore/ channel complex and extending to a smaller pore-type structure at right (arrow)

Circumferential cracks were identified in a total of 9/14 impacts between 58 and 168 m/s and 4/7 impacts between 333 and 897 m/s. These cracks were found both near the apex of the EnCF (Fig. 11, a–b) and further away in the

cortical landscape; in one case, a concentric crack was found approximately 1.5 mm from the cortical entry. Unlike the rebound impacts, circumferential cracks in the perforating impacts did not appear to form concentric generations but were dispersed diffusely around the cortical entry. Cortical pits and pores acted as stress concentrators during impact and were detected as the origin for some circumferential (Fig. 11c) and radial (Fig. 11d) cracks. In elliptical pores, stresses acting normal to the major axis resulted in cracking at each end due to concentration of stresses there (Fig. 11e) [34]. Pore and pit cracks did not always occur in isolation, with an example of a linked pore-crack complex occurring in an 871 m/s impact (Fig. 11f). Cortical pore cracking occurs both near the apex of the EnCF (Fig. 11, a–b) and more distant, with the pore in Fig. 11e being over 1 mm away from it.
