# Experimental and numerical investigation of heave damper hydraulic seal for racing car

This article presents a combined experimental and numerical approach to analyse the failure of a heave damper hydraulic seal for racing car. The *post-mortem* analysis of the damaged seals was carried out with both optical microscopy and finite element analysis using material test data from Dynamic Modulus Analyser (DMA). The stress in the seal and damper was simulated modelling each step including the press-fitting on the piston, the interference with the cylinder and the oil pressure due to the service. The combination of the evidence collected from the numerical simulation and the observation of the surface damages on the seals proved that the cause of failure was the insufficient lubrication during high frequency, short stroke applications since these working conditions induce oil film break. The detailed damage mechanisms have been identified and explained and an alternative seal design that requires further study and testing in this application has been proposed.

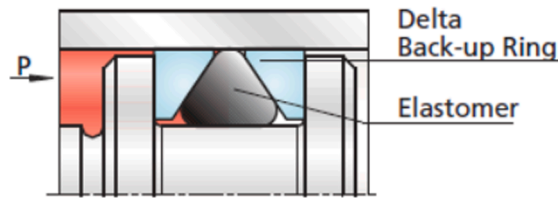
Fig. 2. Turcon® Wedgpak® II Seal [16].

The damper assembly consists mainly of a cylinder body, and a reciprocating piston. The seal is seated onto the piston as in Fig. 2 along with plastic bearings on either side to reduce friction and absorb side loads. The body is made of heat-treated Titanium 6Al-4 V while the piston is made of a steel alloy. Hydraulic fluid is used to create the pressure differential in the damper, and typically runs at 150C.

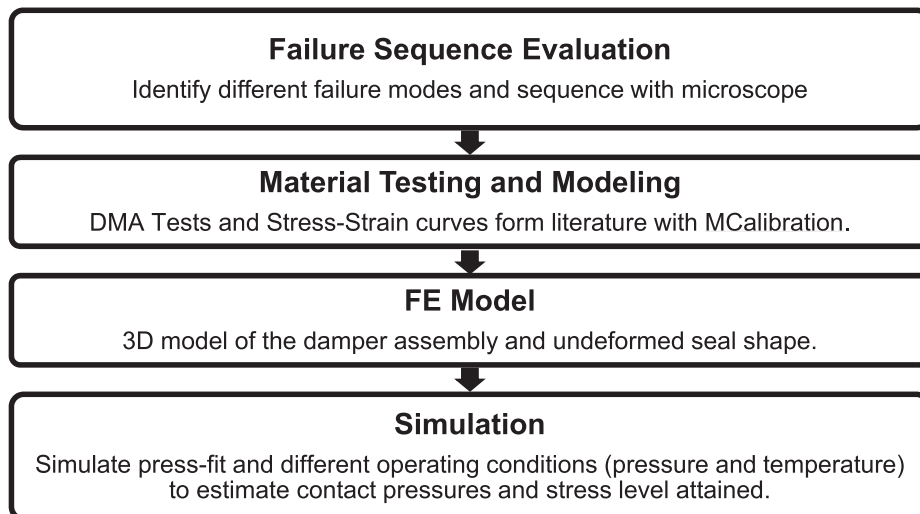
Fig. 3. Steps adopted in the methodology.

A combined experimental and numerical approach was adopted to perform the failure analysis of the seal. The experimental approach consisted in the analysis of the failed seals under optical microscope and material characterisation of samples extracted from the seals while the numerical approach consisted in the identification of the stress and strain field experienced by each component using a 3D finite element model implemented in the commercial FEA package, ABAQUS. The steps are summarised in the flow chart shown in Fig. 3.

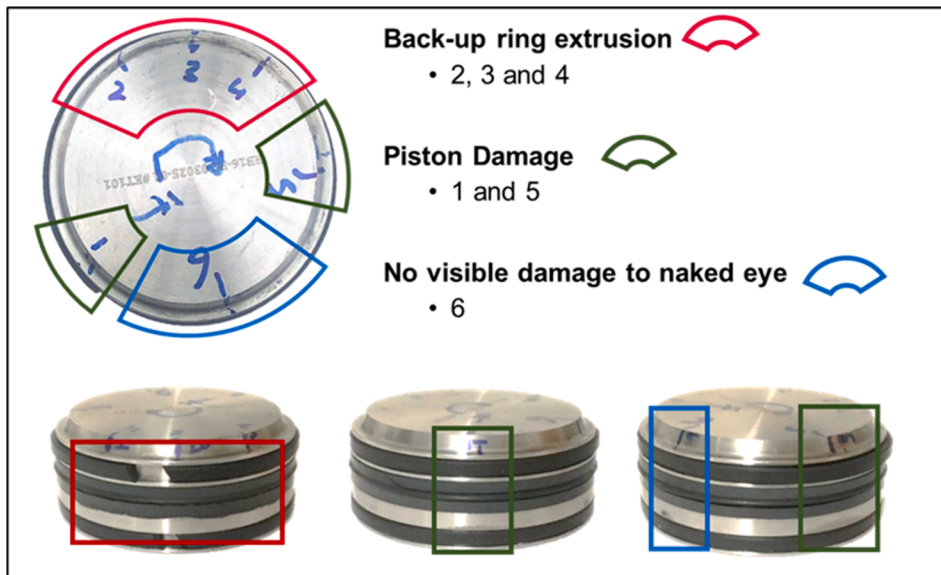
Fig. 4. Overview of sections of interest for on failed sample.

of failure. The seal has experienced the extrusion of the back-up ring on the atmospheric pressure side and the unseating of the elastomer.

The identification of the failure sequence has been carried out comparing a seal affected by the failure in service with one new. New unused samples were collected as standalone seal packs whereas the failed samples consisted of damper piston and sealing components sub-assembly. Six sections with three damage conditions were defined on the piston (Fig. 4). The damage observed are back-up ring extrusion in section 2, 3 and 4; piston damage in sections 1 and 5; and no visible damage in section 6. 100X magnified pictures were taken of each section using a VHX-6000 Digital Microscope from Keyence Corporation. Stitching and automatic focusing features were used to achieve clear pictures. The images have been studied in detail to identify different failure mechanisms and the likely failure sequence.

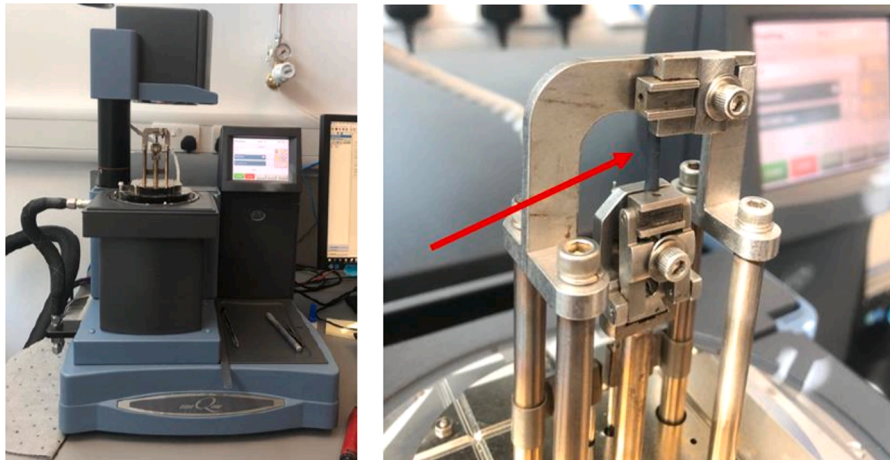
Fig. 5. TA Instruments Q800 DMA (left) and sample in tensile grips (right).

The elastomer material characterisation was carried out with DMA whilst the stress-strain material response of the PTFE was based on data from literature [17]. A strain-controlled frequency sweep was conducted using a Q800 DMA from TA Instruments (Fig. 5). The test was run at two conditions corresponding to room temperature and 150 °C, this latter the temperature of the oil during service, the frequency ranging between 1 Hz and 20 Hz and a strain amplitude of 0.3%. Mooney-Rivlin, Neo-Hook, Odgen, and Polynomial hyperelastic models were compared in terms of goodness of fit of the material data. The best fitted model was implemented in the finite element (FE) model.

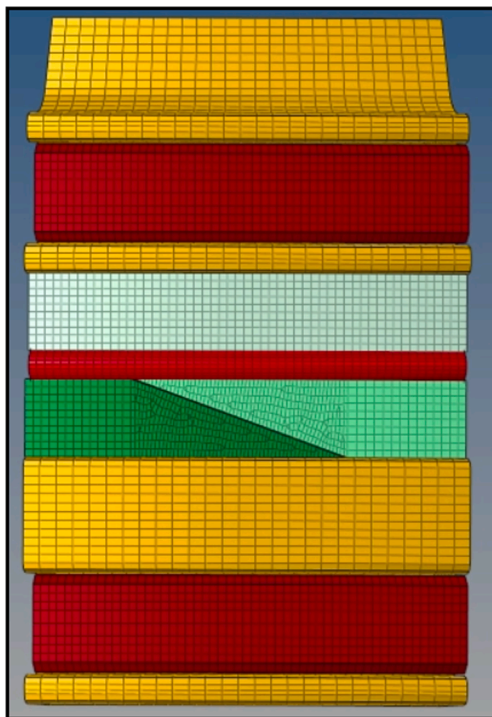
Fig. 6. Meshed piston and sealing components.

The eight-node brick elements (C3D8I in the Abaqus library) [18] was used for the discretisation of the piston and body elements as this element provides an accurate estimation of the stress and strain field without significantly increase computation time. Specific element formulations are instead required for incompressible materials with high Poisson ratios such as PTFE and Fluorocarbon. The element formulations usually adopted are tetra4 (C3D4H in the Abaqus library) pyramid5 (C3D5H in the Abaqus library) and hex8 (C3D8H in the Abaqus library). The final model contains circa 88,000 nodes, 150,000 elements and 18 contacts (Fig. 6).

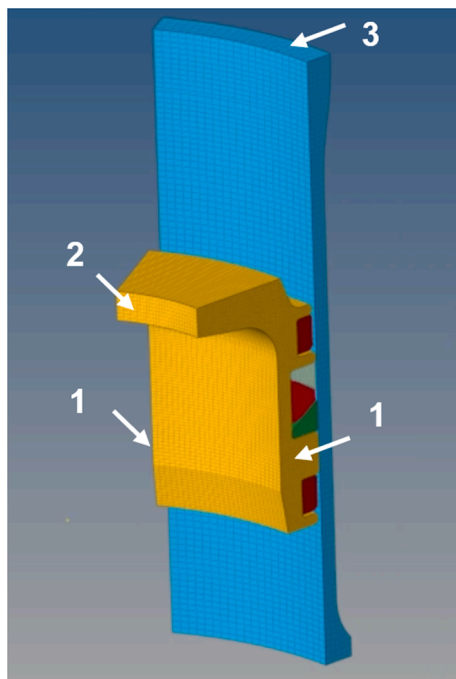
Fig. 7. Cut 3D FE Model.

A cylindrical coordinate system has been used to define the boundary conditions. The two sets of surfaces on the sides of the sector model (1 in Fig. 7) were all constrained in the tangential direction to replicate the radial symmetry condition whilst surfaces 2 and 3 were constrained in the radial and vertical directions, respectively.

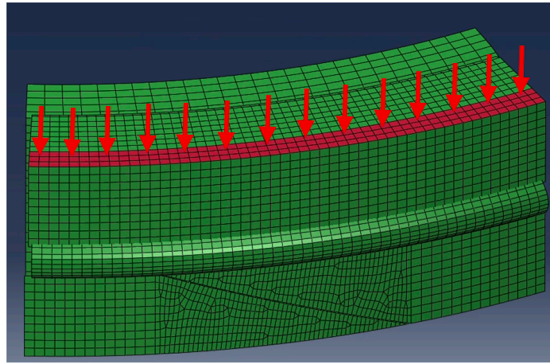
Fig. 8. Seal Pack: Region of uniform 20 MPa applied pressure.

The analysis has been implemented in three steps: interference fit to initialise the stresses due to the press-fit, temperature step to bring the system to the operating temperature and a pressure step to introduce the effect of the oil. In the pressure step a representative 20 MPa uniform pressure applied to the portion of the seal pack that is initially exposed to the high-pressure fluid, the edge of the high-pressure back-up ring (see Figs. 8 and 9).

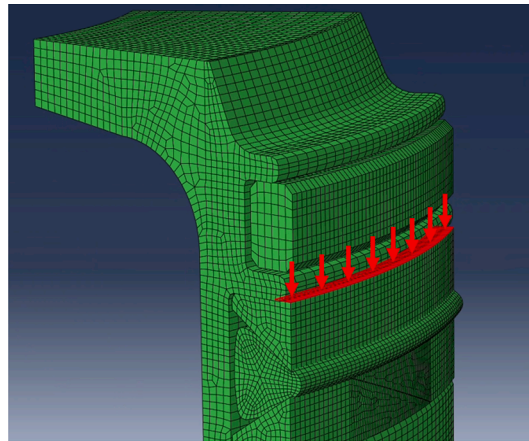
Fig. 9. Seal pack and piston assembly: Region of uniform 20 MPa applied pressure.

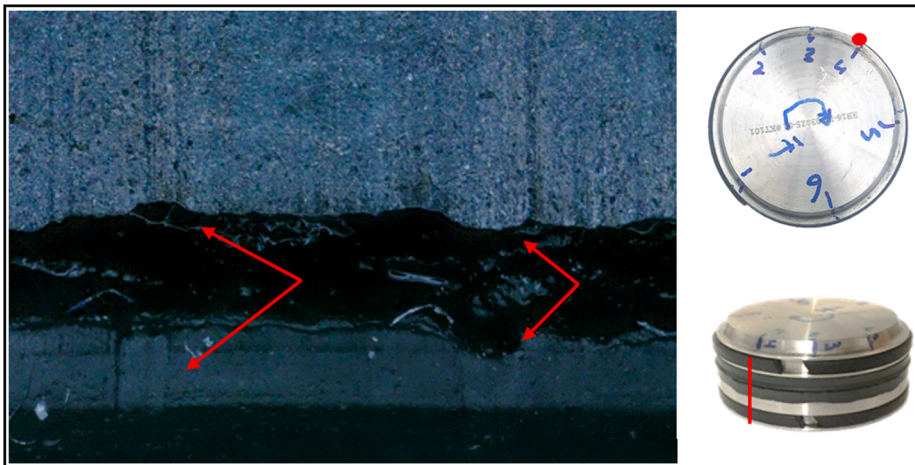
Fig. 10. Elastomer and low-pressure back-up ring wear alignment – section 4.

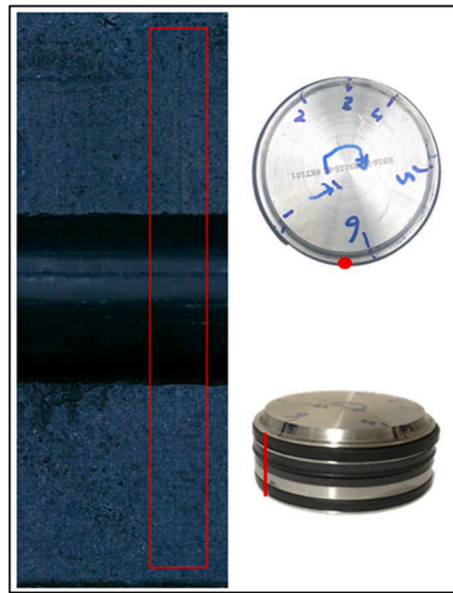
Fig. 11. High- to low-pressure back-up ring wear alignment – section 6.

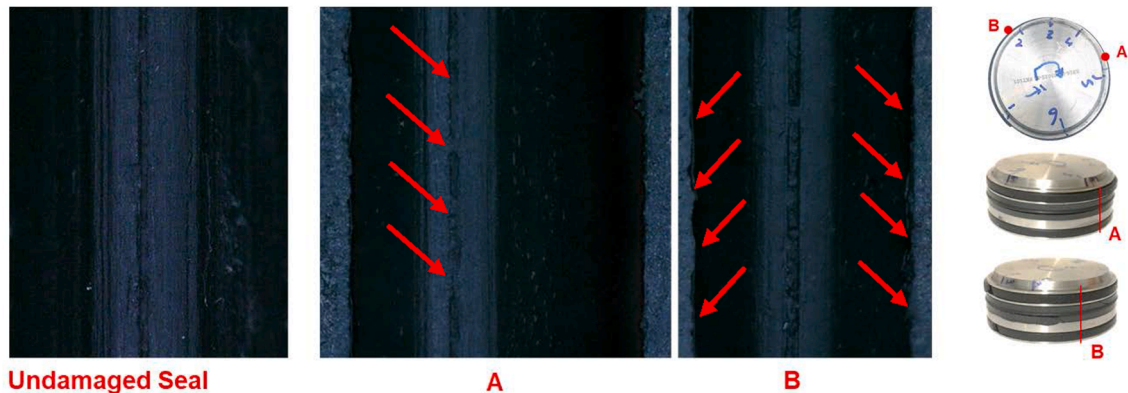
Typical run-in wear can be noticed when comparing the damaged and undamaged seal as shown in Fig. 13A taken from section 5.

The flash line is worn away and the seal surface is visibly smoother. This is typical of seal behaviour during the run-in phase of operation [6]. However, in the other two sections around the seal circumferential thermal damage accumulation has occurred on the flash line as it can be seen in Fig. 13B taken from section 2.

Fig. 13. Flash line wear and thermal degradation.

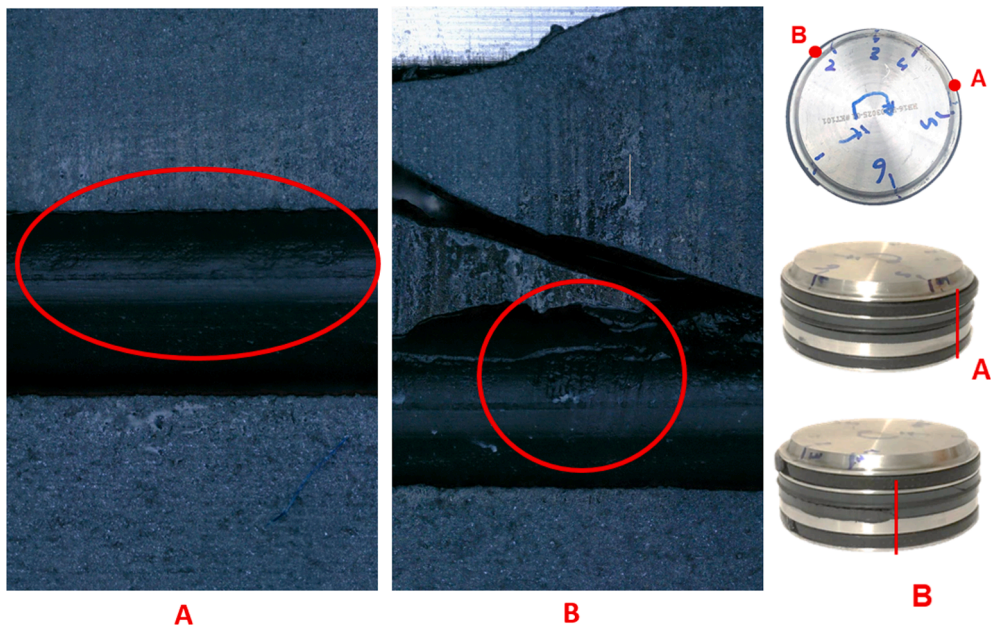
Nibbled extrusion is most notable in section 5 on the low-pressure side of the elastomer (Fig. 14 A). This damage is also paired with light PTFE discolouration. Nibbled extrusion was also found in sections 2, 3 and 4 as shown in Fig. 14B taken from section 2.

Nibbled extrusion was observed in section 5 where no PTFE extrusion has occurred as well as in other sections where the extrusion was observed that strongly suggested that the nibbled extrusion happened prior to the back-up ring extrusion.

Fig. 14. Pre-Extrusion elastomer nibbled extrusion.

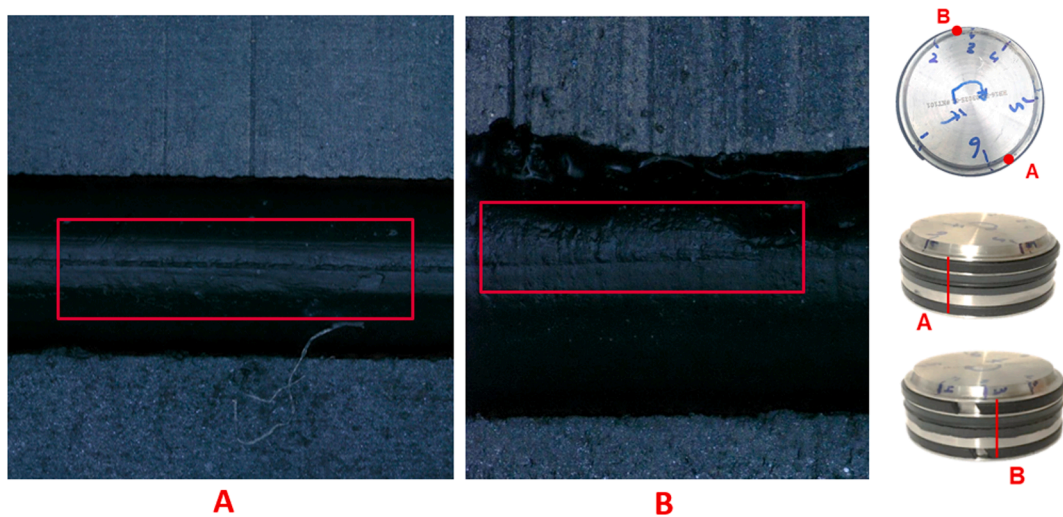
Signs of thermal degradation are most notable in section 6. This damage is characterised by long diagonal striations on the surface of the seal, as highlighted by the red square in Fig. 15 A. This damage is also found from section 2 through to 4 where back-up ring extrusion occurs as shown in Fig. 15 B.

Like the nibbled extrusion, prevalence of this failure in sections without PTFE extrusion, it is assumed that thermal degradation occurs prior to back-up ring extrusion.

Fig. 15. Pre-extrusion elastomer thermal degradation.

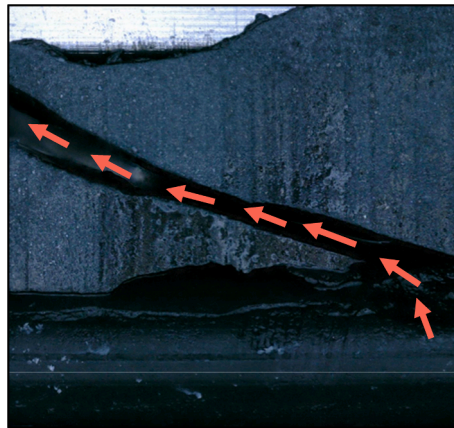
The accumulation of nibbled extrusion and thermal degradation cause significant loss of sealing performance. When that damage corresponds to the cut in the PTFE back-up ring, the fluid is allowed to fill the gap and radially strain it (Fig. 16). The low-pressure backup ring is then pushed onto the damper body. Fig. 17 shows the low radial stiffness of the back-up as two fingers alone provide sufficient force to bend it outward.

Fig. 16. Fluid flow through back-up ring gap.

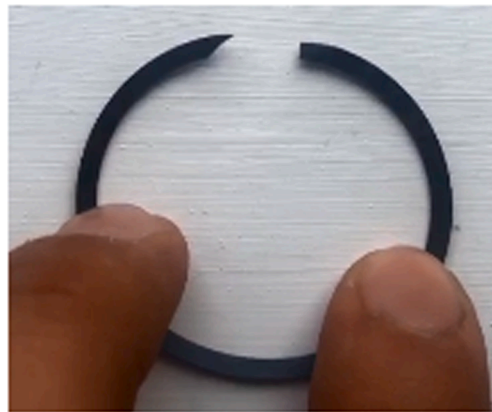
Fig. 17. Back-up ring low radial stiffness.

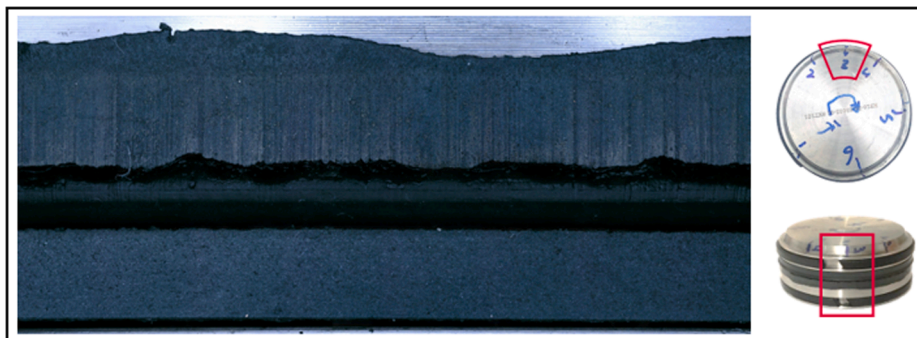
The radial deformation of the back-up rings leads to the thinning of the oil film with a rapid increase in friction and the PTFE is then extruded through the operating clearance between the piston and the damper body. Vertical wear marks from section 3 shown in Fig. 18, support lack of lubrication as the cause of extrusion. Discoloration and the prevalence of plastic flow rather than cracking also suggests that high temperature rather than high oil pressure is the main contributor to the extrusion. This was also confirmed when a cross-section of the extruded portion showed no signs of cracks under the microscope.

Fig. 18. Section 3 PTFE extrusion.

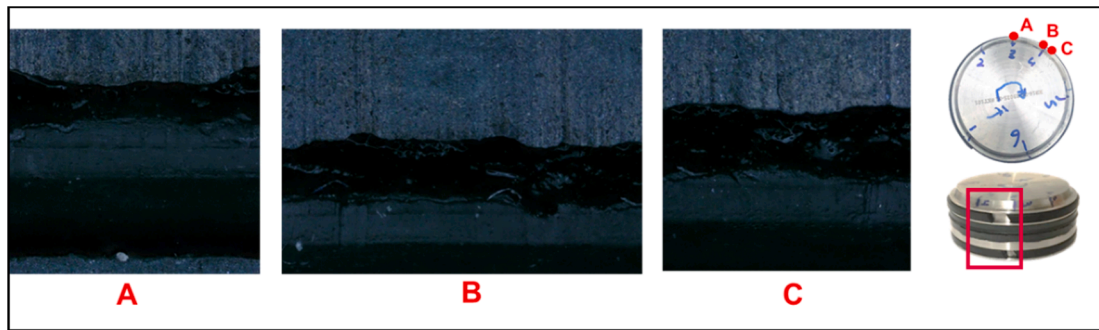
The increased gap due to the extrusion allows the oil under pressure to push and roll the seal out of its seat causing excessive wear (Fig. 19). This is observed in several locations three of them, namely A, B and C, are shown in Fig. 19.

Fig. 19. Unseating damage to the elastomer.

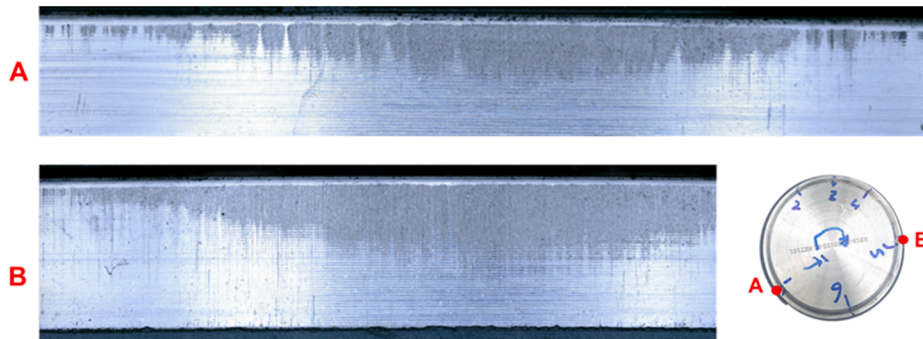
The unseating of the elastomer reduces the available system clearance forcing metal on metal contact between the piston and the damper body. The metal-to-metal contact causes wear marks on the external surface of the piston that slides with friction on the internal surface of the cylinder producing the marks shown in Fig. 20. Similarly, wear marks were found on the sealing surface of the

Fig. 20. Piston damage.

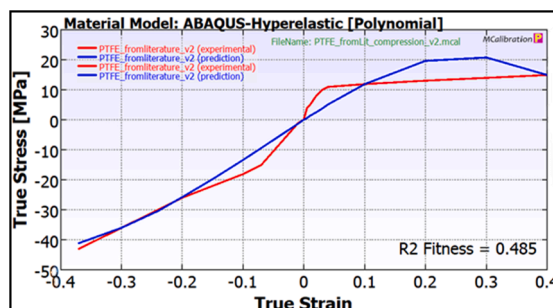
For the PTFE material a polynomial model with three terms was chosen and is shown in Fig. 21. On the other hand, the best fitting model for the Fluorocarbon material was a Mooney-Rivlin model with 3 terms (Fig. 22).

Fig. 21. PTFE stress-strain curve fitted with a hyperelastic polynomial model.

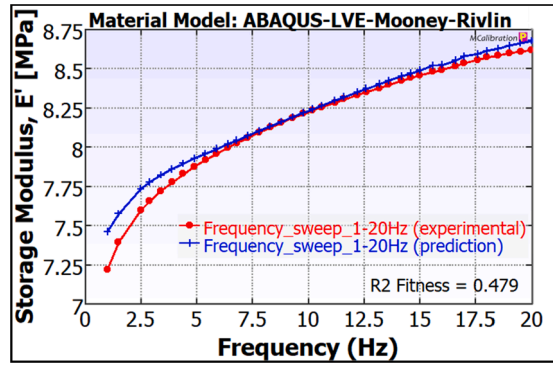
Fig. 22. Fluorocarbon DMA Data fitted with Mooney-Rivlin Model.

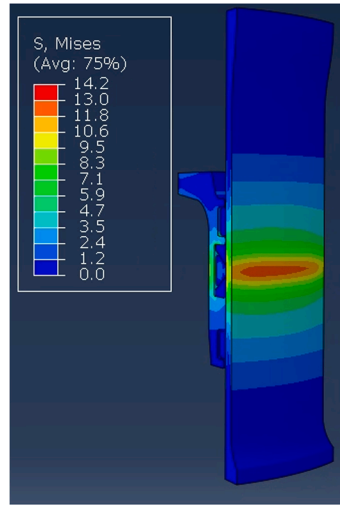
The cut in the back-up was identified as a key component in the failure of the sealing system and the FE model needed to incorporate this feature to capture its effects on the stress and strain field. The model described in section 3 was used to carry out the multistep analysis considering interference fit, thermal analysis and estimate the deformation of the seal under the oil pressure. Results from the interference fit simulation show a maximum stress level of 14.2 MPa and 11.9 MPa in the body and piston, respectively (see Fig. 23). The low stress level in the metallic parts is to be expected as the interference is mostly compensated by the deformation of the seal due to significantly lower modulus of elasticity of the elastomer. The sealing pack is interested by a significantly lower stress with the maximum located beneath the contact surface as expected considering the Hertzian contact theory (Fig. 24).

Fig. 23. Interference fit stress levels.

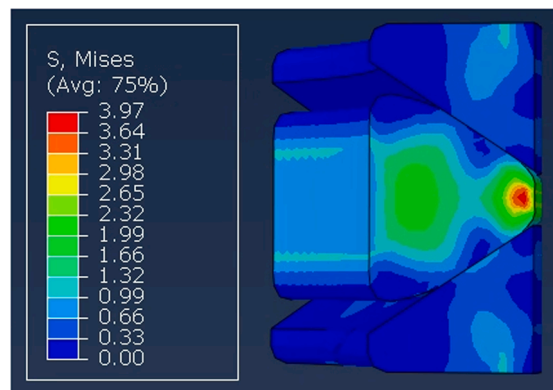
Fig. 24. Interference fit: seal pack stress levels.

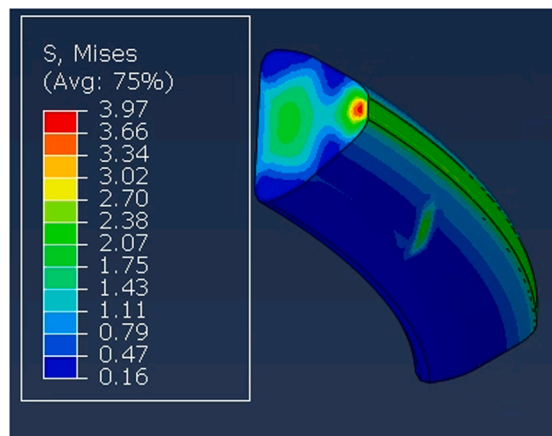
A notable finding is that higher levels of stress are experienced on the elastomer along the line of the low-pressure back-up ring cut as seen in (Fig. 25). Moreover, stress concentration is observed along the edges of the cut back-up ring (see Fig. 26).

Fig. 25. Elastomer stress levels.

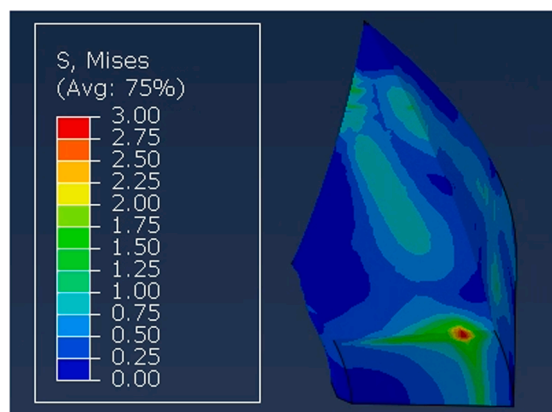
Fig. 26. Low-pressure back-up ring.

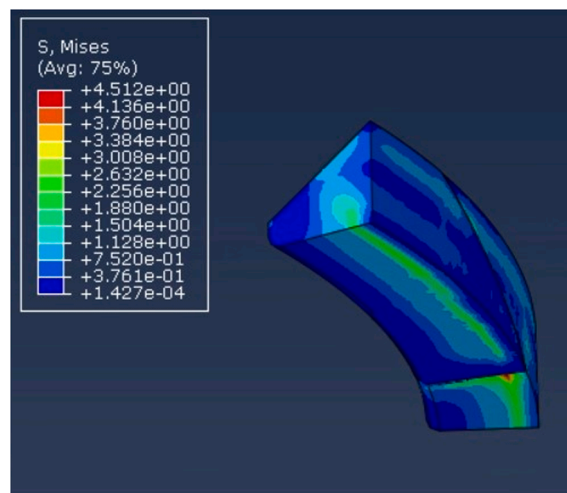
This corresponds to a higher maximum stress in the low-pressure back-up ring compared to the high-pressure back-up ring at 4.51 MPa (Fig. 27) and 2.25 MPa (Fig. 28) respectively.

Fig. 27. Interference fit stress levels.

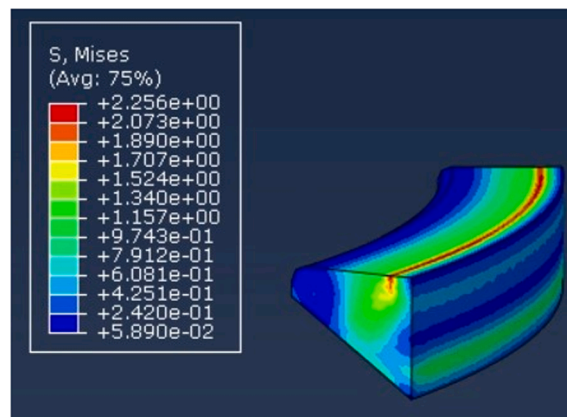
Fig. 28. Interference fit: seal pack stress levels.

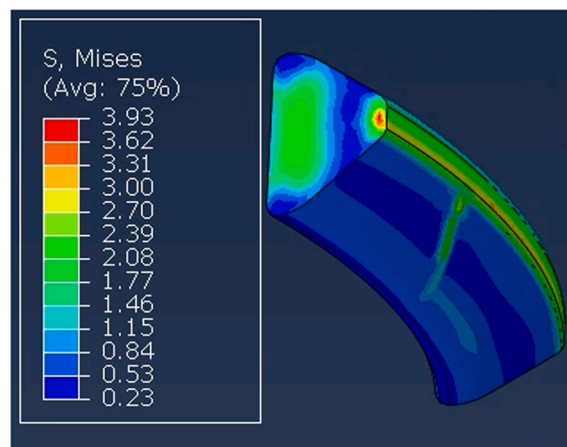
The results of the thermal analysis show as expected minimum variation in the stress with the maximum equal to 3.93 MPa (Fig. 29) against the value of 3.97 MPa attained at the end of the interference fit analysis. This is mostly due to the small difference in the

Fig. 29. Temperature step: elastomer stress levels.

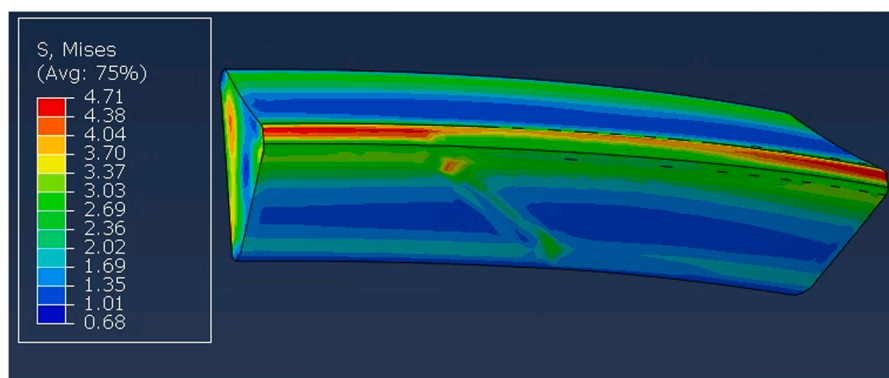
Fig. 30. Pressure step: elastomer stress levels.

After the pressure step, the stress increases mostly at the tip of the back-up ring cut and it decreases at the coincident elastomer surface (Fig. 32). The contact pressure distribution also shows an increase in the maximum stress value in correspondence of the back-up ring cut (Fig. 31).

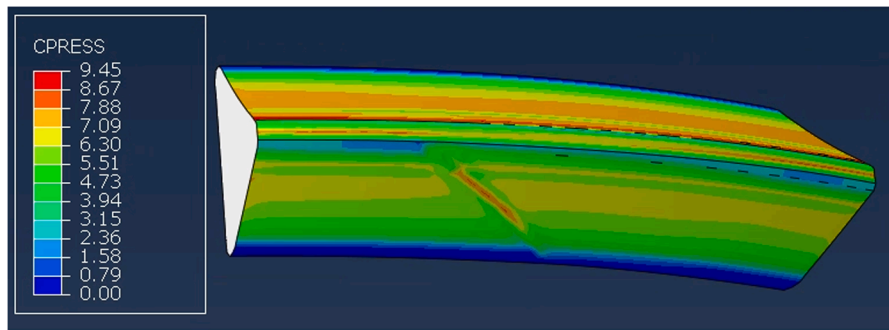
Fig. 31. Pressure step: elastomer contact stress.

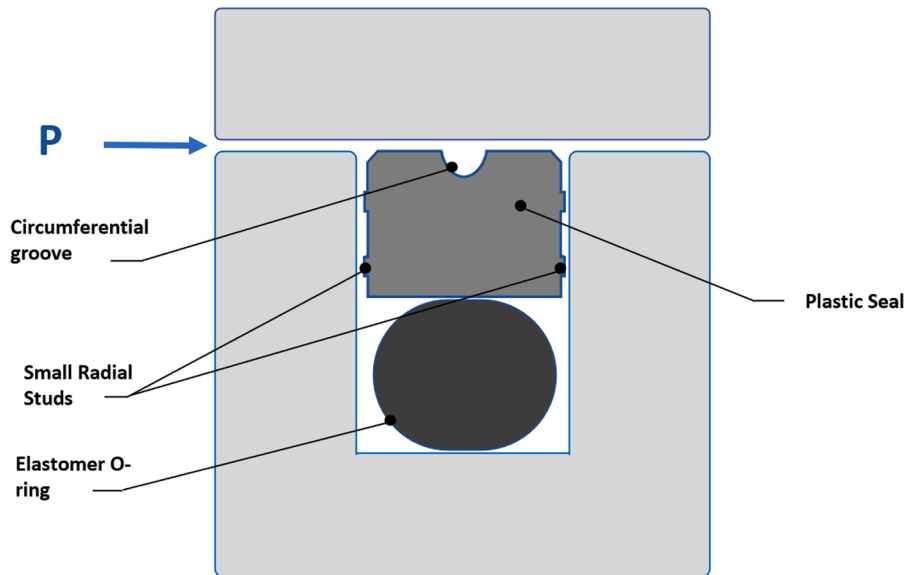
Fig. 32. Suitable seal example.

A more suitable design would consist of an elastomer seal with notches or studs along the sides of the seal to prevent blow-by [9] as well as a groove along the circumference to retain the oil and ensure consistent lubrication. In addition, sloping sides with a positive gradient can be incorporated to promote fluid flow into the circumferential groove. By using PTFE material at the dynamic sealing surface between the seal pack and the body, friction is further reduced by eliminating stick-slip while the material's wider temperature range makes the seal more resistant to increased temperature in the case of dry running. Fig. 29 shows an example of a suitable seal displaying the above-mentioned features.
