## **Damage mechanisms in solid particle impact and erosion testing of thermal barrier coatings**

The ability of both cyclic and randomly spatially-distributed impact tests of columnar EB-PVD ceramic thermal barrier coating (TBC) systems with yttria stabilised zirconia (YSZ) and gadolinium zirconate (GZO) topcoats to simulate their behaviour in solid particle erosion tests has been investigated. The impact tests were able to replicate the main mechanisms and surface morphology in the erosion tests although there was more compaction in the impact tests. Densification below impact craters on YSZ and sub-surface cracking between the dense layer and the un-densified columns were revealed by focussed ion beam milling. Cracking over several columns and break-up of the columnar structure was observed in the impact and erosion tests on GZO. Clear differences in TBC erosion rate, with GZO being much less resistant to erosion, were replicated in the cyclic and randomly spatially-distributed micro-impact tests.

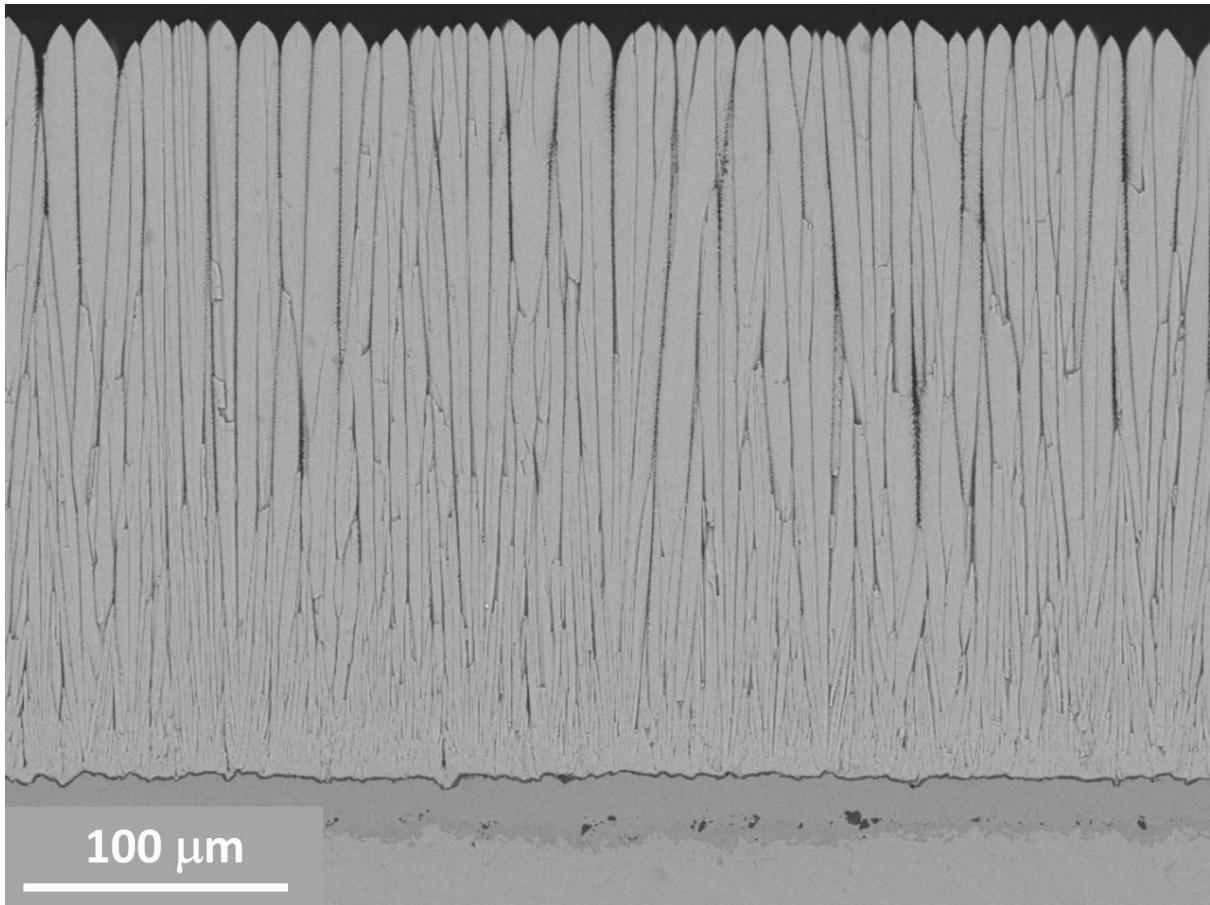
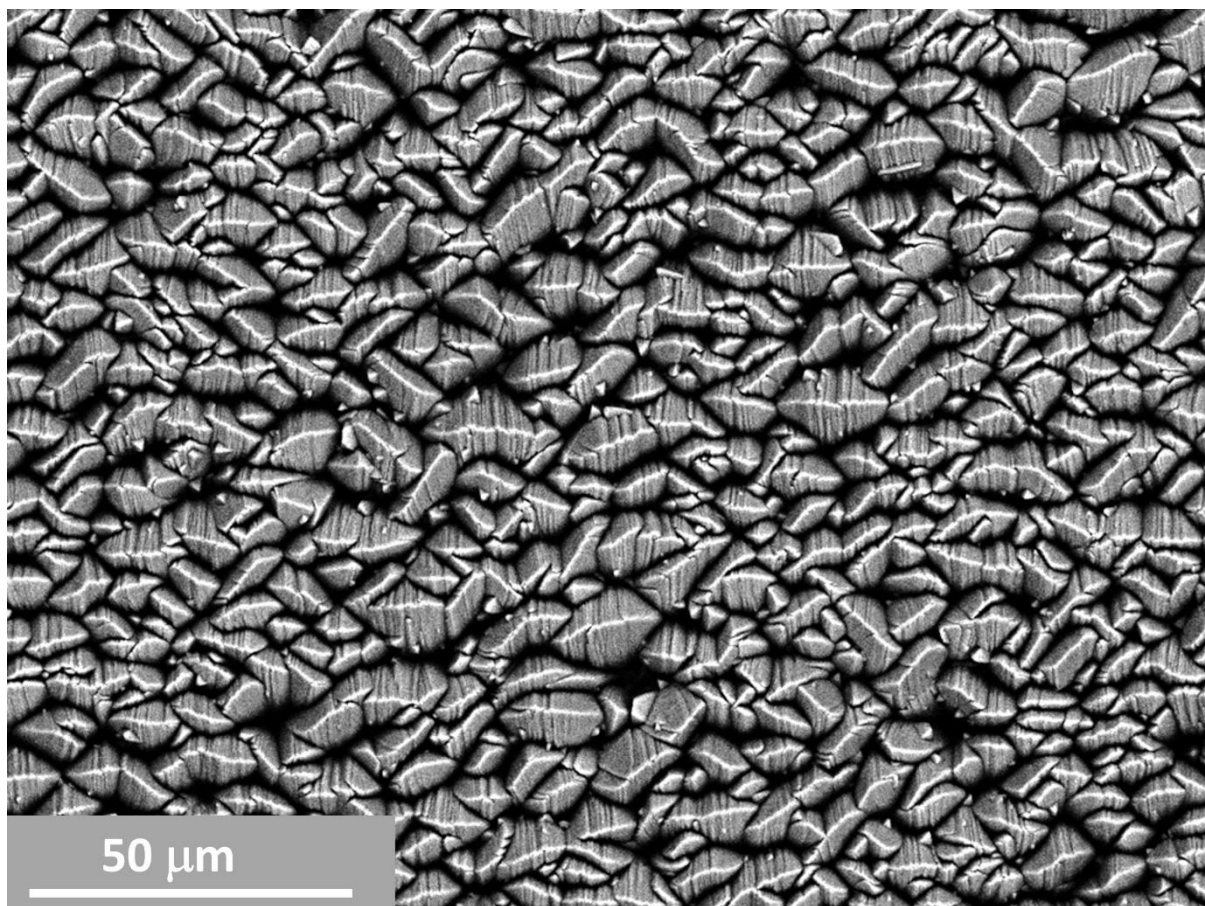
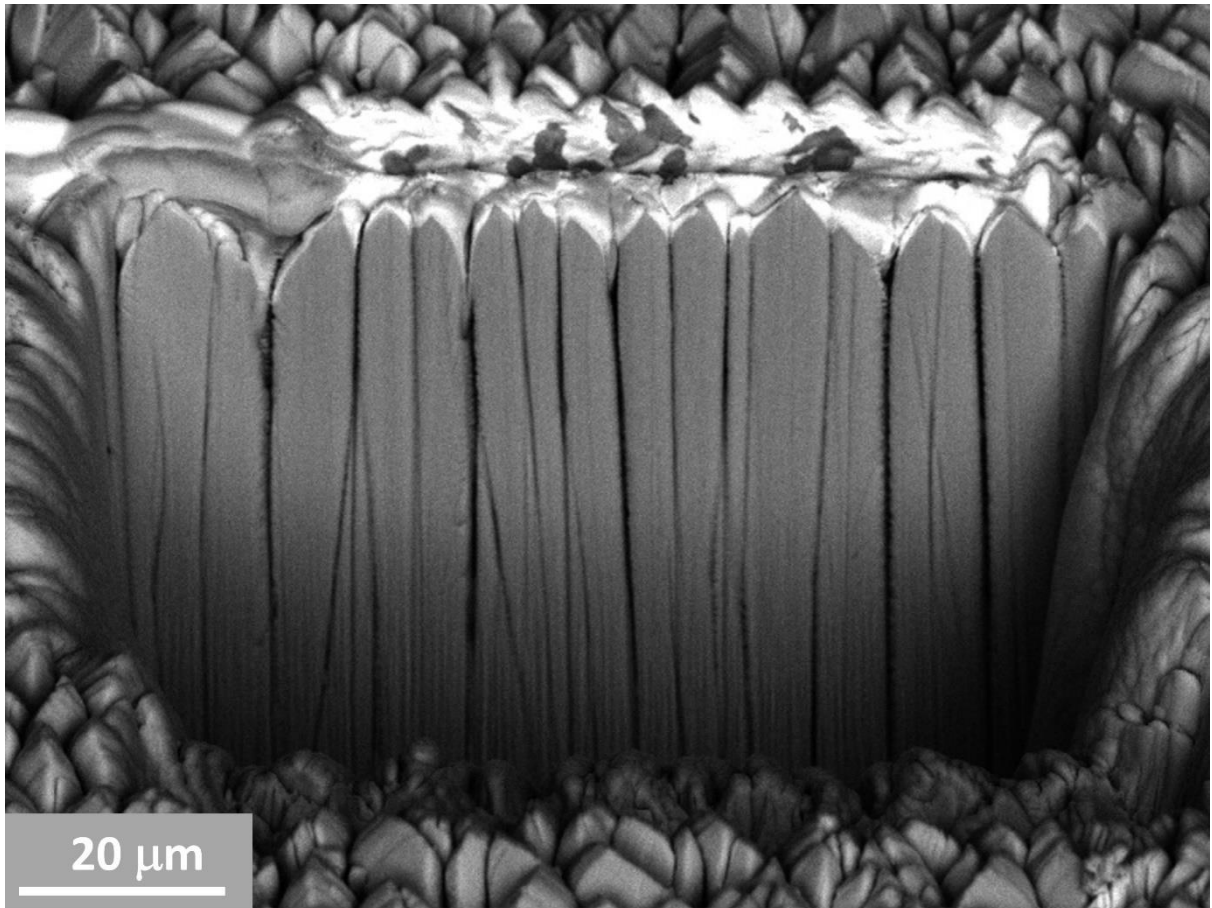
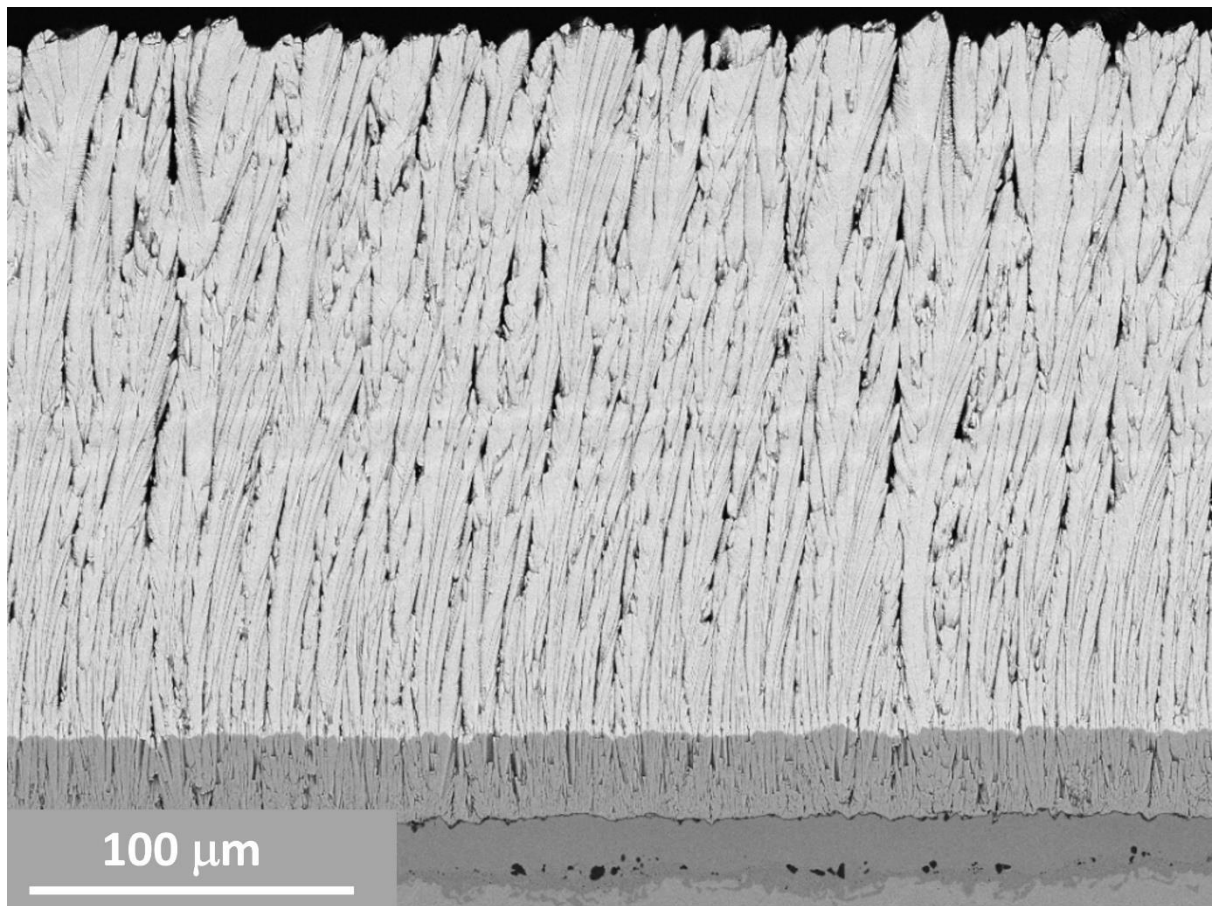
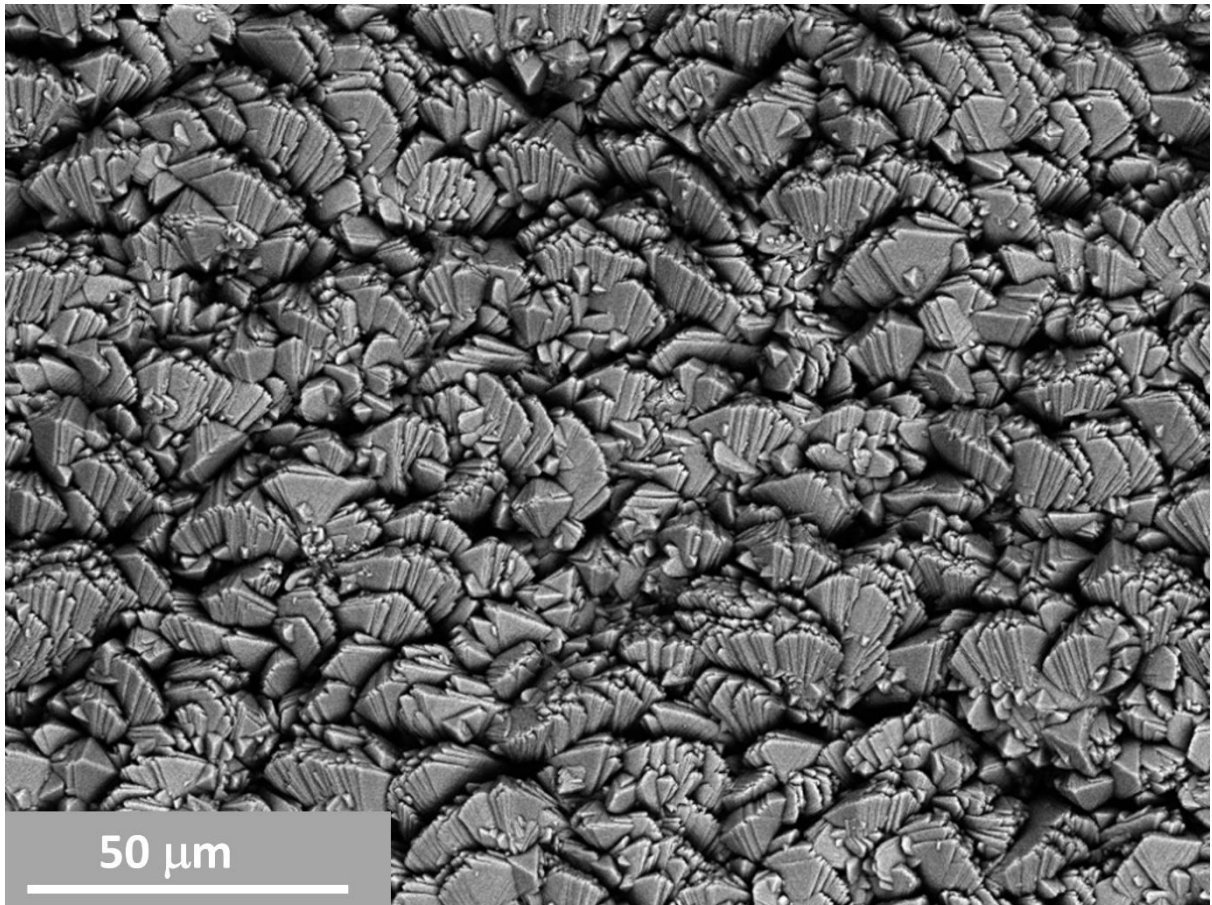
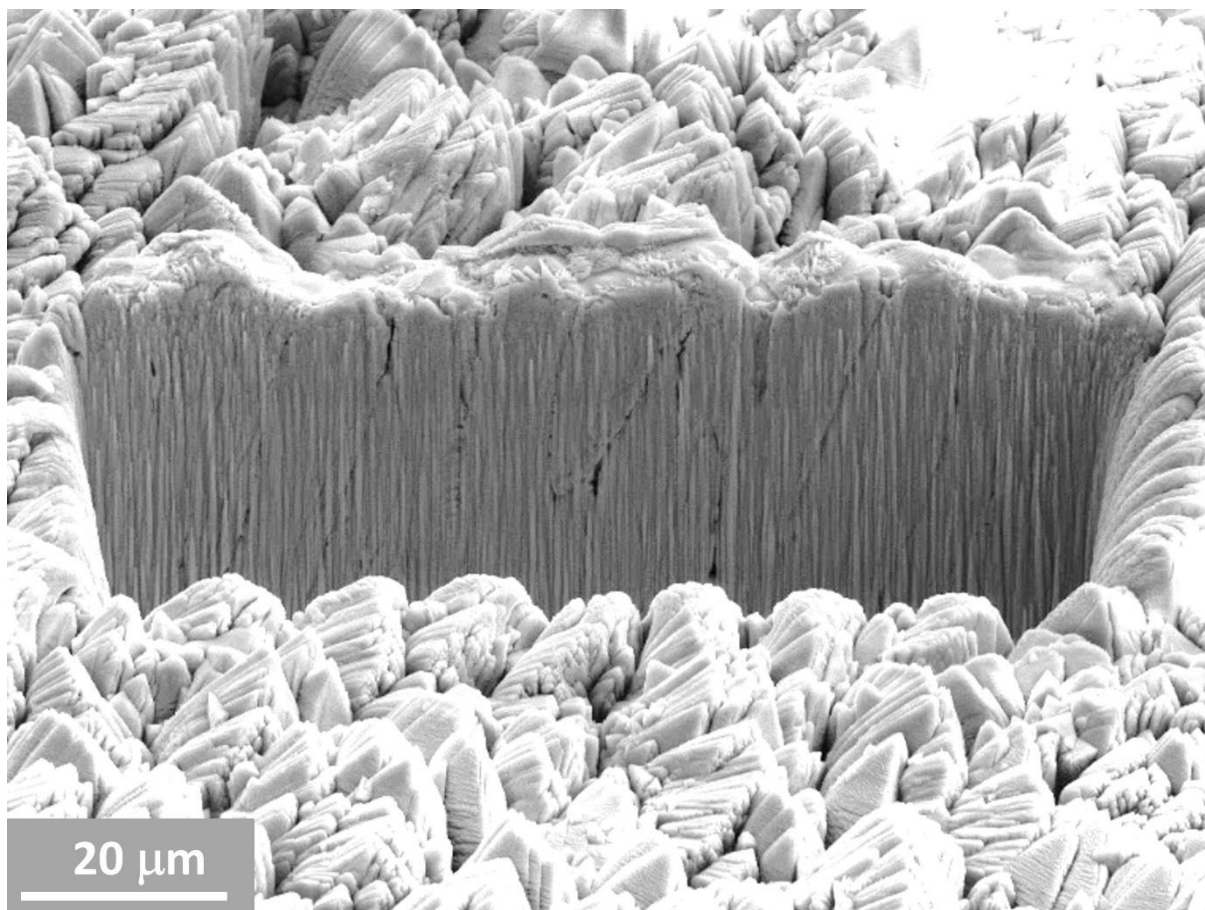
Fig. 1(a-f) shows SEM images of top and side views of typical 7YSZ and GZO coatings. FIB sections in fig. 1(e-f) show that the columns are oriented normal to the surface on 7YSZ and at  $\sim 15^\circ$  off from normal on the GZO. Surface roughness was determined from line scans in confocal microscopy (Olympus LEXT) images. The mean and standard deviation of the  $R_a$  surface roughness from 10 line scans over  $640\text{ }\mu\text{m}$  of 7YSZ and GZO were  $(1.4 \pm 0.1)\text{ }\mu\text{m}$  and  $(0.9 \pm 0.3\text{ }\mu\text{m})$  respectively.

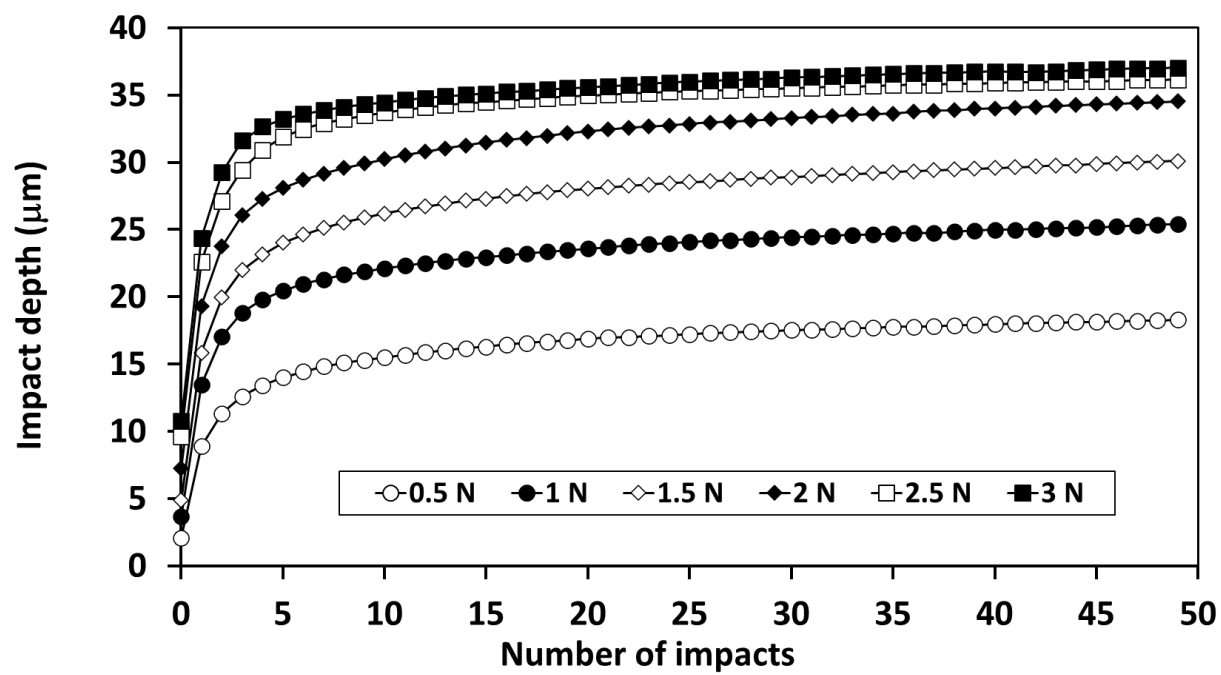
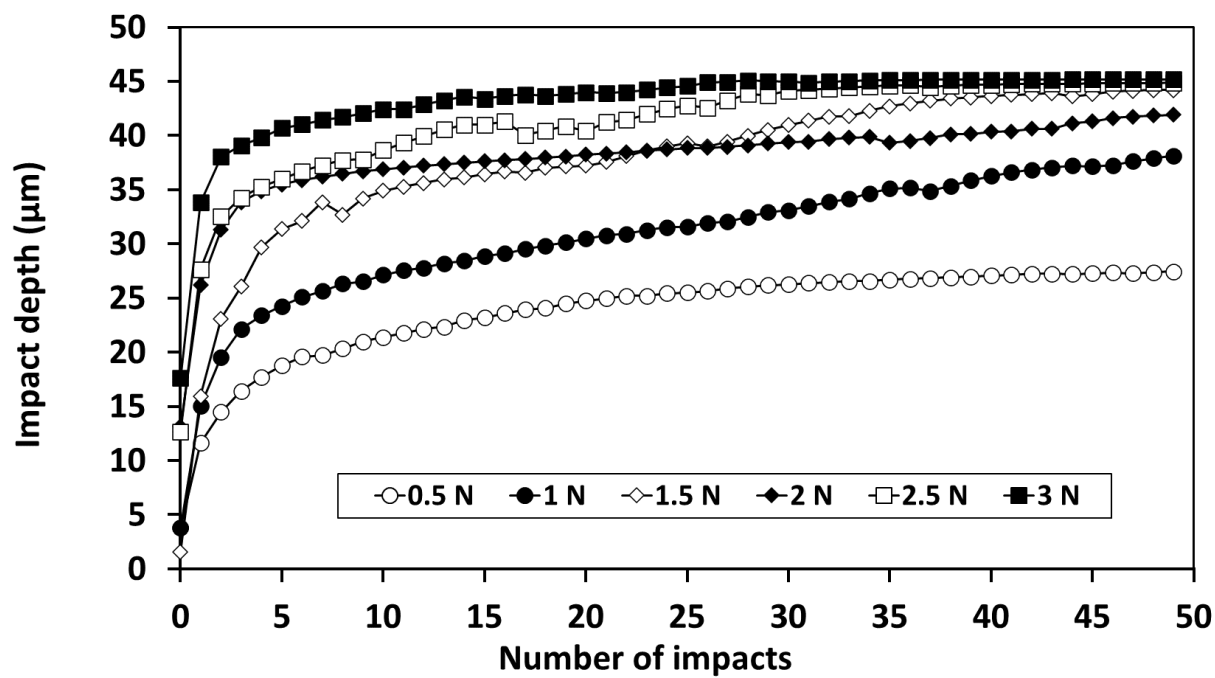
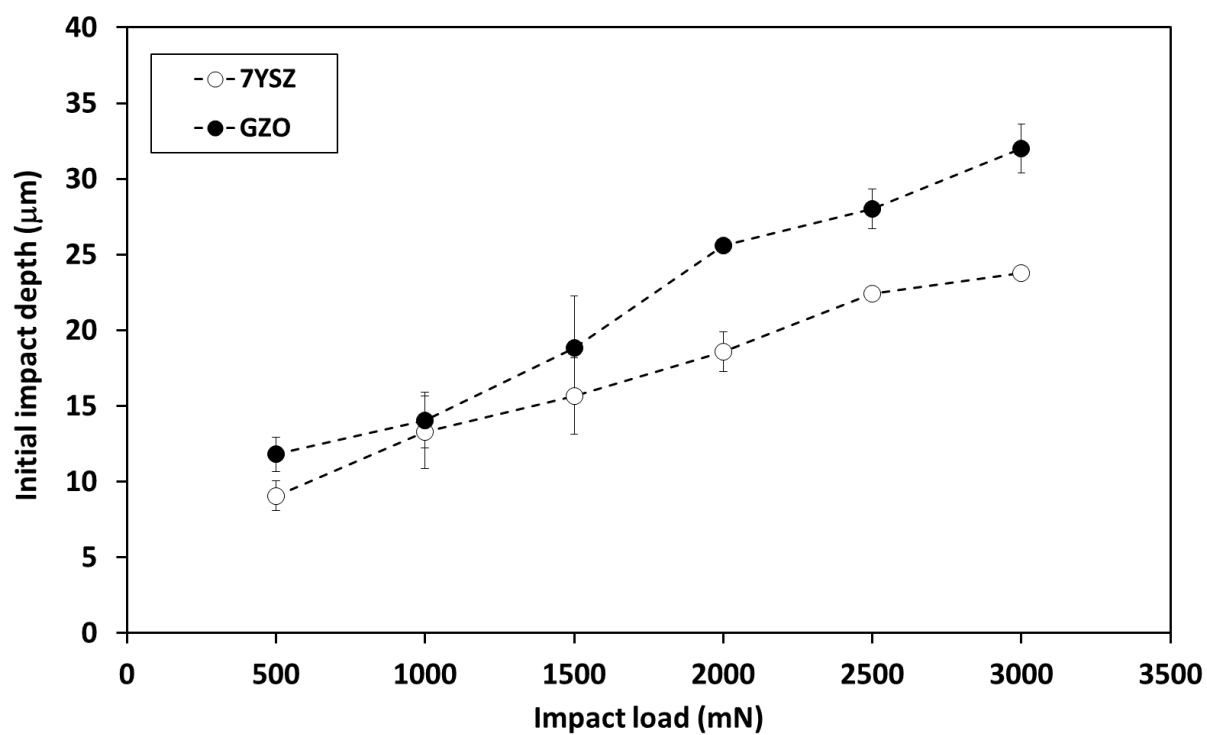
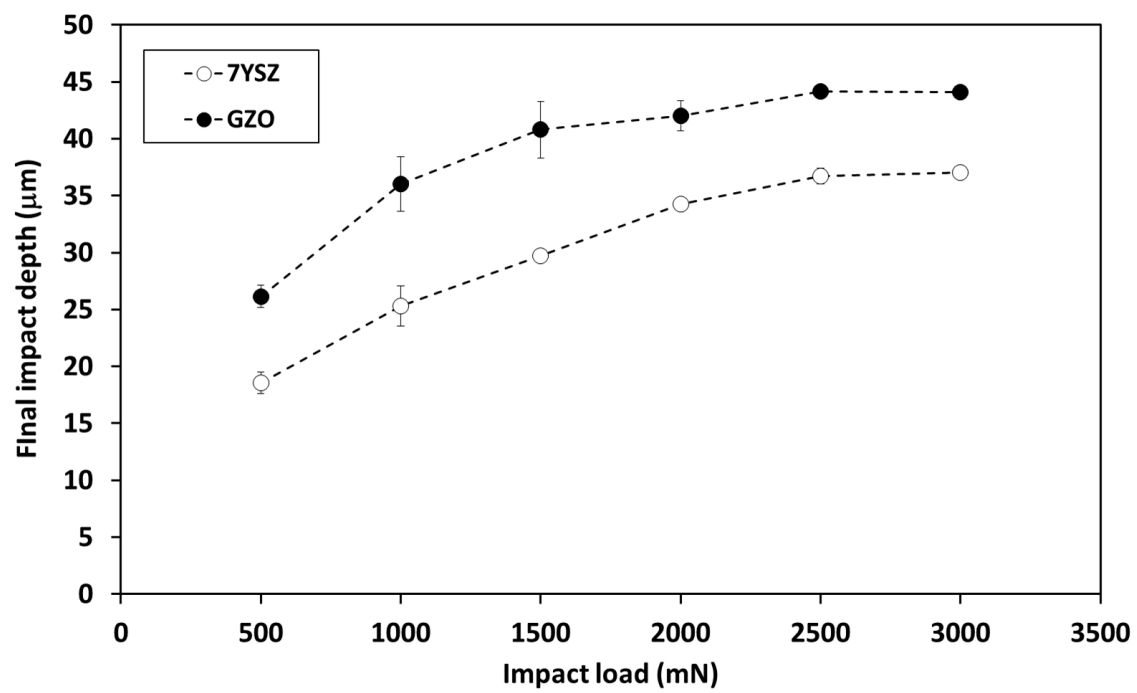
Typical impact depth vs. number of impacts curves are shown for 7YSZ in fig. 5(a) and for GZO in fig. 5(b). Occasional downward depth steps were seen in the majority of curves on GZO but were never observed on 7YSZ. The variation in the initial and final impact depths are shown in figs. 5(c) and (d) respectively. Initial impact depths are larger on GZO and differences with 7YSZ grow with continued impacts. At 2500 and 3000 mN the depth on GZO exceeded the maximum available depth range of the test instrument used before the end of the tests so the values reported in fig. 5(c) are lower bounds.

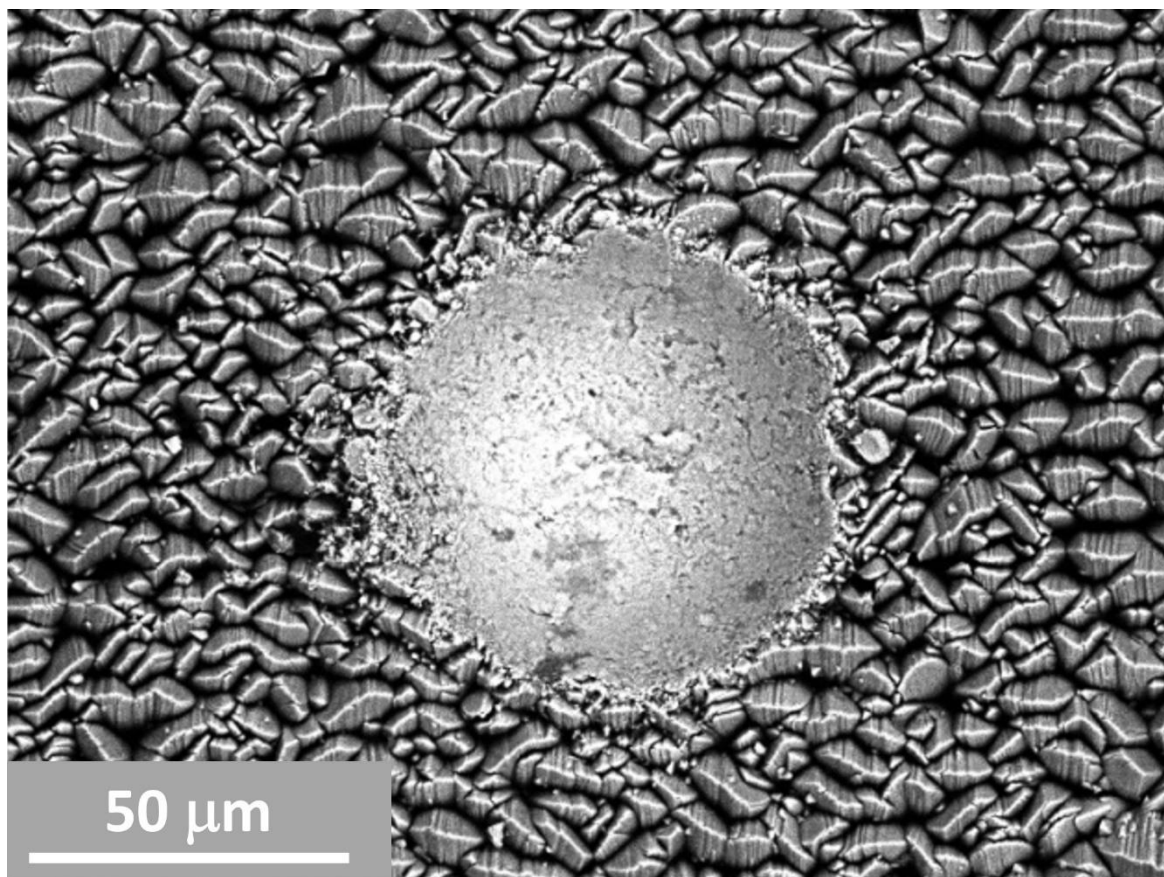
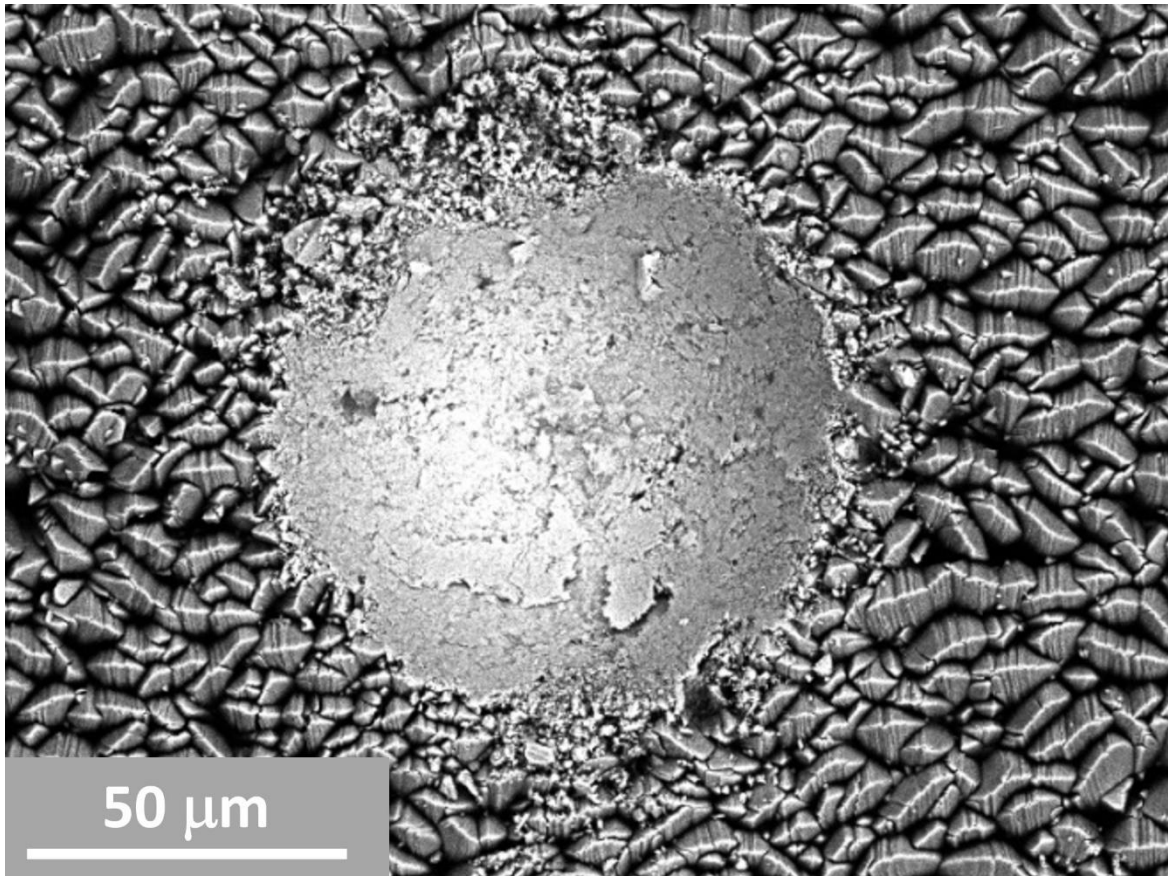
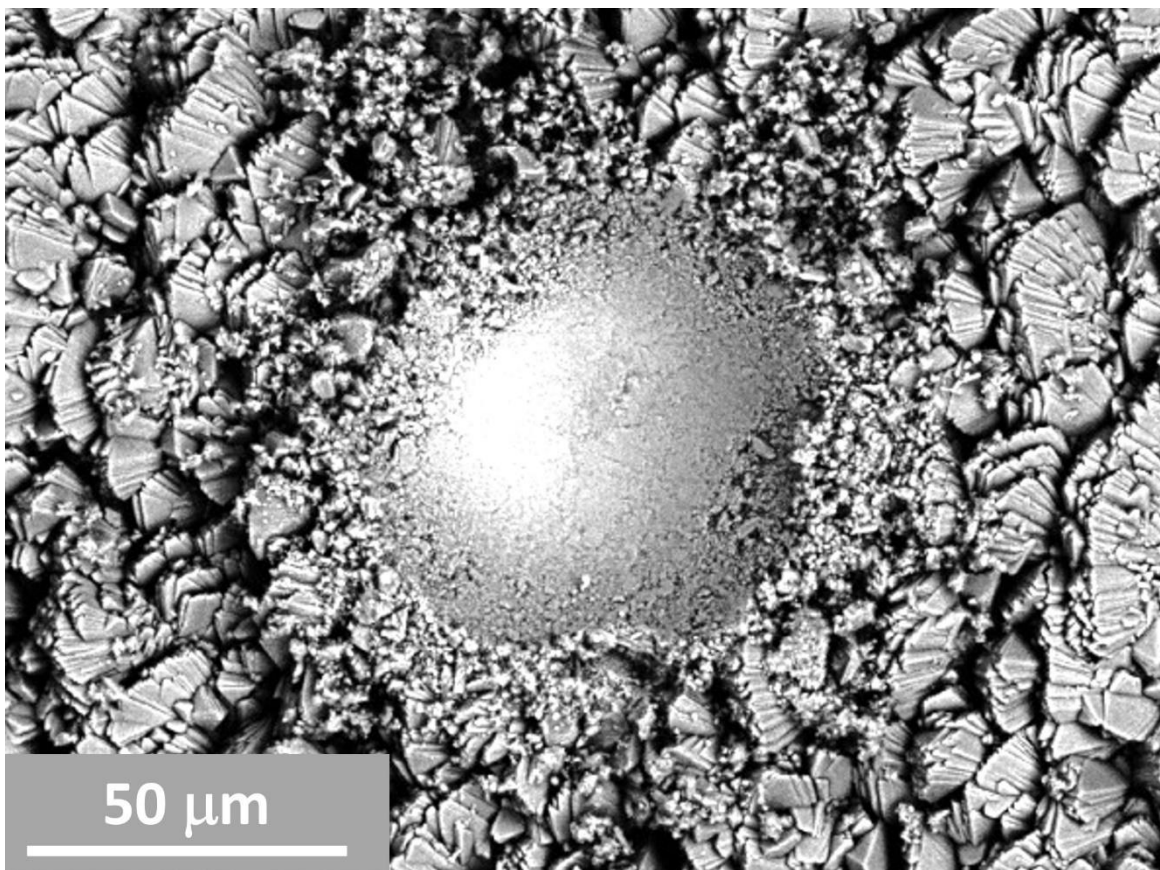
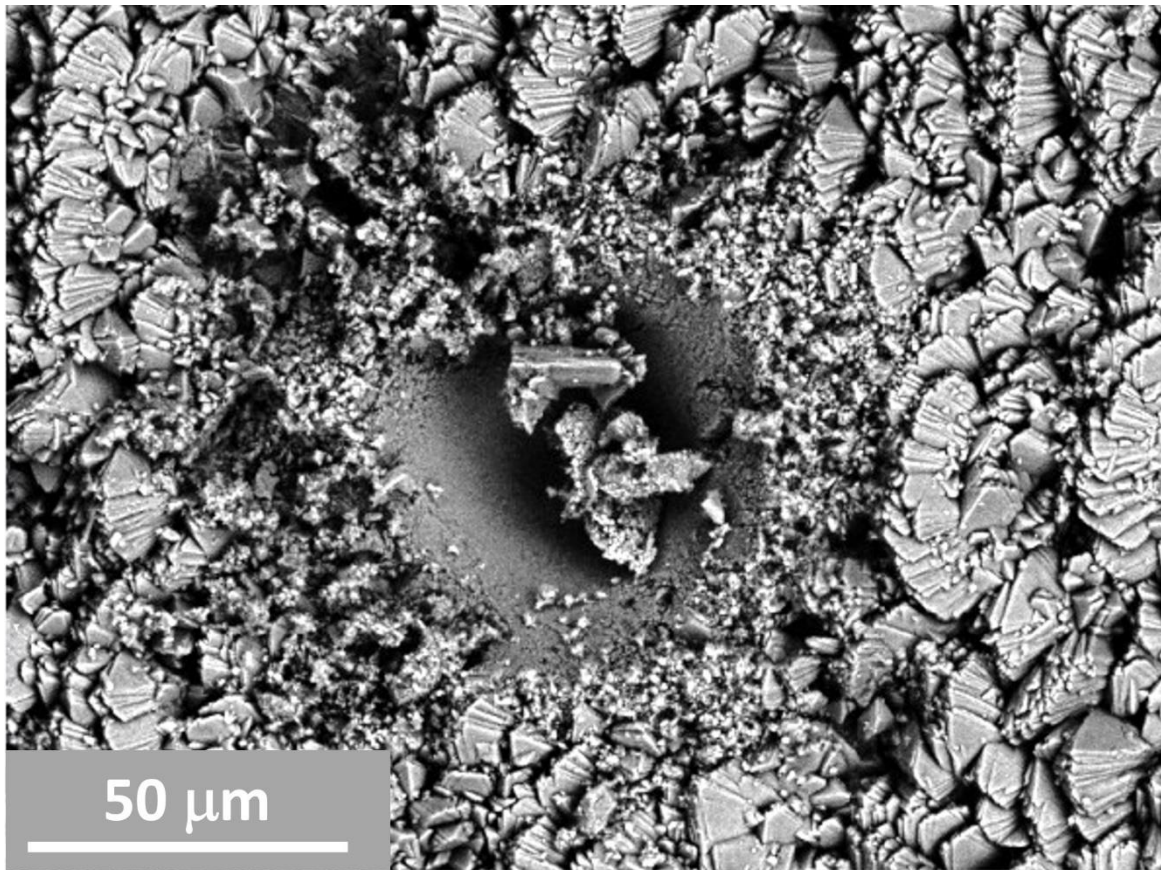
Illustrative SEM images of impact craters are shown in figure 6. For all the tests the final impact crater size extended across several columns. The top-view images (fig. 6(a,b)) show that, with the spherical probe in the cyclic tests on 7YSZ, the deformation was dominated by compaction, squashing the tips of the columns with some localised cracking around the periphery of each crater. On GZO there was also compaction, but this was associated with more extensive cracking at the periphery and in several tests, even at the lowest load, there was debris present within the impact craters (fig. 6c,d). There was also cracking in the bottom of the crater, especially at higher load on GZO.

Although top views of cyclic impact craters on 7YSZ (e.g. fig. 6a,b) show little differences in mechanism with load, the FIB-milled sections show the median/lateral cracking seen in the eroded samples (fig. 13(a,b)), and in previous studies [6]. Since the predominant cracking is parallel to the surface Wellman and Nicholls [6] proposed a mechanism where (i) on initial loading a region of inelastic deformation (possibly densification) forms surrounded by elastic deformation (ii) on unloading the elastic region is prevented from relaxation due to constraint from the inelastic region (iii) there is resultant tensile stress and cracks initiate parallel to the surface. The 7YSZ TBC has ~50% of the theoretical density so inelastic deformation is likely to be densification (compaction) of the columns [6].

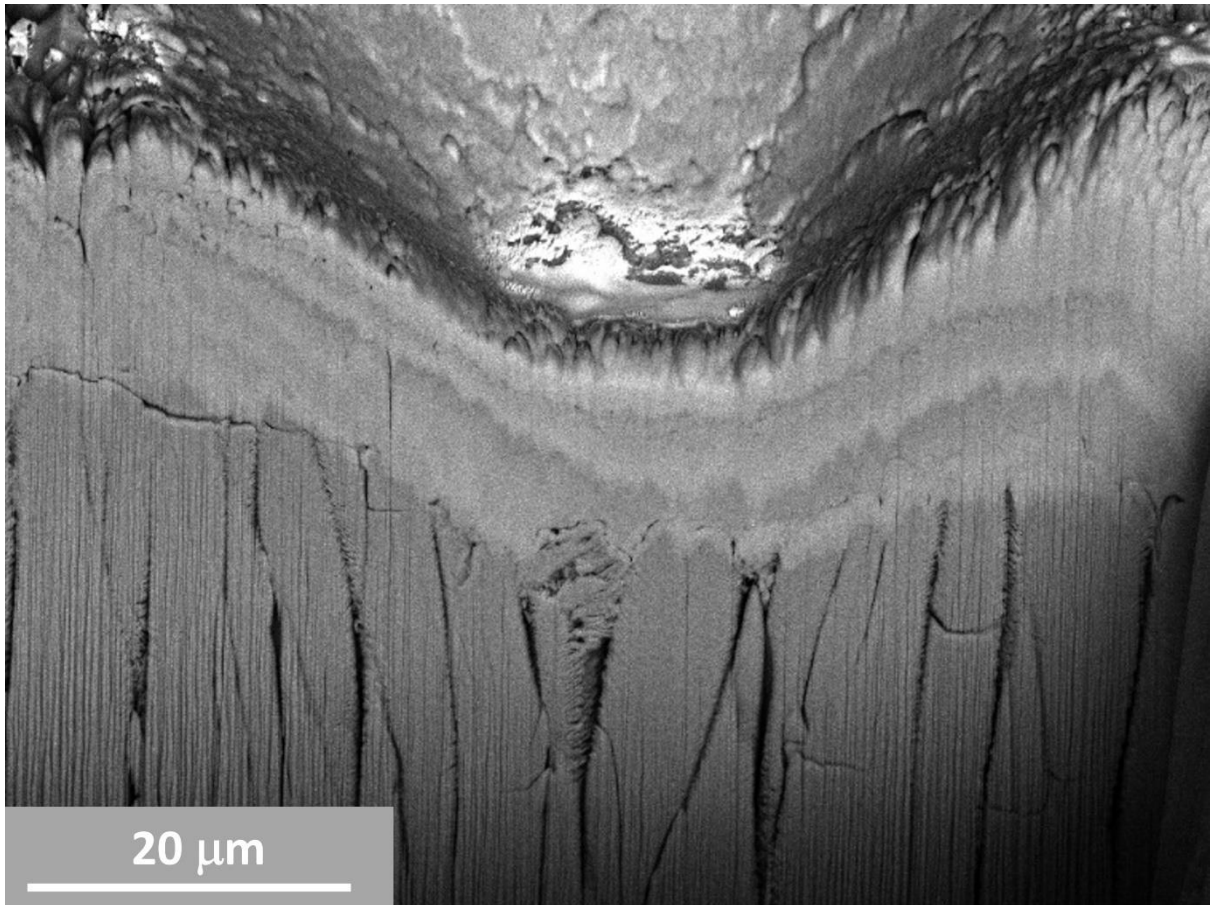
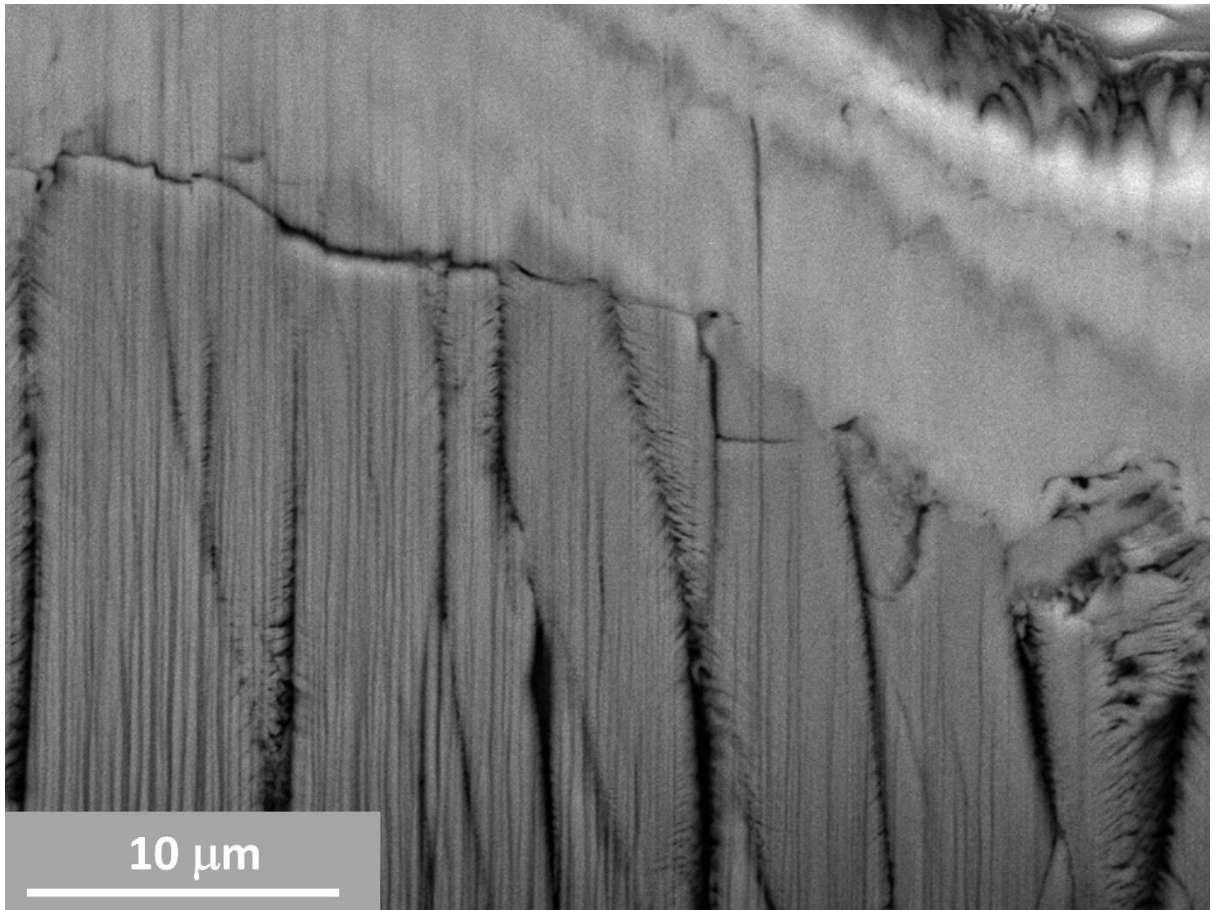
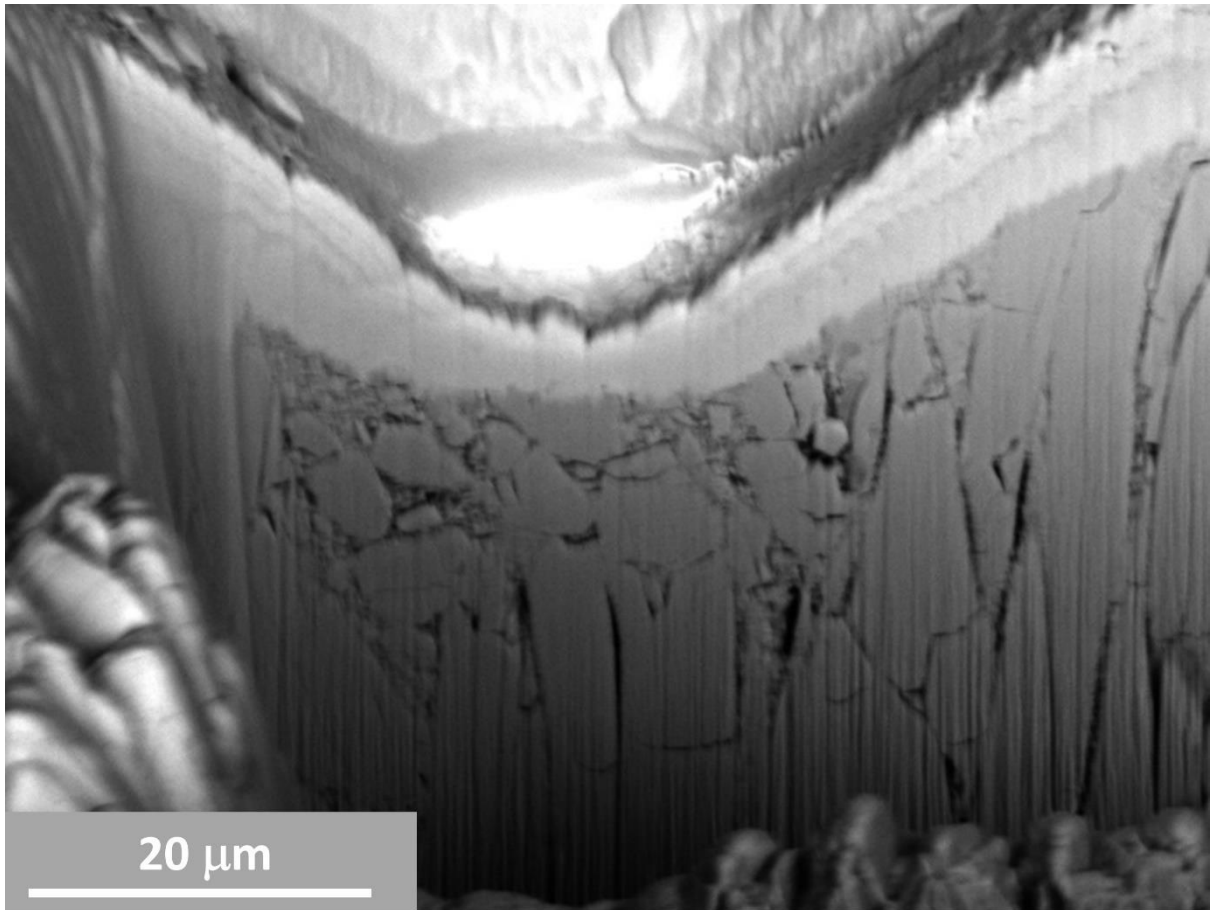
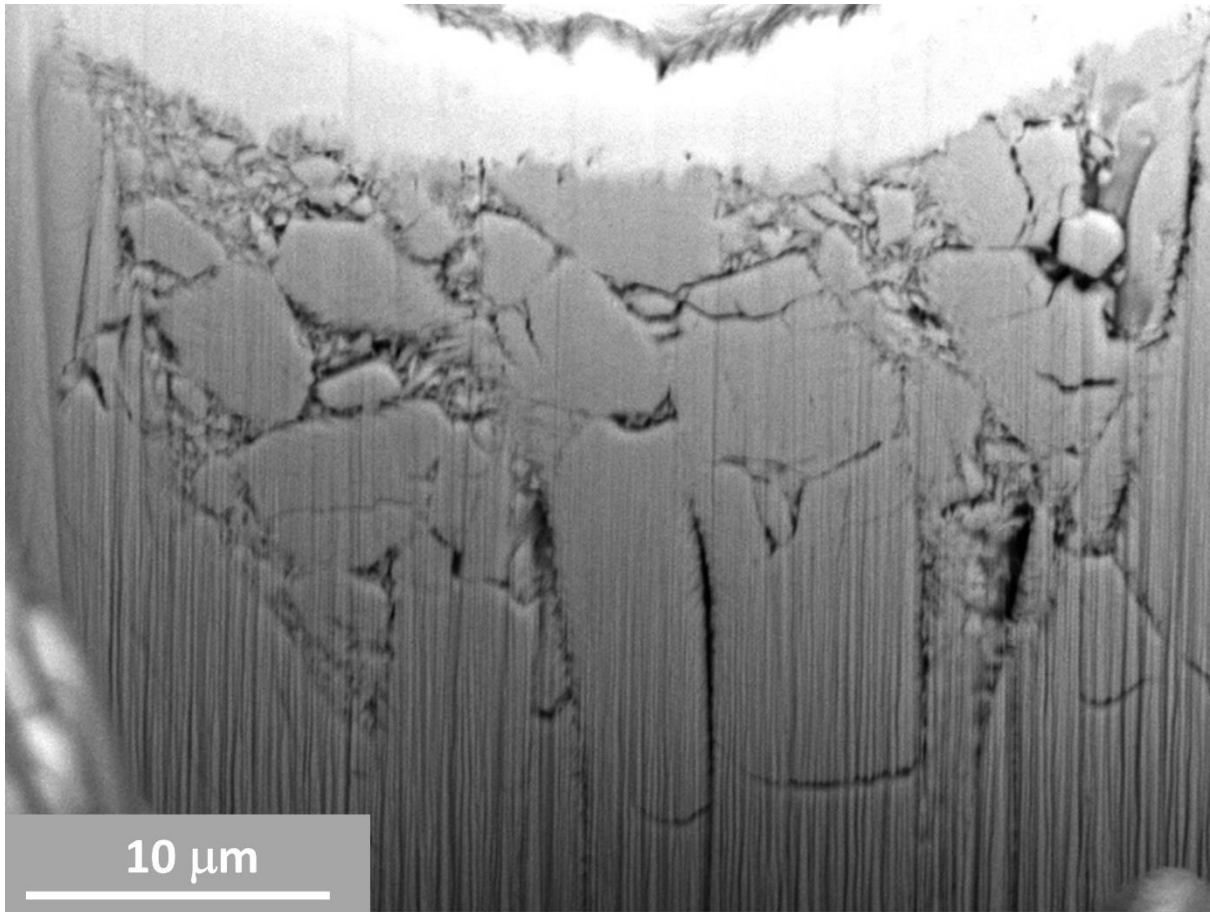
Figure 7 shows images after FIB-milling through cross-sections through impact craters on 7YSZ at (a,b) 500 mN and (c,d) 3000 mN. There is a lighter compacted region extending around 5-15  $\mu\text{m}$  below the impact craters within which no cracks can be observed. At 500 mN cracks formed at or close to the boundary between the compacted region and the region immediately below it, and extended over several columns. Damage at 3000 mN was more extensive with several areas where the columnar structure appears to be broken up into very small fragments.

In the cyclic impact test with the spherical probe there is more compaction than in true Mode I small particle erosion but nevertheless the mechanism appears very similar. Figure 7 clearly shows that the densified layer with sub-surface cracks forming at the intersection of the dense

layer and the un-densified columns, and some additional cracking along the column boundaries. The magnitude of the developed stresses in impact and the position of the von Mises (plasticity) stress maximum below the surface can be estimated from analysis of the impact depth data, for the spheroconical indenter. This analysis shows that large stresses develop below the impact zone, above the yield stress of the TBC, consistent with the presence of the layer of densified/compacted material in the SEM images of the FIB-milled craters. The maximum von Mises stresses were initially around 10  $\mu\text{m}$  below the surface, consistent with the size of the densified zone, and the typical crack depths of 10-15  $\mu\text{m}$  below the surface. Wellman and Nicholls noted that mode II has the effect of densifying the near surface of the coating, conditioning the TBC for later material removal, e.g. through small particle erosion [11]. The SEM images of FIB-milled craters in figure 7 are consistent with this interpretation.
