## **Damage mechanisms in solid particle impact and erosion testing of thermal barrier coatings**

The ability of both cyclic and randomly spatially-distributed impact tests of columnar EB-PVD ceramic thermal barrier coating (TBC) systems with yttria stabilised zirconia (YSZ) and gadolinium zirconate (GZO) topcoats to simulate their behaviour in solid particle erosion tests has been investigated. The impact tests were able to replicate the main mechanisms and surface morphology in the erosion tests although there was more compaction in the impact tests. Densification below impact craters on YSZ and sub-surface cracking between the dense layer and the un-densified columns were revealed by focussed ion beam milling. Cracking over several columns and break-up of the columnar structure was observed in the impact and erosion tests on GZO. Clear differences in TBC erosion rate, with GZO being much less resistant to erosion, were replicated in the cyclic and randomly spatially-distributed micro-impact tests.

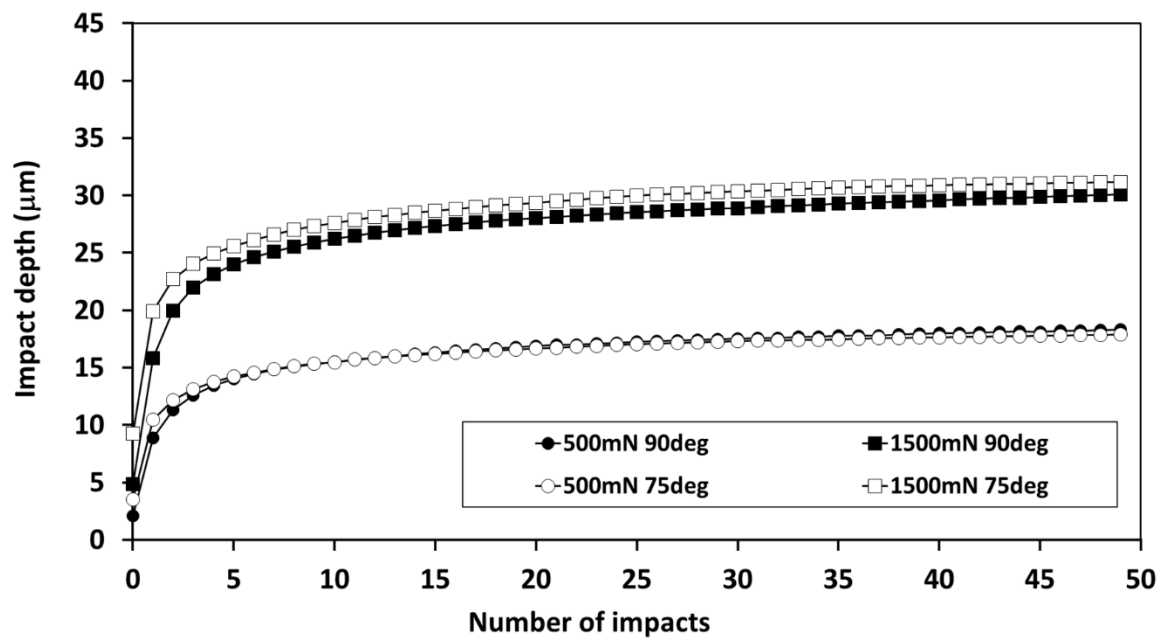
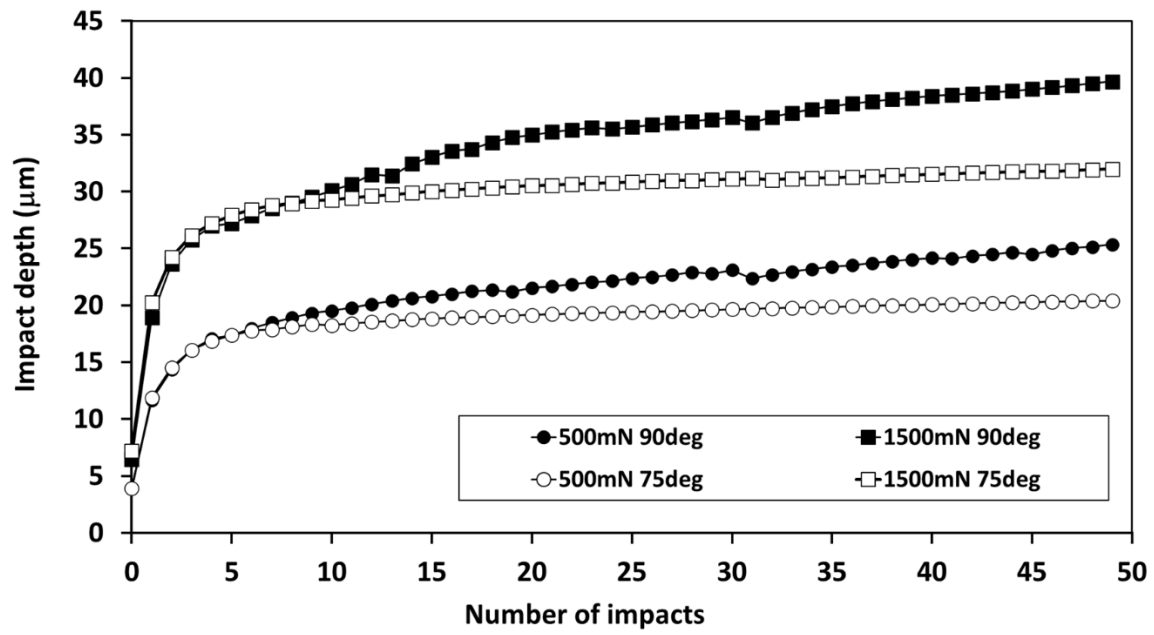
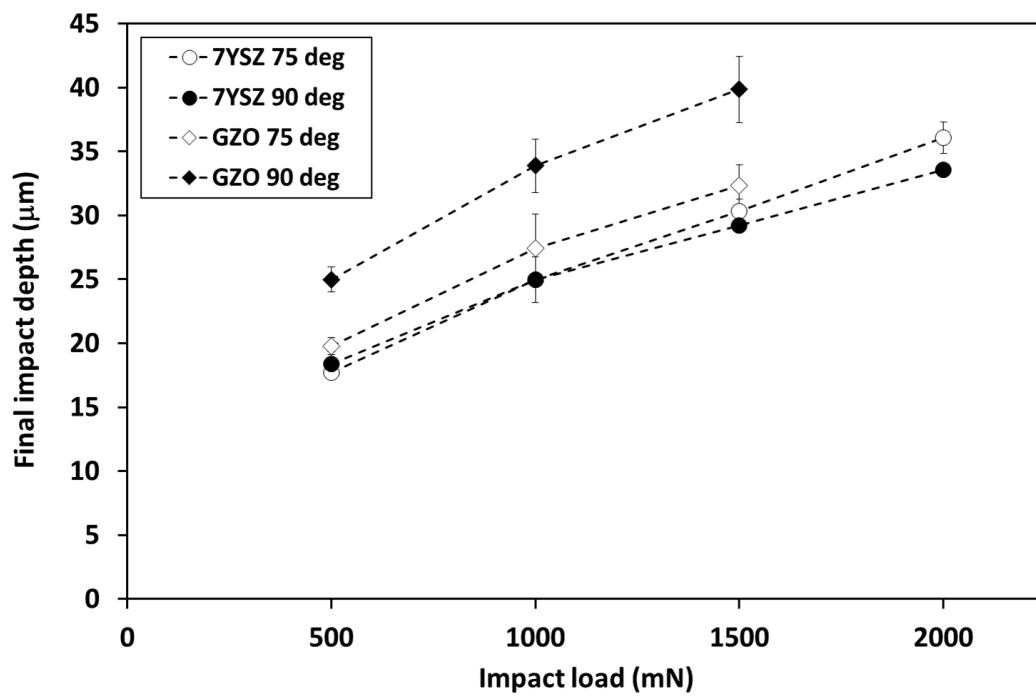
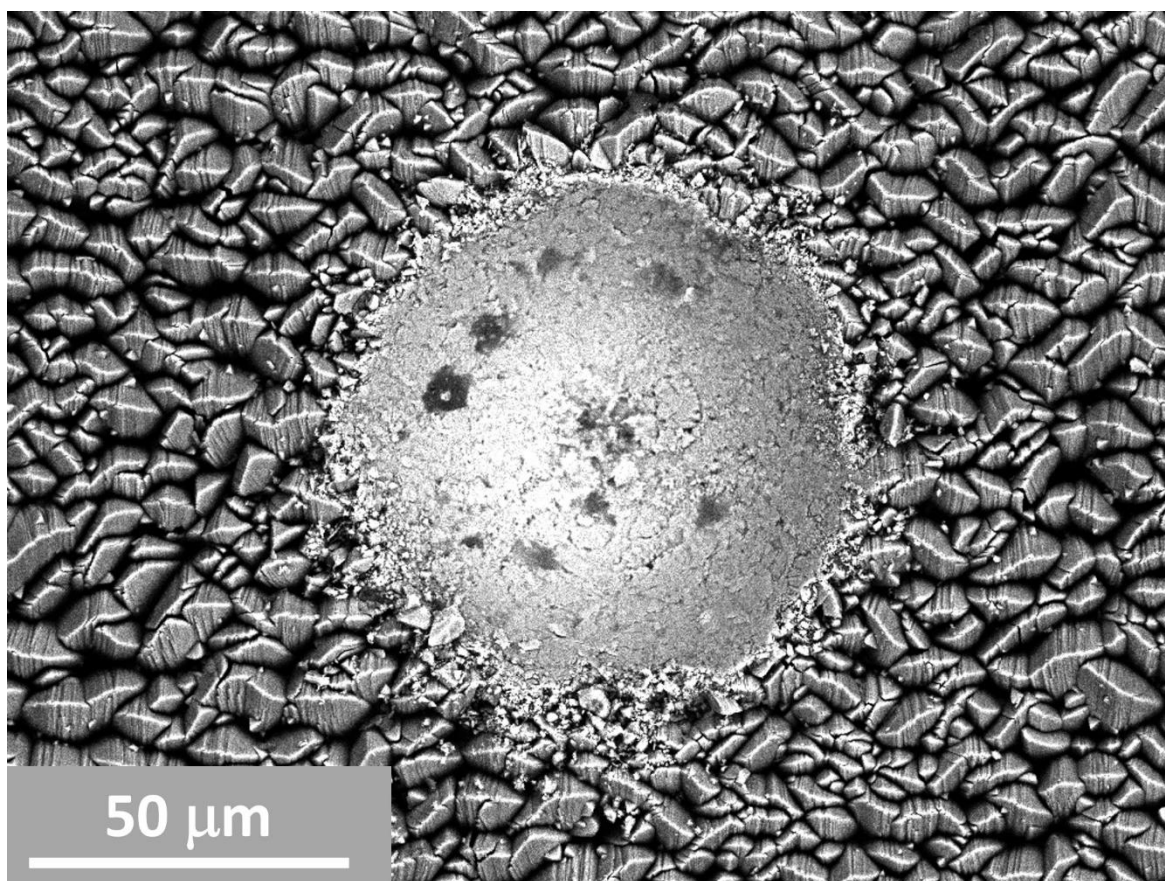
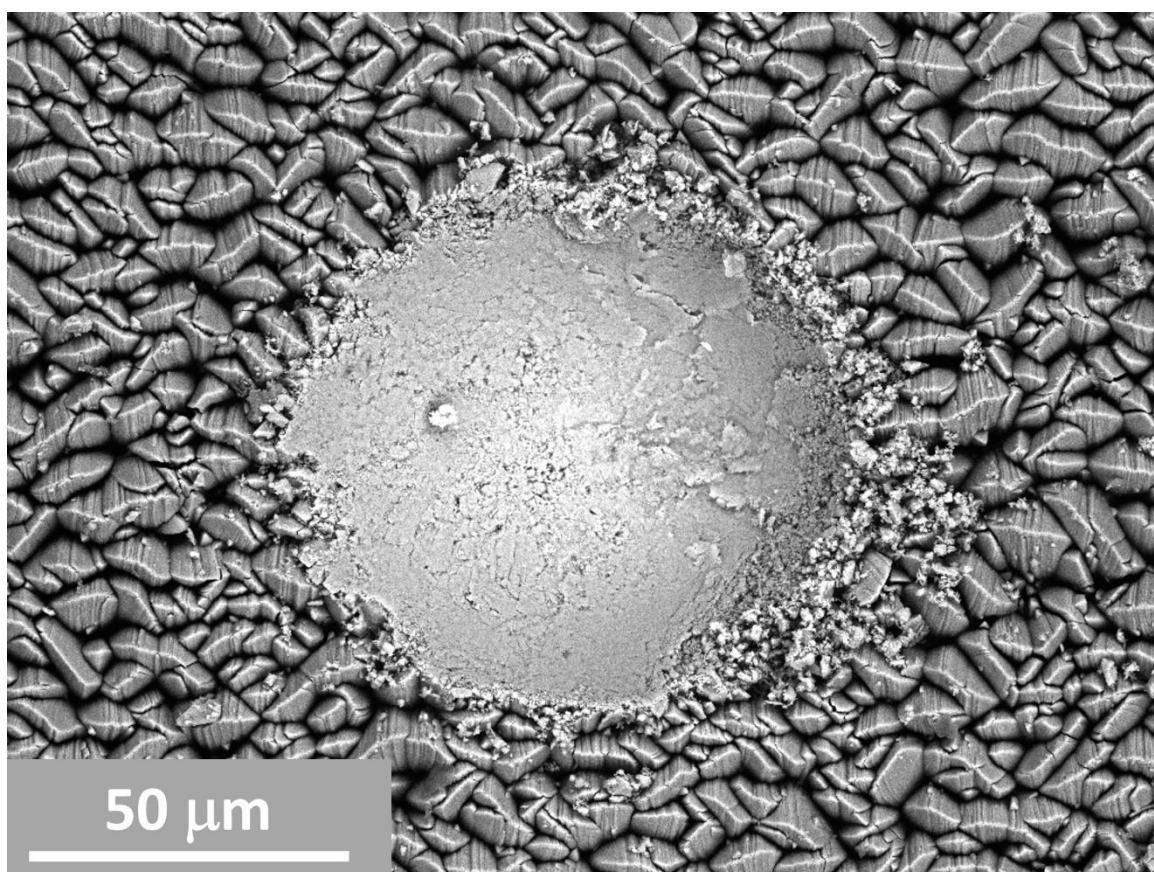
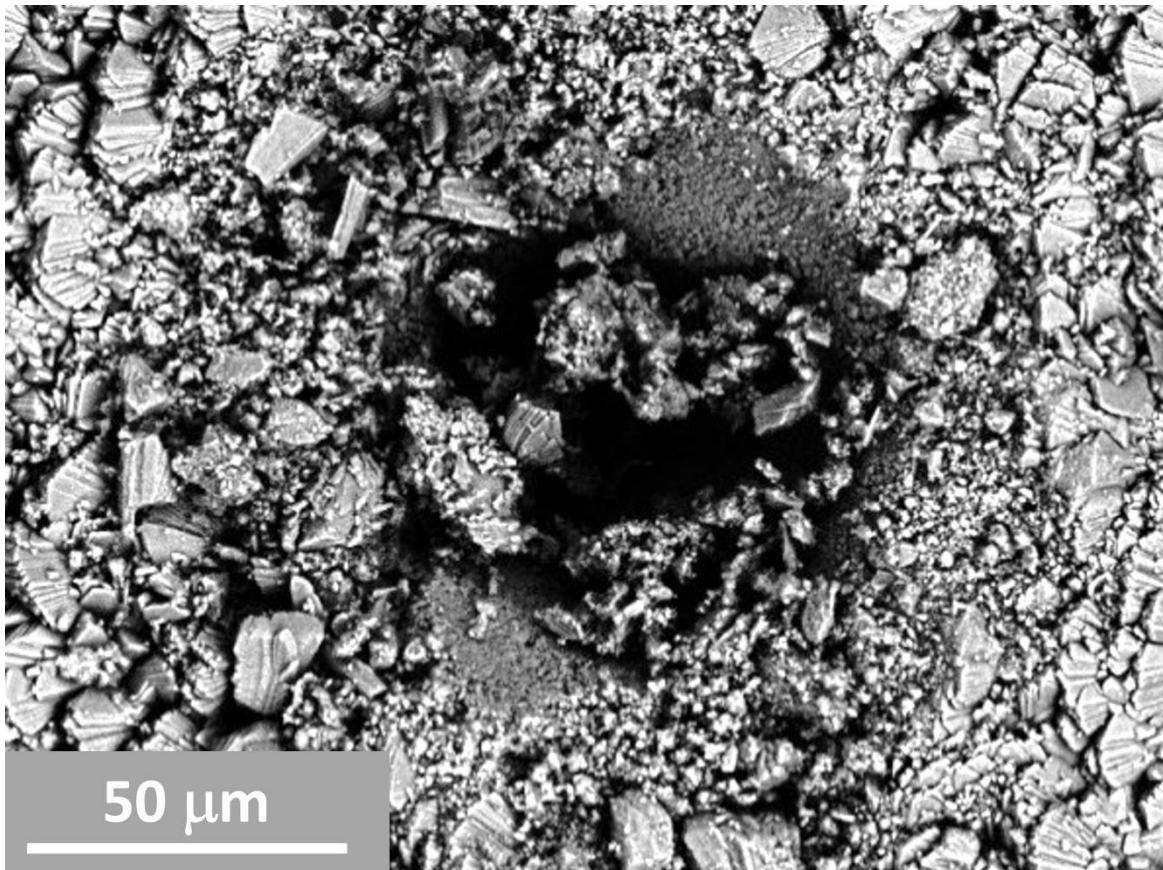
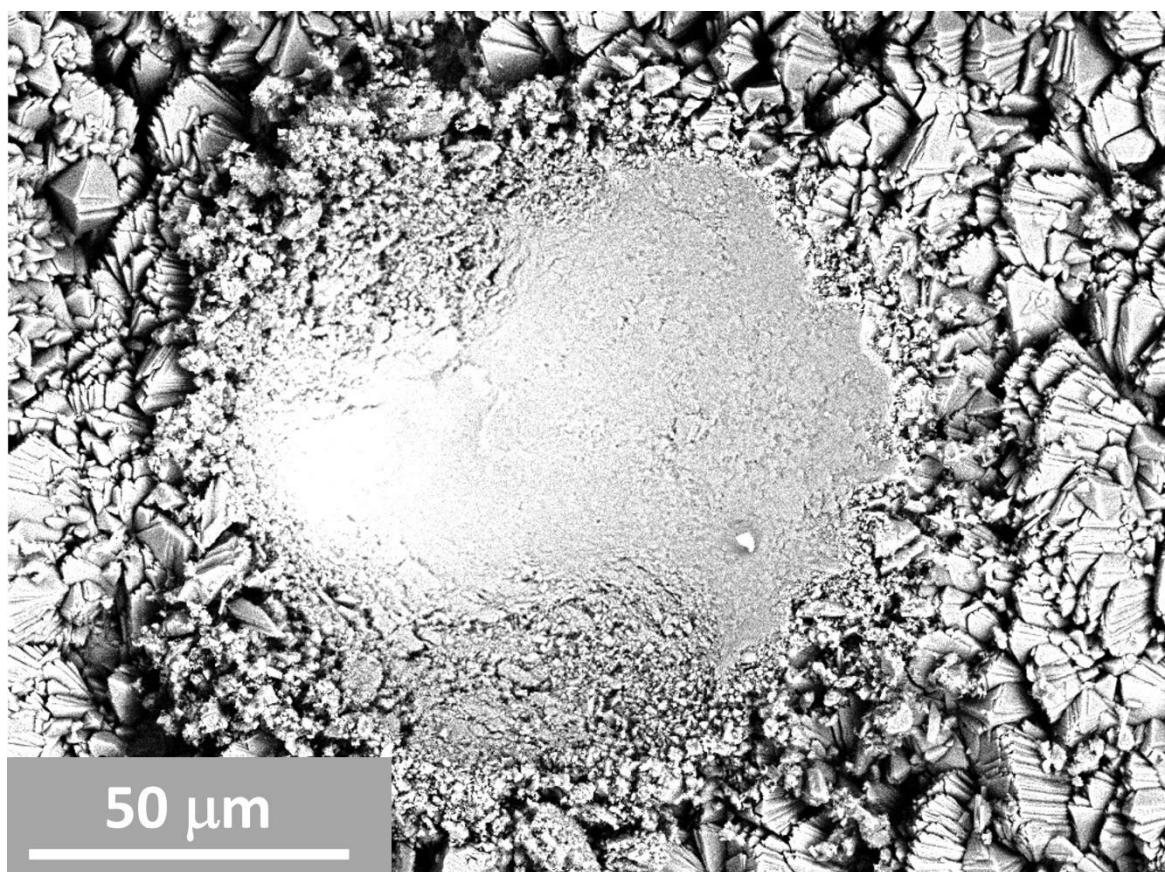
Figure 8 compares typical 500 mN and 1500 mN impact depth vs. number of impacts curves at 75° with typical curves at 90° impact. On 7YSZ (fig. 8(a)) the curves were almost indistinguishable for the two angles. On GZO (fig. 8(b)) they were initially identical at both angles but then started to deviate from each other from ~8 impacts, with the impact damage at 75° being much reduced and the small downward depth steps are absent. Fig. 8(c) shows comparative final impact depth data on both TBCs at 75° and 90°. In the 75° tests on GZO the cracking zone at the periphery was less wide than in the 90° tests. The debris inside the impact craters was only observed in a couple of tests. Comparative images on both TBCs at 1500 mN and both angles are shown in figs. 8(d)-8(g).

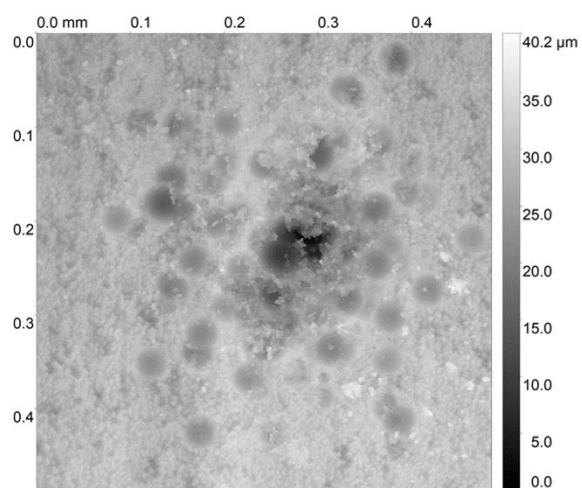
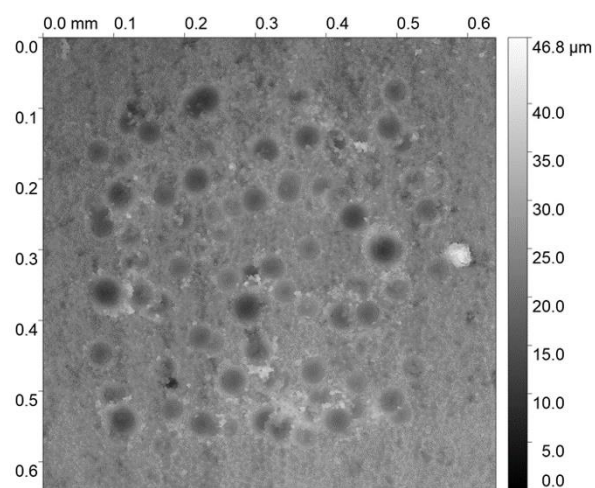
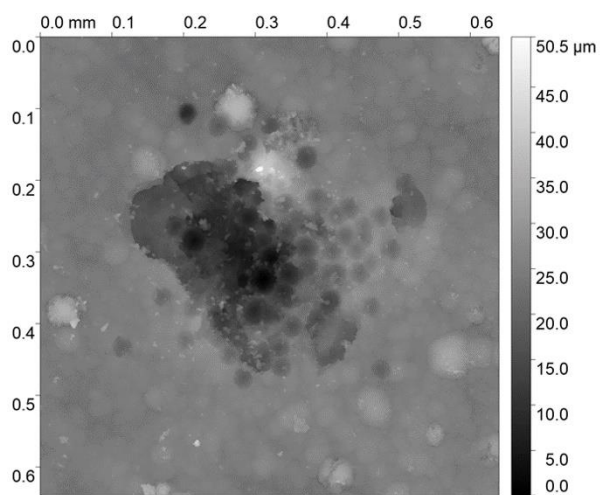
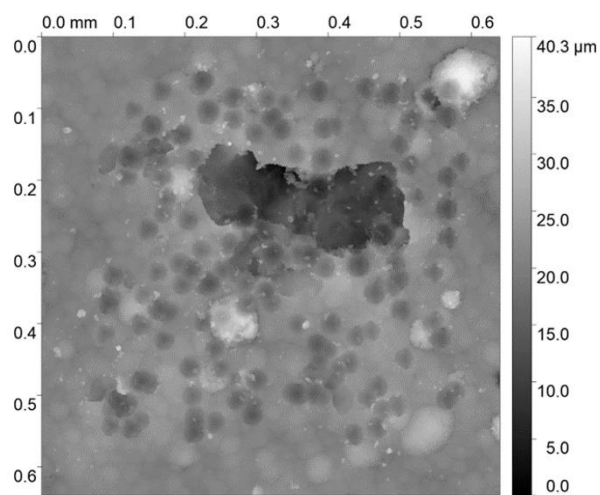
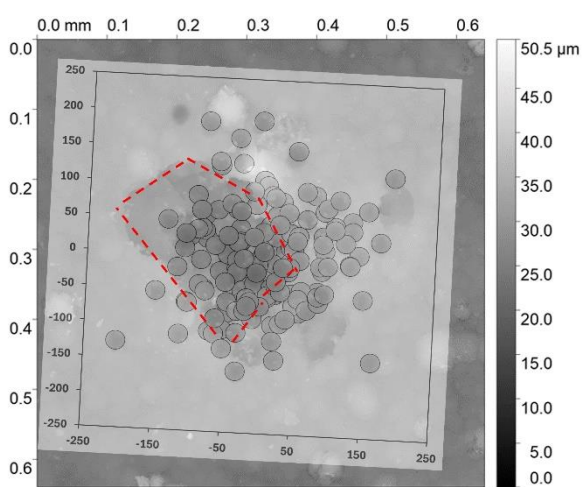
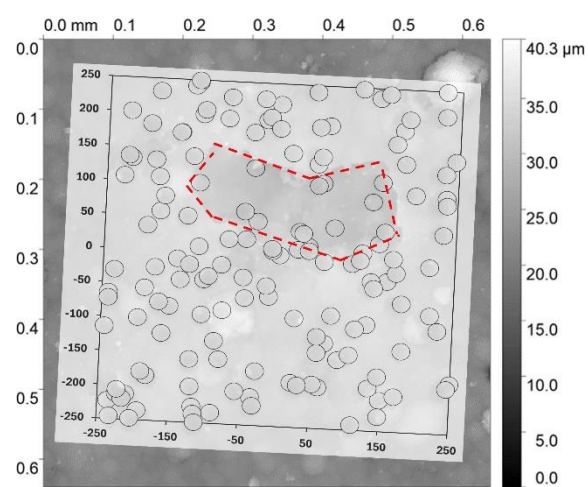
Laser scanning confocal images of the 150-impact random impact experiments at 500 mN are shown in fig. 9. The tests with Gaussian and rectangular distributions on 7YSZ are shown in figs. 9(a) and 9(b) respectively. The tests with Gaussian and rectangular distributions on GZO are shown in figs 9(c) and 9(d) respectively. Fig. 9(e,f) shows the programmed impact positions on GZO overlaid on the confocal images from figs. 9(c) and 9(d) respectively. Comparing the images in figs. 9(a-d) it can be seen that 7YSZ was significantly more resistant to impact damage than GZO. With a Gaussian distribution there was greater damage near the central point on 7YSZ. On GZO (fig. 9(c,d)) there was an extensive region with more material removal in the tests with rectangular and Gaussian distributions. Laser scanning confocal images of the 150-impact random impact experiments on GZO at 1000 mN are shown in figure 10. In comparison to the tests at 500 mN the central region with greater coating loss extended further over the test region. Fig. 10(c) shows laser scanning confocal microscopy and fig 10(d) BSE SEM images of the test on GZO with a Gaussian distribution. A higher resolution BSE SEM image of the central region is shown in fig. 10(e). The columnar structure has been completely

the distributions of the impacts against the LEXT images (figs. 9(c,d)), it can be seen that, although the heavily fractured areas can be associated with higher impact densities, there are also fractured areas with little/no impacts in the vicinity. The 500 mN rectangular distribution test on GZO shown in figure 9(d) is an example. There are heavily fractured regions where the nearest impact site was  $>50\text{ }\mu\text{m}$  away which indicates cracking from one column is extending over several columns (i.e. the same major material removal mechanism as in erosion). FIB-milled sections through damaged regions in randomly spatially-distributed impact tests at 500 mN on GSZ (fig. 13(c)) also show the sub-surface cracking across several columns and detachment. SEM images of the edge of the eroded region on 7YSZ where the impact density is much lower show some compaction and flattening of the tops of the columns (fig. 14(b,c)) as is observed in the micro-impact tests.

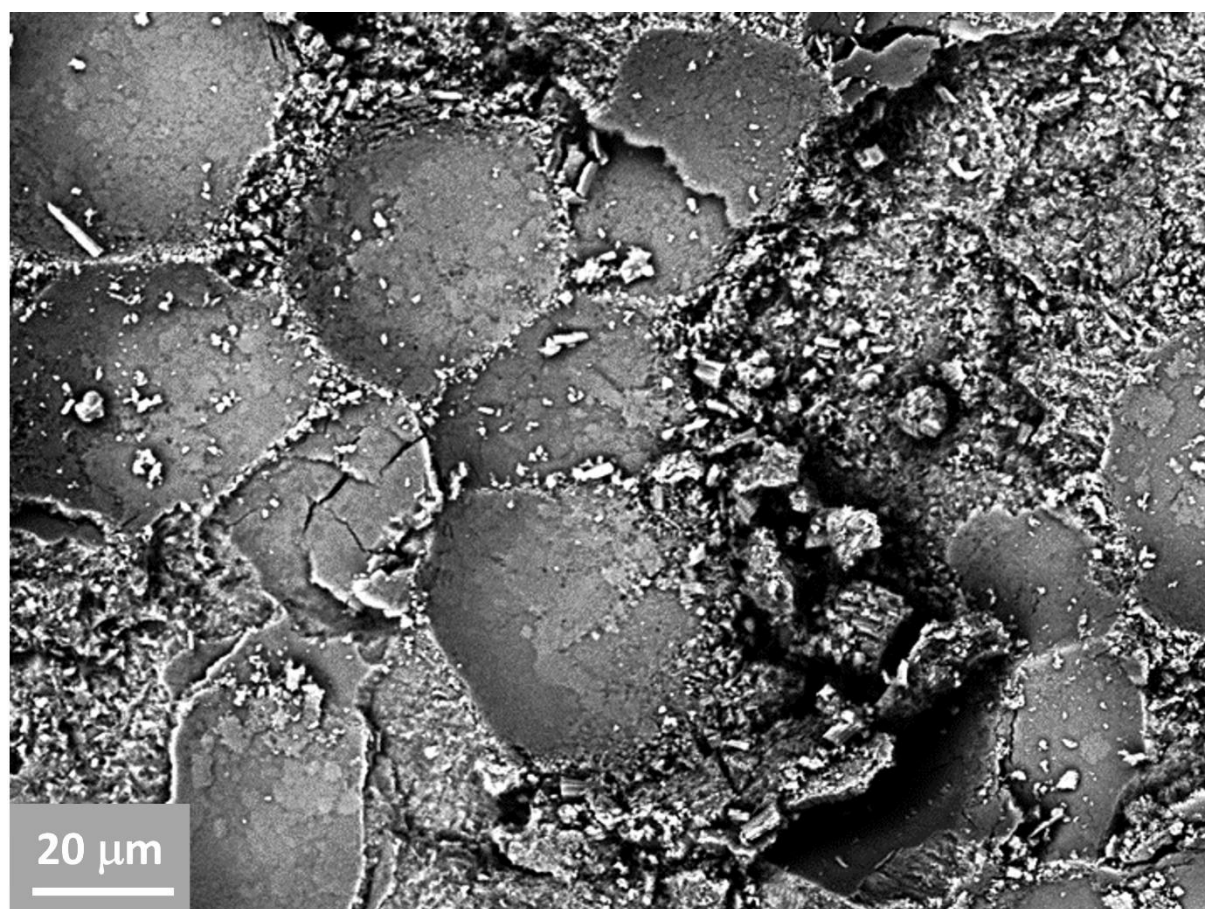
10(e).

broken down into fine-scale fragments. There is evidence of fracture in the base of some impact craters. Table 1 shows the volume lost determined from the laser scanning confocal measurements.

SEM images of the GZO surface (figs. 10(d,e) and 14(a)) show very similar fine-scale debris from complete break-up of the columns after erosion and micro-impact tests. We have previously shown that the columnar structure on GZO is broken into progressively smaller fragments by continued impacts [22] and that only the craters left by the final impacts are observed since most of the previous impact craters are covered by impact debris. By overlaying

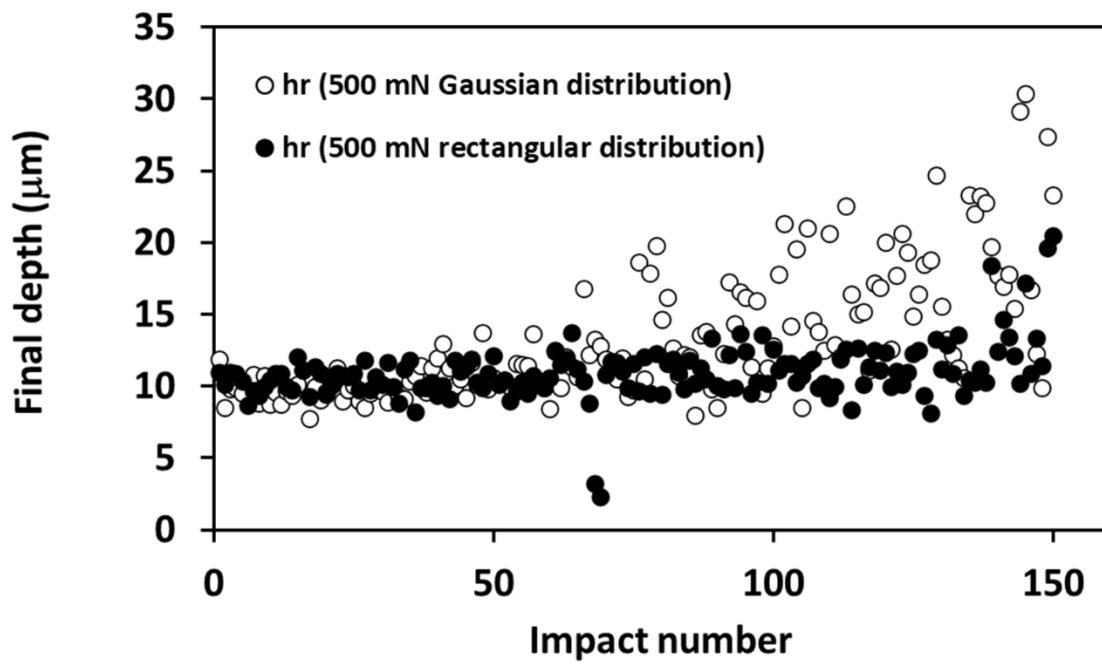
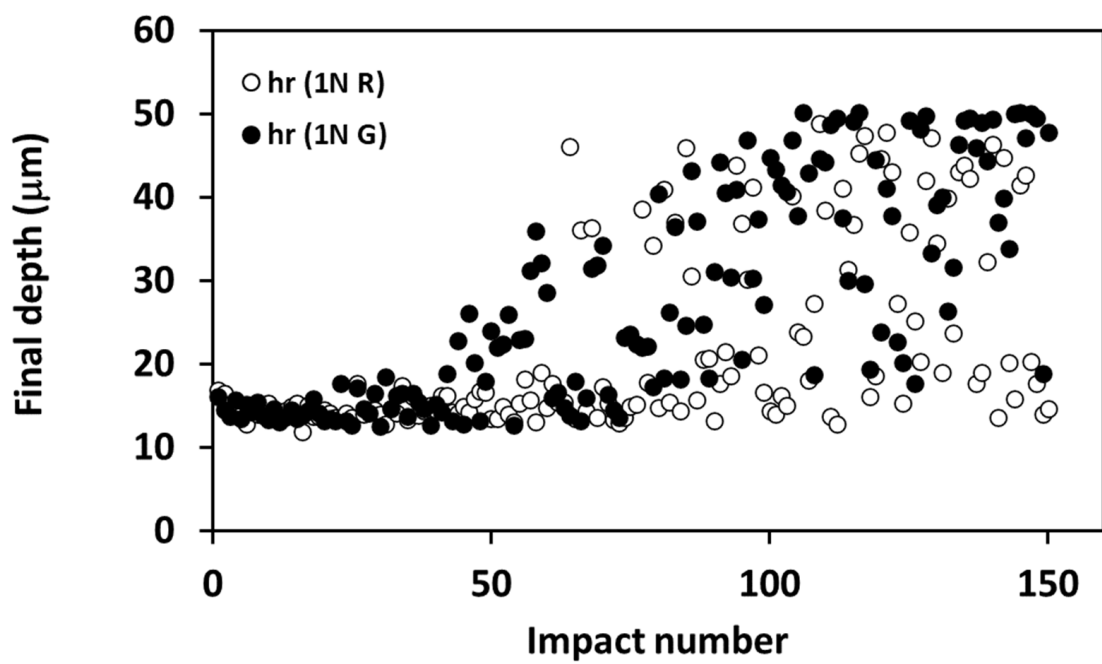
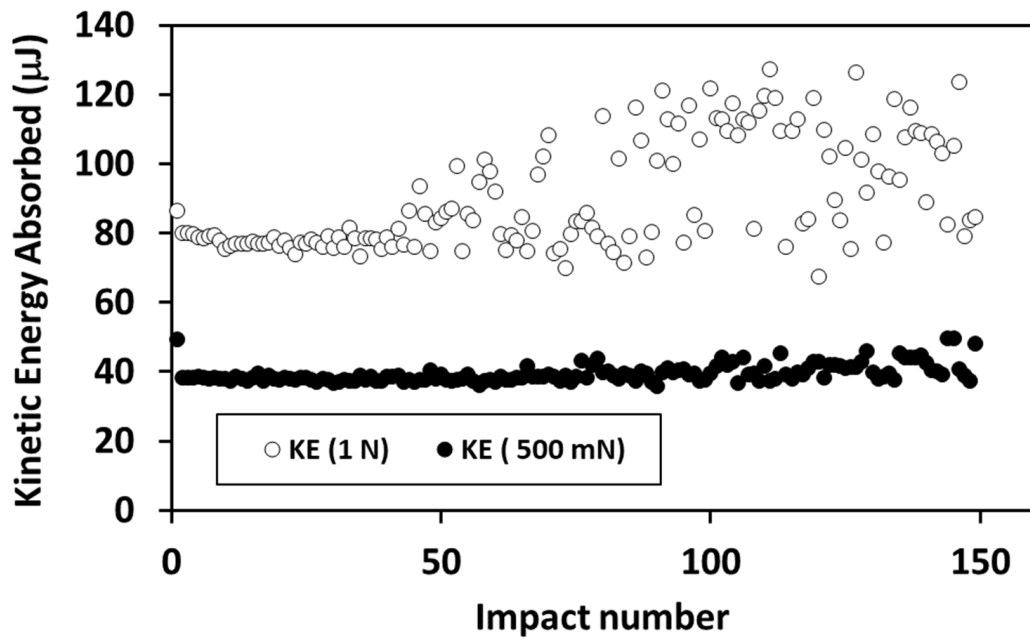
The variation in final depth with number of impacts in the tests on GZO is shown for 500 mN and 1000 mN in fig. 11(a) and (b) respectively. At both loads the transition to a more severe damage regime occurred more quickly in the tests with the Gaussian distribution. In the Gaussian distribution test at 1 N the more severely damaged region extended over less of the test area than for the rectangular distributions, resulting in a lower wear volume.

kinetic energy absorbed was more sensitive to the transition to more severe wear. Fig. 11(c) shows the *KE* absorbed for the tests on GZO at 500 and 1000 mN with Gaussian distributions.

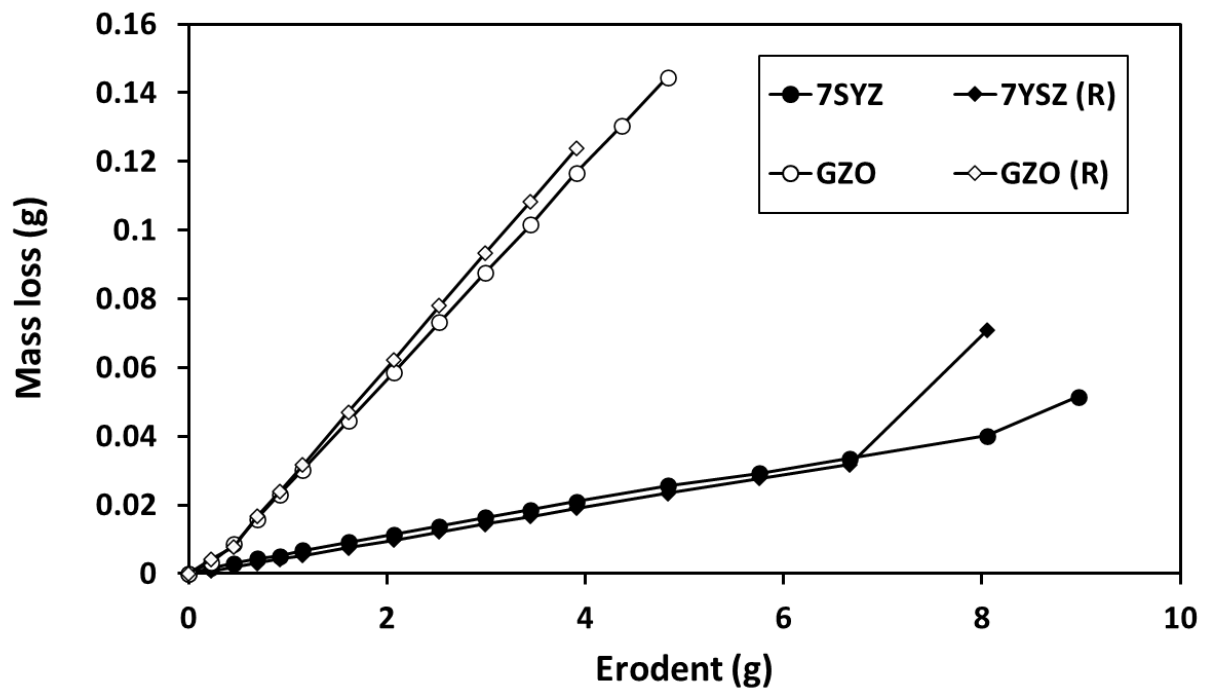
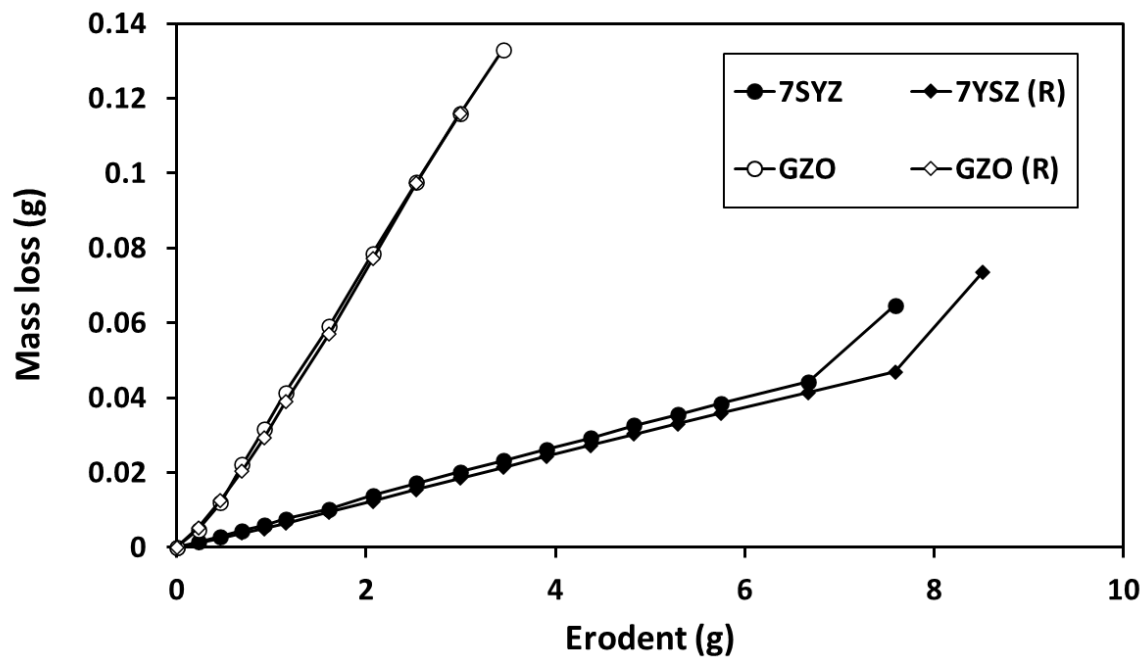
12. Mass loss in erosion tests with (a) angular and (b) spherical alumina particles. Two tests were performed for each set of conditions (R in the figure legends signify the repeat tests).

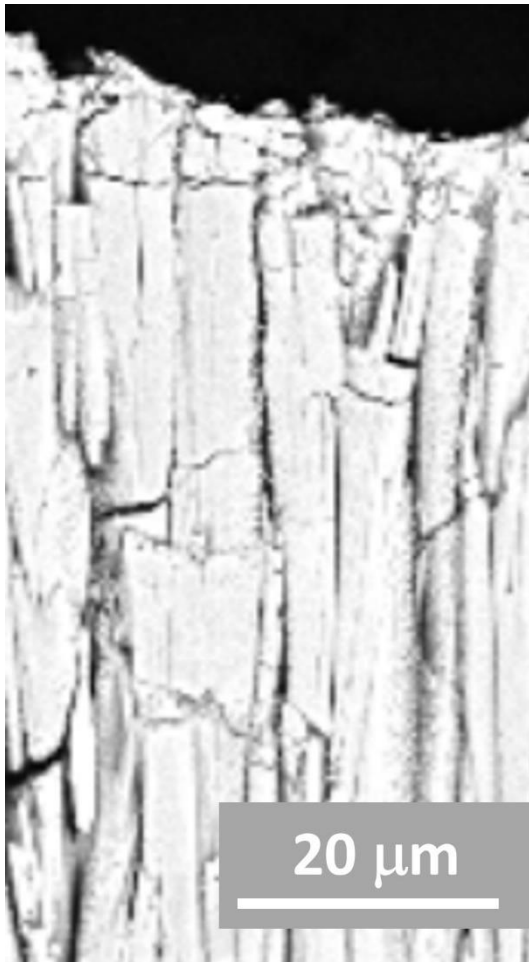
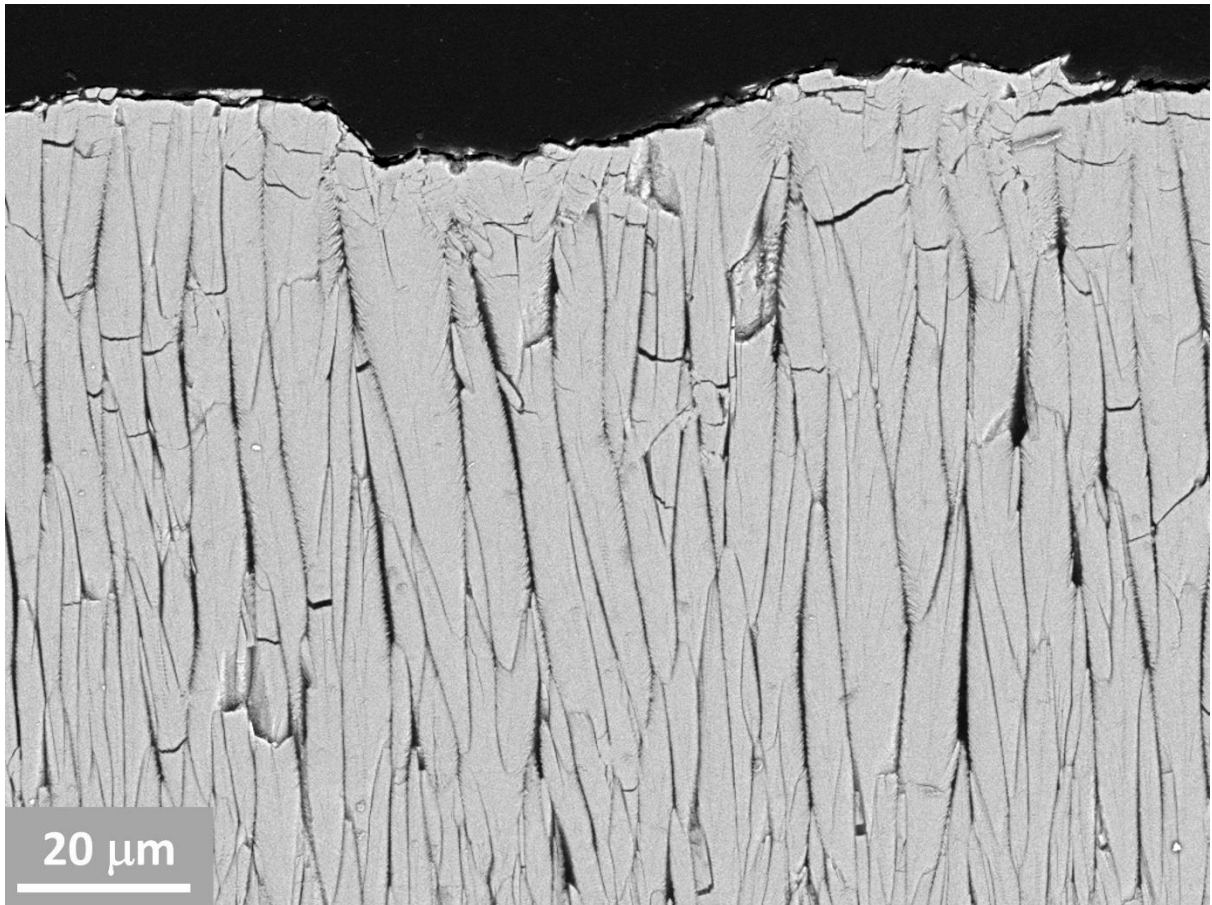
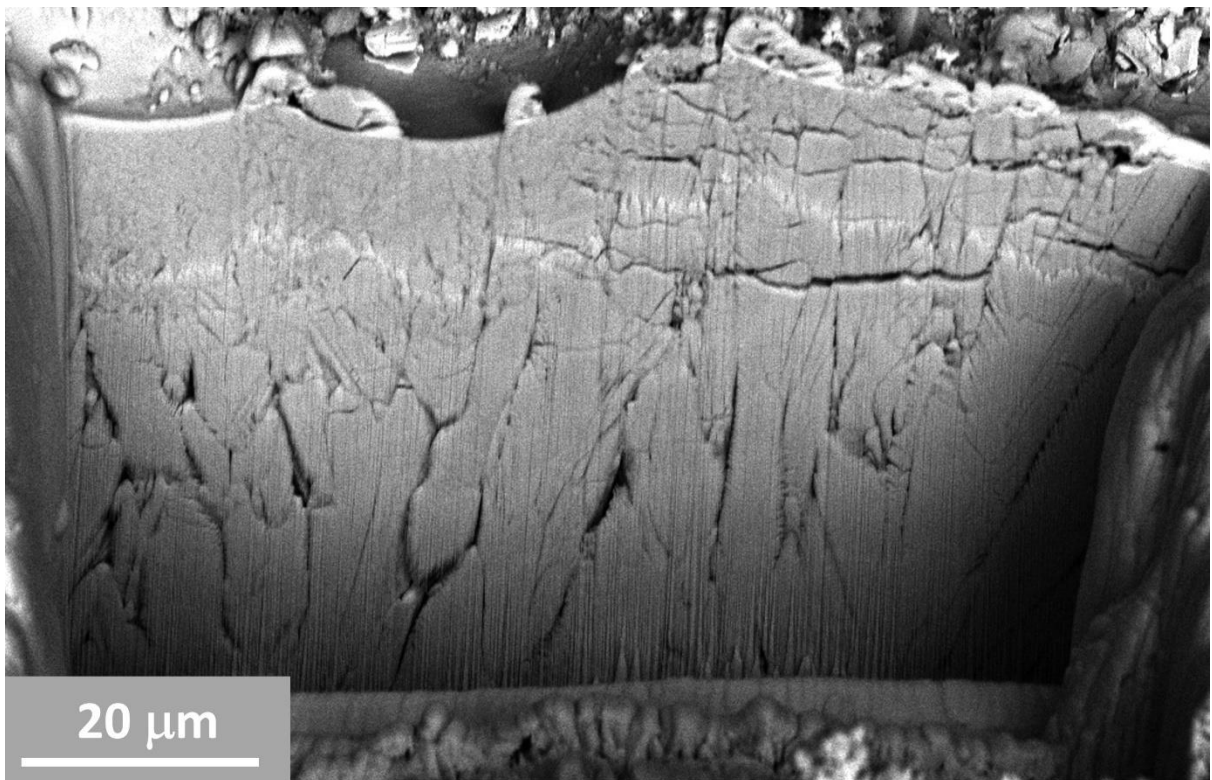
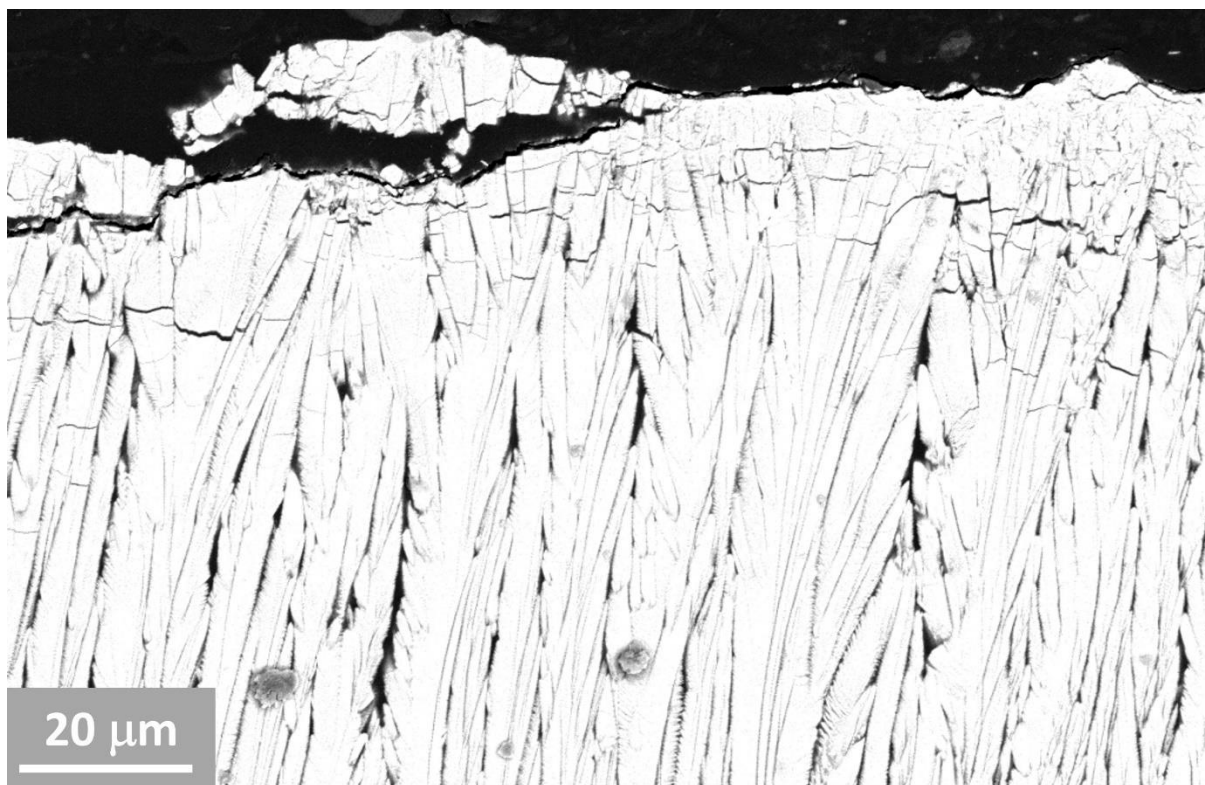
SEM images of cross-sections of the eroded 7YSZ show evidence of cracking between columns in the tests with angular (fig. 13(a,b) and spherical (fig. 13(c)) alumina erodent. Near the region where the coating has spalled off there is evidence of a more severe damage mode with complete destruction of the columnar structure.

Although top views of cyclic impact craters on 7YSZ (e.g. fig. 6a,b) show little differences in mechanism with load, the FIB-milled sections show the median/lateral cracking seen in the eroded samples (fig. 13(a,b)), and in previous studies [6]. Since the predominant cracking is parallel to the surface Wellman and Nicholls [6] proposed a mechanism where (i) on initial loading a region of inelastic deformation (possibly densification) forms surrounded by elastic deformation (ii) on unloading the elastic region is prevented from relaxation due to constraint from the inelastic region (iii) there is resultant tensile stress and cracks initiate parallel to the surface. The 7YSZ TBC has ~50% of the theoretical density so inelastic deformation is likely to be densification (compaction) of the columns [6].

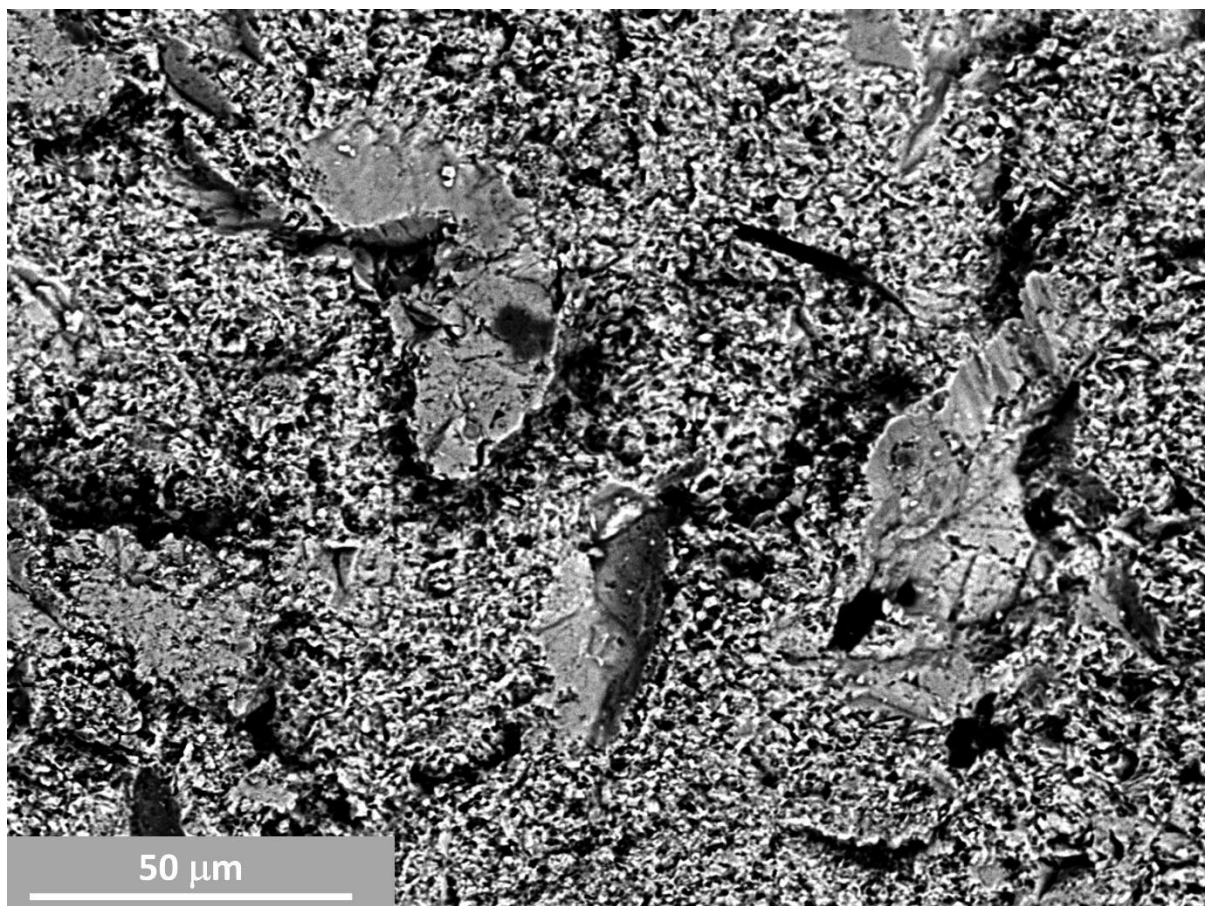
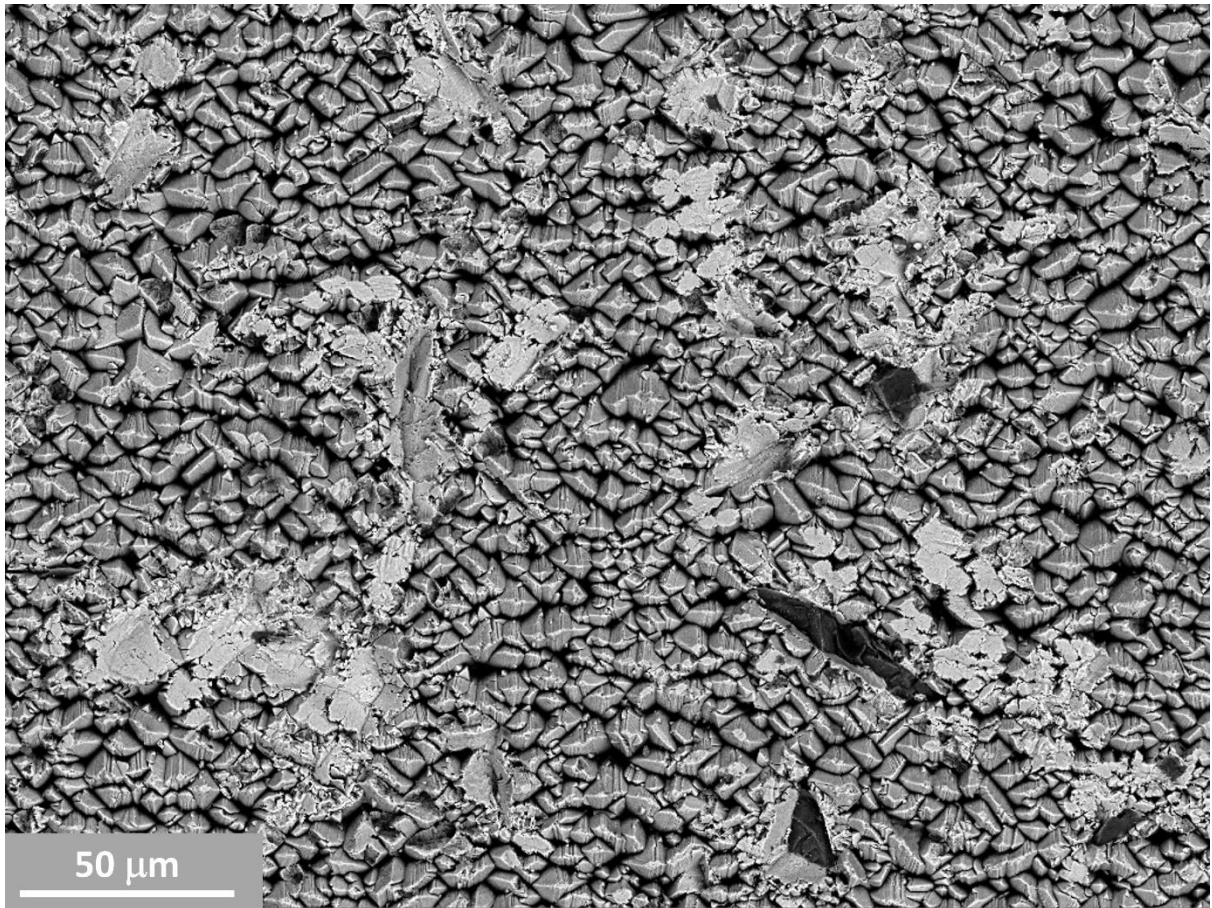
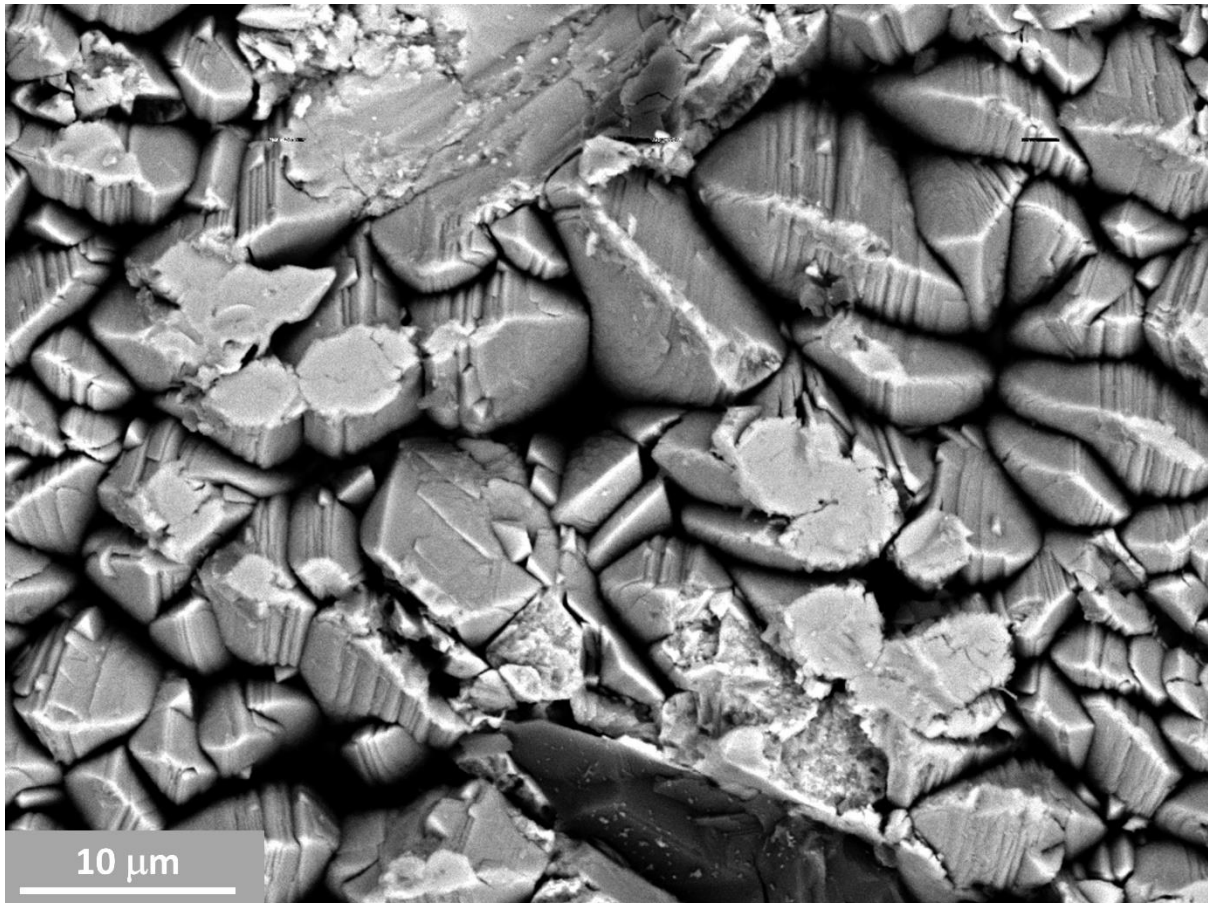
Fig. 14(a) shows the top-surface of GZO eroded by angular alumina. The GZO surface appeared similar after spherical and angular alumina erosion. The top surface of 7YSZ at the edge of the eroded region (fig. 14(b) and (c)), where the impact density was lower, shows evidence of compaction with the tops of the columns squashed, accompanied by some fracturing.

14. SEM images of the top-surface of eroded TBCs (a) GZO (b,c) 7YSZ at the edge of the eroded region.
15. Load dependence of (a) initial and (b) final impact volume in cyclic impact tests.
