## **Damage mechanisms in solid particle impact and erosion testing of thermal barrier coatings**

The ability of both cyclic and randomly spatially-distributed impact tests of columnar EB-PVD ceramic thermal barrier coating (TBC) systems with yttria stabilised zirconia (YSZ) and gadolinium zirconate (GZO) topcoats to simulate their behaviour in solid particle erosion tests has been investigated. The impact tests were able to replicate the main mechanisms and surface morphology in the erosion tests although there was more compaction in the impact tests. Densification below impact craters on YSZ and sub-surface cracking between the dense layer and the un-densified columns were revealed by focussed ion beam milling. Cracking over several columns and break-up of the columnar structure was observed in the impact and erosion tests on GZO. Clear differences in TBC erosion rate, with GZO being much less resistant to erosion, were replicated in the cyclic and randomly spatially-distributed micro-impact tests.

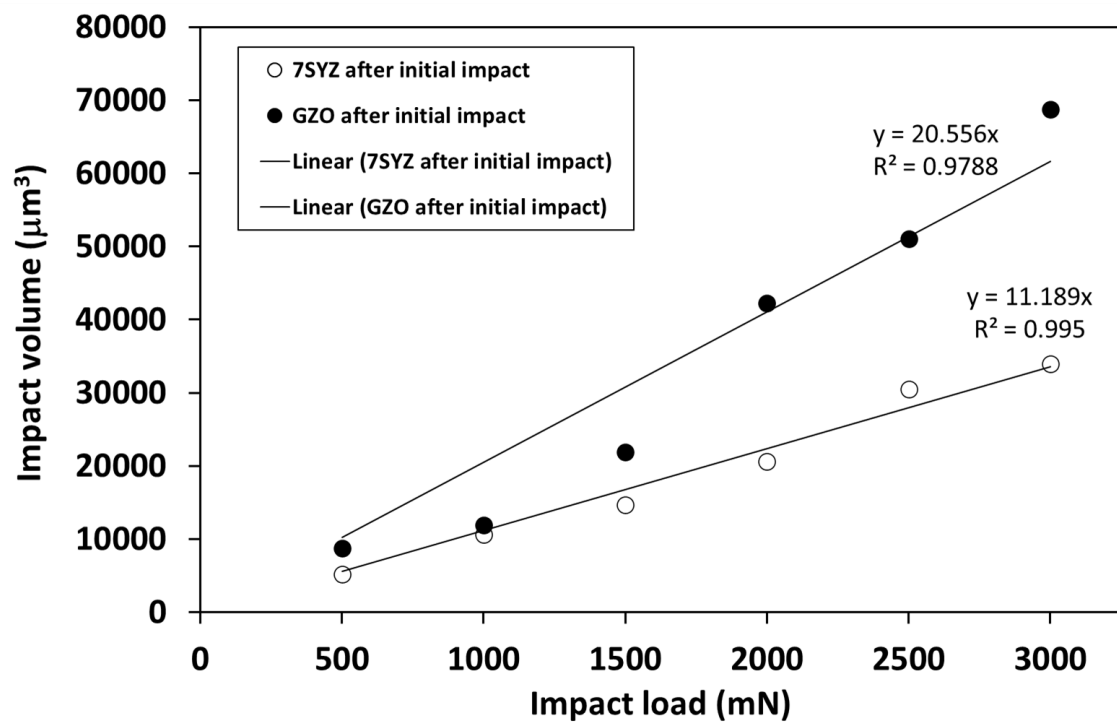
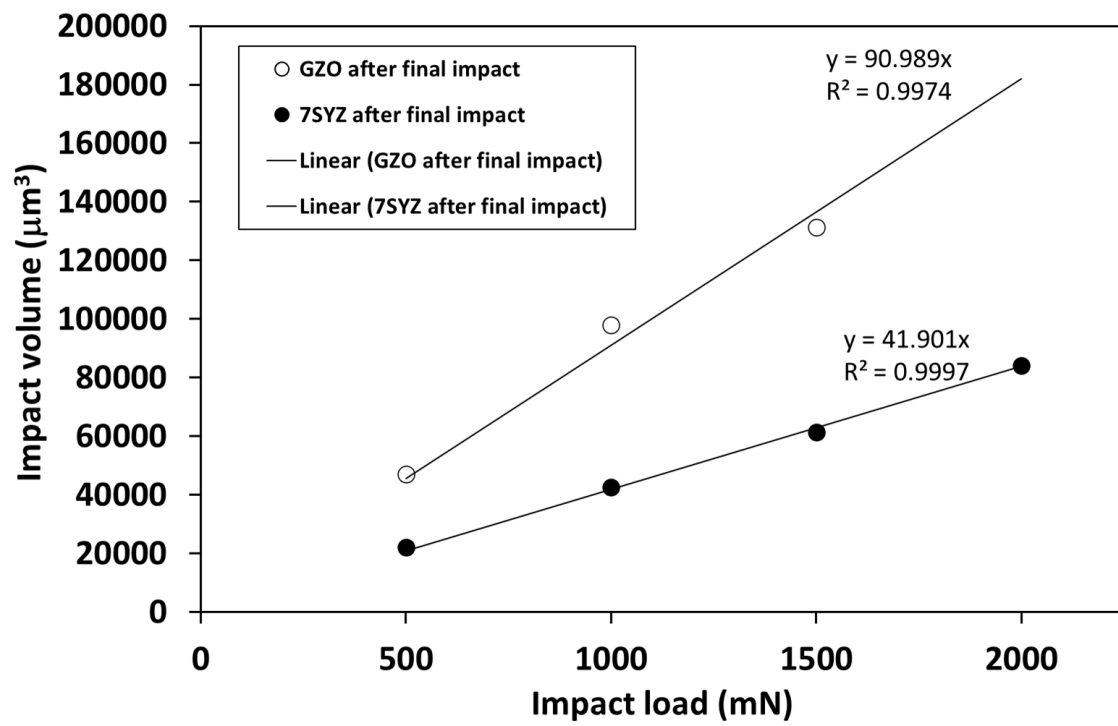
14. SEM images of the top-surface of eroded TBCs (a) GZO (b,c) 7YSZ at the edge of the eroded region.
15. Load dependence of (a) initial and (b) final impact volume in cyclic impact tests.

Linear fitting to the data for volume of material removed at the end of the nano- and micro-impact tests vs. the applied load was used as an estimate of erosion rate. The volume of material removed in cyclic micro-impact tests was lowest for 7YSZ at  $90^\circ$  impact, and was a factor of 2.2 higher for GZO under the same conditions. For YSZ there was around 10% more material removal at  $75^\circ$  impact than at  $90^\circ$ . For  $75^\circ$  GZO there was around 50% less material removal at  $75^\circ$  impact than at  $90^\circ$ , with these differences in angle dependence being consistent with the GZO being more brittle. In the statistically distributed tests at 500 mN GZO was a factor of 2.1 worse than 7YSZ in the rectangular distribution and a factor of 2.9 worse in the test with a Gaussian distribution. In the nano-impact tests GZO was a factor of 1.9-3.3 less erosion resistant than 7YSZ although due to the larger effect of the high surface roughness at smaller length scale the volume calculation has higher uncertainty with more scatter and a less obvious linear fit. The same approach to estimate impact volume from depth data has been applied to the nano-impact data of Venkatesh and co-workers on chromium carbide-based coatings [16].
