## **Diagnostics and prognostics with Acoustic Emission, Vibration and Spectrometric Oil Analysis for spur gears; a comparative study**

Whilst vibration and spectrometric oil analysis for gear fault diagnosis are well established, the application of AE to this field is still in its infancy. This paper describes an experimental investigation on spur gears in which natural pitting was allowed to occur. Throughout the test period, AE, vibration and spectrometric oil samples were monitored continuously in order to correlate and compare these techniques to natural life degradation of the gears. It was observed that the AE technique was the most sensitive in detecting and monitoring pitting.

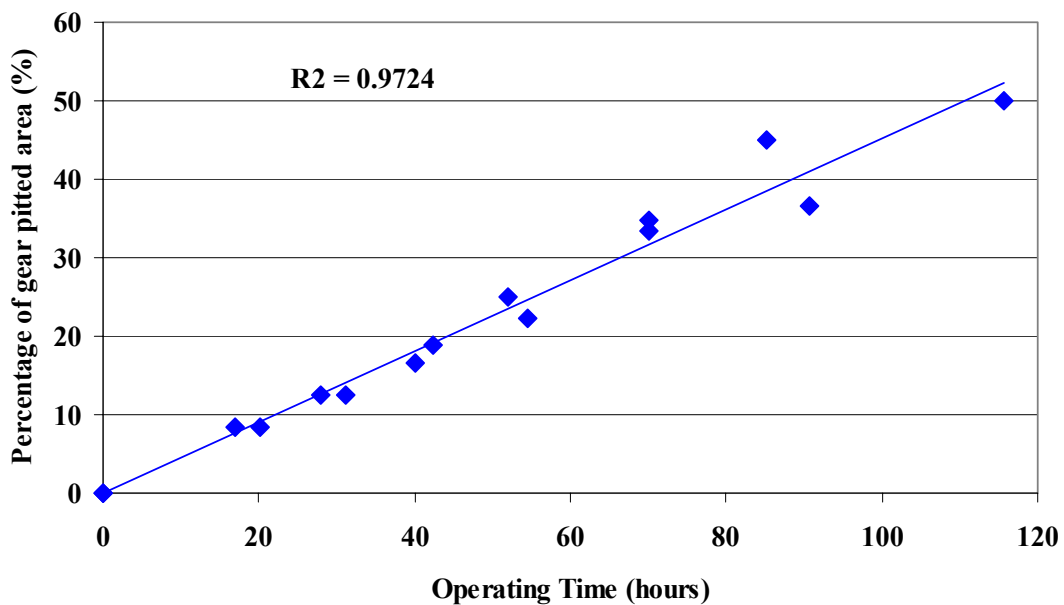
Figure 1 shows percentage of the gear surface pitted area plotted against the test operating time. A linear model was fitted to the acquired data with a correlation coefficient value ( $R^2$ ) of 0.9724. Figure 2 shows results of AE r.m.s levels from the sensor on the pinion gear plotted against percentage of pinion gear pitted area. The relationship between AE levels and level of pitting was linear. It can also be seen that despite the application of the same torque, both tests had different AE r.m.s values at 10% pitting though the gradient of progression from 10% pitting was nearly identical. The authors attribute the difference in AE r.m.s levels to the assembly of the rig during

**Figure 1**      **Pitting rates of the test gears under 220Nm at 745 rpm**

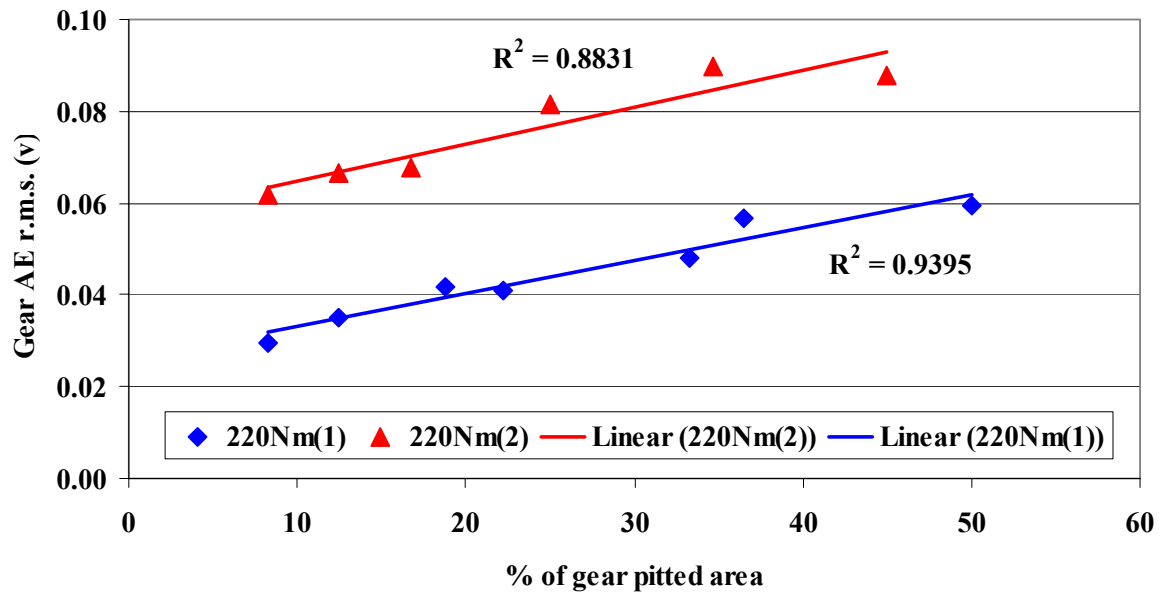
Figure 2 AE r.m.s plotted against % gear surface area pitted; 220 Nm, 745 rpm

installation of the second test gear. The authors cannot guarantee that the exact positioning of the gear wheels and clearances within the gearbox were identical for each test condition; best practice was followed. Figure 3 shows a plot of pinion bearing AE r.m.s levels versus the percent pinion gear pitted area illustrating an exponential relationship between AE levels and percentage of gear pitted area. It should be stated that the average attenuation from the gear face to the bearing casing was measured at approximately 35dB. However, as observed by Toutountzakis et al [7] the attenuation value does vary significantly. Figure 4 was taken from Toutountzakis' report [7] which shows the AE response acquired simultaneously from the sensors mounted on the pinion gear and bearing casing; the variation in attenuation values is evident. The reason for this was attributed to the position of the bearing ball/roller elements during rotation. Toutountzakis employed the same test-rig as the authors.

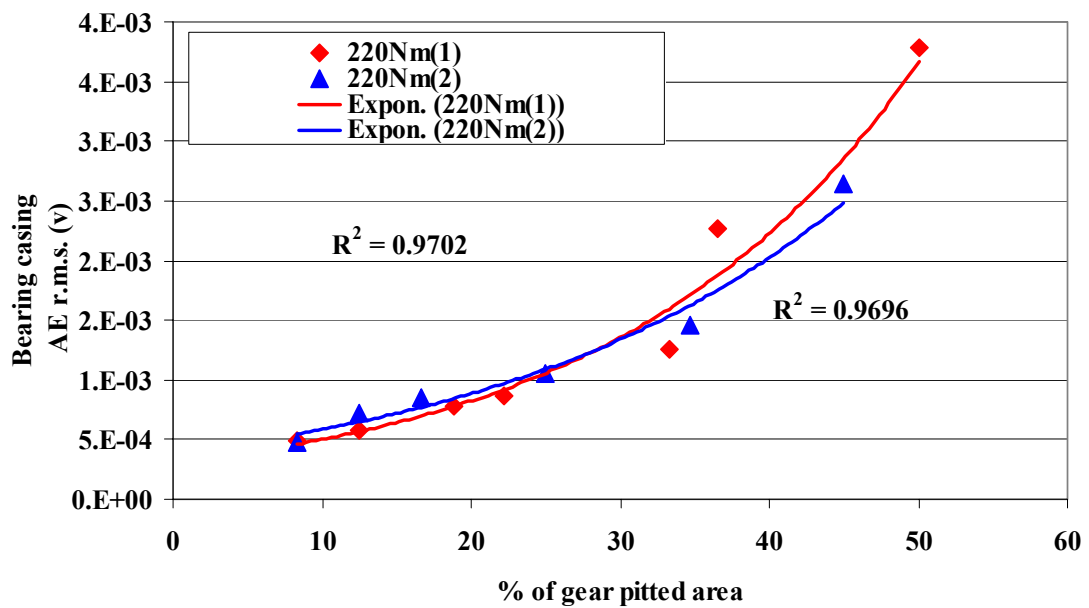
Figure 3 Bearing casing AE r.m.s against % gear surface area pitted; 220 Nm, 745 rpm

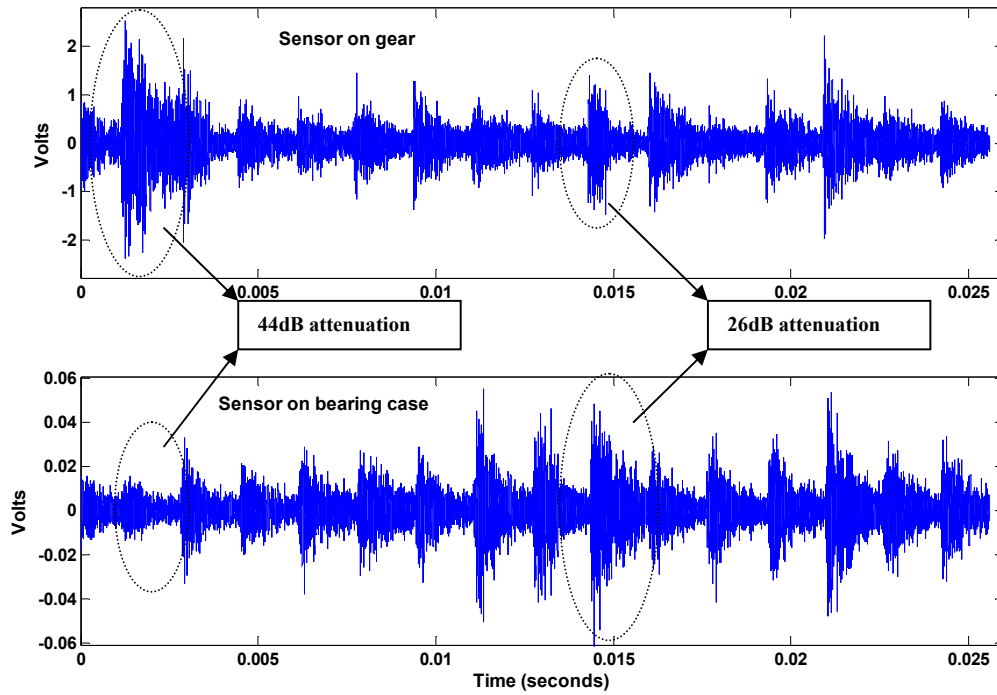
**Figure 4** Variation in AE attenuation levels between pinion gear and bearing casing [7]

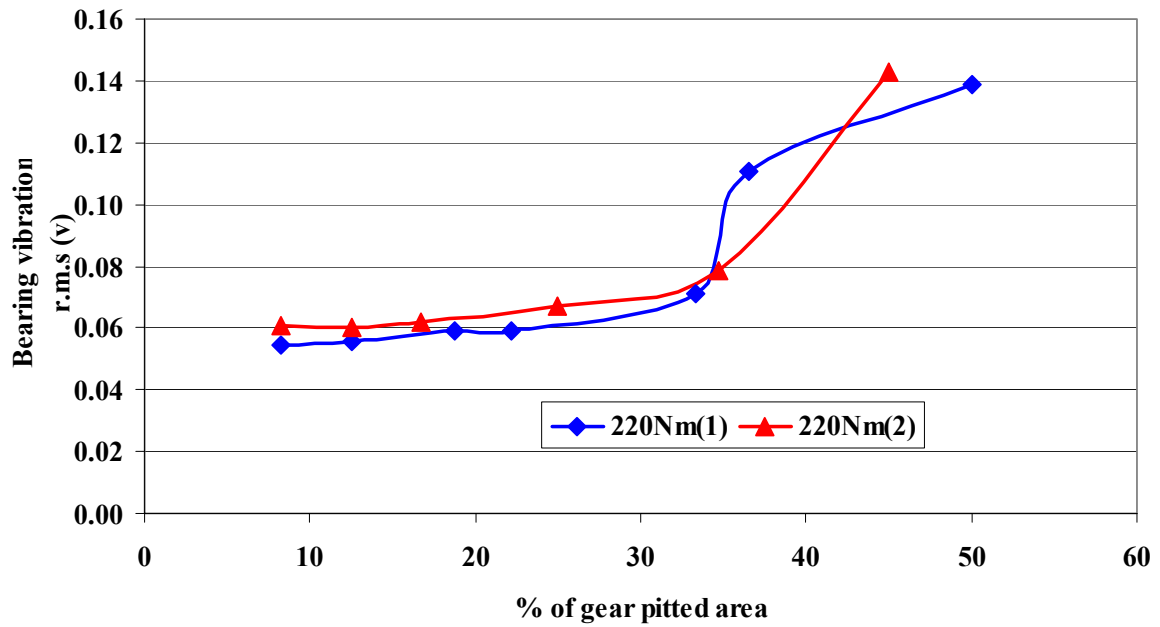
Figure 5 shows vibration r.m.s values plotted against percentage of pitted area. Vibration levels remained relatively constant until 30% pitted area, after which levels rose steadily. Results from the SOA analysis, figure 6, were inconclusive; whilst ‘test 1’ indicated a possible linear relationship between Fe concentration and percentage pitted area ‘test 2’ showed a similar pattern to vibration results; relatively constant Fe concentration until just after 30% pitted area when levels steadily increase. Interestingly, the experiments revealed pitting occurred from the dedendum and moved towards the pitch-line, figure 7 show a heavily pitted (42% surface area) gear.

Figure 5 Vibration r.m.s against % pitted area; 220 Nm, 745 rpm

It was observed that AE r.m.s levels measured from the pinion and bearing casing showed increasing levels with increased pitting area which was not necessarily the case for vibration and SOA observations. This emphasised the sensitivity of the AE technique. From vibration results a plateau was observed for the vibration r.m.s until the gear surface pitted area increased to approximately 30%, see figure 4. This showed that vibration technique was unable to monitor the pit growth process until the pit development was advanced. Hence at this point, it can be concluded that the AE technique has an advantage over the vibration technique in terms of pit growth monitoring. The reason for the delayed increase in vibration also confirms that the changes in stiffness only occur at high levels of surface damage [12]. For SOA monitoring the levels of Fe concentration in the two tests differed by as much as 100% for a pitted area of 35%. Moreover, the relationship between the FE concentration levels and pitted area differed significantly for the two tests. This was rather disappointing and suggests that SOA may be able only to provide approximate indications of current gear level damage and unable to form the basis of a prognostic monitoring system.

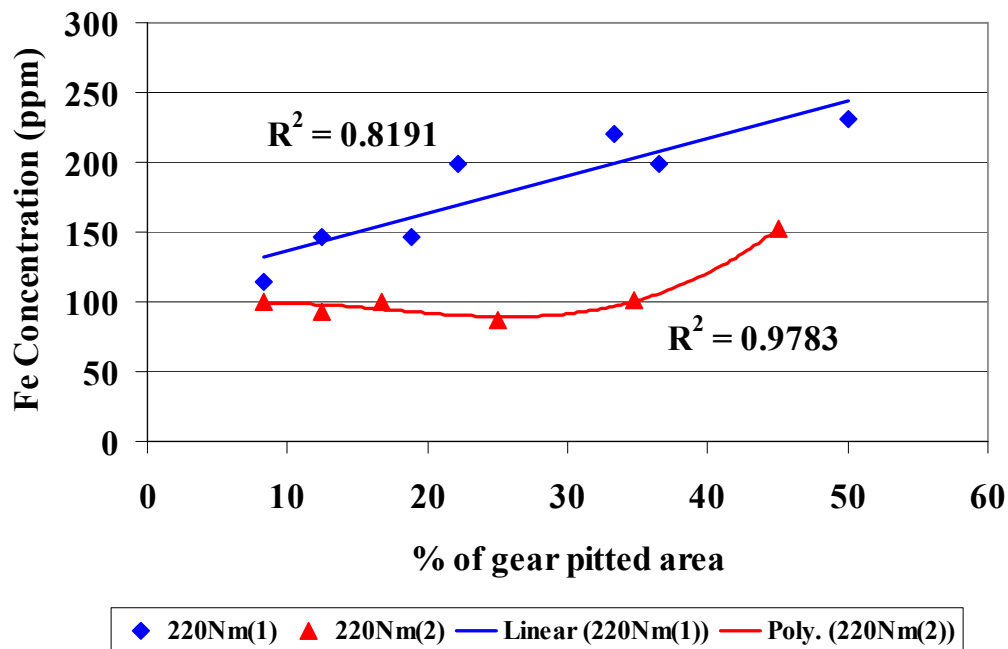
Figure 6 Fe concentration against % pitted area; 220 Nm, 745 rpm

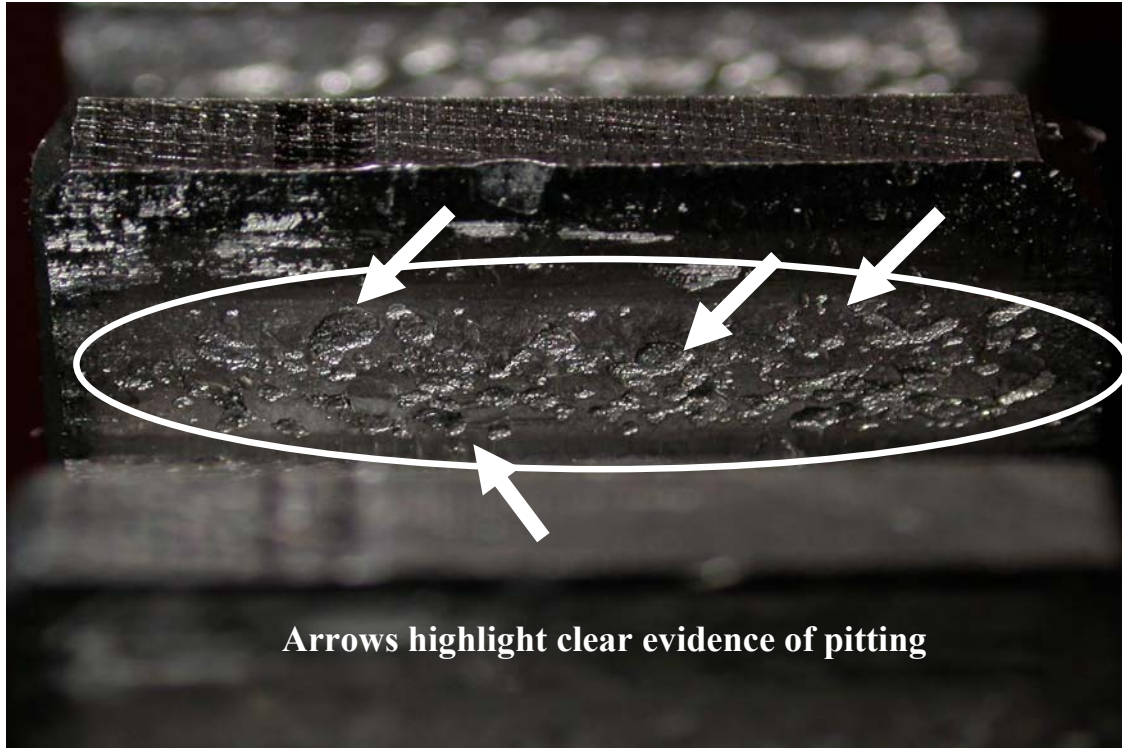
**Figure 7**      **42% pitted area of gear face**
