## **MECHANICAL EVOLUTION OF THE ROTATING BIOLOGICAL CONTACTOR INTO THE 21<sup>ST</sup> CENTURY**

**Abstract:-** This paper presents a review on the evolution of the mechanical design of Rotating Biological Contactors (RBC) within the United Kingdom. The findings documented have been taken from the biggest mechanical survey on RBCs ever undertaken worldwide and focuses on 300 operational units. The paper looks at the main components of the RBC and discusses the evolution of each member. Mechanical deficiencies associated with each design are briefly presented, giving an insight into reasons for improvements. This is the only known document that details changes in design philosophy employed over the last 30 years, with illustrative examples.

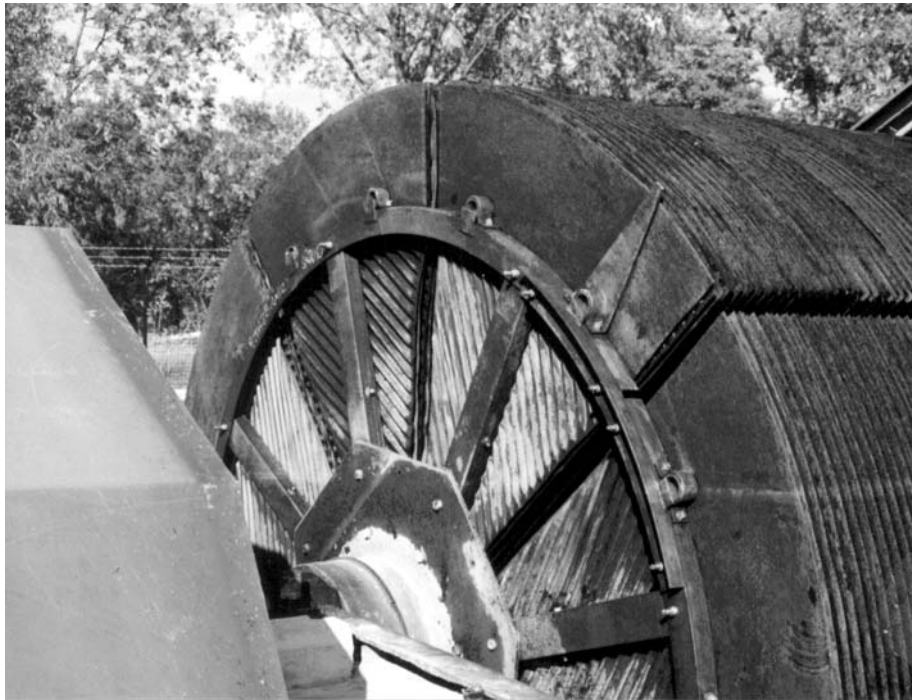
**Figure 30**      **Design to overcome loss of rigidity**

The problem of rigidity, particularly on the end media panels was initially addressed by cementing the first five media panels together. Whilst this increased the rigidity, problems of this nature were still observed. More recently, particularly on the larger RBC units, supports have been designed to maintaining rigidity, see figure 30. Furthermore, to overcome crumbling of the end panels, a thick polypropylene panel, in the order of 5mm, has replaced the end media panel, see figure 31. In this particular instance, the design also overcomes loss of rigidity.

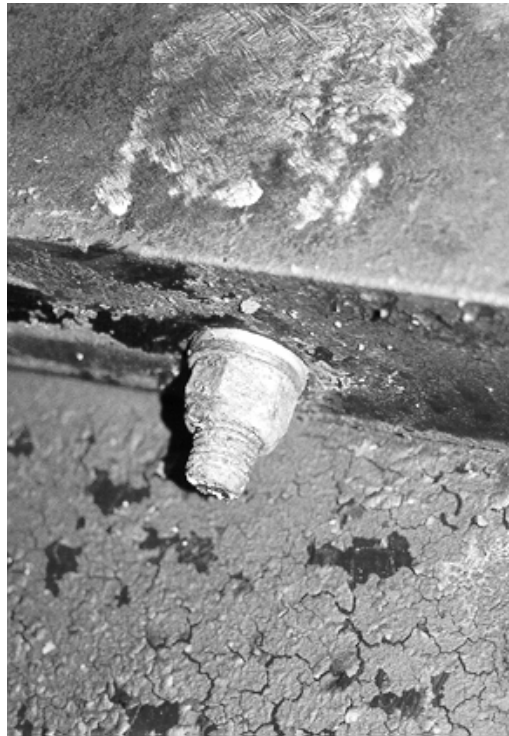
**Figure 70** Plastic washer

Of the designs already detailed it has been observed on numerous units that a mixture of materials were employed giving rise to galvanic corrosion. For instance whilst, the through rods employed were of stainless steel, the 'U' straps used to secure these through rods to the support structure were a mixture of stainless and galvanised steel. Furthermore, stainless steel bolts had been used to clamp components onto a steel structure. It must be noted that the main hollow shaft on RBC's detailed was always of mild steel. To assist in separation of stainless steel bolts from the steel structure plastic washers have been employed, see figure 70. Over the passage of time, these plastic washers will creep with the net result of loss of bolt tightening torque, see figure 71.

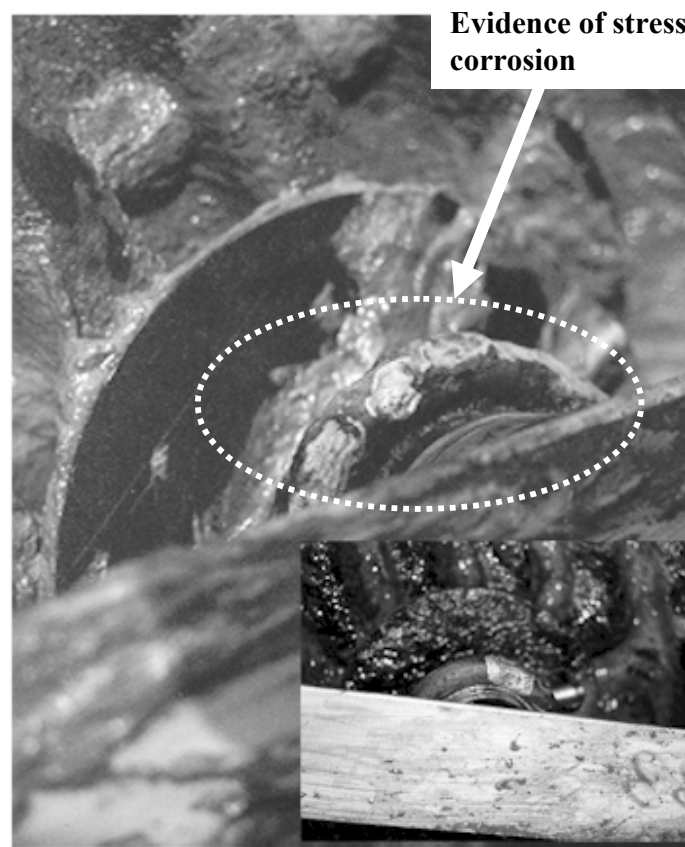
**Figure 72**      **Stress corrosion of ‘U’ bolt**

Other direct consequences of mixing materials include corrosion of the ‘U’ bolts and ‘U’ straps, see figure 72. In these instances there is a direct loss of cross-sectional area of the bolts resulting in a reduction of load carrying capability and eventual fatigue fracture. It is interesting to note that on the ‘U’ bolts corrosion begins in the regions experiencing the highest stresses, see insert of figure 72. This phenomenon is referred to as stress corrosion fatigue.

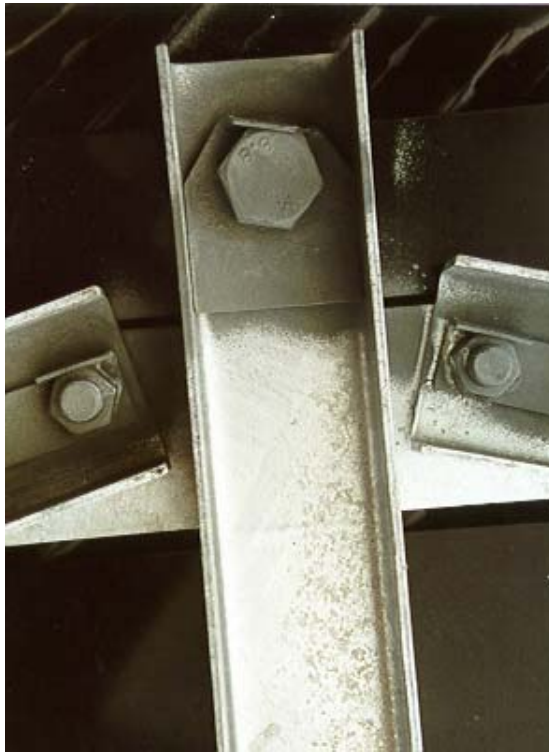
**Figure 83      Use of positive locking plates on nuts and bolts**

Best practice relating to the design of through rod end clamps is governed by the design of the media pack support frame, moreover, most manufacturers acknowledge the loading pattern described above will give rise to bolt loosening. To combat loss of bolt tightening torque use is made of positive locking for both nuts and bolts, see figure 83. Initial difficulties of properly aligning tab washers have been overcome by pre-forming the washer on a jig thereby ensuring the “upturned” section always aligns with the flat of the nut or bolt. The design arrangement illustrated in figures 80 and 83 offers structural flexibility for this rigid method of securing the through rod to the supporting structure.

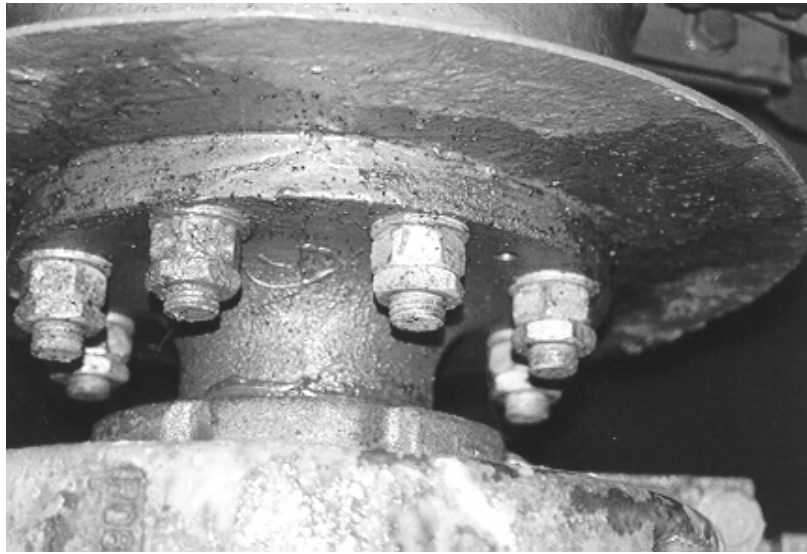
**Figure 100** Coupling bolts used to clamp stub shaft to the main hollow shaft

All RBC designs employ a stub shaft for locating the entire unit onto its bearings. In some design configurations, the stub shaft is bolted onto a plate which in turn is welded to the ends of the main hollow shaft, see figure 100. Without a thorough understanding of corrosion fatigue at low rotational speeds [4] these bolts have been known to fracture with devastating consequences, see figures 101 and 102. In some instances, apart from the complete loss of operation of the RBC unit, the GRP basin tank which contains the sewage liquor has been known to get damaged. Cognizance of the lowering effects on fatigue limits due to the combined effect of corrosion and low rotational speeds can overcome this mechanical deficiency.

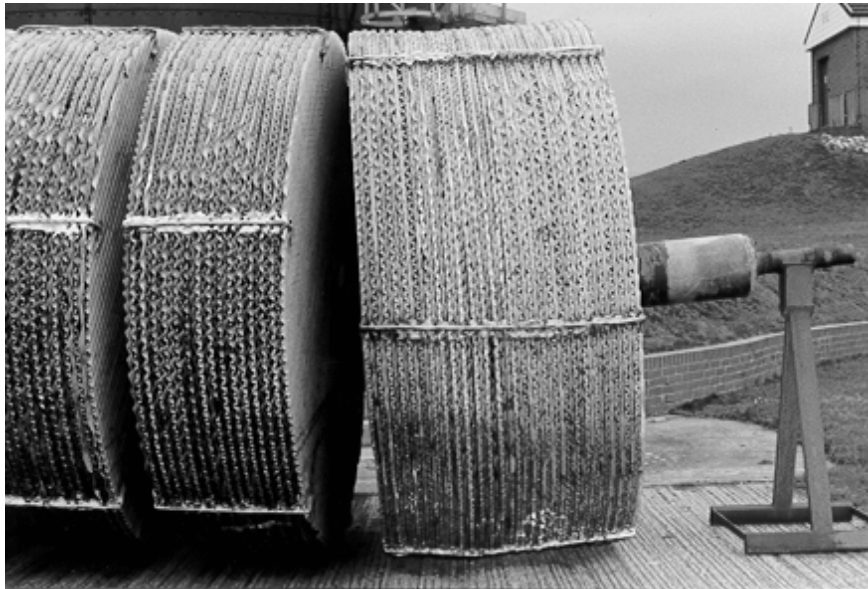
**Figure 103    Shaft fracture**

The effect of fractured coupling stub shaft bolts on other auxiliary systems, such as the gearbox and bearings is devastating. Even more damaging to the auxiliary systems, including the stub shaft, is complete fracture of the main hollow shaft, see figure 103. However, with a better understanding of the effects of corrosion fatigue at low rotational speeds, maximum stress levels for design of the main components of the RBC have been detailed [4].

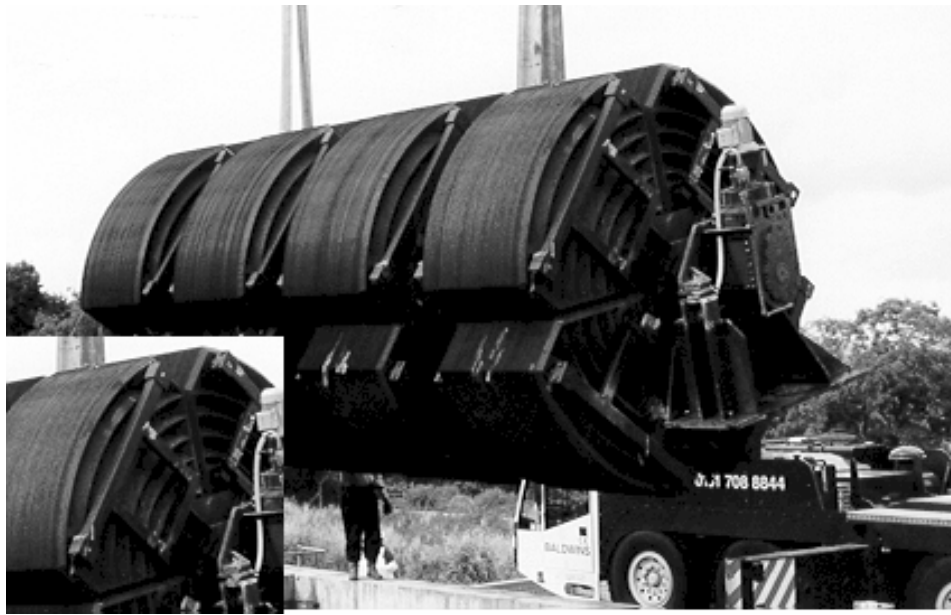
**Figure 104    New generation RBC**

The majority of mechanical deficiencies on the support structure are attributed the effect of low frequency corrosion fatigued coupled with mixture of materials, inadequate clamping arrangement of all through-rods and the use of a polymer sheeting and washers to avoid direct contact of differing materials. The economic argument in relation to the current designs is really concerned with the conflict between balancing the initial capital cost of the equipment, with the cost of maintenance over the life of the RBC. However, good design should be focused on providing equipment requiring little maintenance, at a competitive cost, whilst maintaining stringent manufacturing standards.
