## **MECHANICAL EVOLUTION OF THE ROTATING BIOLOGICAL CONTACTOR INTO THE 21<sup>ST</sup> CENTURY**

**Abstract:-** This paper presents a review on the evolution of the mechanical design of Rotating Biological Contactors (RBC) within the United Kingdom. The findings documented have been taken from the biggest mechanical survey on RBCs ever undertaken worldwide and focuses on 300 operational units. The paper looks at the main components of the RBC and discusses the evolution of each member. Mechanical deficiencies associated with each design are briefly presented, giving an insight into reasons for improvements. This is the only known document that details changes in design philosophy employed over the last 30 years, with illustrative examples.

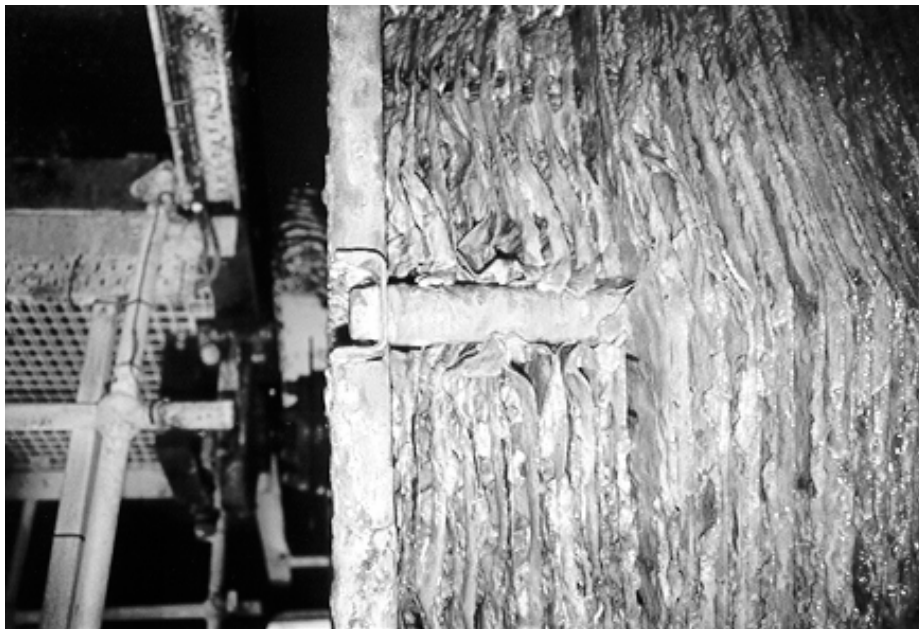
**Figure 24      Tearing of High density polypropylene media panels in the vicinity of  
the support through rod**

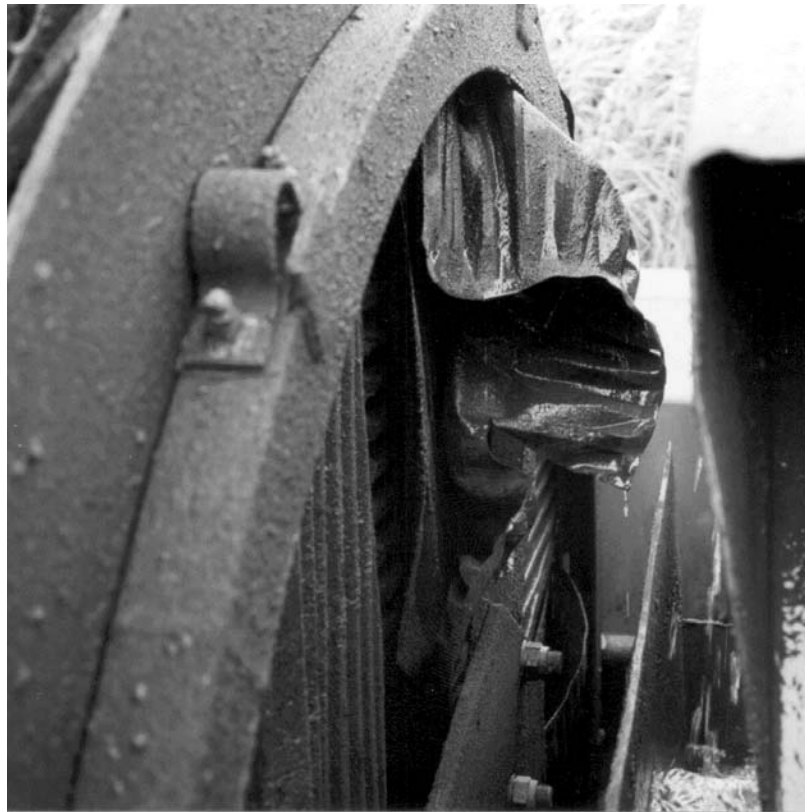
**Figure 26**      **Crumbling of High density polypropylene media panels**

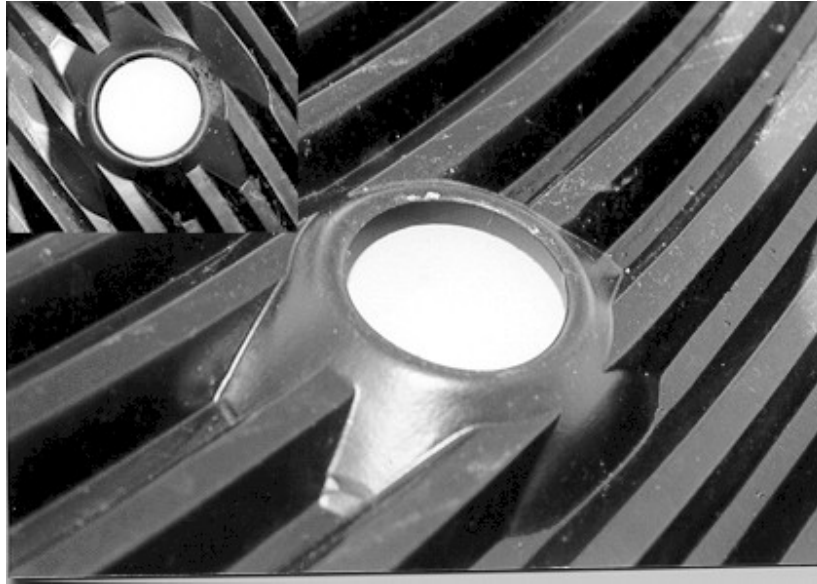
The most common media designs employ high density polypropylene materials. The various design configurations employing this material have common mechanical deficiencies, particularly strength and rigidity. Tearing of panels generally occurs in the region through which the support rods pass, see figure 28. The reason is attributed to inadequate strength of the hole/ring circumference and poor quality finishes in cutting/manufacture these holes. The jagged edges give rise to stress concentrations, which eventually lead to crack growth and tearing in this vicinity. Current designs have improved the strength in this particular region and more stringent finishing requirements are in place, see figure 29.

**Figure 29** Improved strength of hole in media panel

Following a mechanical design audit on RBC's [4] it was noted that the thickness of high-density polypropylene media panels employed (0.5mm) was insufficient to avoid tearing, improve operational life and to retain rigidity. Whilst an increased thickness is currently employed, 0.9mm, it has meant that capital costs have increased whilst whole life costs have reduced.

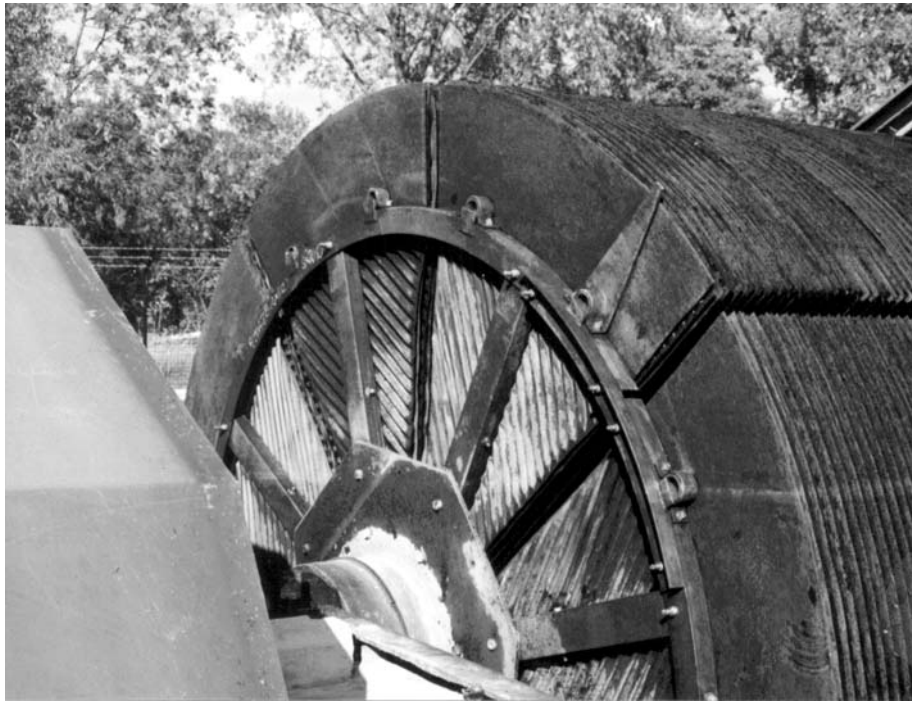
The problem of rigidity, particularly on the end media panels was initially addressed by cementing the first five media panels together. Whilst this increased the rigidity, problems of this nature were still observed. More recently, particularly on the larger RBC units, supports have been designed to maintaining rigidity, see figure 30. Furthermore, to overcome crumbling of the end panels, a thick polypropylene panel, in the order of 5mm, has replaced the end media panel, see figure 31. In this particular instance, the design also overcomes loss of rigidity.

**Figure 30**      **Design to overcome loss of rigidity**

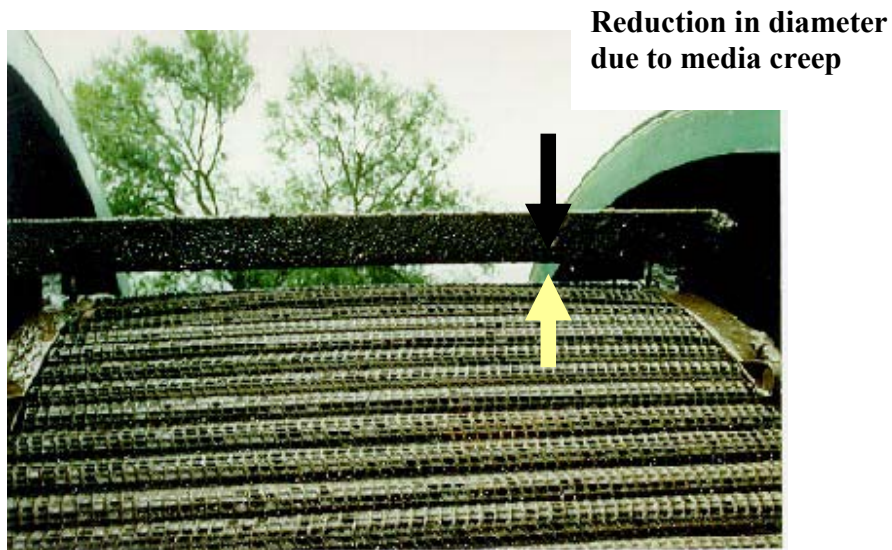
A draw back with this particular design is that the circumferential straps, used to located the media coils can become loose, see figure 38. With the passage of time and under heavy biomass growth, creep of the circular coils results in compression of the media sections. Consequently, the entire media section loses its rigidity and initial size, and the circumferential straps become ineffective in positioning the media sections. The amount by which the media sections can creep is illustrated in figure 39. Furthermore, the flow of sewage liquor through the media sections affected by creep becomes impeded, consequently, the affected media pack carries excessive liquor during its rotation. A direct result of loose straps is media movement, which in turn results in additional impact forces on the support structure causing acceleration forces to be reacted back to the gear drive unit. These reactive forces have caused the foundation bolts, securing the drive unit to the foundation, to work loose. Figure 40 illustrates the consequence of such a mechanism.

**Figure 39** Gap between structure and media coils caused by media creep

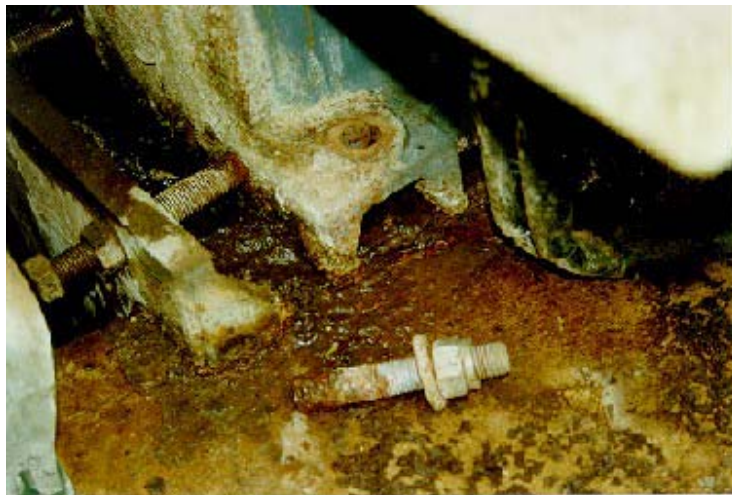
**Figure 40** Fracture of foundation bolts due to transient torque produced by loose media pack

As a direct result of the described wearing action a jerking motion of the entire RBC unit was observed. This jerking action caused the rotor to be rapidly accelerated resulting in transient torque forces being reacted back onto the drive unit, resulting in foundation bolts retaining the power unit to fracture. This mechanism is similar to that reported earlier in this paper and illustrated in figure 40.

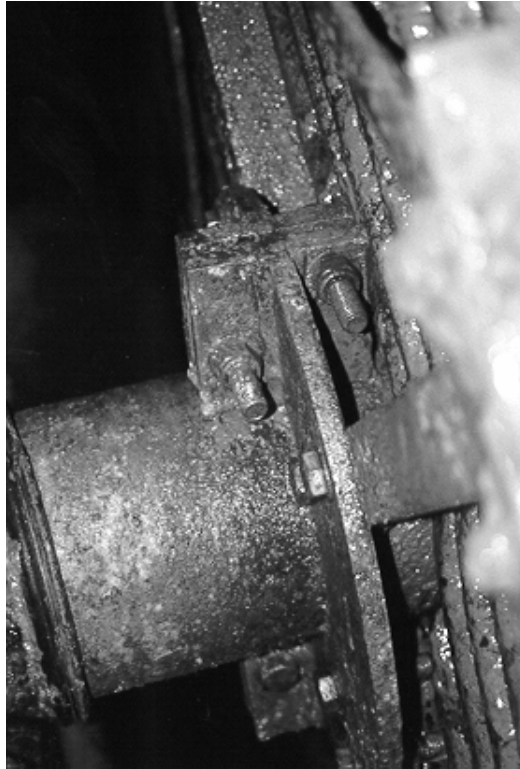
**Figure 46      Bolted shaft plate**

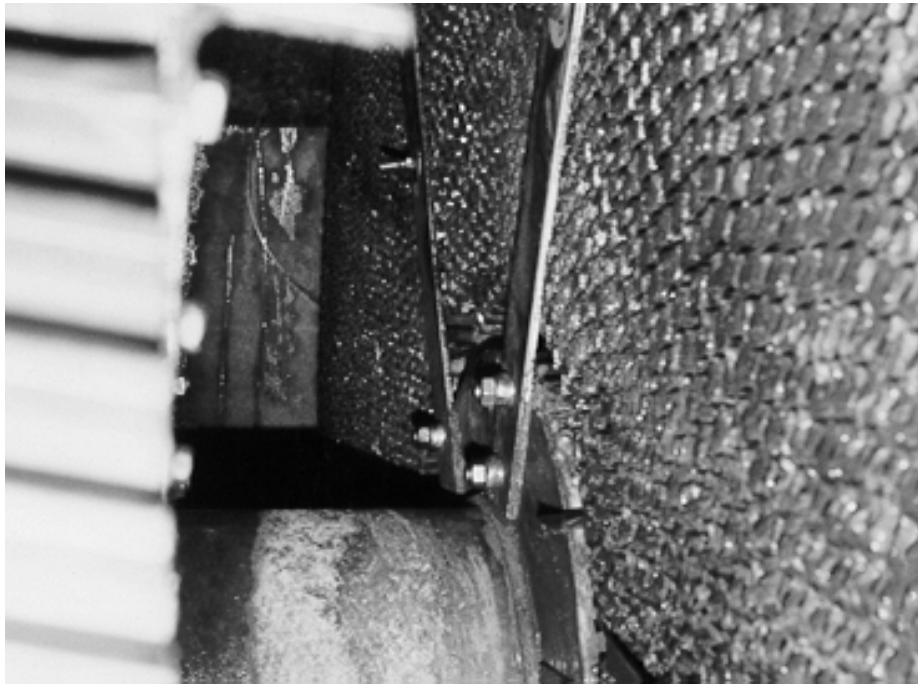
A weakness with this design is that the action of clamping the neoprene strips between the media pack and the radial spiders produces a compressive stress into the side walls of the PVC media corrugations. Moreover, because both the neoprene and the PVC media pack are viscoelastic materials, creep will most certainly occur, or even crushing, resulting in loss of clamping force between the media pack and spiders. The consequences of losing the clamping force between the spiders and media pack, is that the weight of the media pack is transferred directly onto the shaft hub causing crushing of the PVC corrugations. Figure 52 clearly illustrates the effect of crushing which has taken place under one of the radial spiders.

**Figure 52      Evidence of crushing of media**

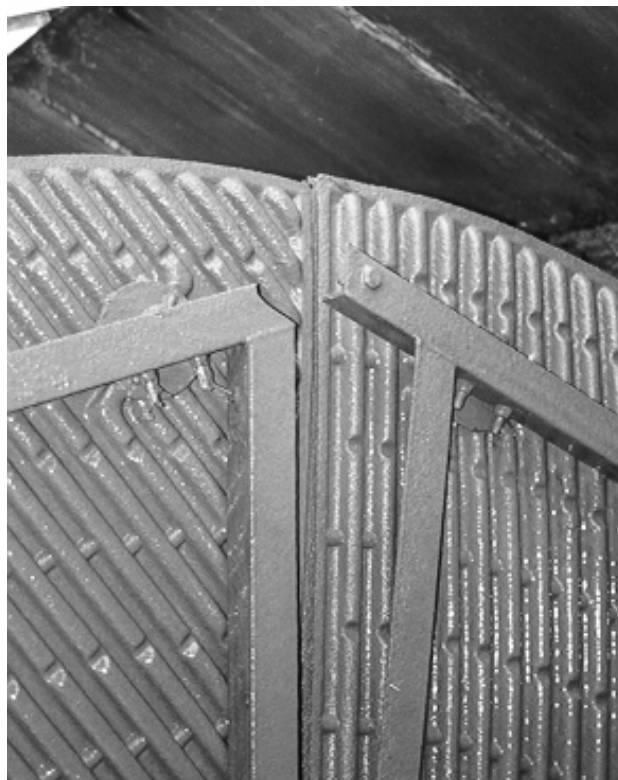
Furthermore, a number of these RBC designs have suffered from support frame failure. It is perhaps interesting to note that this design employs structural steelwork having the lowest cross-sectional dimensions compared with other similar size RBC examined. Whilst it could be argued that this design offer low capital costs they hide the high whole life cost. In addition, due to the low fatigue limits of a lighter frame, fatigue fracture is common, see figures 58 and 59.

**Figure 59** Fractured support structure

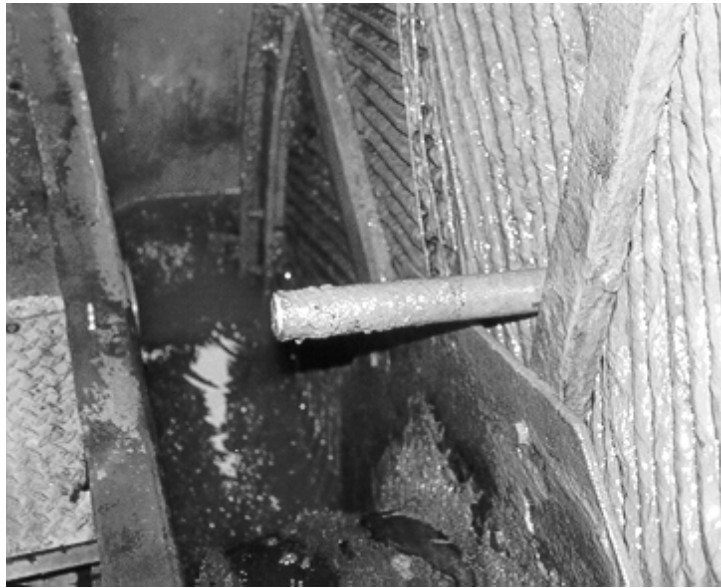
Another common design of RBC with a diameter ranging from 2 to 3 meters is illustrated in figure 60. It consists of channel radial spider arms and an angle circumferential rim. The design consists of between 4 to 8 segment sections with three supporting through rods are employed per segment. During manufacture, the segments are lowered into the support structure frame. For this reason a section in the region where the radial spider arm was clamped to the outer circumferential rim was cut away in the circumferential rim, see figure 65. Whilst the reasons for the cut away section is understood, it does pose the problem of introducing localised stresses. Two of the through rods are retained by 'U' shaped straps on the outer circumferential rim, as illustrated in figure 61. The third through rod, referred to as the inner through rod is rested onto a plate within the radial channel arm, see figure 62. A bolt is used to retain the inner through rod in this position, see figures 60 (insert) and 62. As the inner through rod was not secured to the radial arms they have been known to work loose with costly consequences, see figure 63.

**Figure 63      Loose inner through rod**

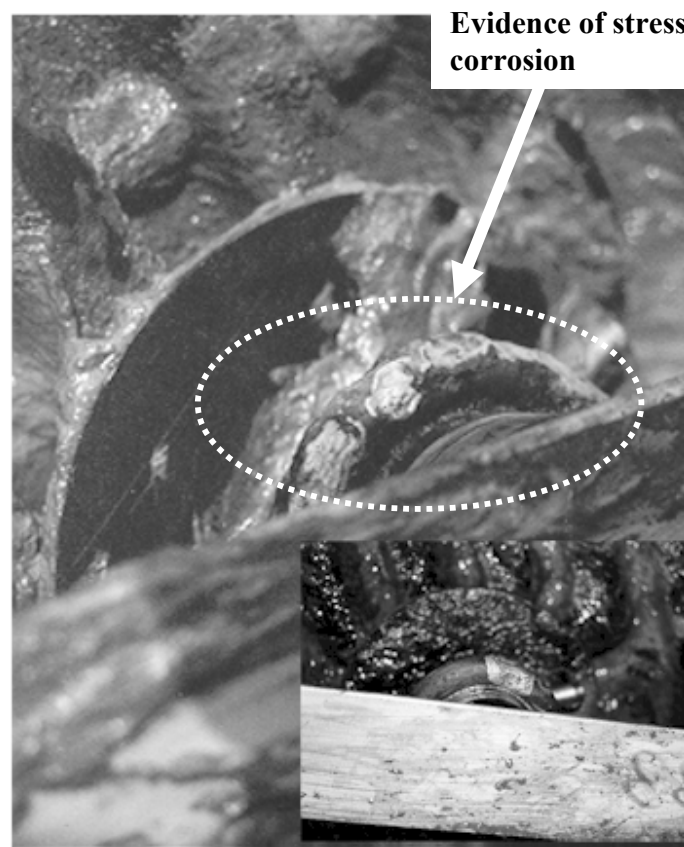
Other direct consequences of mixing materials include corrosion of the ‘U’ bolts and ‘U’ straps, see figure 72. In these instances there is a direct loss of cross-sectional area of the bolts resulting in a reduction of load carrying capability and eventual fatigue fracture. It is interesting to note that on the ‘U’ bolts corrosion begins in the regions experiencing the highest stresses, see insert of figure 72. This phenomenon is referred to as stress corrosion fatigue.

**Figure 72**      **Stress corrosion of ‘U’ bolt**

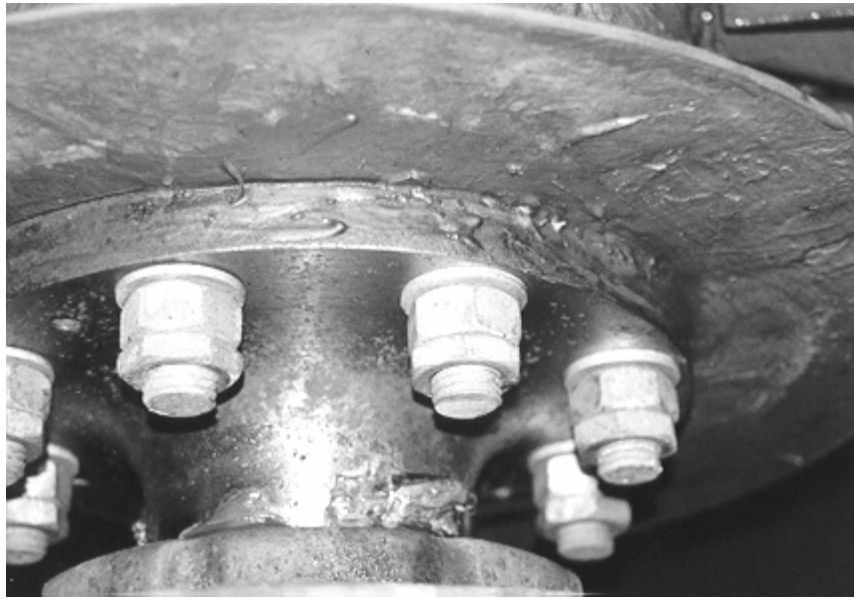
The spider is bolted to a shaft split hub and are mechanically locked by the use of lock nuts, see figure 75 for a typical arrangement. The types of positive locking employed include nylon lock nuts or double lock nuts, dependent on RBC unit, the latter can be seen in figure 76. The drawback with nylon lock nuts exposed to sewage liquor over a passage of time is that they have been known to work loose. Traditionally manufacturers employing double lock nuts (sometimes referred to as ‘Jam’ nuts) have placed the smaller nut on top of the bigger nut. Double lock nuts have the advantage of requiring minimum skill provided certain basic rules are applied. Historically the nuts are of different thickness, one standard nut and the other half the thickness of the standard nut. In assembly the thinner nut should be fastened first and the large nut fastened on top on the thinner nut [5].

**Figure 76**      **Improper bolting of double lock nuts**

The spider is bolted to a shaft split hub as with previous designs described earlier. Other features of this design are identical to those reported in figures 75, 76 and 77. The through rods are secured to the media pack support frame using a single bolt and locking is achieved by making use of a spring washer, however, on a number of RBC's this through rod securing bolt has become loose, see figure 81.

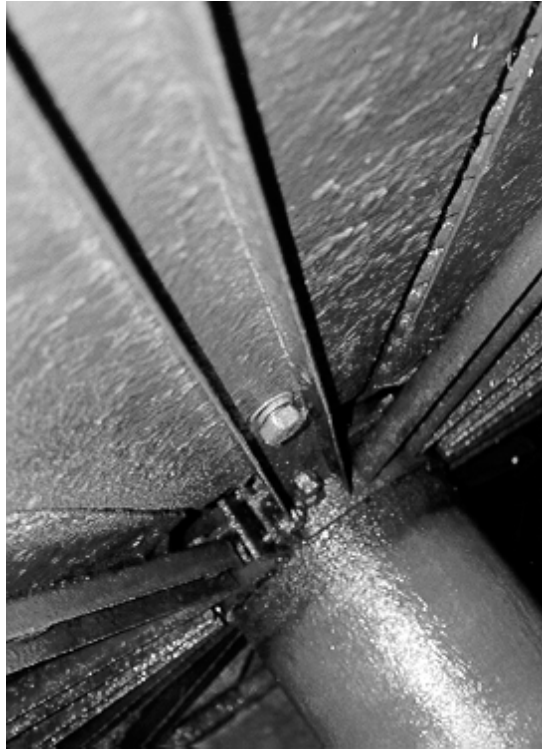
**Figure 81      Loose bolt employing spring washer**

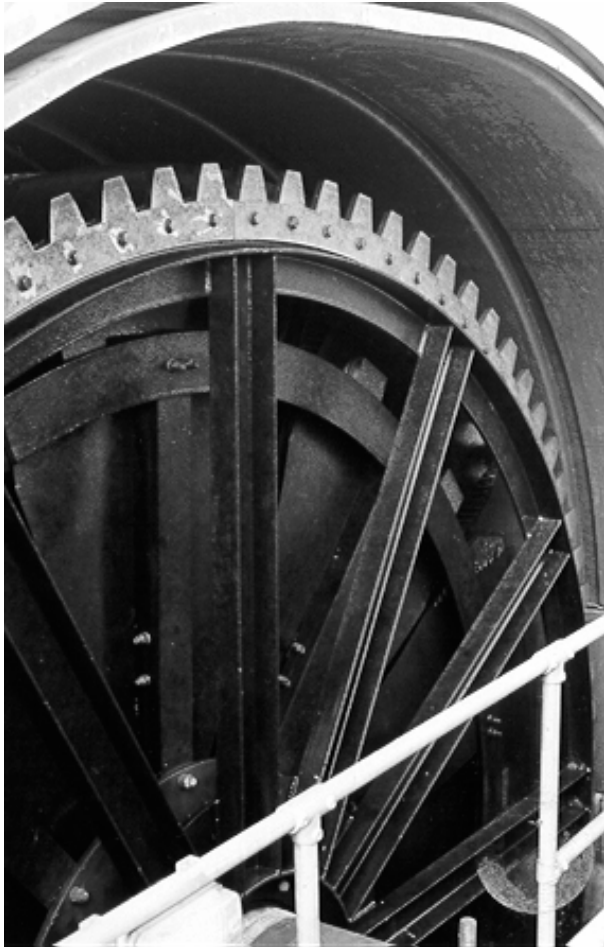
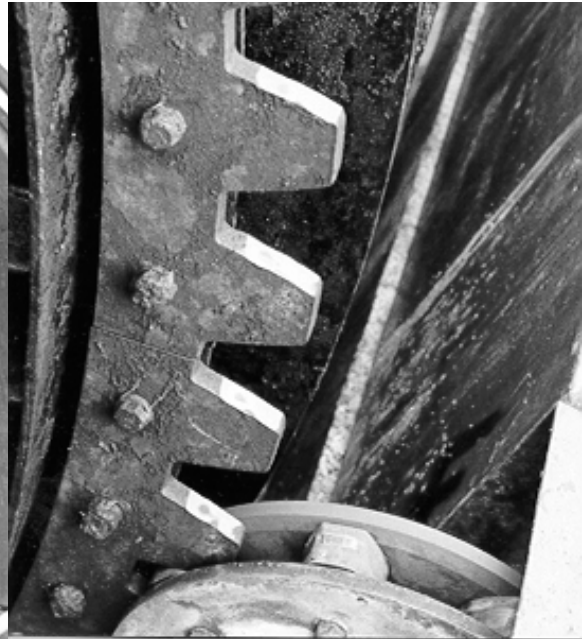
The difficulties with this arrangement are that with the passage of time the chain will loose its tension and in many instances has broken. In much smaller sized RBC units (diameters of 1 meter or less) a belt connection is sometimes employed to drive the main shaft. Some RBC units employ a gear and pinion power transmission arrangement, as illustrated in figures 87 and 88. In this particular instance the pinion wheel consisted of 8

**Figure 87 (left) Pinion and gear transmission arrangement; Larger gear wheel**

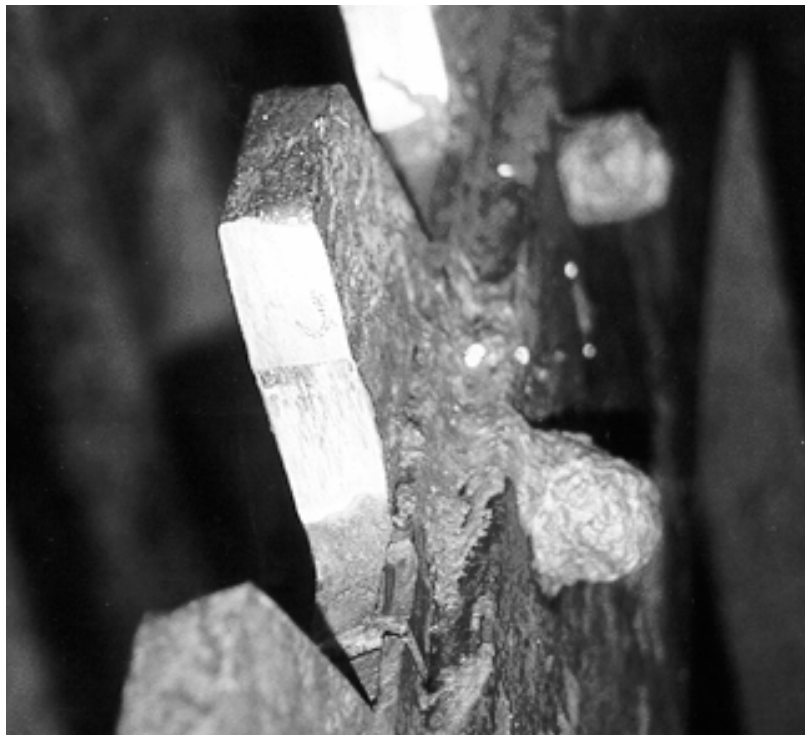
This susceptibility has been very evident as severe grooving has been observed on the side of the segmented gear wheel plates, see figure 89. Moreover, it has been noted on a few RBC units that severe wear had occurred on the contacting face of the gear tooth, resulting from high contact pressures and the unavoidable sliding that takes place between tooth pairs, see figure 90.

**Figure 90**      **Wear on contact face of gear tooth**

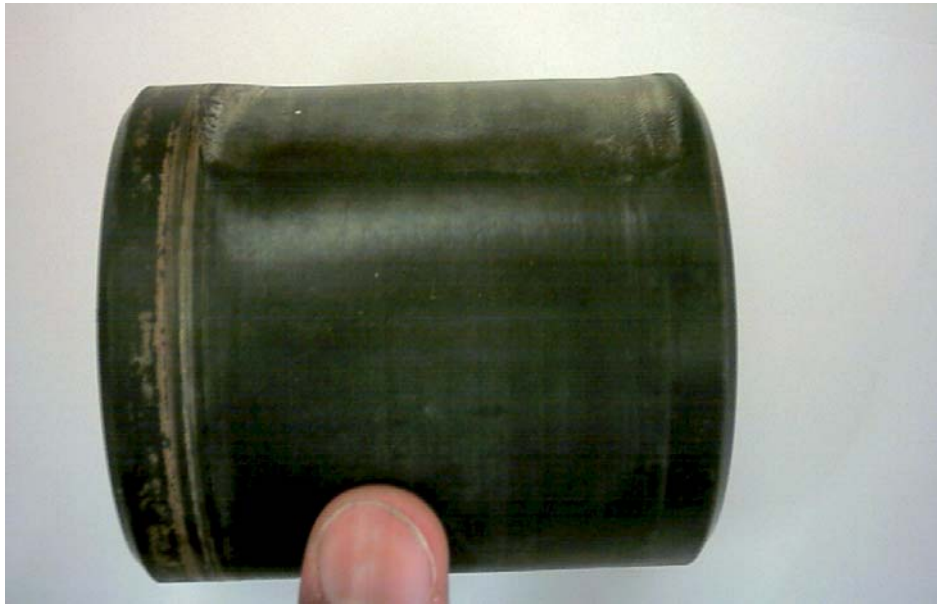
Fundamental design limitations include excessive Hertzian compression stress at the contact surface between the roller and the larger gear wheel, as illustrated in figure 91. Moreover this particular design requires the pinion to be perfectly aligned with the larger gear wheel; failure to comply with this fundamental requirement would most certainly result in accelerated surface flaking/blistering of the outer diameter of the roller. Figure 92 shows the wear to be unevenly distributed along the length of the roller, suggesting that correct alignment was never achieved.

**Figure 92** Evidence of uneven wear due to misalignment

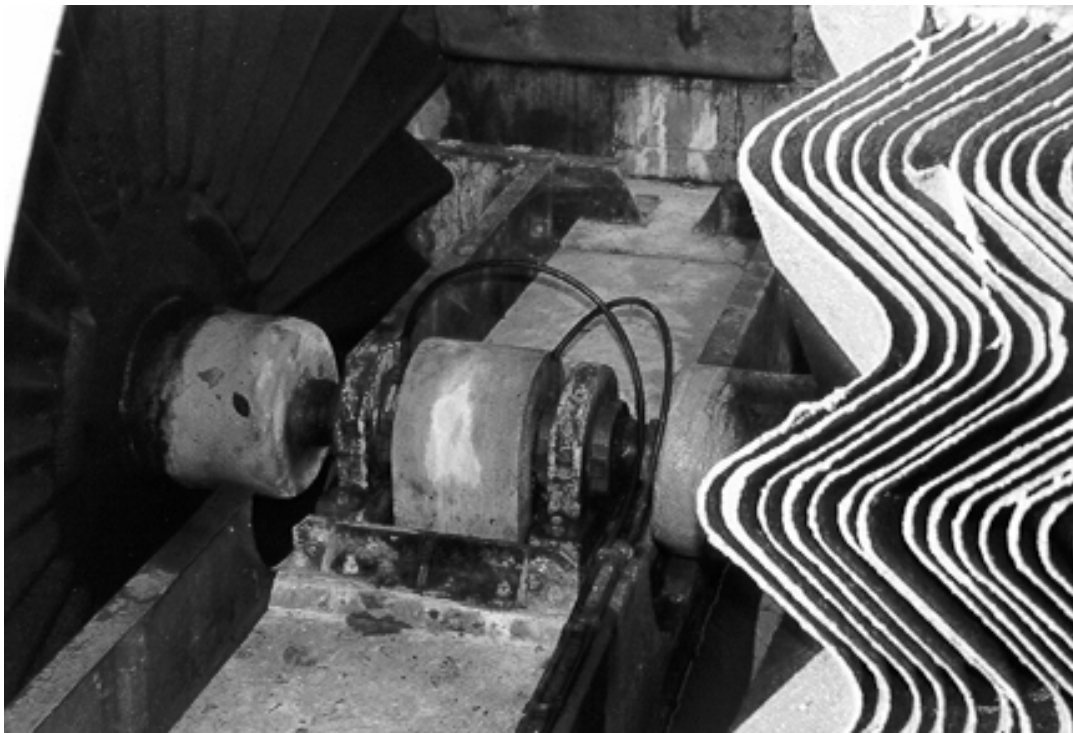
**Figure 94      Coupling employed to avoid the use of two power units**
