## **The Didcot Demolition**

**Roland Alford**

**Cranfield Forensic Institute, Cranfield University & Alford Technologies Ltd**

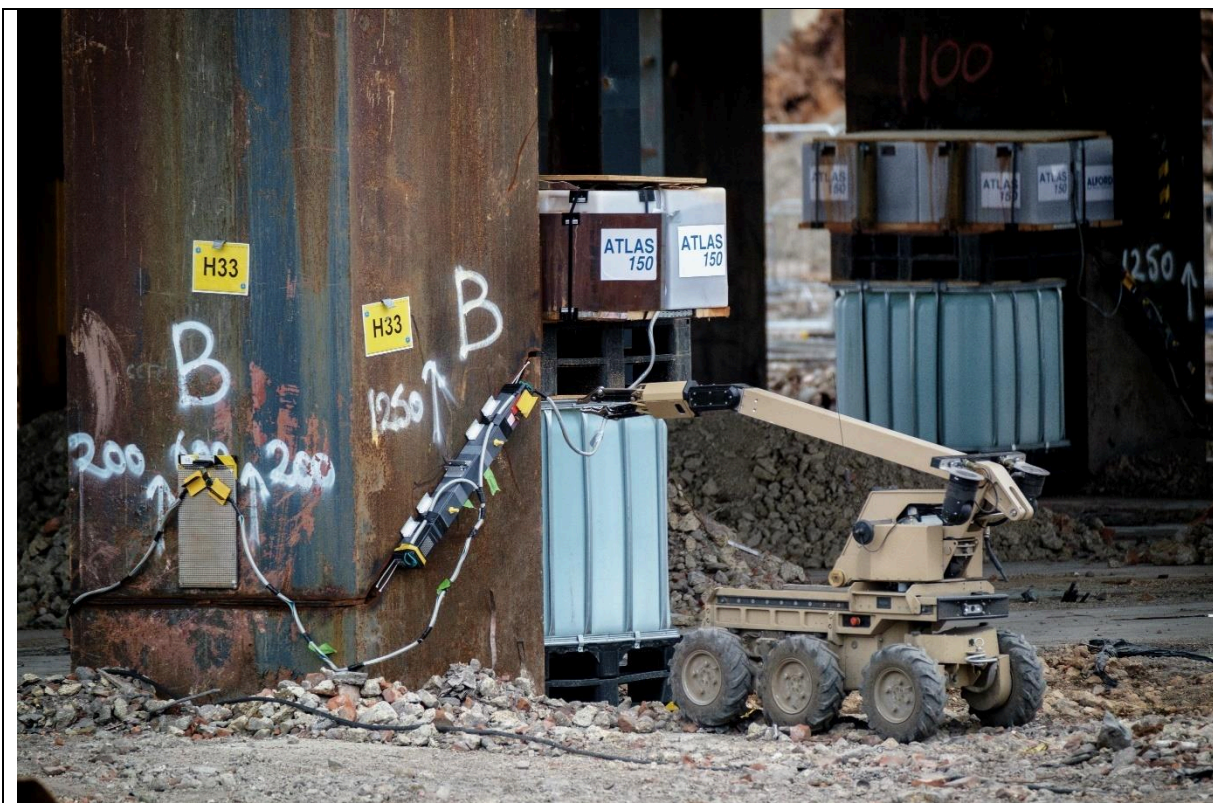
**Fig 4. The modular ATLAS 150 was designed and developed specifically to kick columns out of alignment. The Magnetic Bunch Connector board can be seen with two protected detonating cord links.**

flanges and the robot operators got to work practicing the delicate operation of placing these charges, each weighing roughly 8kg, in the correct location and orientation (fig. 4).

The answer was what became known as the Magnetic Bunch Connector. This was an explosive connection board consisting of a sandwich of plywood, sheet explosive and perforated sheet steel. This was fixed to the structure using magnets and acted as a central “exchange” for the initiation train. Each charge being connected was fitted with a detonating cord tail terminating in a magnetic connector that could be attached to the MBC using powerful magnets. Each board would be initiated with a detonator fitted with a small booster-charge that was also fixed using magnets. When the

detonator fired, the entire MBC board initiated and each of the detonating cord tails, of equal length, were initiated simultaneously. Looking about like an explosive spider when installed, the system was found to be highly effective.
