# Mechanical Stress Effects on 550 °C Hot Corrosion Propagation Rates in Precipitation Hardened Ni-Base Superalloys: CMSX-4, CM247LC DS and IN6203DS

Neil Chapman<sup>1,2</sup> · Simon Gray<sup>2</sup> · Joy Sumner<sup>2</sup> · John Nicholls<sup>2</sup>

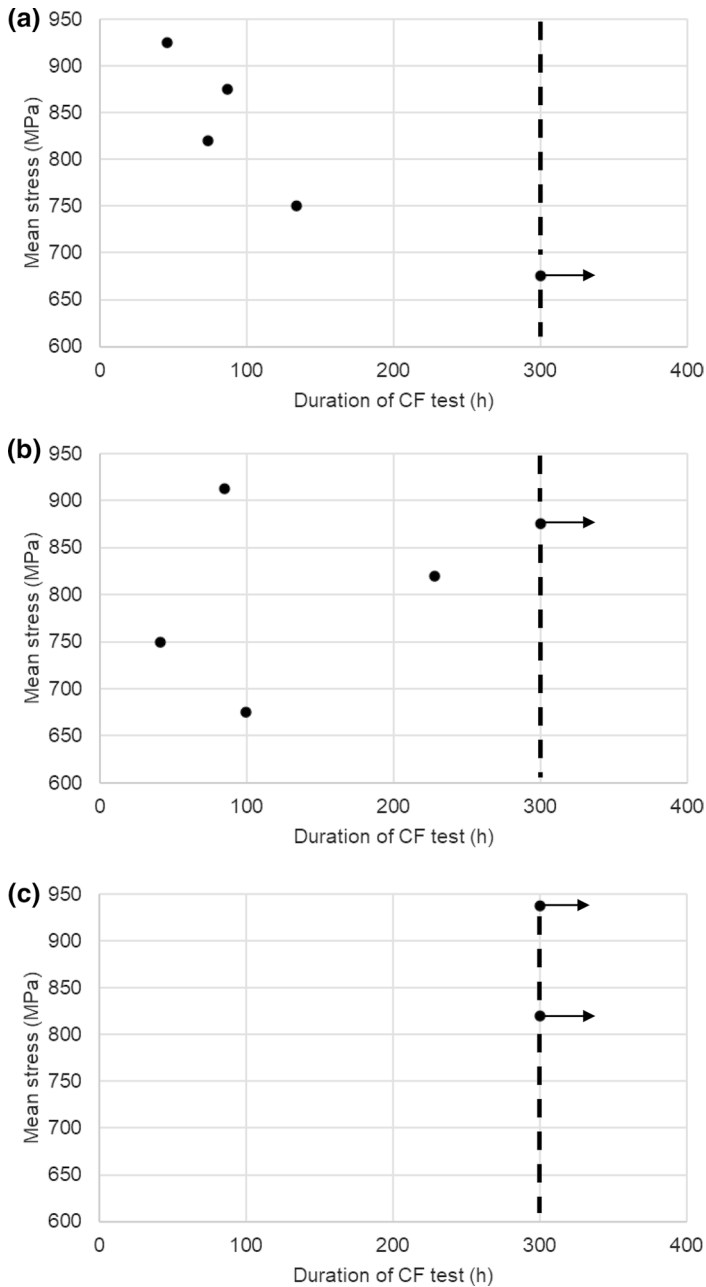
**Fig. 4** CF results of **a** CMSX-4, **b** CM247LC DS and **c** IN6203DS. Dashed lines represent end of test, arrows indicate runout specimens

surface-connected gamma-prime eutectic features were within the gauge length of the fatigue specimens. This randomness was therefore the most likely cause of the scatter observed within the CF results of CM247LC DS material (Fig. 4).

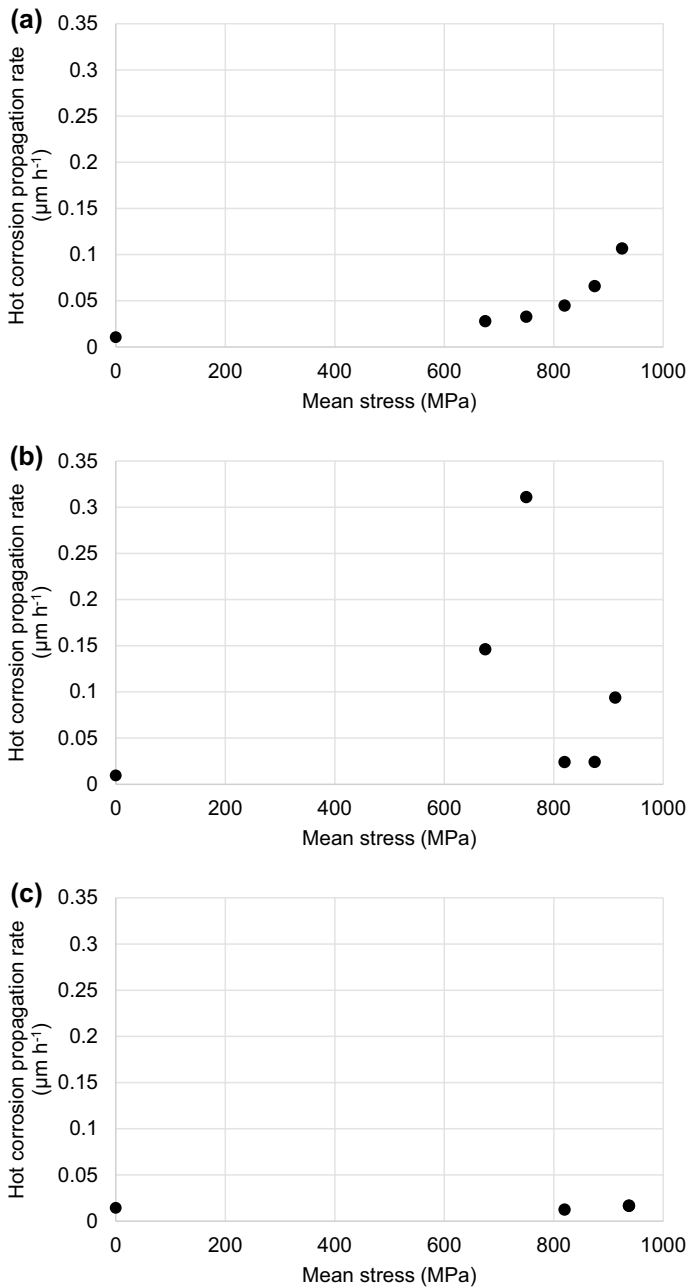
**Fig. 6** Mechanical stress effect on the maximum hot corrosion propagation rates of **a** CMSX-4, **b** CM247LC DS and **c** IN6203DS

Figure 6 shows a scatter plot for each material illustrating the effect that mechanical stress has on the calculated hot corrosion propagation rates. Also included in these plots is the respective hot corrosion propagation rate from the cylindrical specimens (obtained from the rate component in Eqs. 1–3) which were exposed without any mechanical stress being applied. No significant evidence of an increased hot corrosion propagation rate was found due to the mechanical stress applied during the CF testing of the IN6203DS material (rates of  $0.012$  and  $0.016 \mu\text{m h}^{-1}$  were calculated which were plausibly equal to the rate component of  $0.0142 (\mu\text{m h}^{-1})$  in Eq. 3). All fatigue specimens manufactured from CMSX-4 and CM247LC DS materials though did experience an increase in the hot corrosion propagation rate during the CF testing when compared with the respective rate components in Eqs. 1 and 2. In the case of CMSX-4, a predictable increasing trend in the calculated rate (rising from  $0.028$  to  $0.107 \mu\text{m h}^{-1}$ ) was associated with the mechanical stress which compared with the rate component of  $0.0105 (\mu\text{m h}^{-1})$  in Eq. 1. For CM247LC DS, the rates associated with the CF tests ranged between  $0.024$  to  $0.311 \mu\text{m h}^{-1}$  which were

all greater than the rate of  $0.000935 \text{ } (\mu\text{m h}^{-1})$  quoted in Eq. 2. However, no obvious trend was apparent for the mechanical stress-influenced CF hot corrosion propagation rates for CM247LC DS, and this appeared to be the cause of the greater degree of scatter in the CF results of this material.
