# Internal Cracks and Non-Metallic Inclusions as Root Causes of Casting Failure in Sugar Mill Roller Shafts

**Abstract:** The sugar mill roller shaft is one of the critical parts of the sugar industry. It requires careful manufacturing and testing in order to meet the stringent specification when it is used for applications under continuous fatigue and wear environments. For heavy industry, the manufacturing of such heavy parts (>600 mm diameter) is a challenge, owing to ease of occurrence of surface/subsurface cracks and inclusions that lead to the rejection of the final product. Therefore, the identification and continuous reduction of defects are inevitable tasks. If the defect activity is controlled, this offers the possibility to extend the component (sugar mill roller) life cycle and resistance to failure. The current study aims to explore the benefits of using ultrasonic testing (UT) to avoid the rejection of the shaft in heavy industry. This study performed a rigorous evaluation of defects through destructive and nondestructive quality checks in order to detect the causes and effects of rejection. The results gathered in this study depict macro-surface cracks and sub-surfa

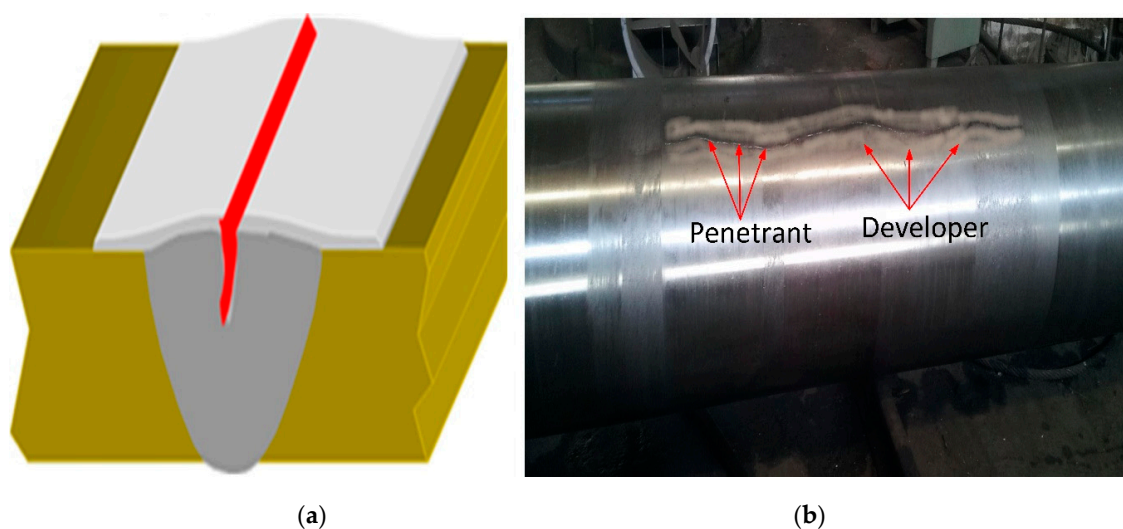
Liquid penetrant testing is the most popular non-destructive technique in the industry, owing to the fact that it is cheap, versatile, and applicable at any stage of the manufacturing process. The main feature of penetrant testing is to detect surface breaks/flaws by flowing a thin liquid into the flaw and drawing the penetrant out by means of a developer [34]. Stainless steel, steel, aluminum, rubber, and cast iron are commonly inspected after casting or forging with this technique [35]. In this test, a dust cleaner (SKC-1; Magnaflux; ITW India Private Limited) was used to remove dust particles, oil, or grease particles. A penetrant (SKL-SP1; Magnaflux ITW India Private limited) was sprayed from aerosol, a dwell (soaking) time of 12 minutes was allowed for it to permeate well into the crack/flaw. After the dwell time, the penetrant was removed with a clean rag. After that, the thin coating of the developer (SKD-S2; Magnaflux ITW India Private limited) was sprayed, with a dwell time of 25 minutes for it to exit the cracks and to create an indication line on the developer (Figure 4). The part was examined critically to find the penetrant indication line growing with time as penetrant bleeds out of cracks. The accessible surface was inspected as per ASTM-E165 standard.

**Figure 4.** (a) Schematic diagram depicting the application of cleaner, penetrant, and developer; (b) Sugar mill roller shaft after penetrant testing (PT).

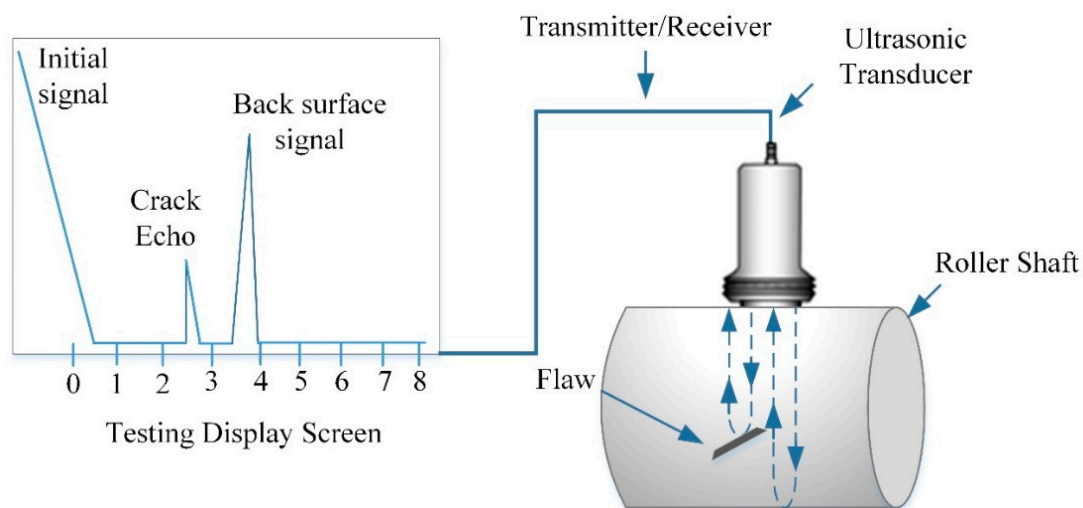
is given by  $v = f\lambda$ . The UT inspection system incorporates a portable probe of transmitter/receiver, transducer, and a display screen (see details in Figure 5). A pulse is generated by imposing an alternating voltage that activates a piezoelectric probe crystal to produce signals by coupling the probe to it. The sound waves emitted from the boundary of the workpiece reveal any crack/cracks that is received as feedback from the probe. Through a reverse piezoelectric crystal effect, received waves are converted into voltages and displayed on the screen. Here, an ultrasonic system was used (HY-350; Suzhou De Sisen Electronics Co. Ltd, Jiangsu, China) that permits a detection range of 0~6000 mm thickness, and a dynamic range of >32 dB, with a single probe. The sensitivity of the system is 0~110dB in order to overcome the effect caused by the surface roughness of the detected workpiece. The transducer system (HY-350; Suzhou DeSisen Electronics Co. Ltd, Jiangsu, China) production is driven by a pulser with a 2.0-MHz frequency-based ultrasonic energy. The system resolution is >40 dB. The location of the crack is obtained by moving the probe. The crack waves are produced from zero to maximum, as the probe moves from the defect-free region to the defective region. The characteristics of the crack wave obtain the location of cracks.

**Figure 5.** Schematic diagram of the ultrasonic testing (UT) set-up, depicting the test screen and compression probe.

After plotting the DAC curve, the scanning of the component is carried out, keeping the same settings of the equipment. In order to ensure 100% area coverage of the component, scanning is carried out with 10% overlapping of the probe area.

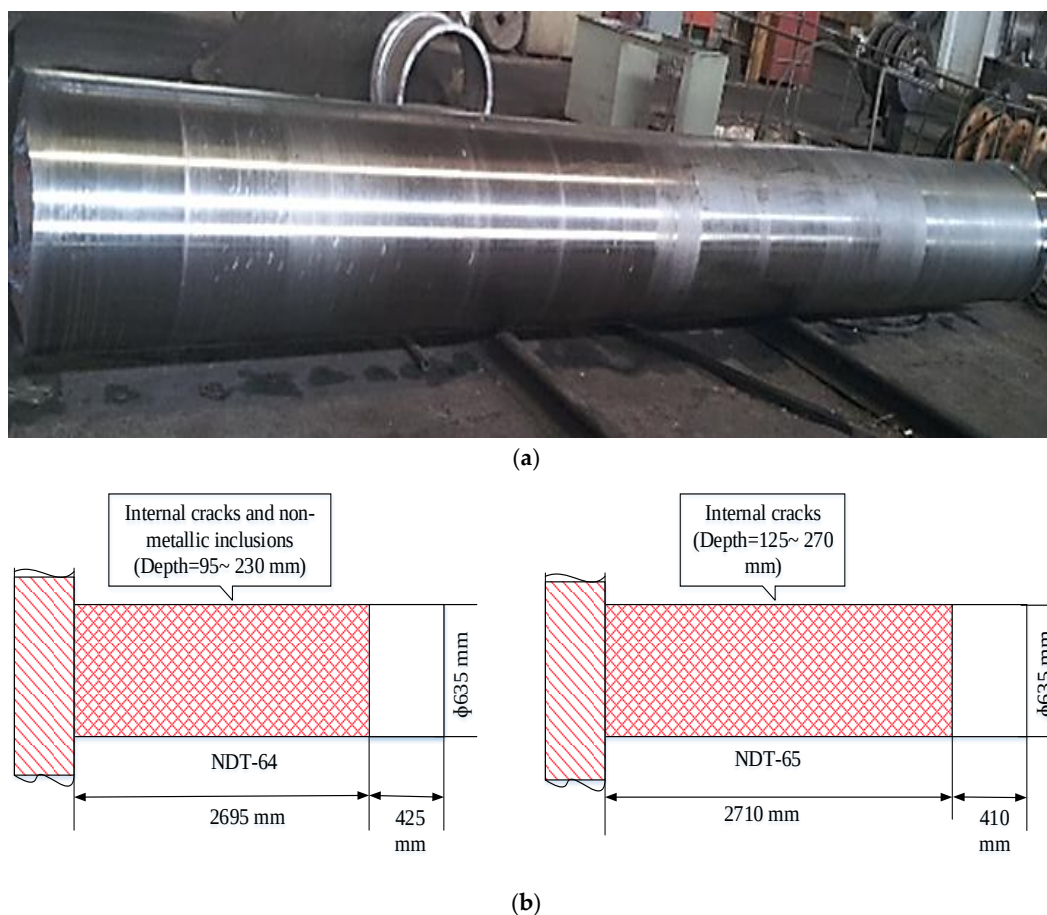
During the scanning of the component, a few indications were found to be above the DAC curve, within 12.7 mm. Based on the indication pattern, the scanned component on the DAC curve showed an indication of flaw. Ultrasonic testing precisely indicates subsurface cracks/discontinuities and the possibility of nonmetallic inclusions [36]. UT measurement was performed twice to validate the presence of cracks and inclusions. The presence of cracks was observed under the supervision of the local industry quality control department non-destructive testing (NDT-64). The NDT-64 reports of the shaft under observation showed non-metallic inclusions and deep internal cracks at a depth of 95~230 mm, randomly distributed throughout the shaft length of 2695 mm (details in Figure 7). For further clarification, UT testing was performed under the supervision of a multi-national quality control department (NDT-65). So, rejection was ensured with the identification of a flaw with its position. NDT-65 depicted internal cracks within the depth of 125~270 mm, randomly distributed through the length of 2710 mm. Based on the detection of cracks and foreign particles, the rough machined ingot was rejected.

**Figure 7.** (a) A rough machined shaft that was rejected after UT inspection; (b) UT report locating internal cracks and foreign particle inclusions under duplicate measurements.

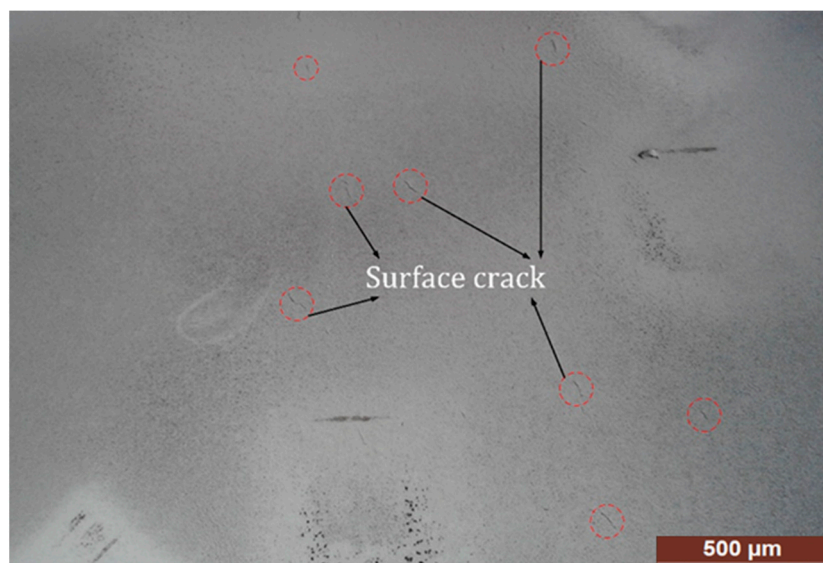
After preparing small size samples for destructive testing, magnetic particle testing was applied to detect discontinuities and crack dispersion on the specific portion of the shaft highlighted under UT. In the MT procedure, any distinct variation or discontinuity that distorted the magnetic lines, named flux leakage, was observed due to surface/subsurface cracks identified through a portable yoke system. Black iron particles were sprayed with liquid suspension, enabling the free flow of particles over the workpiece surface. Fine iron particles were accumulated at the poles of a magnet. However, in any discontinuity/crack, iron particles accumulated at the flaw/crack location and followed the same orientation as a flaw/crack pattern, making visible the cracks highlighted in Figure 8. This indicates that cracks are randomly distributed, as can be seen by the naked eye. MT verified the results of UT by highlighting subsurface cracks. However, the cause of cracks and the nature of foreign particles could not be detected through magnetic particle testing. So, further investigation was required to find the root causes of sub-surface cracks or non-metallic inclusions.

**Figure 8.** Surface cracks after performing magnetic particle testing.

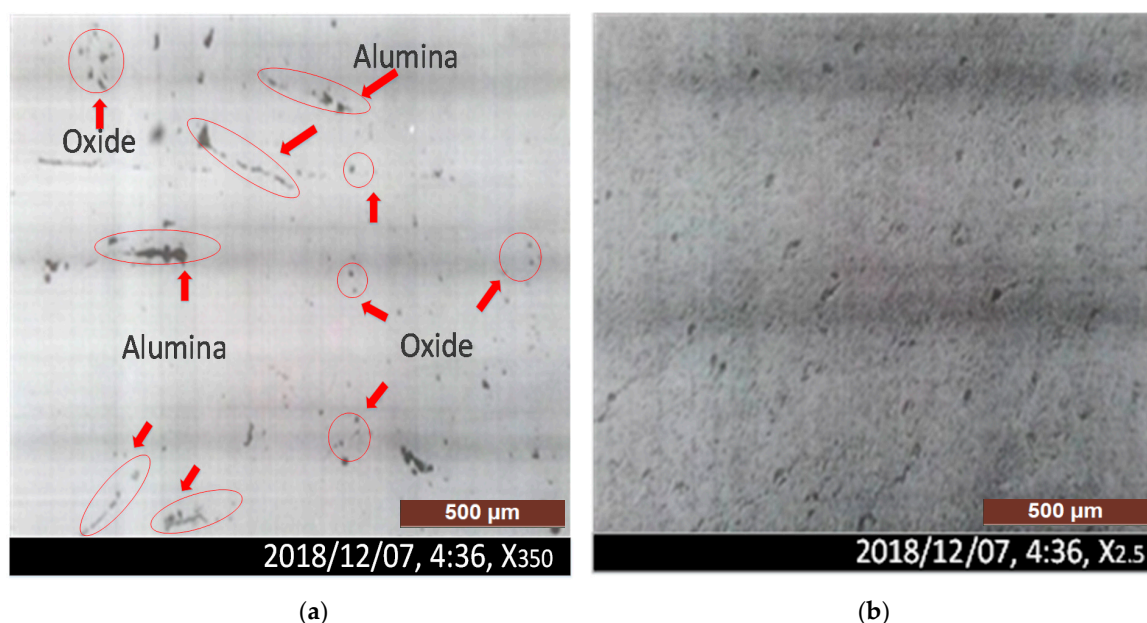
Figure 11a depicts the specimen under macroscopic observation, which revealed oxide and alumina-type inclusions, observed as per ASTM E-45 [37]. The specimen was polished without etching to observe the non-metallic inclusions. Findings depicted the presence of randomly distributed alumina and oxide-type inclusions. Besides, the sample was hotly etched in HCl (1:1), as inclusions were observed, randomly distributed as per ASTM E-381 [38]. The random condition is presented by R-5 (Figure 11b). By comparing the metallographic tests with ASTM standards, oxide and alumina-type inclusions were recognized. The refractory material of the ladle and roof of the furnace were the sources from which alumina-type inclusions were transferred to casting material. Low-quality flux was the primary source of oxide-type inclusions. These non-metallic inclusions have a significant contribution to shaft rejection [39]. By applying standardized procedures at each step, the failures can be reduced to a minimum.

**Figure 11.** (a) Micro-inclusions, oxide and alumina-type inclusions, observed as per ASTM E-45 (b) The specimen was hotly etched in HCl (1:1), as inclusions were observed and randomly distributed as per ASTM E-381. The random condition is R-5.

Microscopic testing, non-etched and hot-etched, was carried out to possibly detect the reasons associated with the rejection of the sugar mill shaft. The alumina and oxide-type foreign particles and microcracks, which were randomly distributed, indicated possible reasons for inclusions in the rough machined sugar mill shaft. Among numerous possible reasons for rejection, the results concluded that non-metallic inclusions, such as alumina and oxide-type inclusions, added through furnace hot-top and refractory material of the lining in the furnace, were the critical reasons that led to the shaft rejection.
