# Improving Pipe Failure Predictions: Factors Effecting Pipe Failure in Drinking Water Networks

## ABSTRACT:

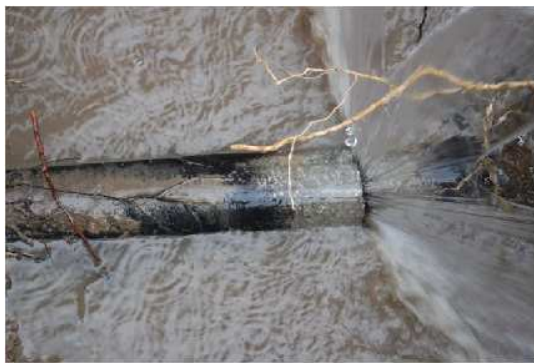
Circumferential break  
on an asbestos cement pipe.

Typical water pipe failure modes include circumferential break, longitudinal split, joint failure, and holes (both blowouts and pinhole leaks) (Farrow et al., 2017). Failure modes are associated with differing forces acting on the pipe. A typical circumferential break is often caused by tensile forces (soil movement or thermal expansion and contraction) and loading (heavy traffic) forces. Longitudinal splits are often caused by transverse and radial forces (e.g. internal water pressure)

possibly in conjunction with a pre-existing defects acting as a point of weakness. Joint failures are typically caused by tensile or compressive forces, while holes are typically caused by radial forces in conjunction with corrosion (Hu and Hubble, 2007; Makar et al., 2001). Figure 2 shows different failure modes acting *in situ*.

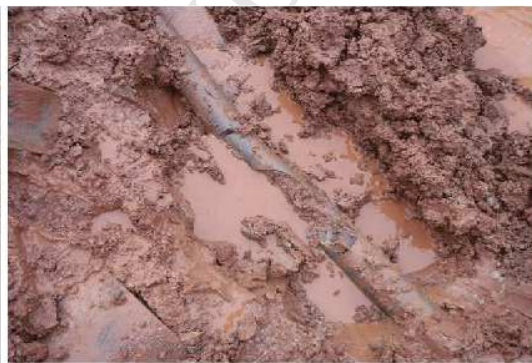
Longitudinal split  
on a polyvinyl chloride pipe.

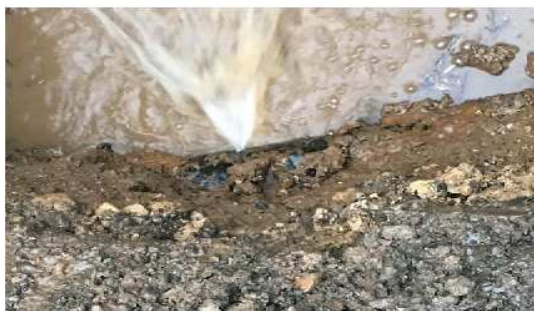
Corrosion pin hole  
on an iron pipe.

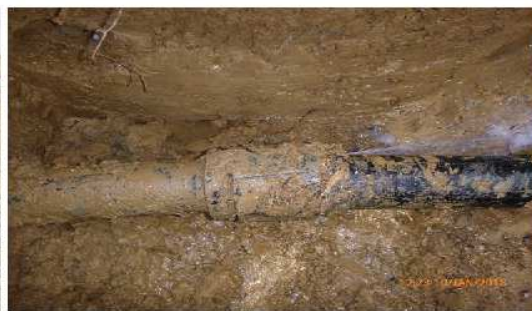
Joint failure (disconnection or gasket failure) on an asbestos cement pipe.

Figure 2. Modes of failure (images courtesy of Anglian Water, 2018).

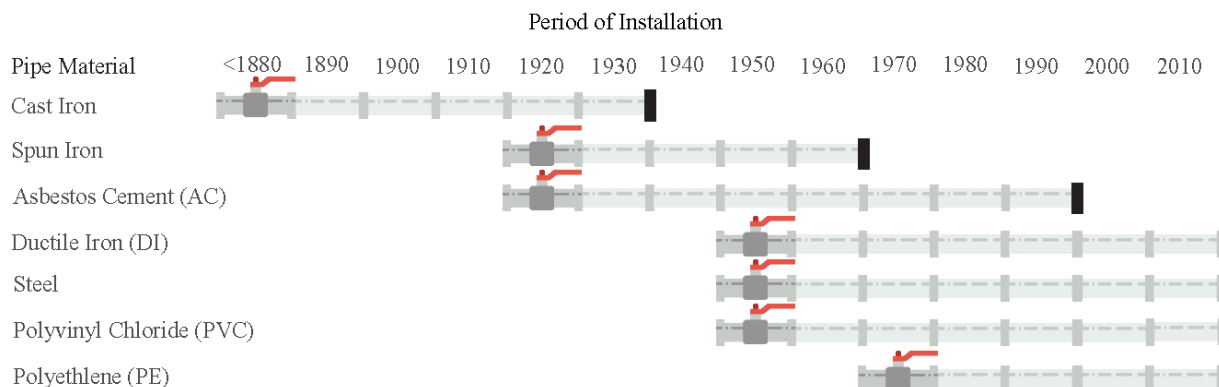
Figure 3. Approximate installation period of drinking water distribution pipe materials in the UK.

Cast iron is one of the oldest pipe materials in the UK, with some pipes dating back even to the mid-1800s (Figure 3). Iron pipes are rigid and had three main manufacturing methods, in sequence: horizontal pit casting, vertical pit casting (cast iron) and centrifugal spinning (spun iron), with each method improving on the former. Cast iron and spun iron pipes are considered together in this review as they have similar failure mechanisms, but are differentiated from the more resilient ductile iron. Ductile iron (DI) and steel were introduced in the late 1950s as alternatives to iron pipes. DI is also manufactured using the centrifugal spun method, but to a stricter manufacturing standards. The material introduces magnesium into the alloy to change the graphite within the microstructure to spheres instead of flakes, producing a tougher material as compared to cast and spun iron. Steel is stronger and more ductile than cast iron, but has a lower tensile strength, and resistance to corrosion (requires more maintenance *in situ* such as cathodic protection) than DI, meaning that DI is preferred for use in diameter pipes typically between 300

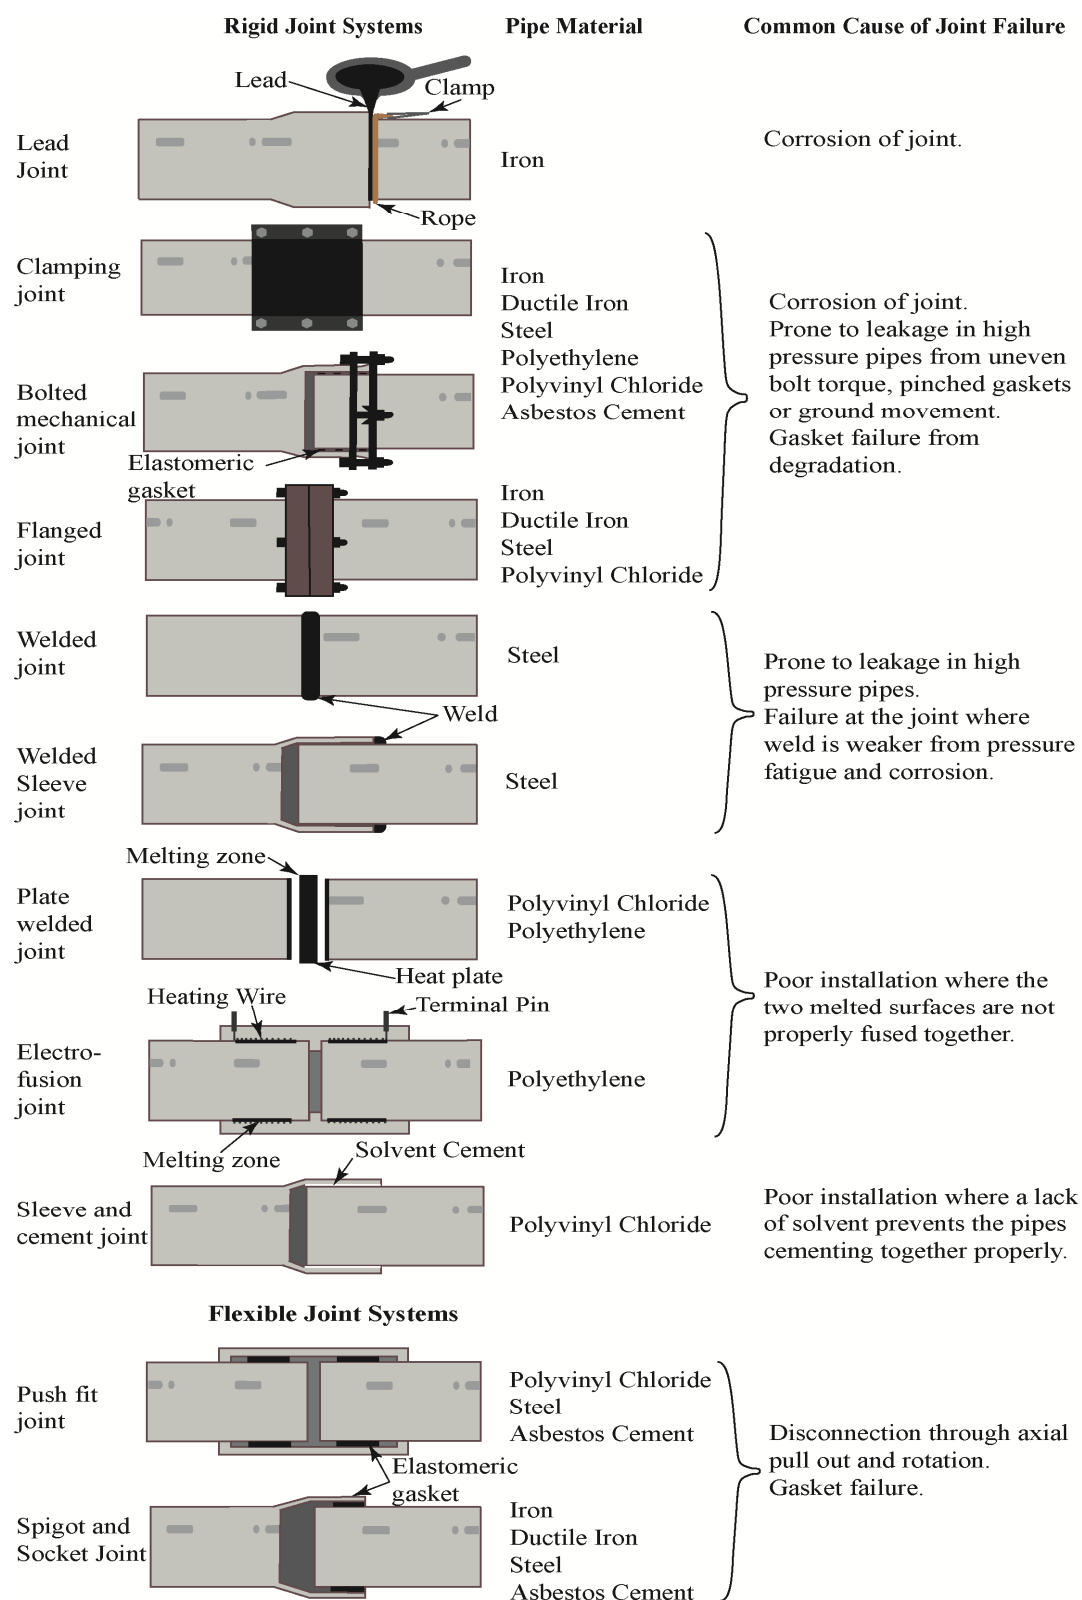
162 Figure 4. Typical joint systems and failures.

Joint failures include 1) joint leaking, 2) joint fracture, 3) disconnection or 4) gasket failure. Joint leaking can be a result of either poor installation, joint type or ground movement subsequent to installation. Typically rigid joints leak as a result of poor installation such as uneven bolt torque, or pinched gaskets, thermal expansion and corrosion of bolts or connection surfaces (Ruchti, 2017; Twort et al., 2001). However, rigid joints are more susceptible to leakage and joint fracture as a result of ground movements, where multi-directional tensile forces exert stress on the pipe (Farrow *et al.* 2017). Flexible joints are designed to withstand small movement, and are favourable in areas of high ground movement, but multi-directional ground movement or poor installation can result in flexible joint disconnection, (i.e. forcing a straight joint onto two angled pipes). Dingus et al., (2002) and Burn et al., (2005) reported that 15 % and 16 % (average) respectively of all PVC pipe failures were due to joint failure. Kirby (1981) reported that over insertion and angularity of the pipe accounts for 12.4% of all failures in PVC push fit joints. Arsénio et al., (2013) established that disconnection through joint rotation and axial pull out were the most important failure mechanisms for push fit joints (flexible joint) in PVC pipes. This is typically found where the angle of the pipe joint increases past 10° requiring a reduction in joint depth. Gasket failure is a result of age, drying out, loss of elasticity or degradation over time (Farrow et al., 2017). Kirby (1981) established that ~ 11% of PVC failures were attributed to insufficient solvent and poor joint assemblage while 4% arose from the use of excess solvent.

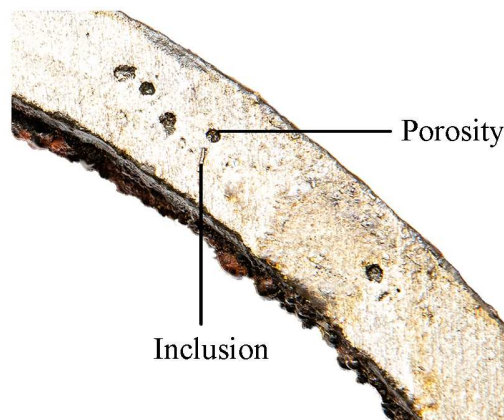
Figure 5. Porosity and inclusion defects in a cast iron pipe.

Defects introduced during manufacturing increase the probability of pipe failure. Defects in pit cast iron include: 1) non-uniform wall thickness, 2) porosity, 3) inclusions, 4) cold shuts and 5) micro-cracks (Trew et al., 1995) (Figure 5). Non-uniform wall thickness is a result of rising slag and off-centre inner core moulds, causing localised weakened areas of pipe wall. Porosity is caused by air trapped in the mould when the molten iron solidified, causing micro-crack formation paths. Inclusions are objects unintentionally introduced into the material fabric, breaking continuity and causing subsequent weak points. Cold shuts are discontinuities in liquid streaming, resulting in incomplete fusion of two adjoining surfaces. Micro-cracks (longitudinal or transverse) are caused from uneven temperatures (i.e. during cooling), forming weak points from which larger cracks formed under pressure (Makar et al., 2001; Rajkolhe and Khan, 2014; Thacker and Scholar, 2015).

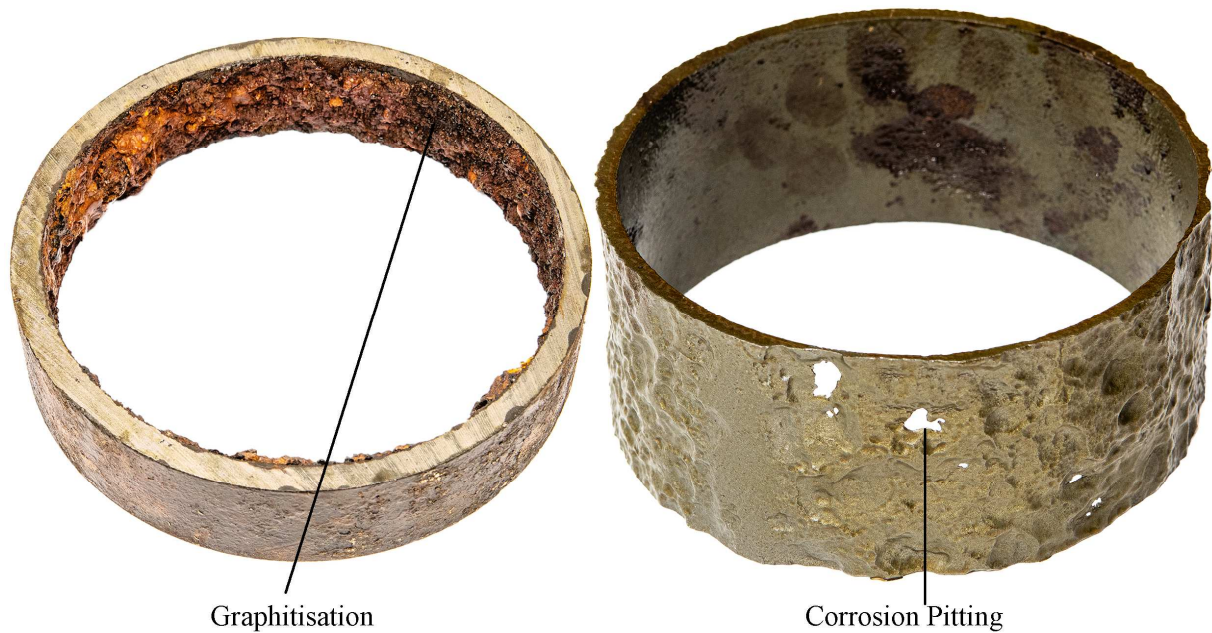
Figure 6. Cast iron pipe corrosion and chemical degradation.

Highly corrosive soils can deteriorate pipes at faster rates, especially for older pipes without protection. Two main types of corrosion occur in metal pipes: 1) graphitization and 2) corrosion pitting (Figure 6). Graphitization, described by Makar, Desnoyers and McDonald (2001), occurs mainly in cast iron, and is a key corrosion process that occurs when iron oxide reacts with the graphite in the iron alloy, leaching the iron and leaving the graphite behind. In some cases of

aggressive graphitisation all iron is removed, significantly weakening the pipe. (Farrow et al., 2017; Rajani and Kleiner, 2001). Corrosion pitting occurs in all forms of metal pipes, from the presence of sulphate and chloride ions in the surrounding environment, causing deterioration of the pipe material from electrochemical and or chemical action corrosion (Volk et al., 2000).

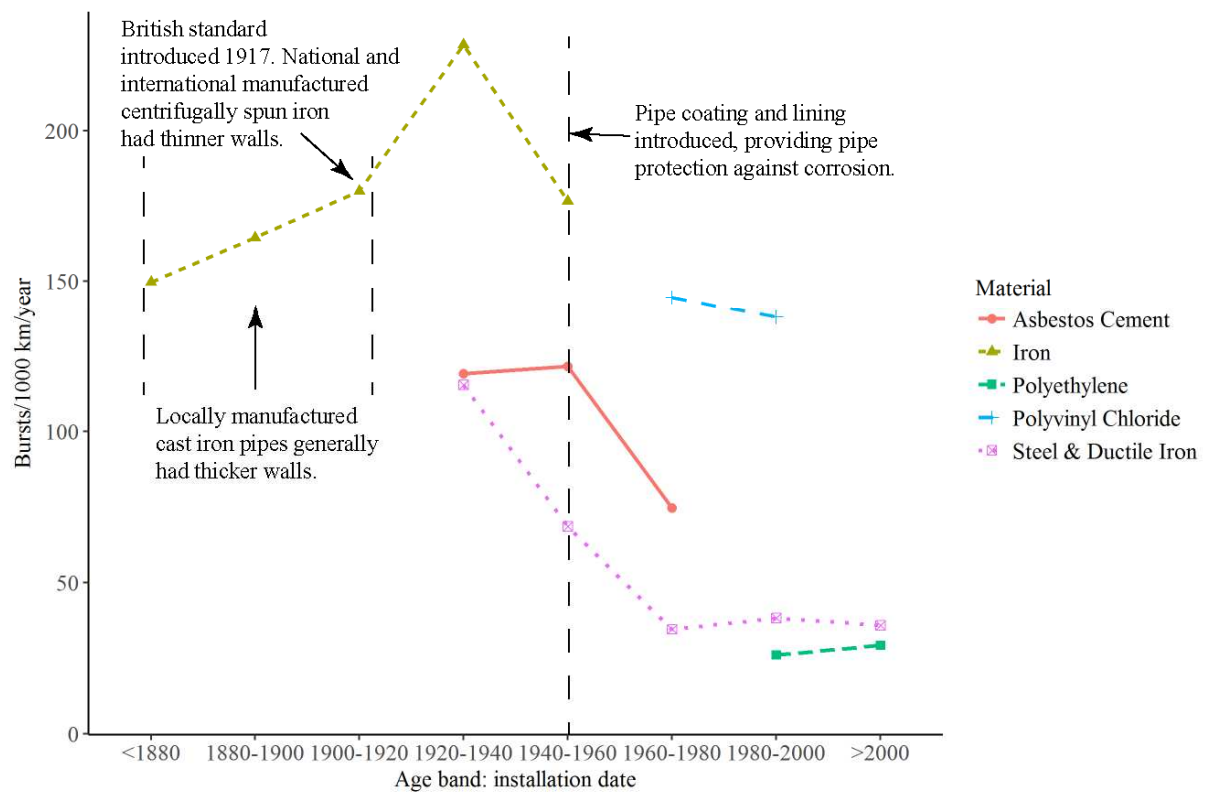
Figure 7. Summary of introduction year and successive failure rates by age by material type (Utility Provider, 2018).

Failure rates for iron, DI and steel peak for pipes installed during the 1920s – 1940s, AC during the 1940s – 1960s. Both PE and PVC have steady failure rates by age. Iron shows that failure rates increase for newer pipes, up to the 1920s – 40s and then fall again which is unexpected. This could be due to manufacturing, where materials and standards have been manufactured differently, resulting in different quality of materials (Wols and van Thienen, 2016); early iron pipes were locally cast and had very thick walls. Iron pipe standards were then introduced in 1917 with BS 78 1917, where pipes were mainly spun to a specification which produced thinner walls that failed earlier than thicker pipes. Thereafter failure rates fall up to the 1960s, which is due to the shift towards centrifugally spun iron and pipe protection, constructional methods which

produced a more resilient pipe or the replacement of these lower quality pipes with newer materials (Wols and van Thienen, 2016). All material failure rates start to improve after the 1940s – 1960s, perhaps due to the age of the installation, improved construction practices and improved protection against corrosion.

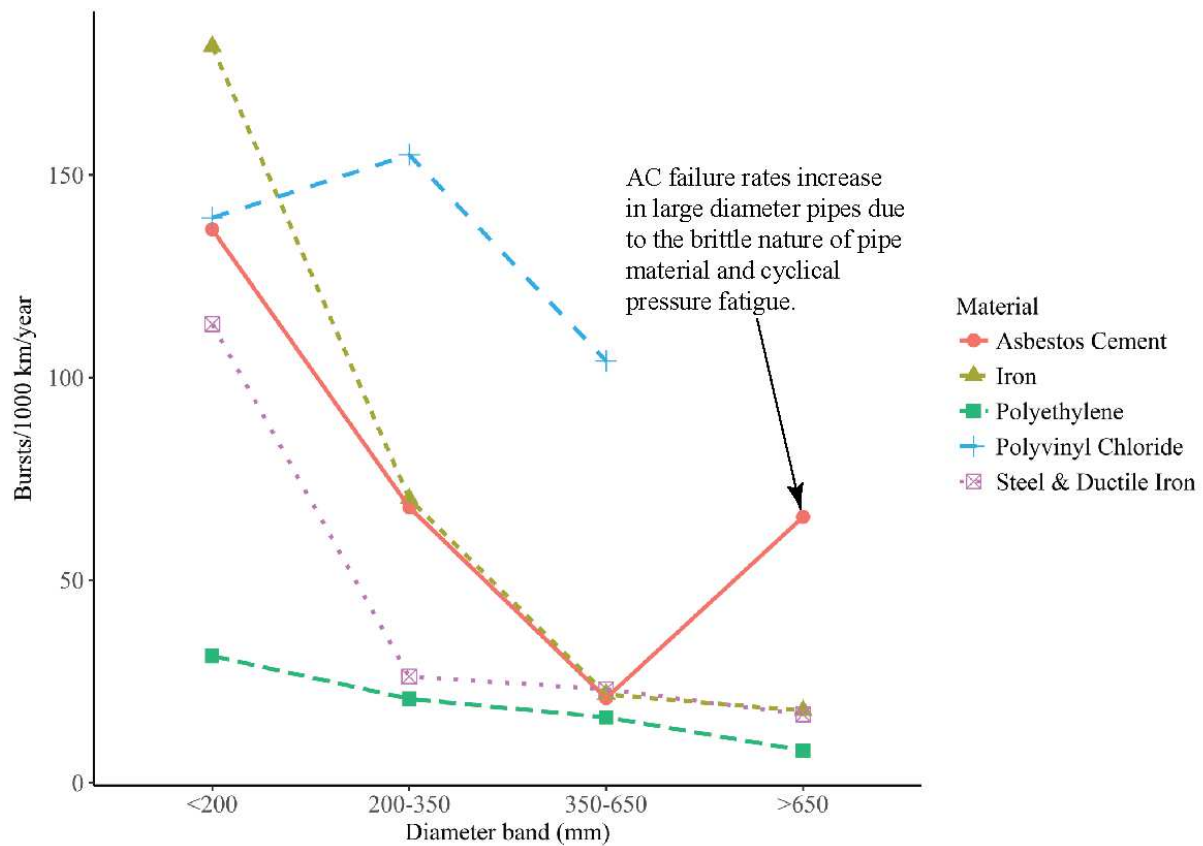
Figure 8. Summary of failure rates by diameter size and pipe material type (Utility Provider, 2018).

Pipe failure records suggest a strong relationship between failure rates and pipe diameter size (Hu and Hubble, 2007; Kettler and Goulter, 1985; Kimutai et al., 2015; Pelletier et al., 2003). The highest failure rate was reported in pipes < 200 mm in diameter, however, it has regularly been noted that this diameter range is also the most frequent (Bruaset and Sægrov, 2018; Fuchs-Hanusch et al., 2013; Gould et al., 2011; Hu and Hubble, 2007). Higher failure rates in small diameter pipes may be associated with low resilience to ground movement and corrosion (thinner walls), poor joint reliability (Gould et al., 2013) and susceptibility to nearby construction activities especially in urban areas and at shallower depths (Bruaset and Sægrov, 2018). Circumferential failures are typically associated with pipes < 200 mm in diameter, and are the most frequent failure mode for metal and AC pipes of this diameter (Bruaset and Sægrov, 2018; Wengström, 1993). Where longitudinal failures occurred in smaller diameter pipes, Ruchti (2017) reported differential settlement as the common mechanism for failure. When researching large pipes Rajeev *et al.* (2014) found longitudinal failures and holes to be the common failure mode for larger pipes, typically > 300 mm in diameter; the evaluation suggesting corrosion and internal water pressure as the main causes. Typical failure rates by diameter size and material type are presented in Figure 8.

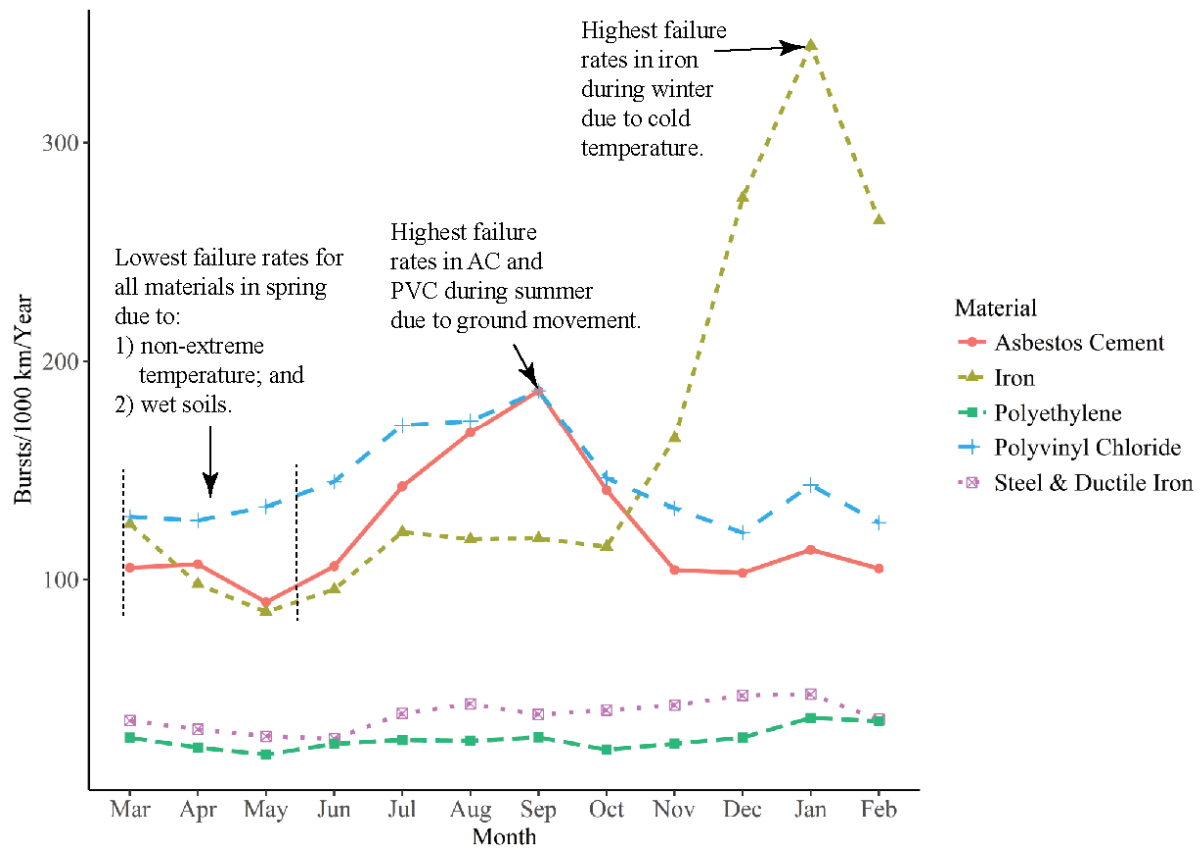
Figure 9. Summary of seasonal failure rates by material type (Utility Provider, 2018).

A comparison of seasonal failure from the utility provider is shown in Figure 9. The results show that highest failure rates for iron are during the winter months, whilst AC and, to a lesser extent, PVC have higher failure rates during the summer. DI, steel and PE show little variation to seasonal change but can be seen to slightly increase during the winter.

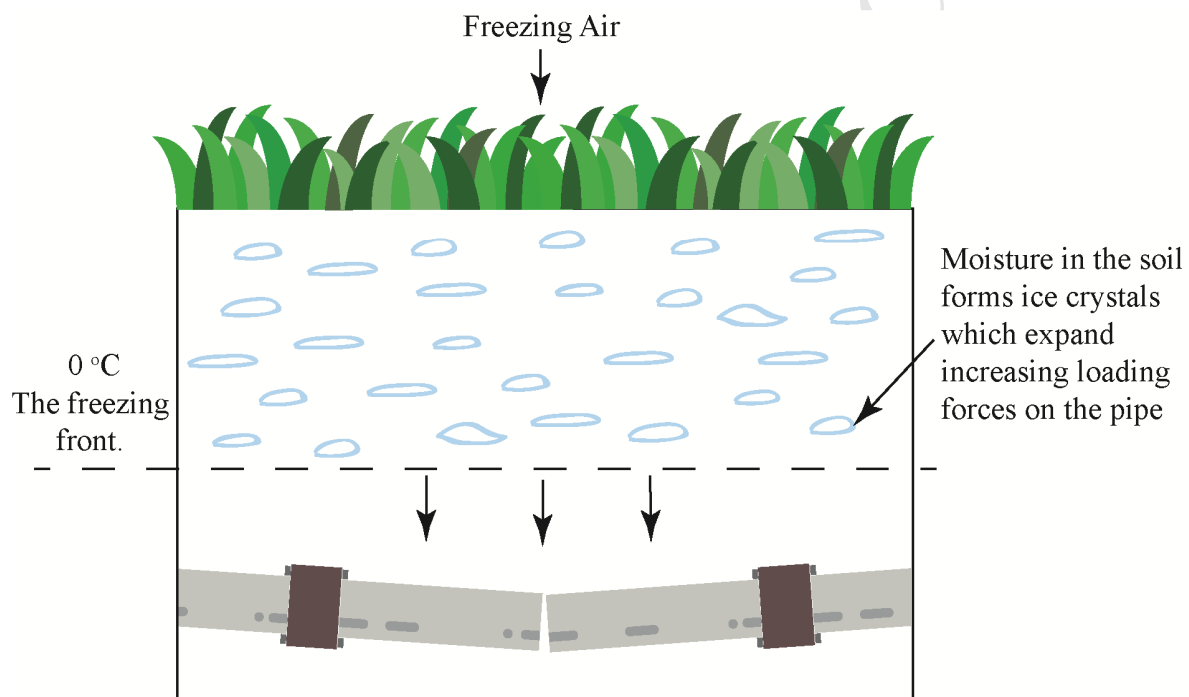
Figure 10. Frost loading on pipe.

cause the internal water to freeze and expand, placing pressure on the pipe (especially where defects are present) (Edwards et al., 2009) – freezing water can expand by 9% in volume. Furthermore, prolonged frost periods can cause increased brittleness in plastic pipes resulting in premature failure (Rezaei et al., 2015). Future trends in climate change suggests that milder temperatures during winter will result in fewer pipe failures during this period, especially in iron pipes (Wols and van Thienen, 2016).

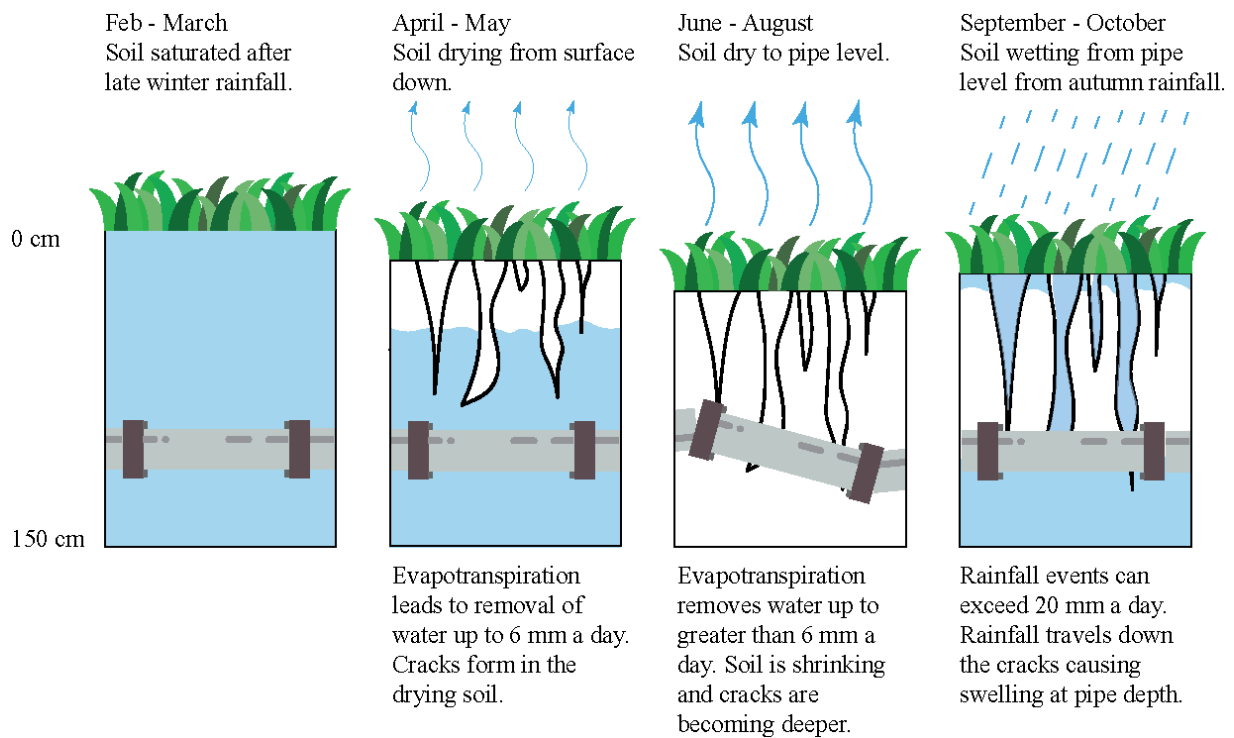
Figure 11. Seasonal shrink swell effect in clay-rich soils (after Farewell *et al.*, 2012, p. 10).

Pipe failure is lowest during the spring when soils are consistently wet, so movement is unlikely. Chan, Gould and Davis (2005) suggested that the late summer and early autumn months are the most influential time of year for AC failure rates, since soil moisture and temperature varies the most during this period, increasing the shrink swell effect. This is also shown in the data from the UK utility provider in Figure 9. UK soils normally dry to 1 – 1.5 m (Pritchard et al., 2015a), but long periods of drought can result in deeper drying and higher failure rates (Farewell et al., 2012b). High failure rate in PVC push fit joints are associated with ground movement causing disconnection through joint rotation and axial pull (Arsénio et al., 2013). The effects of soil shrink swell on pipes from changes in soil moisture are shown in Figure 11.
