# Improving Pipe Failure Predictions: Factors Effecting Pipe Failure in Drinking Water Networks

To reduce leakage and improve service levels, water companies are increasingly using statistical models of pipe failure using infrastructure, weather and environmental data. However, these models are often built by environmental data scientists with limited in-field experience of either fixing pipes or recording data about network failures. As infrastructure data can be inconsistent, incomplete and incorrect, this disconnect between model builders and field operatives can lead to logical errors in how datasets are interpreted and used to create predictive models. An improved understanding of pipe failure can facilitate improved selection of model inputs and the modelling approach. To enable data scientists to build more accurate predictive models of pipe failure, this paper summarises typical factors influencing failure for 5 common groups of materials for water pipes: 1) cast and spun iron, 2) ductile iron, 3) steel, 4) asbestos cement, 5) polyvinyl chloride (PVC) and 6) polyethylene (PE) pipes. With an improved understanding of why and how pipes

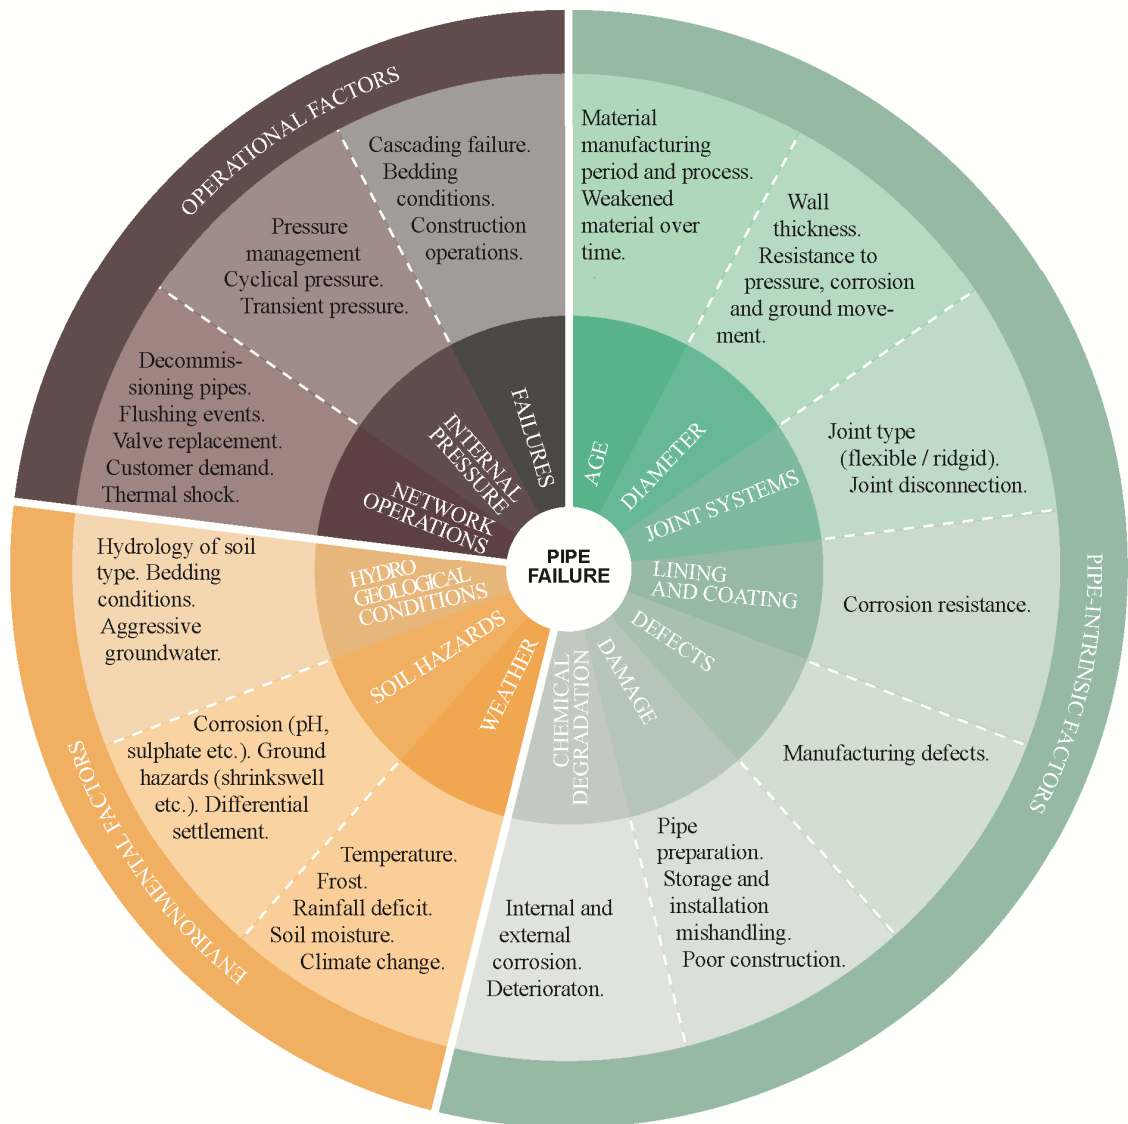
Figure 1. Factors influencing the failure of drinking water pipes.

There are many different modes and mechanisms for pipe failure. Complex relationships between factors and their relative contributions to the failure mechanism are unique for each pipe material and geographic region (Gould et al., 2013; Rajeev et al., 2014). Factors can be categorised to three groups: 1) pipe-intrinsic, 2) operational and 3) environmental. Figure 1 presents the major factors affecting water pipe failure.
