## Short communication

## On residual tensile strength after lightning strikes

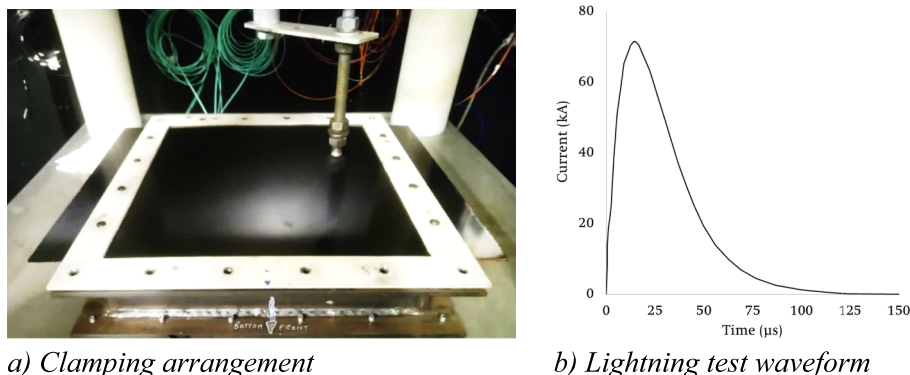
Fig. 1. Laboratory lightning strike test with a) clamping used and b) waveform used.

A large test panel measuring 650 mm × 440 mm × 4 mm with a stacking sequence of [45/90/-45/0]<sub>4s</sub> was manufactured using Hexcel's HexPly® IM7/8552 carbon/epoxy pre-preg. The test panel was bolted into a grounded rig, below an electrode as shown in Fig. 1a, to ensure firm contact between the specimen and grounding clamps, forming a route to ground for the injected current. It was demonstrated previously that only a small portion of the injected current flows through the bolts to the grounding clamps due to the distance between the local attachment point and these bolts, and the bolt holes do not have a tangible effect on the residual strength of the specimen [5]. Lightning strike tests were performed at Cardiff University's Lightning Laboratory, part of the Advanced High Voltage Engineering Research Centre. A 100 µs long lightning Waveform D with a peak current of 75 kA and  $T_1/T_2$  of 18/40 µs, following the EUROCAE ED-84 standard [18], as shown in Fig. 1b, was injected into each quadrant in turn, following a previously established procedure [5]. Current injection in the centre of one quadrant allows grounding into that corner with minimal impact on the other three quadrants of the panel. In the lightning tests, a small insulating plastic diverter sphere (to prevent contamination between the electrode and the specimen) and a thin metallic fuse wire (50 mm long) were used to guide the lightning arc to the exact point at the centre of each quadrant on the panel [19]. These points in the four quadrants are far apart thus the lightning damage is not expected to overlap into neighbouring quadrants, as confirmed by the previous study [5]. Previous

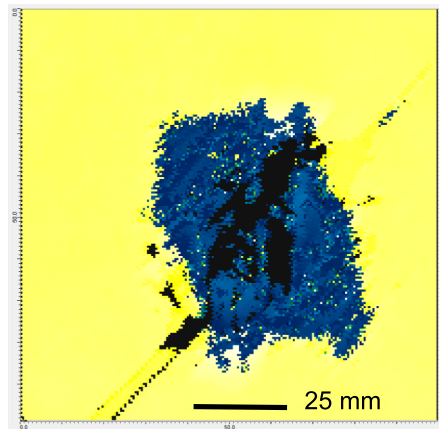
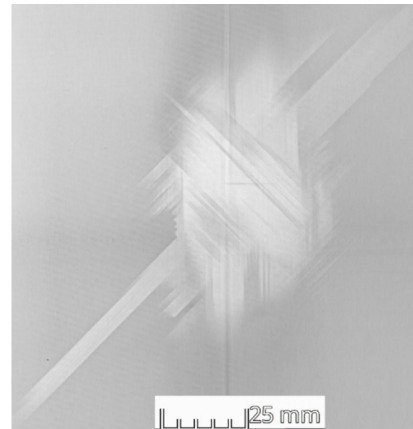
a) Ultrasound scan of a typical TAL specimen

b) CT scan of a previous CAL specimen [5]

**Fig. 2.** Lightning damage in a typical specimen after lightning strikes with a 75kA peak current.

An initial visual inspection of the post-strike damage showed many broken, lifted, and separated fibres and a large amount of surface pitting around the strike area, as shown in Fig. 4a. Matrix damage (i.e., cracking or thermal decomposition) and further surface pitting was also observed a short distance from the initial lightning attachment point. The lightning struck panel was further inspected at the Bristol Composites Institute using an ultrasound scanner with a multi-format coherent receiver developed for advanced modulation format signals. The time-of-flight information is presented in Fig. 2a, indicating the extent of damage caused by the lightning strikes. The lightning damage is comparable to the previously reported CT scan image in Fig. 2b from Ref. [5], for a 75 kA Waveform D strike on the same material and stacking sequence, confirming repeatability. The scans show that the lightning damage is superficial and unsymmetrical through the thickness.

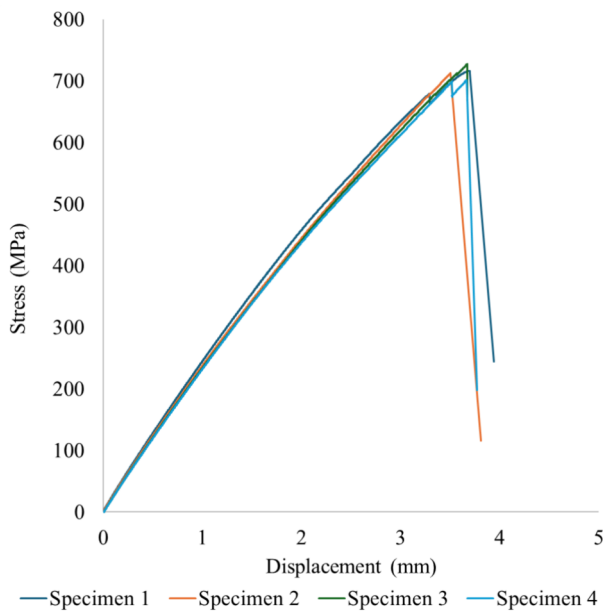
**Fig. 3.** Stress-displacement curves from four TAL tests.

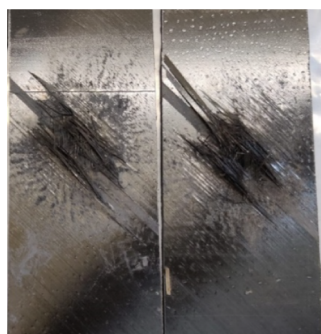
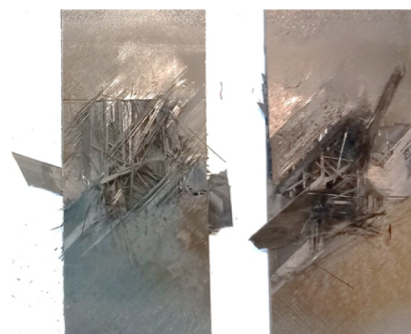
a) Post-strike, pre-TAL testing

b) Post-TAL testing

**Fig. 4.** Images showing Specimens 3 and 4 (L-R) a) before TAL testing and b) after TAL with failures at the gauge section.

Gauge section failure around the lightning damage site was observed in all four tensile tests, with exemplar failures shown in Fig. 4. During tensile loading the specimen failed at its centre and delamination propagated from the existing lightning strike delamination and damage regions to the specimen edges. The in-plane damage was extensive, owing to the complexity of the lightning damage pattern shown in Fig. 2. The majority of post-tension damage is observed in the upper plies which is directly correlated to the locality of severe lightning damage, discussed previously. Inspection of the specimen post-strike and post-TAL indicate that only the top few 0° plies have been damaged, which has limited the reduction in TAL failure stress to 23 %. While these results can indicate the global failure of the specimen, it is important to analyse contributions to failure and residual strength at a ply level.

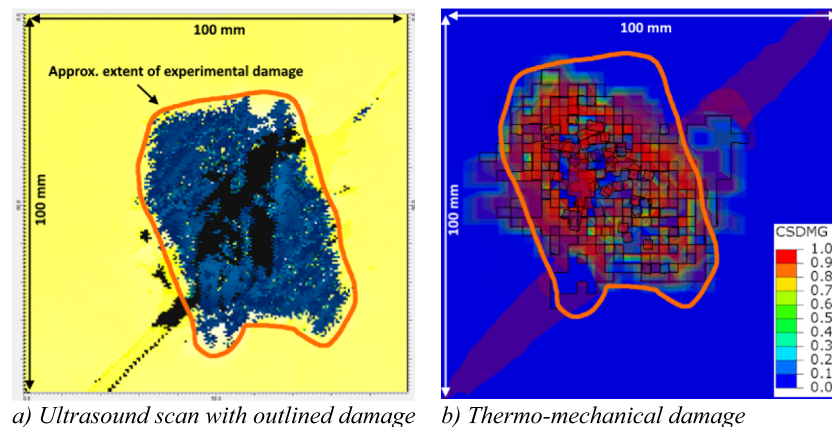
Fig. 5. Comparison of experimental ultrasound scan and thermo-mechanical damage predictions where colours represent delamination damage.

stress predictions, was applied to predict the TAL failure stress. Sequentially coupled thermal-electric and thermo-mechanical models were combined with TAL analyses. Thermal-electric models were used to predict thermal damage resulting from Joule or resistive heating, while thermo-mechanical models were used to predict lightning mechanical damage due to the combined effects of mechanical strain (from dynamic loading) and thermal strain (due to temperature transferred from the previous thermal damage simulation). Both the thermal-electric and thermo-mechanical models completed previously [22] measured 275 mm × 250 mm to replicate the quadrant of the larger lightning test panel. Since the TAL specimens measured 220 mm × 85 mm, the geometric size of the TAL model was reduced to match the experimental arrangement. Given the repeatability of the lightning strike damage between studies (Fig. 2), predicted thermal-electric and thermo-mechanical results presented previously were reused [22,23]. Fig. 5 compares the ultrasound scan, including an approximate outline of the overlaid damage area, with the predicted lightning mechanical damage and delamination from the thermo-mechanical simulation.

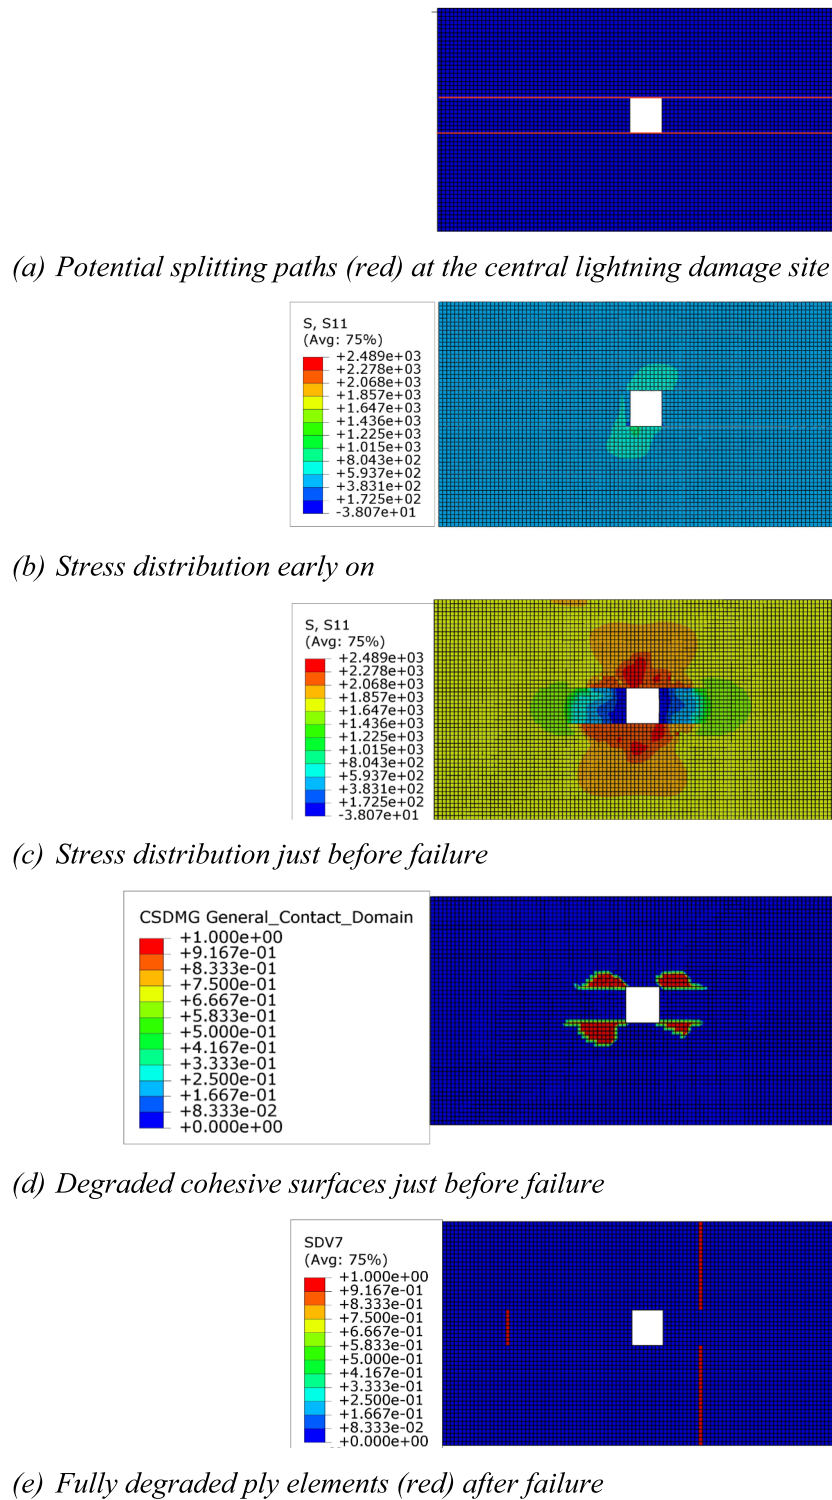
Fig. 6. FE results in the 3<sup>rd</sup> 0° ply of the TAL model.

During TAL simulation, separation of cohesive surfaces initiated and propagated from the lightning damaged area along the pre-defined splitting paths. This is demonstrated by the stress distribution in a typical 0° ply as shown in Fig. 6. Fig. 6 includes the approximate lightning fibre damage, transferred from the thermo-mechanical simulation, which is smaller than the area in Fig. 5 given Fig. 6a only shows the critical fibre damage in the 3<sup>rd</sup> 0° ply while Fig. 5 shows overlaid delamination for multiple plies. Early on, high stresses occurred near the lightning damage site (Fig. 6b). As splitting and delamination grew, the high stresses spread beyond the lightning fibre damage site and their concentration was reduced (Fig. 6c). The 0° splitting and delamination are represented by the degraded cohesive surfaces (Fig. 6d). The TAL model fails from its centre near the existing lightning damage site to the model edges (Fig. 6e), but some elements to the left are also affected post failure. The delayed fibre failure initiation immediately triggered the ultimate failure in the TAL model.
