## Short Communication

# Hygrothermal effects on translaminar fracture toughness of quasi-isotropic laminates with different stacking sequences

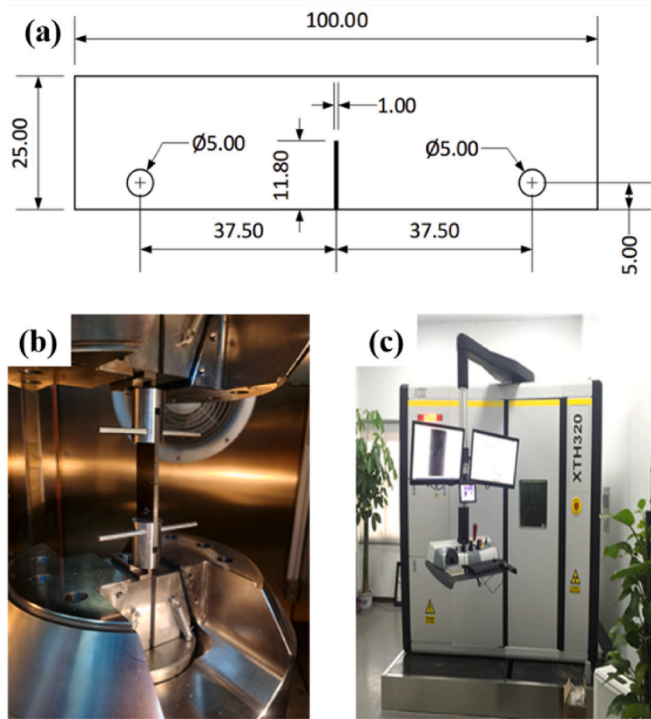
**Fig. 1.** Specimen and test set-up (a) geometry and dimensions of specimen, based on ASTM E1922; (b) test jig in chamber; (c) CT scanner, NIKON XTH 320 LC CT.

The eccentrically loaded single-edge-notch tension (ESET) specimen design and testing process strictly follow the ASTM E1922 standard [22]. The dimensions of the specimen are shown in Fig. 1a. Hexcel's IM7/8552 carbon/epoxy UD prepreg was used. The test panels were divided into two groups featuring different quasi-isotropic stacking sequences, i.e.  $[90/45/0/-45]_{4s}$  and  $[45/90/-45/0]_{4s}$ . The nominal thickness and width of specimens were 4 mm and 25 mm, respectively. The specimens, including the notches, were cut from a plate using 1 mm diameter carbide endmills on a computer numerical controlled (CNC) router. No cutting damage was visible at the holes. The notch tip was extended manually using a precision saw blade with a width of 0.25 mm. After drying in a chamber (70 °C) for 6 hours, these samples were placed in a humidity chamber to be conditioned at 80 °C and 85 % RH for 3 months as per the ASTM D5229/D5229 M standard [23] until two consecutive measurements of mass were within 0.02 % after a week. The final percentage of mass gain was 0.7 %. The specimens were loaded on a 250 kN Zwick/Roell 250SE test machine with loading pins inserted into the two holes in the specimen as per the ASTM E1922 standard [22]. The experimental setup in an environment chamber is shown in Fig. 1b. All tests were carried out at 120 °C in a thermal chamber. A NIKON XTH 320LC X-ray CT scanner was subsequently used to observe the crack propagation of specimens in Fig. 1c. The location, size and morphology of damage were examined with a resolution of 50  $\mu$ m. The scanning voltage was 100 kV (160  $\mu$ A) and the exposure time for each radiograph was 500 ms.

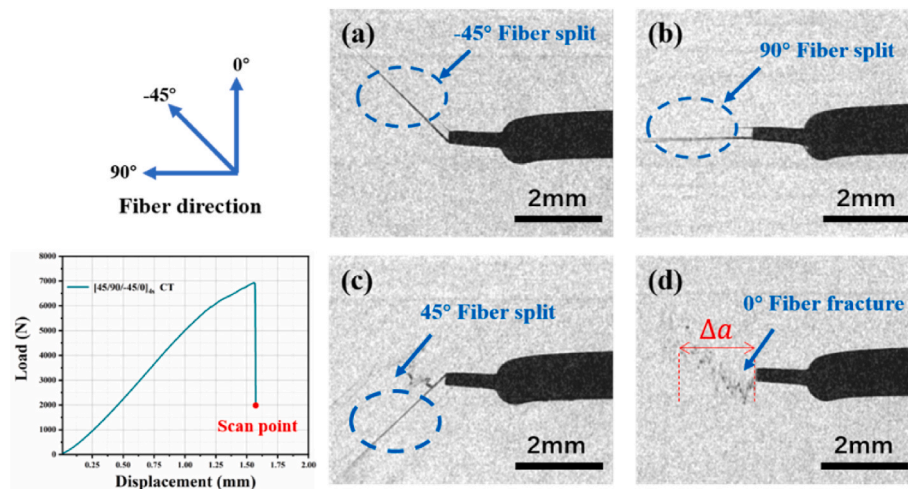
**Fig. 2.** Typical CT images of damage in (a) -45° ply, (b) 90° ply, (c) 45° ply, (d) 0° ply of  $[45/90/-45/0]_{4s}$  specimen at HTW. Note. These images were captured immediately after the peak load, and  $\Delta a$  is the 0° crack increment.

As shown in Fig. 2, a set of images through the thickness were taken from a CT scan done immediately after a HTW specimen reached the

peak load. In all of the  $90^\circ$ ,  $-45^\circ$  and  $45^\circ$  plies, damage such as splitting, and fiber failure could be observed. According to previous *in situ* experimental results of the same specimens at RTD condition [18],  $0^\circ$  ply fracture already occurred before the peak load, and it was found that only after all plies were broken including the  $\pm 45^\circ$  plies, that significant load drops occurred. In the current study at HTW, it was also found that at the peak load all plies are broken including the  $\pm 45^\circ$  plies (Fig. 2c). This indicates that the fracture process zone was fully developed along the direction of translaminar fracture at the large load drop, which is consistent with the previous studies using the same specimen [17,18].

The definition of crack length influences the value of fracture toughness [24]. Here, the effective crack length  $a$  was adopted, which consists of two parts: the machined notch length  $a_N$  and the size of the fracture process zone  $\Delta a$ . Including the size of the fracture process zone is necessary when  $\Delta a$  is no longer negligible, to make the measured fracture toughness accurate. Here,  $\Delta a$  is quantified by the average fiber breakage length in all  $0^\circ$  plies at HTW, taken as the average value of 1.9 mm from the CT images e.g. in Fig. 2d. This is in comparison to the  $\Delta a$  value of 1.4 mm at RTD [18].

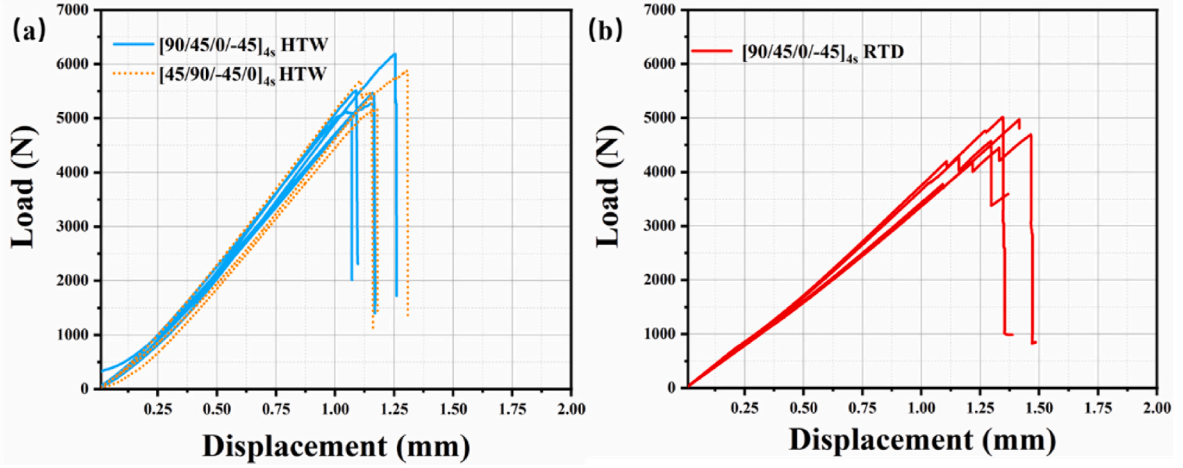
**Fig. 3.** (a) Load-displacement curves of two sets of specimens at HTW. Note. The peak load of  $[90/45/0/-45]_{4s}$  and  $[45/90/-45/0]_{4s}$  are  $5514 \text{ N} \pm 407.3$  and  $5587 \text{ N} \pm 369.3$ , respectively. (b) Load-displacement curves of specimens at RTD. Note. The peak load is  $4812 \text{ N} \pm 216.3$ .

The load and displacement curves from two sets of HTW tests at Zhejiang University are shown in Fig. 3a, while those tested at RTD using an Shimadzu test machine with a 10 kN load cell at the University of Bristol are also shown in Fig. 3b [18]. The following points were observed: (1) An approximately linear load-displacement relationship is apparent at the beginning of the tests. The initial slopes in Fig. 3a and b are slightly different at different environmental conditions. This is because the displacements were measured at the crossheads of two different machines. However, displacements were not used for data reduction according to the ASTM E1922 standard [22]. A final drop occurred at the peak load (Fig. 3a). No obvious load drops occurred before the peak load at HTW. In contrast, multiple load drops were observed on the load-displacement curves at the RTD as seen in Fig. 3b [18]. The final load drops at both temperatures (room temperature and  $120^\circ\text{C}$ ) were accompanied by compression failures at the rear end of the samples. It is believed that the compressive failure occurred after the fracture process zone was fully developed, because the fracture process zone at HTW looks similar to that already fully developed at RTD but larger. The compressive failure stopped any further fracture propagation, but the average maximum load at HTW is already nearly 20 % higher than that at RTD.

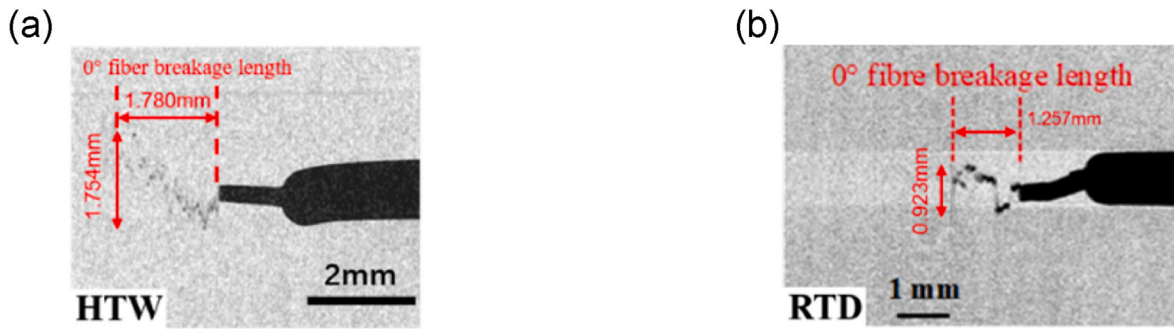
**Fig. 4.** Typical CT images of 0° plies at (a) HTW and (b) RTD [18] conditions. *Note.* The saturated damage height at HTW and RTD condition are 1.754 mm and 0.923 mm, respectively.

- 1) The initial splits in *ex situ* CT scan images of typical  $0^\circ$  plies at RTD and HTW conditions were compared [18]. It was observed that the  $0^\circ$  splitting was longer at HTW than at RTD. The longer  $0^\circ$  fiber

splitting blunts the stress concentration at the tip of the notch, which retards the fiber breakage [18]. This leads to the increase of failure load at HTW and demonstrates the effect of 0° splits on translaminar fracture toughness.

- 2) Zobeiry et al. defined the extent of fiber breakage parallel to the 0° fiber direction as the saturated damage height [26]. Compared with the results at RTD, the height of saturated damage at HTW also increases significantly as shown in Fig. 4. The average saturated damage height based on the measurements in the 0° plies is 48 % higher at HTW than that at RTD. This indicates longer fiber debonding or pull-out lengths. As described in Ref. [21], the Mode II fracture toughness decreases with increased temperature and humidity level giving increased fiber pull-out length, thus leading to a larger saturated damage height. A larger saturated damage height in Fig. 4 leads to higher translaminar fracture toughness at HTW.
