# A study on helicopter main gearbox planetary bearing fault diagnosis

Helicopter main gearbox  
Planetary bearing  
Self-adaptive noise cancellation  
Kurtogram  
Envelope analysis  
Condition monitoring

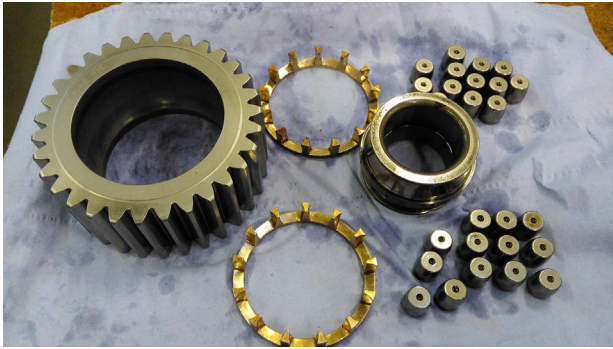
Fig. 6. The components of 2nd planetary bearing.

on the outer race of 2nd epicyclic planetary bearing, a 2nd epicyclic planetary bearing was disassembled (Fig. 6). The bearing had two layers of races, as well as two sets of rollers and cages.
