## A microscopy study of nickel-based superalloys performance in type I hot corrosion conditions

<sup>a</sup>Institut Clément Ader, IMT Mines, Albi, France; <sup>b</sup>Surface Engineering and Precision Centre (SEPC), Cranfield University, Cranfield, UK

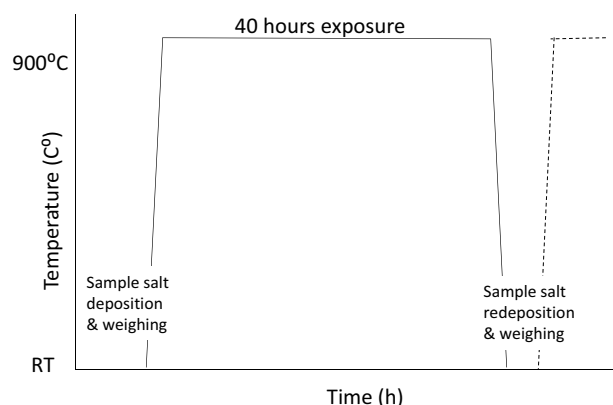
Figure 1 further illustrates each cycle, sample exposure of 40 h in a vertical controlled atmosphere furnace at 900°C. After 40 h of exposure in the furnace, the sample were weighed, resalted, and reweighed again. Each sample was salted using a deposit salt solution at a flux rate of  $1.5 \mu\text{g}/\text{cm}^2/\text{h}$  and placed on a hot plate at 180°C to be certain of the evaporation of the water.

Figure 1. Schematic of a cycle of exposure [6].

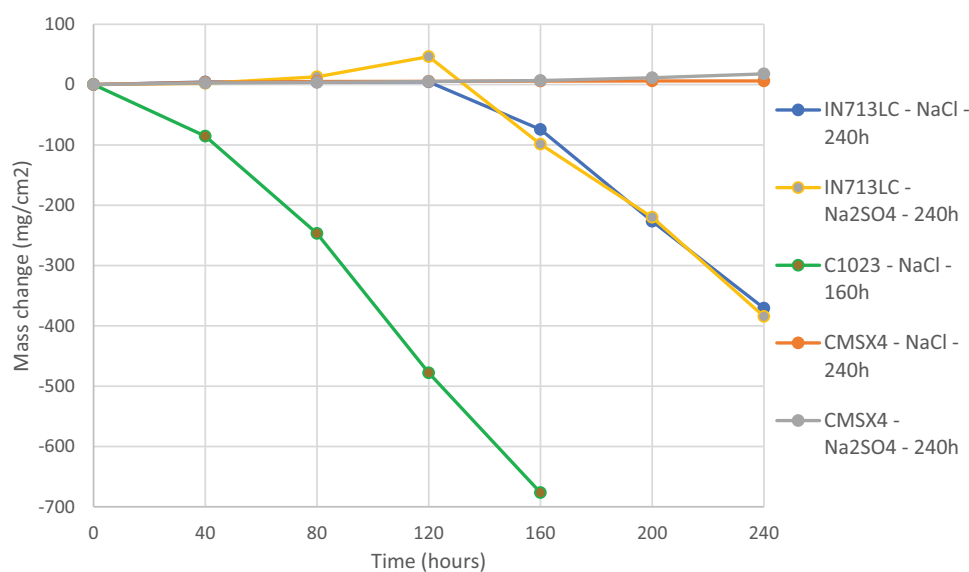
Figure 2 illustrate the mass change data of all three superalloys (IN713LC, C1023 and CMSX-4) covered with sodium sulphate and sodium chloride for 160 and 240 h at 900°C.

The mass change data for samples CMSX-4, covered with sodium sulphate or sodium chloride, exhibit very little mass change. However, IN713LC and C1023 showed significant mass loss. C1023 showed the highest mass loss values of  $\sim 700 \text{ mg/cm}^2$  after 160 h of exposure. IN713LC interestingly showed approximately  $400 \text{ mg/cm}^2$  mass loss covered with both salts (sodium sulphate and sodium chloride) after exposure of 240 h. The mass change data for IN713LC showed a significant downward trend initiated at 120 h, which suggested a change from incubation to propagation. However, alloy C1023 showed rapid mass loss showing an incubation time shorter than 40 h, and rapid propagation.

Figure 2. Mass change data of alloys IN713LC, C1023, and CMSX-4 covered with salts deposits exposed to air + 300 vppm  $\text{SO}_x$  gaseous atmosphere gas for 160 and 240 h at 900°C.

much less corrosion damage than C1023 and IN713LC after 240 h of exposure. The dimensional metrology data shown in Figure 6 is in good agreement with mass change data in Figure 2

It was also observed from Figure 2 that IN713LC and C1023 differ in their incubation time; thus the onset of propagation not only depends on the microstructure but also on the alloy chemistry. Figures 4 and 9 indicate that CMSX-4, when covered with sodium chloride or sodium sulphate, shows greater degradations; thus, CMSX-4 is not resistant to corrosion but, has an incubation time greater than 240 h of exposure at 900°C. Both IN713LC and C1023 alloys are chromia formers. These chromium oxides on the layers help them to prevent corrosion, but this is not quite effective. Presence of grains and the level of refractory elements within both polycrystal alloys are deciding factors. Park and co-workers [22] studied the role of chromium, aluminium, and the effect of refractory elements on nickel-based super alloys in high-temperature oxidation environment. Their findings suggest that the appropriate level of refractory elements such as molybdenum is key to have alloys minimum oxidation rates or it may hinder the formation of chromia or alumina, as well as the volatilisation of their oxides. High valence ion of molybdenum is likely to have consumed high level of oxygen and formed molybdenum oxides. Molybdenum oxides can be readily fluxed by alkali salt forming acid melts containing sodium molybdate increasing the rate of type

The various salts used in this study have different impacts on each alloy. Sodium chloride and sodium sulphate seem to have a similar corrosion damage results (as shown in Figure 2 mass change data), whereas samples covered with calcium chloride salts (Figure 3 mass change data) show a more minimal effect on the corrosion of the alloys.

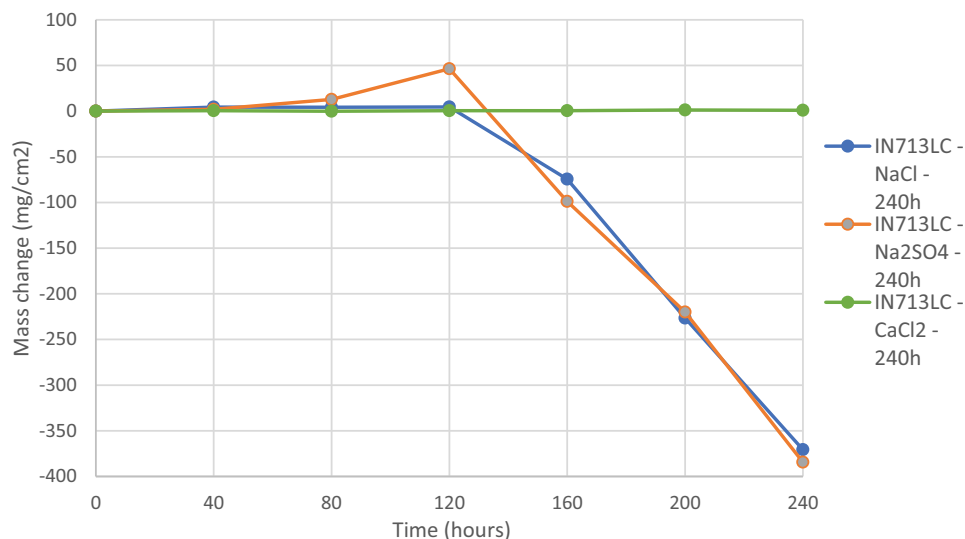
Figure 3 demonstrates the effect of three salts (sodium chloride, sodium sulphate, and calcium chloride) on mass change data for IN713LC alloy.

It is noticeable in Figure 3 that sodium sulphate and sodium chloride play a similar role on IN713LC and leads to a loss of mass of  $\sim 375 \text{ mg/cm}^2$  after 240 h of exposure at 900°C. It is also noticeable that these two molten salts have the same incubation time of 120 h and the same corrosion rate after this time of incubation of respectively  $-141,34 \text{ mg/cm}^2/\text{h}$  for IN713LC salted with sodium sulphate and  $-127,79 \text{ mg/cm}^2/\text{h}$  for IN713LC salted with sodium chloride. However, calcium chloride seems benign with negligible mass change was observed for the sample during the 240 h of exposure of IN713LC sample. The sample of IN713LC salted with this calcium chloride salt showed no sign of corrosion. The data suggest that calcium chloride salt deposits are not as reactive, and contributing to corrosion damage, as the other salts. This behaviour suggests possible formation of  $\text{CaSO}_4$ , which exhibit high melting points value  $\sim 1460^\circ \text{C}$  [11,16].

**Figure 3.** Mass change data of alloys INC713-LC covered with various salts deposits exposed to air + 300 vppm  $\text{SO}_x$  gaseous atmosphere gas for 240 h at 900°C.

change data for IN713LC (in Figure 3) are also in line with these metal loss data (i.e. higher mass loss value when covered with sodium chloride salt).

This was observed on Figure 3 that IN713LC has exhibited the same mass change when exposed to sodium chloride and sodium sulphate. Sodium chloride may react with  $\text{SO}_2/\text{SO}_3$  in the gas phase, forming a corrosive environment leading the formation of sodium sulphate and hydrogen chloride. This reaction could explain why sodium chloride and sodium sulphate have the same impact on the alloy. We can also conclude from Figure 3 that the sulphation of sodium chloride to sodium sulphate chemical reaction decreases the incubation period, i.e. 120 h. Indeed, the two curves corresponding to sodium chloride and sodium sulphate are similar and correspond to the same molten salt corroding the alloy, i.e sodium sulphate. This reaction sequence likely to cause the formation of hydrogen chloride [2,23] which may be lost to the gaseous environment.

Figures 5 and 10 show some attack with calcium salts. However, it was observed in Figure 3 that calcium chloride salt seems to be benign and have no effect on mass change. It can be expected a loss of mass when salting the alloy with calcium chloride because it

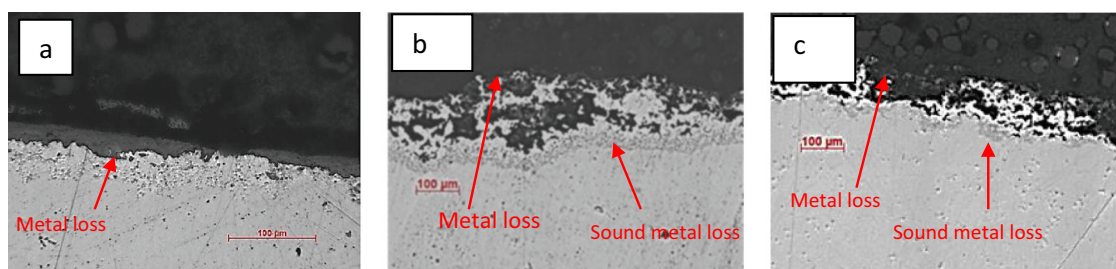
The three alloys were observed under the optical microscope after 240 and 160 h of exposure and salted with sodium chloride.

Images presented in Figure 4 show that both IN713LC and C1023 alloys suffer damage on the edge of the samples. However, the surface of CMSX-4 sample showed less degradations compared to the other two alloys. The loss of metal around the edges of both IN713LC and C1023 showed a similar morphology at scale/gas interface, whereas IN713LC showed

a consistent internal layer suggests uniform internal damage around the specimen.

**Figure 4.** Optical images of cross-sections through alloy CMSX-4 (a) and IN713LC (b) covered with sodium chloride deposits exposed to air + 300 vppm  $\text{SO}_x$  gaseous atmosphere gas for 240 h and C1023 (c) covered with sodium chloride deposits exposed to air + 300 vppm  $\text{SO}_x$  gaseous atmosphere gas for 160 h at 900°C.

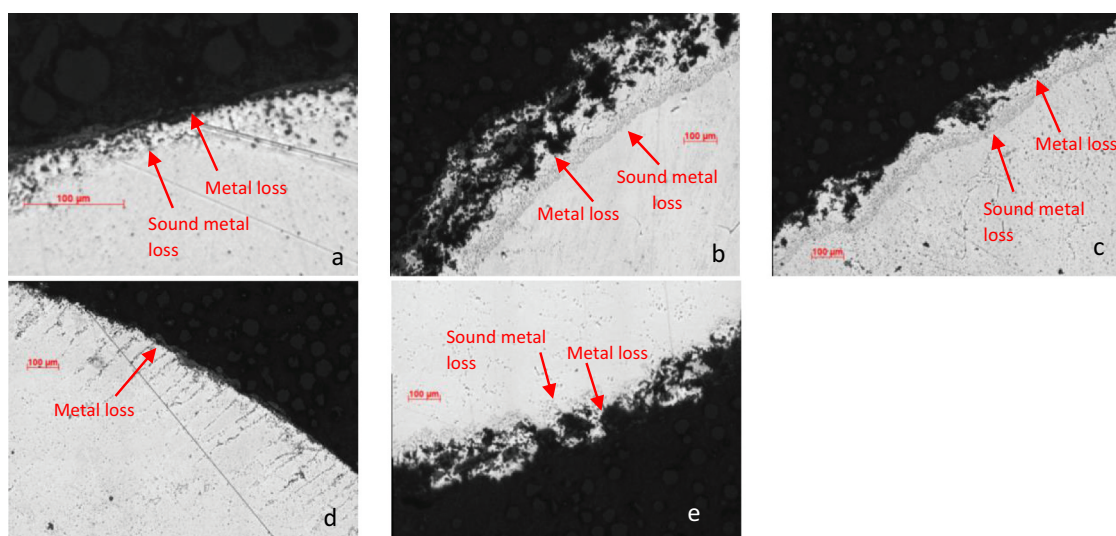
In Figure 5, the images under the optical microscope showed that the degradation on the edge of

IN713LC samples was more severe when salted with sodium chloride and sodium sulphate (Figure 5(b,c)), respectively) in comparison with sample covered with calcium chloride salt (Figure 5a). This behaviour was

**Figure 5.** Optical images of cross-sections through alloy IN713LC covered with (a) calcium chloride, (b) sodium chloride and (c) sodium sulphate deposits exposed to air + 300 vppm  $\text{SO}_x$  gaseous atmosphere gas for 240 h and C1023 covered with (d) calcium chloride and (e) sodium chloride deposits exposed to air + 300 vppm  $\text{SO}_x$  gaseous atmosphere gas for 160 h at 900°C.

also observed on C1023 samples, a significant metal loss on the edges for sample covered with sodium chloride (Figure 5e) versus the sample covered with calcium chloride salt (Figure 5d). An interesting feature noticed is the internal damage on both alloys covered with calcium chloride salt has a different morphology.

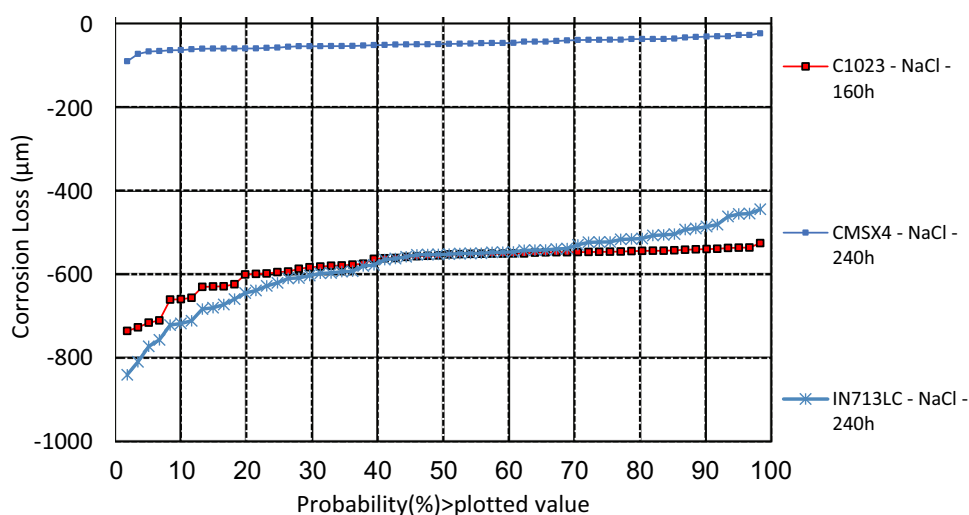
Figure 6 illustrates the damage distributions for alloys CMSX-4, IN713LC, and C1023 covered with sodium chloride deposits exposed to simulated hot corrosion type I combustion gases (air+300 vppm  $\text{SO}_x$ ) at 900°C. It is clearly seen that CMSX-4 showed

The median (50%) corrosion loss value for sample CMSX-4 covered with sodium chloride salt is approximately 45  $\mu\text{m}$ , whereas median corrosion loss values for Inconel 713LC and alloy C1023 are almost 10 times higher ( $\sim 550 \mu\text{m}$ ). However, this is to be noticed that C1023 had a shorter exposure (160 h) compared to other alloys (CMSX-4 and INC713) exposed for 240 h.

**Figure 6.** Plot of the probability of sound metal loss of alloys CMSX-4 and IN713LC covered with sodium chloride salts exposed for 240 h and C1023, covered with sodium chloride salts exposed for 160 h to air + 300 vppm  $\text{SO}_x$  gaseous atmosphere gas at 900°C.

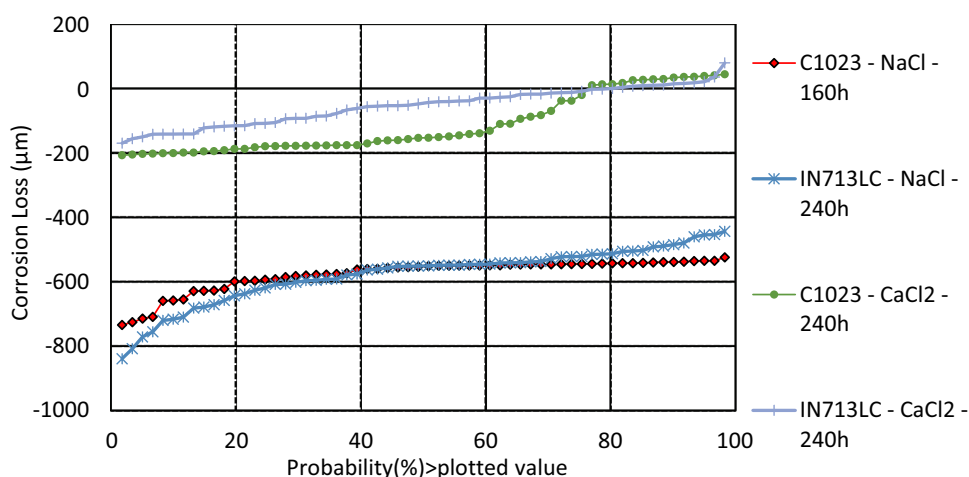
Figure 7 shows that samples covered with sodium chloride deposit exhibited significantly higher metal loss values. The median metal loss values for both alloys (C1023 and IN713LC) was observed as high as  $\sim 550 \mu\text{m}$ . However, when same alloys (INC713 and C1023) were covered with calcium chloride deposits, the median metal loss values were found to be much lower ( $\sim 160$  and  $\sim 40 \mu\text{m}$ , respectively). The mass

**Figure 7.** Plot of the probability of sound metal loss of alloys C1023, and IN713LC covered with sodium chloride and calcium chloride salt deposits exposed for 160 and 240 h to air + 300 vppm  $\text{SO}_x$  gaseous atmosphere gas at 900°C.

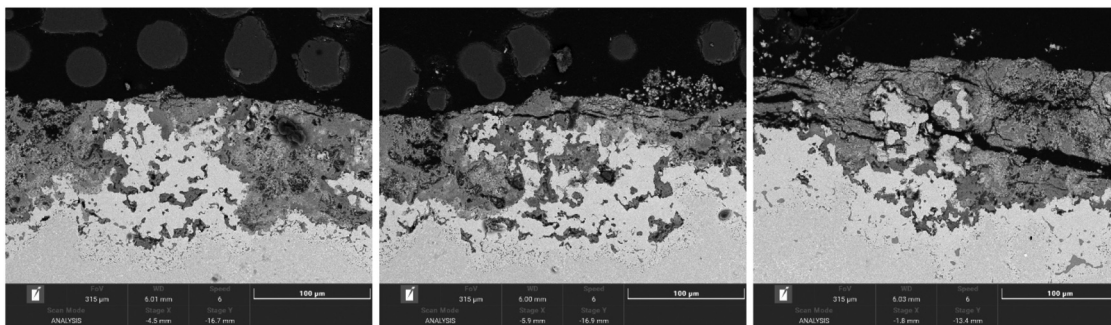
**Figure 8.** BSE images of alloy C1023 covered with sodium chloride salt deposits exposed to air + 300 vppm  $\text{SO}_x$  gaseous atmosphere gas for 160 h.

Figures 8 and 9 illustrate the cross-sections through the scales formed on chromia former alloy C1023 and single-crystal alloy CMSX-4 covered with sodium sulphate salt deposits after exposure for 160 and 240 h respectively at 900°C. The cross-section images for C1023 show no external scales are present and suggested the scales are likely to be spalled off the surface. An interesting feature noticed is the significant internal patchy appearance within each image in Figure 8 suggests the propagation of internal attack within the polycrystal alloy is irregular probably initiating a local scale breakdown and then propagating. Figure 9 shows the cross-section images for alloy CMSX-4 is thinner and more uniform scale forms compared to alloy C1023, which is also in agreement with mass change data. The internal damage is also noticeable underneath the thin scales within the alloys, suggesting an internal sulphidation with broad front attack (typical type I hot corrosion mechanism).

It can be seen in Figure 8 that C1023 exhibits deep internal attack after a short exposure of 160 h in comparison to longer exposure for CMSX-4 and INC713 in Figures 9–11. Chromium level in alloy C1023 (15 wt %) is higher compared to chromium level (10%) in IN713LC. Chromium addition into alloys is known for its property as a corrosion resistance, element. However, results suggested that chromium content is not the deciding factor for corrosion rate here. Molybdenum is the (refractory) element with highest concentration of 8.5% in C1023 compared to 4.3 and 0.6% in INC713 and CMSX-4 alloys

The key difference between the alloys is that CMSX-4 is a single-crystal alloy while IN713LC and C1023 are equiaxed grains alloys. The mode of attack is different between these two classes of alloys. Comparison between Figures 8, with 9 and Figure 10 (d–f)

underlines the fact that within a single-crystal alloy, the corrosion occurred as a uniform layer at the surface of the sample. Whereas IN713LC and alloy C1023 exhibit preferential attack forming local corrosion product and suggested a nonlinear progression in patches of corrosion inside the sample possibly initiating at grain boundaries. Sui et al. [20] reported similar work on nickel-based polycrystal super alloys in high-temperature corrosive conditions under strain conditions. One of the key conclusions of their studies was that grain boundary and local stress concentration region as the surface defects are usually the sites where corrosion pit preferentially begin. It was further highlighted in their work that corrosion resistance is essentially dependent on defects' density at the surface of alloy. In this paper, the test was carried out in static corrosion conditions under no strain. However, both IN713LC and C1023 being polycrystal alloys exhibit grain boundaries and resulted higher corrosion damage than single-crystal alloy CMSX-4 [20]. It is likely that structural defects make available pathways for diffusion of chromium to the external oxide and inward transport of oxygen and sulphur. The crystalline defects such as vacancies and grain boundaries contribute in controlling the transport of element species through diffusion, leading to higher oxidation and corrosion rates [21].

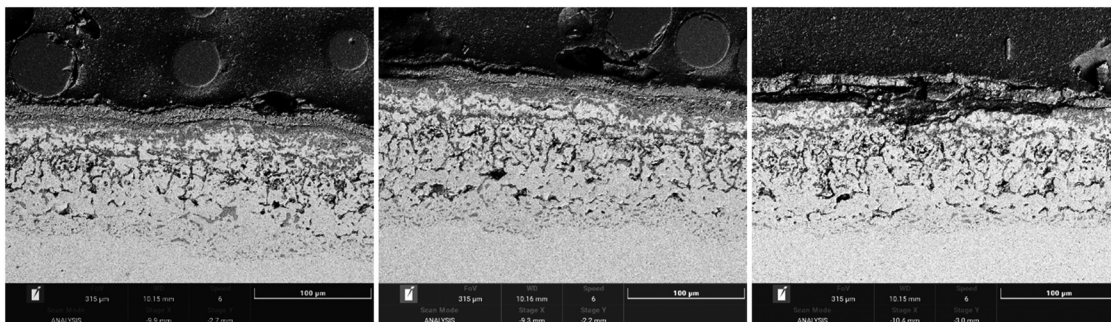
**Figure 9.** BSE images of alloy CMSX-4 covered with sodium sulphate salt deposits exposed to air + 300 vppm  $\text{SO}_x$  gaseous atmosphere gas for 240 h.

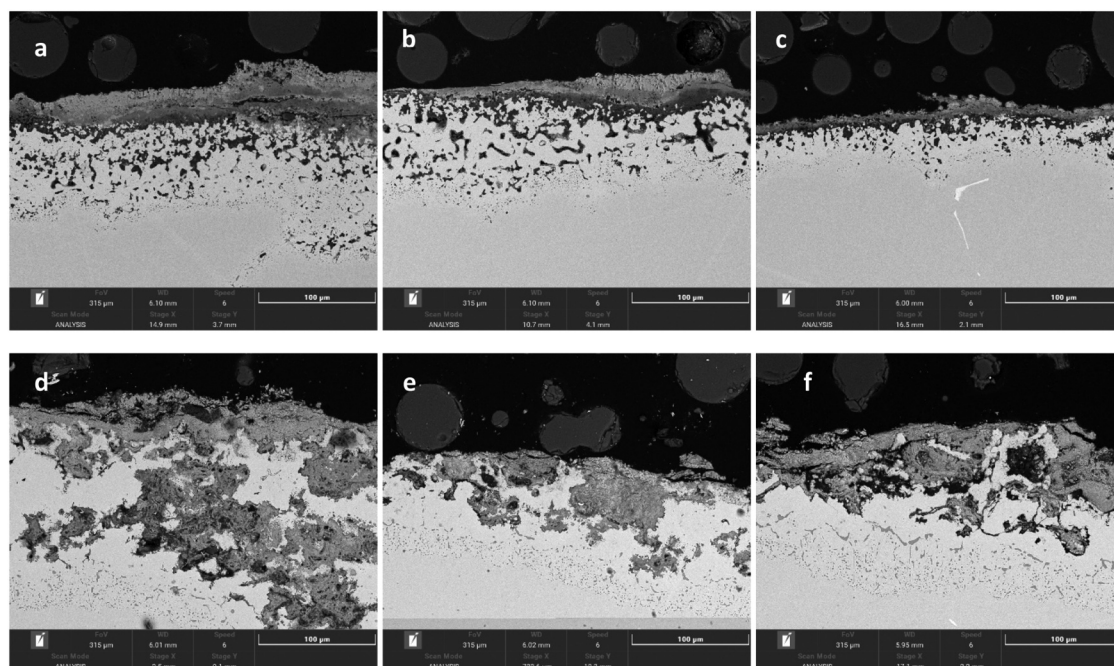
Figure 10 shows the cross-sectional images of IN713LC covered with calcium chloride and sodium chloride salt deposits exposed to air+300 vppm  $\text{SO}_x$  gaseous atmosphere gas for 240 h.

Figure 10 (a–c; cross-sectional images of IN713LC) shows the presence of an outer scales and internal corrosion within the alloy at the scale alloy interface. Clearly, the calcium chloride deposits have entered propagation after 240 h with a mix mode of internal attack showing both internal oxidation and sulphidation. The attack is, however, much less advanced than with sodium chloride salt. Figure 10 (d–f) shows the attack under an initial sodium chloride deposits is much severe. It is evident that the outer oxide has spalled (it is absent) and alloy had an internal irregular patchy internal oxidation degradation. It is also to be noticed that morphology of internal degradation of alloy IN713LC in Figure 10 (a–c) is similar to internal degradation morphologies shown in Figure 8 for alloy C1023. However, the exposure period of C1023 alloy sample was only 160 h compared to 240 h exposure of IN713LC alloy.

**Figure 10.** BSE images of IN713LC covered with (a–c) calcium chloride and (d–f) sodium chloride salt deposits exposed to air + 300 vppm  $\text{SO}_x$  gaseous atmosphere gas for 240 h.

The results show that calcium chlorides corrode nickel-based alloys under the conditions of this study. It can be concluded that calcium chloride has a longer incubation period. This incubation period must be at least more than 240 h (the maximal time of exposure of the samples observed in Figure 10 [a–c]).

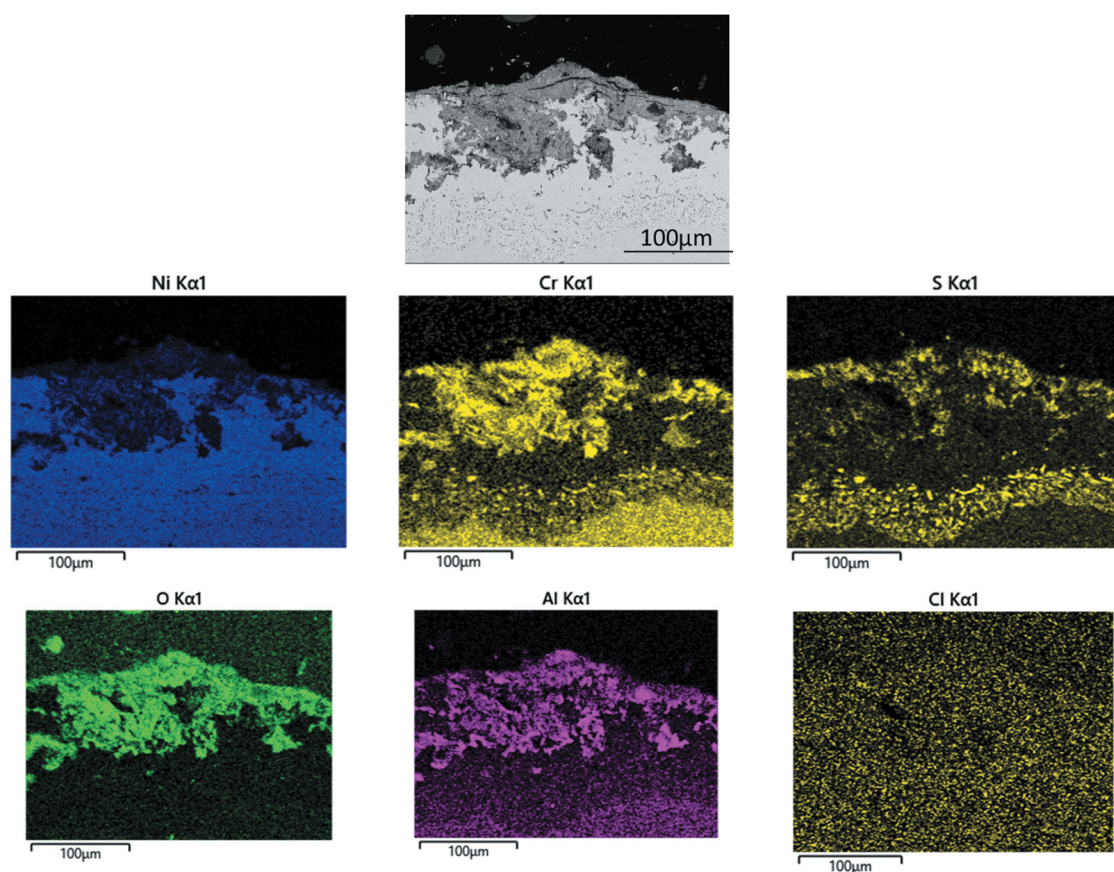
**Figure 11.** EDX mapping of IN713LC covered with sodium chloride salt deposits exposed to air + 300 vppm  $\text{SO}_x$  gaseous atmosphere gas for 240 h.

The EDX mapping in Figure 11 demonstrates the elemental distribution around the alloy/scale interface. The BES image shows obvious internal alloy degradation. The role of sulphur in the corrosion attack mechanism is confirmed by the detection of an S-rich layer concentrated underneath the inner scale, showing that it is penetrating through the outer scale layers. In the outer region oxygen, aluminium and chromium are detected. It is interesting to notice that chlorine is not present at the alloy surface. The enrichment of aluminium and chromium and oxygen suggested the well-known corrosion resistance oxide formations.

Figure 13 illustrates EDX mapping of a cross section through alloy C1023 after 160 h exposure under type I hot corrosion test. It is also interesting to notice that the EDX maps of Figures 11 and 13 are very similar. These maps show the distribution of oxygen throughout the scale. Significant presence of aluminium and chromium was found within the inner oxidation and sulphidation zone. EDX maps also show presence of cobalt which is comparatively localised. Pits in Figure 13 suggesting chromium sulphides attack could preferentially occur. Moreover, during this detailed investigation, chlorine was not detected. The morphology suggested the formation of pits within the alloy which propagated later into irregular patches sideways along the grain boundaries then laterally to form broad front attack.

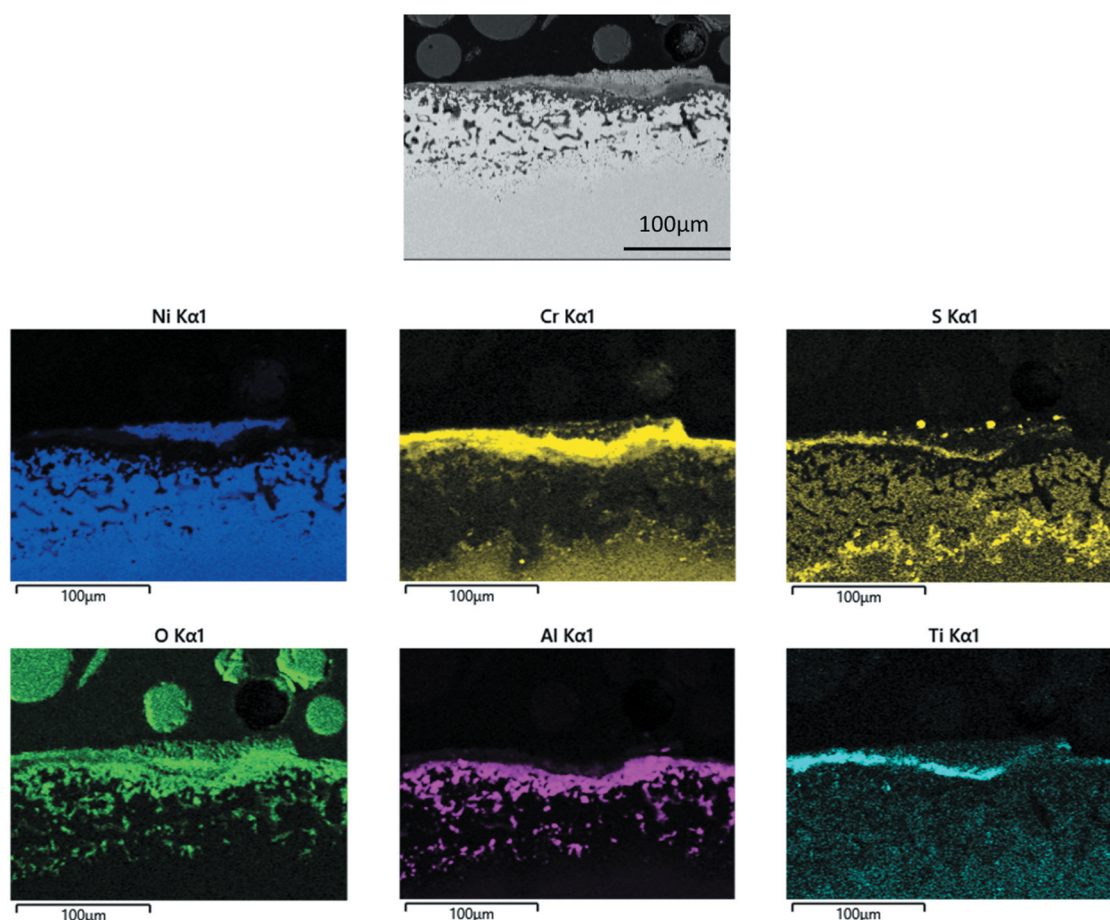
Figure 12 shows EDX mapping of INC 713 exposed to hot corrosion type I conditions for 240 h. It is clearly shown that oxygen is distributed throughout the scale. Chromium enrichment as a thick layer is clearly identified under the corrosive deposits. High level of sulphur was detected underneath the internal damage most probably as chromium sulphide. Significant patches rich in aluminium are also present within the same region most probably alumina. Titanium is also evident at the top region of the oxide/sulphide scale. The backscattered electrons (BSE) image shows the internal degradation has significant porosity.

**Figure 12.** EDX mapping of IN713LC covered with calcium chloride salt deposits exposed to air + 300 vppm  $\text{SO}_x$  gaseous atmosphere gas for 240 h.

However, chlorine is very volatile element, especially at 900°C [26,27]. Chlorine is not part of the chemical process of degradation of the alloy, as seen in Figure 12, because it has evaporated before attacking the alloy.

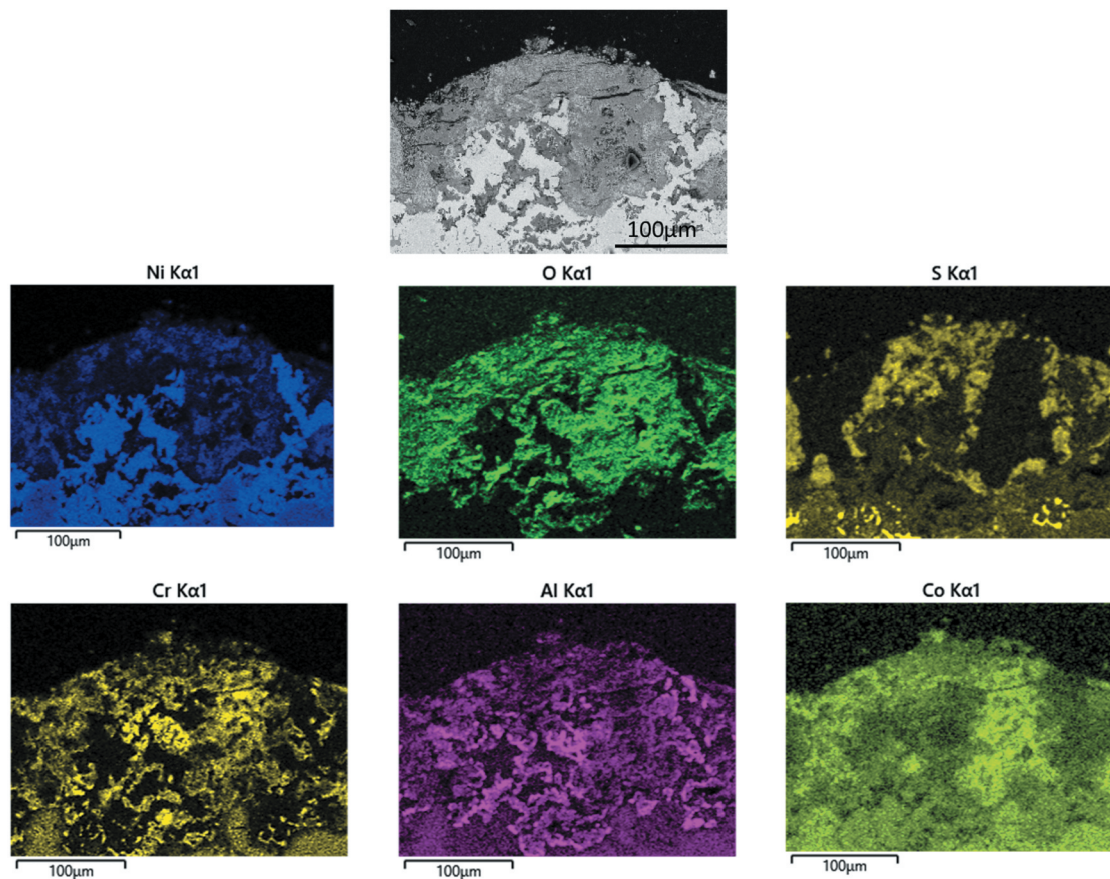
**Figure 13.** EDX mapping of C1023 salted covered with sodium chloride salt deposits exposed to air + 300 vppm  $\text{SO}_x$  gaseous atmosphere gas for 160 h.
