# Towards an Integrated Approach to Recording Military Aircraft Crash Sites

## Abstract

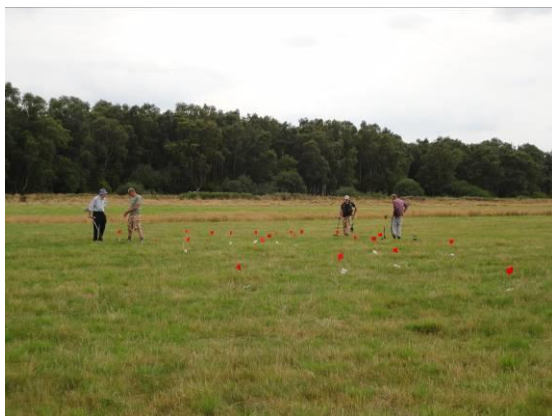
Figure 8 – Metal detecting survey with finds marked with flags of the debris field

The geophysics was then backed up by a non-intrusive metal detection survey. Each find spot was flagged and plotted to map the debris field (Figure 10). By doing this it was possible to ascertain the spitfire’s impact path. Once the crash site had been located then the recovery of the airframe would be the next step of investigation.
