# Fusion Insights from Ultrasonic and Thermographic Inspections for Impact Damage Analysis

Muhammet E. Torbali\*, Muflih Alhammad<sup>†</sup>, Argyrios Zolotas<sup>‡</sup>, Nicolas P. Avdelidis<sup>§</sup>  
*Cranfield University, Bedford, UK, MK43 0AL*

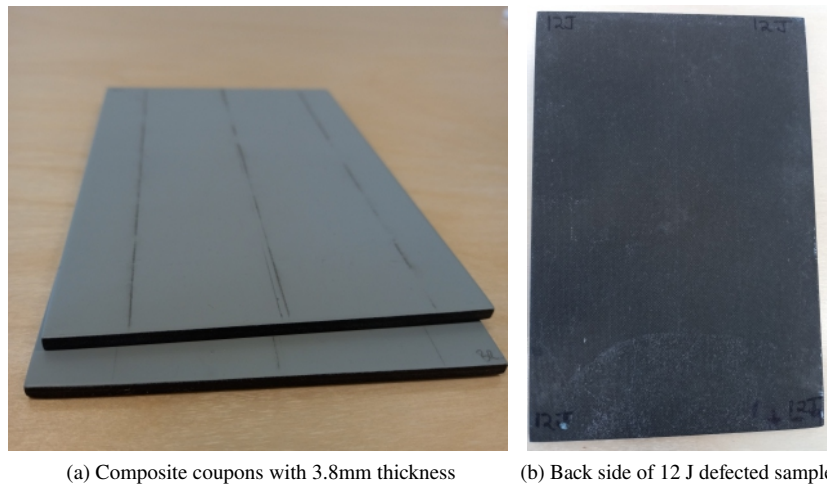
**Fig. 1 Image of composite samples that exhibit no surface defect**

A set of CFRP composite laminates formed by 18 plies, 3.8 mm thickness and 100x150 mm size have been used (representing composite material in aerospace structures). The coupons were made from UD pre-preg IMS-977-2 material with  $[45/-45/90/0/90/0/90/-45/45]_{2s}$  layup commonly found in aviation composites. Samples have been impacted under ASTM standards with three different energy levels (8J, 12J and 20J) to compare the visibility of different-sized defects. Figure 1 shows an example of composite coupons from both sides to observe thickness and dimensions. Both surfaces seem sound and smooth, meaning there is no visible damage on the surfaces.

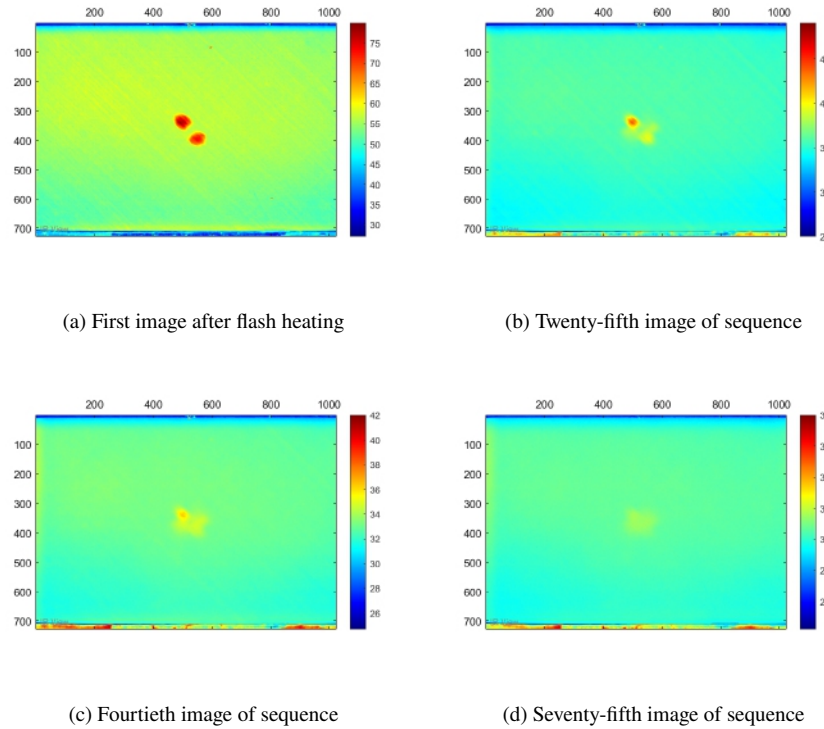
**Fig. 2 Raw thermograms in different orders to indicate the defect at various stages of cooling period**

The thermal inspection was performed by pulsed thermography, and samples were subjected to two 6.2 kJ output energy heat sources, Xenon arc flashes, for a duration of 2 ms, from a 50 cm distance and 45° angles to the surface of the samples. Thermal images have been recorded by X6900 FLIR infrared camera, from 100 cm distance and 90° angles to the sample surface, with an InSb-CCD Matrix Sensor and image resolution of  $640 \times 512$  pixels. Thermal data has included an image sequence with more than a thousand images during the cooling period. The acquisition setup has been arranged to get images from the entire surface to ease the registration step. Figure 2 shows the thermograms in various orders after heating. As can be seen in the thermograms, the defect shape is altering according to cooling time. Early images have defect clues that seem more solid and sharp; however, later images look blurred and shady. The basis behind this imaging method is having discontinuities caused by the defect, which makes the heat transmission slower over the voids generated by the defect rather than the sound area. Thus, the thermal difference is able to display the defective regions. Although it has a wide range of application possibilities thanks to rapid and contactless nature, pulsed thermography is strongly affected by reflections from the environment, emissivity variations and nonuniform heating [12, 13].

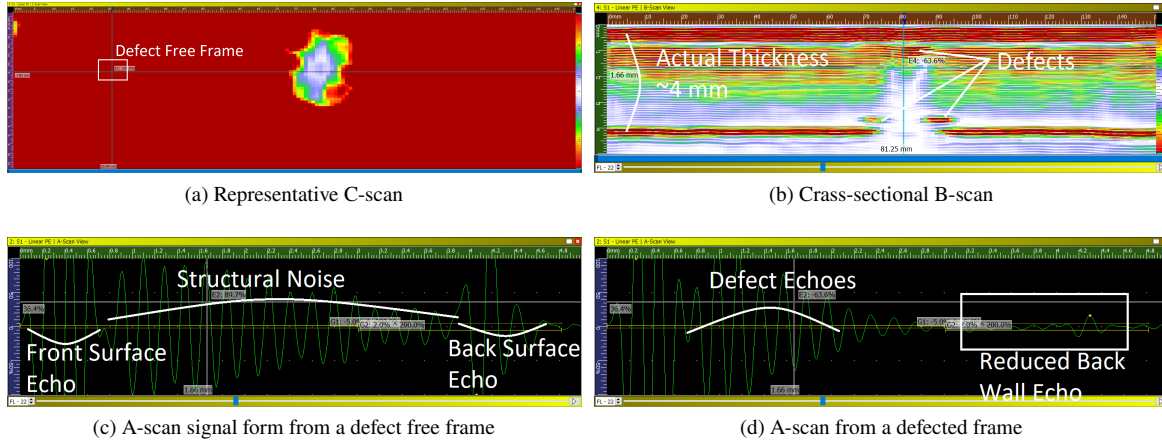
**Fig. 3 A snapshot of raw defect detection on PA ultrasonic equipment for 8J impacted composite coupons**

Ultrasonic inspection of these composite samples was performed by Sonatest Veo+ equipment and a 10 MHz phased array probe, including 64 element transducer with an appropriate wedge for ultrasonic wave transfer to the sample. The higher frequency probe provides better axial resolution through the thickness with the lower Signal-to-Noise ratio (SNR) due to the blind zone effect of the surface than the lower frequency probe [14]. The probe was moved on the surface of the sample, using sprayed water as a coupling mechanism, and an encoder followed the probe to measure the scanning distance. The PA ultrasonic data includes A-scan, cross-sectional form B-scan images and top-view C-scan images with depth information. Figure 3 presents these concepts for an 8 Joule-impacted sample to investigate ultrasonic signals that is originated from defect-free (non-defective) and defective regions. It should be noted that the PA scanning covered the full area (dimension) of the coupon (sample) to make it easier to align different source images.

From the PA viewpoint, the obtained data comprises several signals for each frame of, per mm, dimension throughout the sample sizes. As it can be seen from the previous Figure, i.e. the A-scan signals snapshot, defect echoes need to be extracted by eliminating other echoes. This provides a location-based defect identification by applying smart thresholding method. Thresholding is carried out by trimming the peaks over the threshold, and finally, the amplitude values of defect signals were derived associated with their depth information. After thresholding operations and obtaining the binary defect images, the source images require an alignment process to provide accurate combination outcomes. Spatial referencing is a process used in image registration to align multiple images spatially in order to compare or merge these. This process involves identifying corresponding points or features in different images and then transforming the images to align them based on those points. Spatial referencing can be accomplished using a variety of techniques, including manual methods, feature-based methods, and intensity-based methods. In manual methods, corresponding points are identified manually by a user, whereas feature-based methods use automated algorithms to identify common features such as edges or corners. Intensity-based methods use the similarity of image intensity values to align images. Here, images have been aligned manually using the entire surface imaging and defect edges. Figure 4 schematizes the overall structure, including pre-processing, registration and fusion stages.

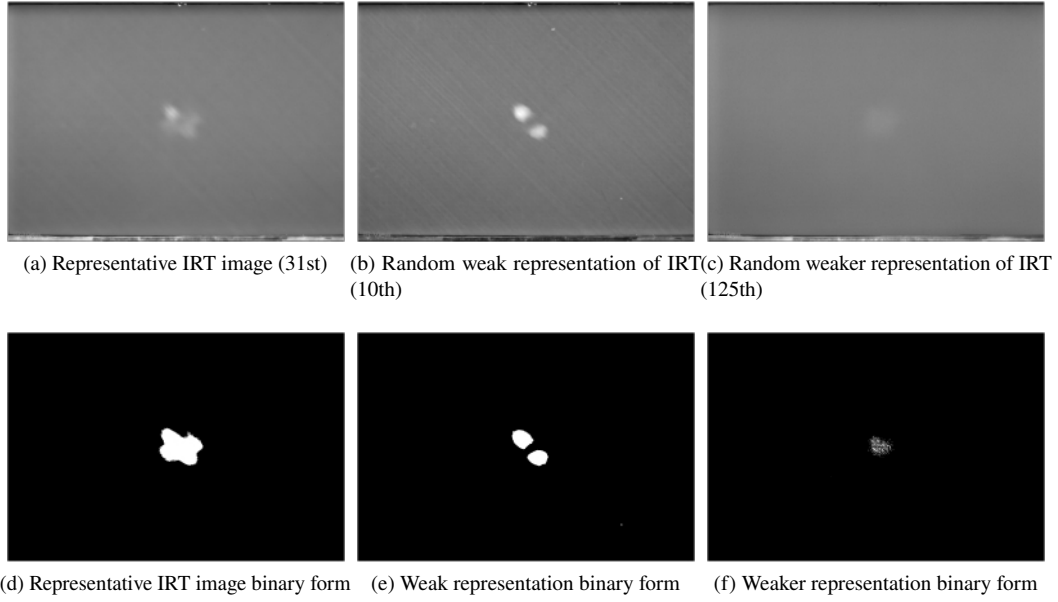
**Fig. 5 The best representative IRT image and two randomly selected images during cooling period and their binary forms**

Figure 5 shows PT inspection images in grey form with different levels of representativeness and their binarized states for 8J impacted specimen. As mentioned before, a significant step is to find the most representative image from the sequence of thousands of images. Here, the highest score of representation belongs to the image in the 31st row (Figure 5a). It should be stated that this image is not coming just after flash heating rather than the 10th image, which has evident pieces of defect clues but missing. Considering the three images in Figure 5b, 5a and 5c, it can be noted claimed that the degree of representation first increased after the heating and then decreased with the increase in cooling. The 125th image looks almost indistinguishably cloudy. This is also evident in binary images. While the 31st image has an apparent defect shape which is better than 10th, the 125th image has highly poor defect clues.

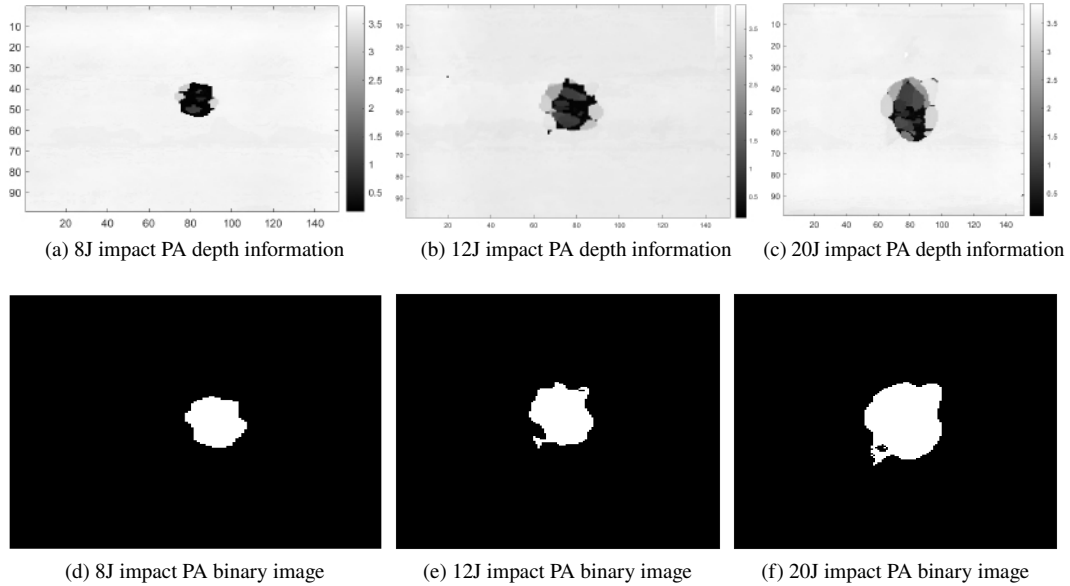
**Fig. 6 Depth information of the samples extracted from PA inspection and binary forms after thresholding**

Figure 6 presents the depth information for three levels of impact damage, i.e. black color indicates regions close to the surface and white color indicates features deeper from surface. It should be emphasized here that damaged areas are seen not only in the area close to the surface but also deeper in the composite closer to back wall. It is noted that the defect sizes are increasing with the higher level of impact energy. Binary images of PA inspection emphasize the gradual increment in the defect size. Small distortion of the shape in binary images may require further investigation in selecting threshold values for related images.

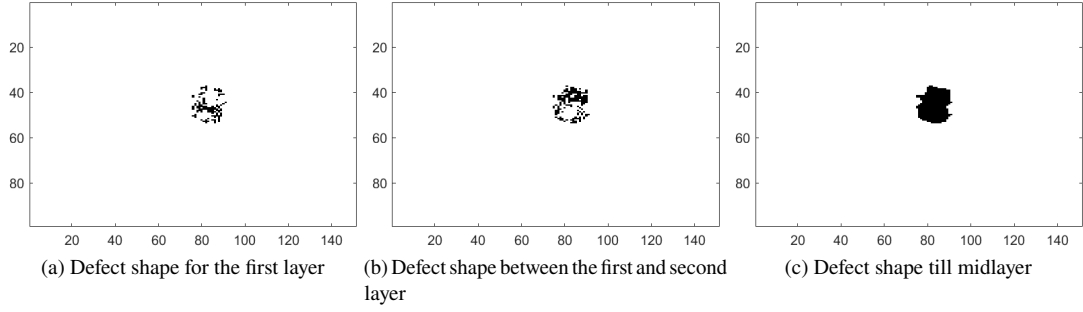
**Fig. 7 Defect shapes for different depths, at first, second and up to middle layers**

Additionally, PA ultrasonic inspection is able to provide defect information layer by layer. Simply, Figure 7 has given defect marks for the first layer, second layer and up to middle layer of the composite structure. Images seem that the

defect on the first layer is beginning outward from the inside; however, more concentrated at the edges in other layers.

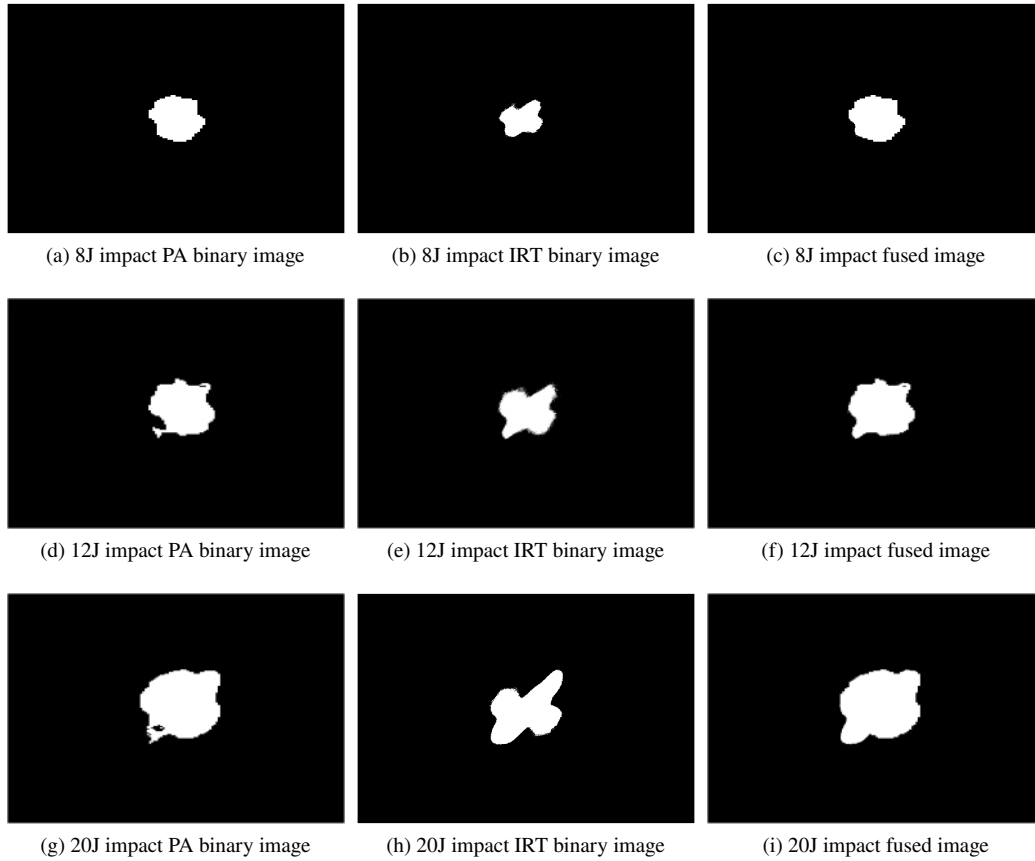
**Fig. 8 Processed source images and fused images for growing impact level using maximum rule**

The fused image showcases the combined information and the resulting shape, and to improve the visualisation of the damage the images are binarized (see Figure 8). Fused images for all levels of impact energies have shown a more circular (round) and continuous form, unlike the sources. Inspection outputs obtained by both methods, although having minor morphological differences, provide consistent results that are mostly in agreement. The fused result combines information from both inspection approaches. It is clearly shown that the fusion approach can offer more efficient defect detection by combining the advantages of both inspection methods. This enhanced sizing of defect mechanisms can enable improved repair operations such as removing and patching [22].

Table 1 presents the calculated defect size. For all three cases, PA inspection outputs a larger defect area compared to IRT (PT). The fused images provide a more informative output by covering the wider area of the possible defect.
