## Numerical Simulation of Bolted Joints Pull Through Failure

**Abstract.** Finite Element Analysis numerical models were generated to simulate and investigate the pull-through damage of bolted joints on composite laminates. Three-dimensional elements were used along with a user material subroutine incorporating the material failure criterion in Abaqus® software. Simplified Discrete Ply Modelling (DPM) and Cohesive Zone Modelling (CZM) were also employed. The numerical model predictive capability was assessed and the parameters influencing the pull-through failure process were investigated. The residual bearing strength of bolted joints following pull-through damage suggested a qualitative agreement between the numerical model and the experimental testing results.

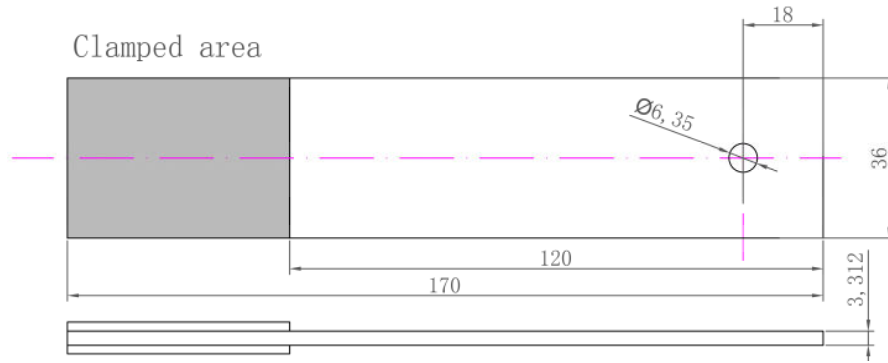
Figure 1. Dimensions of specimen

To accurately predict the pull-through failure, the out-plate stresses introduced along the thickness direction loading were considered. Thus, 3D elements were selected for the finite element modelling, with a user material failure criterion. The material used was Hexcel AS7/8552 and the specimen were designed with a stacking sequence of [45/0/-45/90]<sub>3S</sub>, having a total thickness of 3.312mm. The specimen design is shown in

Figure 1. Eight-node linear brick elements (C3D8) with full integration without hourglass effect were utilized. The simulation was divided in two steps; Firstly, the pull-through loading was applied on the bolt damage for investigating the damage extents. Then, the laminate with the imprinted pull through damage was subjected to bearing loading.

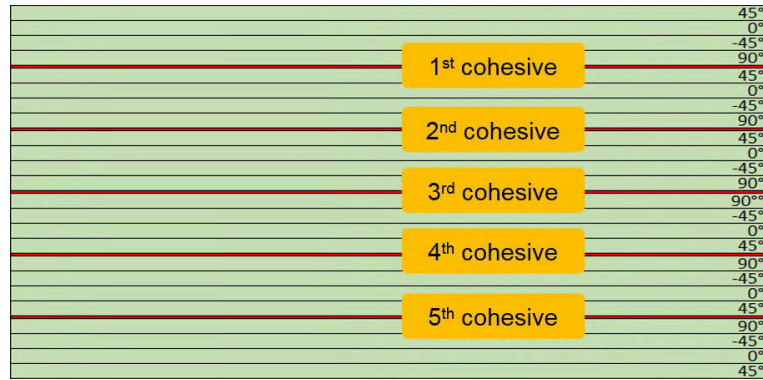
Figure 2 Cohesive behaviour in laminate

In the DMP modelling, the cohesive elements were placed at the interfaces of solid elements to represent the inter-ply delamination. To simplify the modelling, the cohesive boundaries were inserted between every four plies as shown in Figure 2. The critical parameters for numerical simulation of cohesive behaviour are the interfacial strength, penalty stiffness, energy release rate and the meshing size.

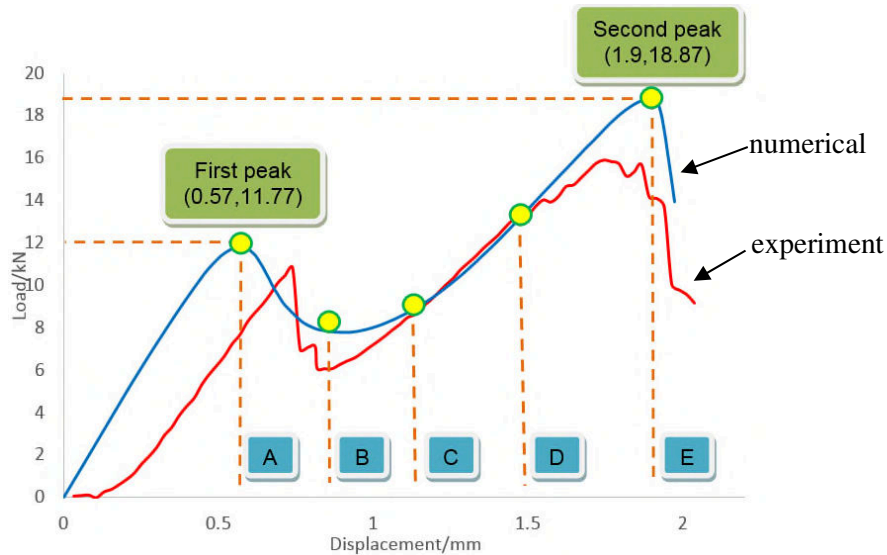
Figure 3. Numerical result and test data

Numerical FE simulation and experimental results of the pull through test are shown in Figure 3. The simulation curve showed two loading peak points, the first peak at (0.57mm, 11.77kN) and the second peak at (1.96mm, 18.87kN). The FE model prediction vs testing error for the first load peak was 8%. The error for the second load peak was 18%. The loading vs displacement curve slopes before the first and second loading peak values were almost identical between simulation and testing.

The initial stage of loading exhibited non-linear behaviour during testing while it was linear during numerical simulation. The loading of numerical modelling dropped less abruptly.

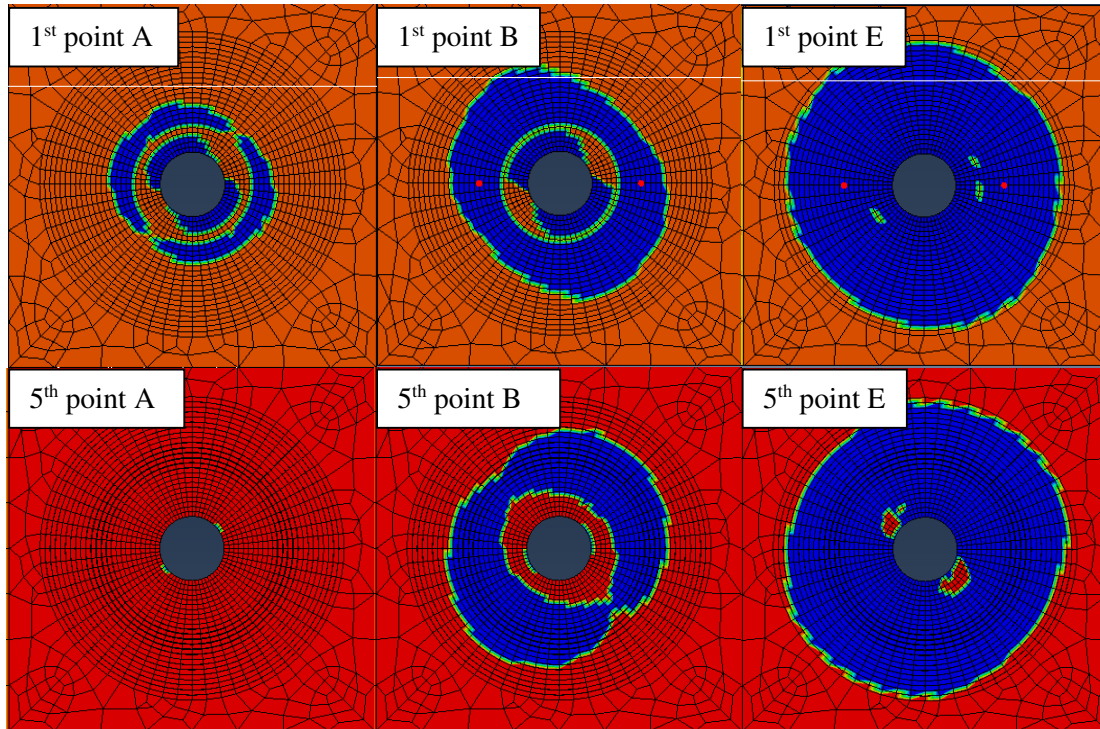
Figure 4. Delamination of cohesive

The delamination of the laminate under pull-through is illustrated in Figure 4. The blue zone denotes the delamination area. Three loading points were selected, point A corresponding to first peak of the pull through curve, point B corresponding to first drop and point E corresponding to the second load peak, as shown on Figure 3. These are also reported for the first cohesive layer and the fifth, the first being the top side where there is contact with the bolt head.

It was concluded that the delamination through the whole laminates was caused by the crack under the bolt head that propagated through the thickness from the top laminates to the bottom laminates. The delamination played an important role in the amplitude of the first peak.

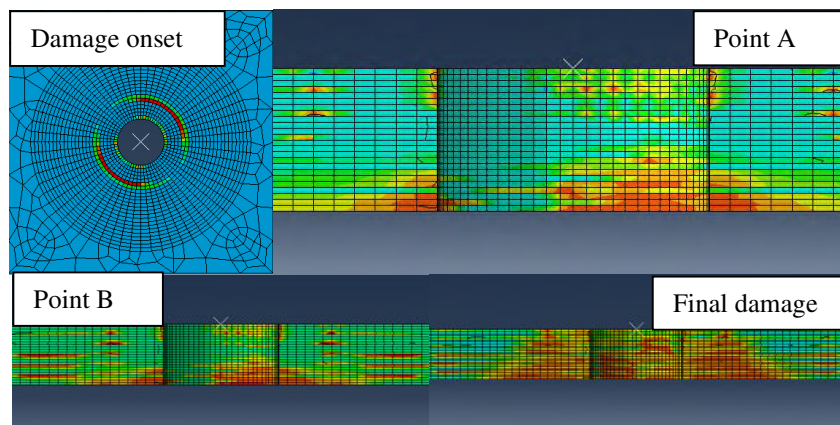
Figure 5 Failure of matrix

Figure 5 depicts the matrix failure. The failure started from the top surface and bottom surface under the bolt head. At the point A of first peak of the pull through phase according to figure 3, the matrix cracking propagated through thickness away the bolt hole. At the final damage, the matrix cracking occupied the regions near the bolt hole through the thickness direction with an envelop of a “staircase”. The matrix cracking coincided with the interlaminar shear stress distribution.

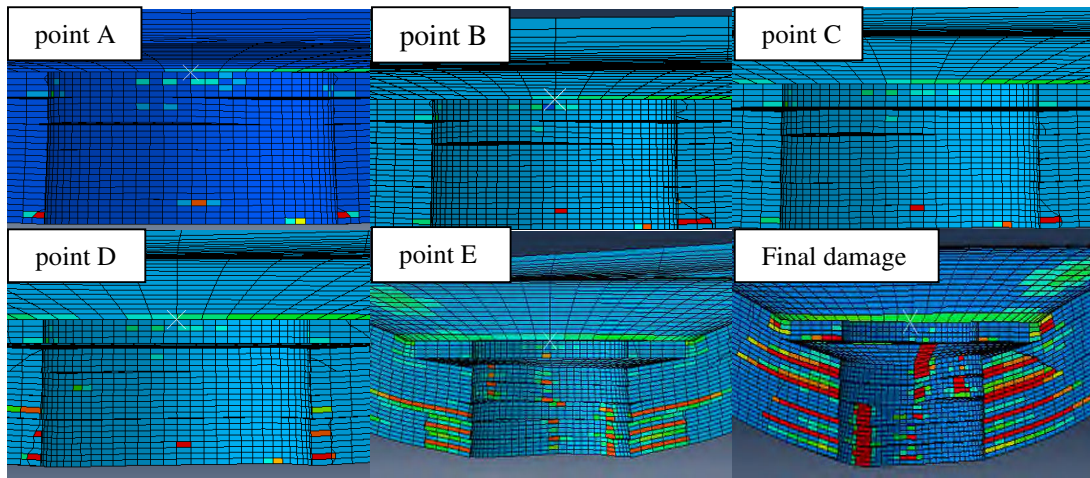
Figure 6 Failure of fibres

The failure of fibres under pull-through loading are shown in Figure 6 . It was found that the initial damage of fibre occurred at the point of first peak in the lower 90°ply. However, the fibre damage did not expand significantly until the second load peak. On the contrary, the matrix cracking propagated quickly after the first peak. It was concluded that fibres bore the pull-through loading after the first load drop, resulting a the second increasing of loading.

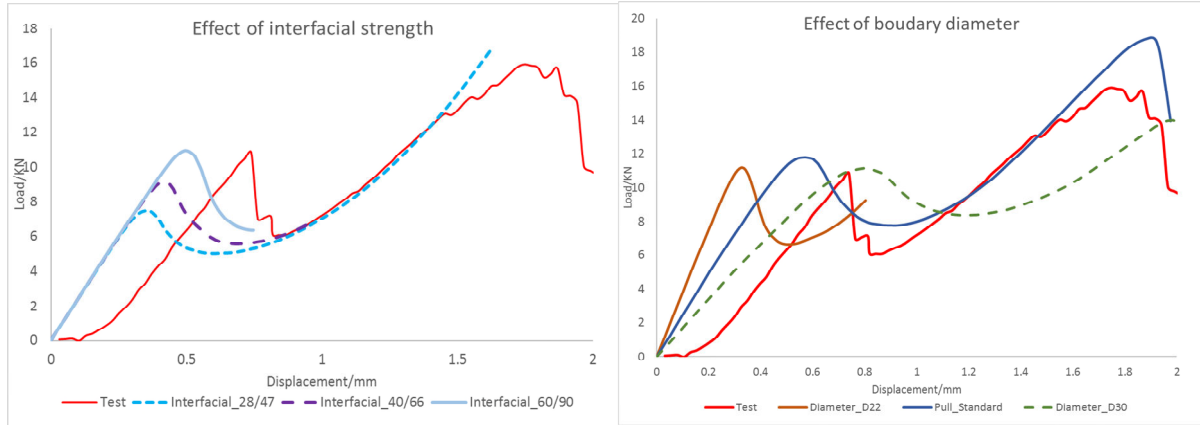
Figure 7 Effects of interfacial strength and boundary diameter

Factors influencing pull-through loading were investigated such as bolt hole to bolt shank clearance, washer diameter, boundary support diameter for pull through and interfacial strength of the composite laminates. The effects of interfacial strength and boundary support diameter for pull through are shown in Figure 7.

For the test and standard numerical modelling, the normal strength  $\sigma_{1max}$  of cohesive interaction and shear strength  $\sigma_{2max}$  were 60Mpa and 90Mpa respectively. To investigate the effect of interfacial strength on the pull-through loading, lower interfacial strengths were employed: 28MPa( $\sigma_{1max}$ )/47MPa( $\sigma_{2max}$ ), 40MPa( $\sigma_{1max}$ )/66MPa( $\sigma_{2max}$ ). It can be observed on figure 7 that the first peak loading was determined by the interfacial strength of the cohesive layers. The onset and propagation of delamination determined the magnitude of first peak of the loading curve.

The boundary diameter was the diameter of support fixture for the pull through test, which was of no influence on the pull-through loading. The diameter from the test was 26mm, but simulations were run with boundary diameters of 22mm and 30mm. From figure 7 it can be observed that the elastic stiffness of laminate under pull-through loading was affected but not the first drop failure load.

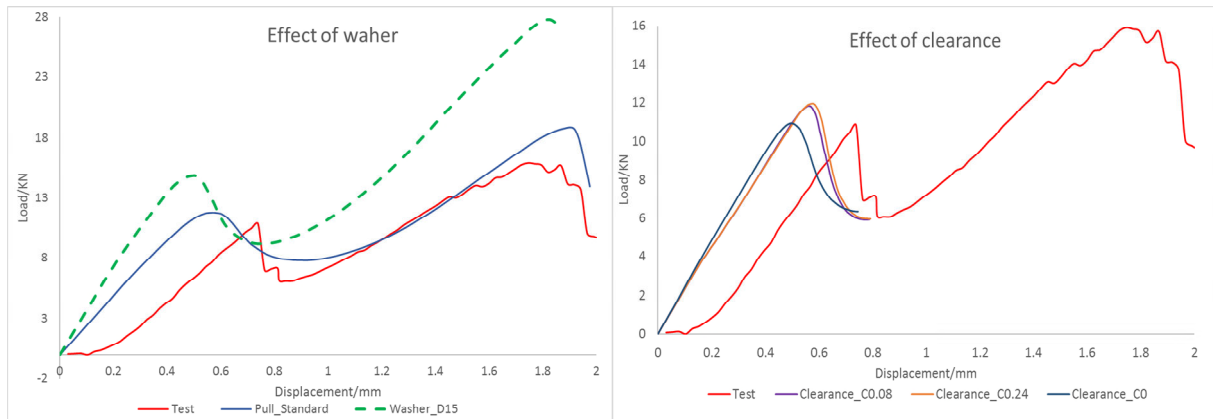
Figure 8 Effects of washer and clearance

The influence of the washer and the bolt clearance of bolted joint were analysed with the results shown in Figure 8. The diameter of washer of the test was 12mm and a larger washer diameter of 15mm was employed to observe the influence. It was seen that the loading of first peak, final loading and elastic stiffness increased. The rise of first peak and elastic stiffness was 47%. However, the increase of final loading was larger, about 73.5% higher than smaller washer. The enlarged washer reduced the pressure on the laminate with the same pull-through loading, resulting enhanced loading capacity.

Clearance had a different effect on pull-through loading versus that on bearing strength of bolted joint. It was concluded that the bearing strength reduces with the increased clearance [6]. The first peak loading increased slightly with a clearance of 0.08mm, however the rise of first peak was negligible when the clearance was further enlarged from 0.08mm to 0.24mm.

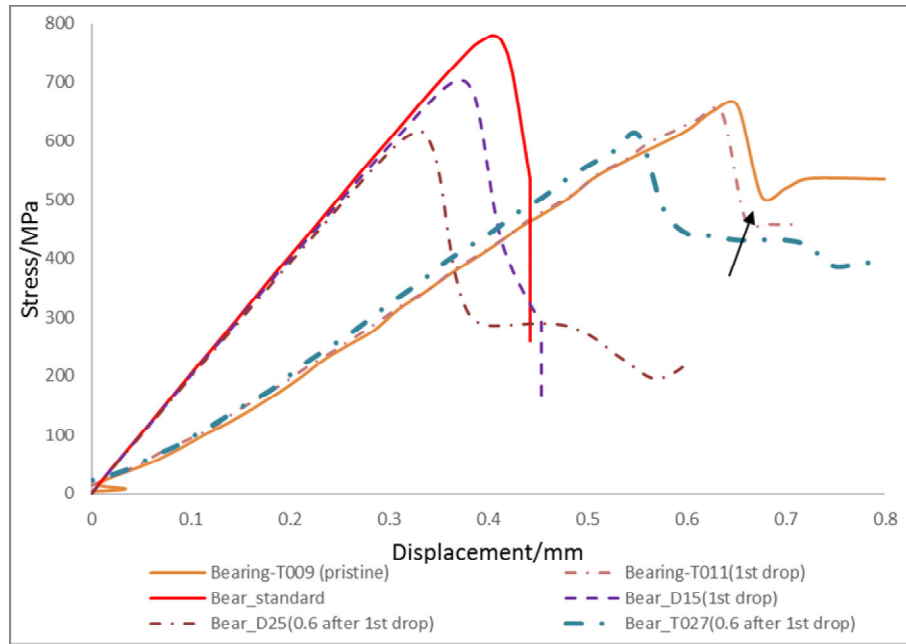
Figure 9 Residual bearing strength

The residual bearing strength of bolted joints following pull-through damage was analysed via experimental testing [5][7]. It was indicated that the residual bearing strength reduced with bigger pull-through damage in place. The numerical modelling for residual bearing strength was created with inherent delamination and the results were illustrated in Figure 9.

It was found that the residual bearing strength was influenced by the inherent damage resulting from pull-through loading. For test data, the bearing strength decreased by 1.5% at the 1<sup>st</sup> drop and 7.6% at 0.6mm passing 1<sup>st</sup> drop. The results of FE model had the similar trend with test data; however, the ratio of reduction was bigger at the point of 0.6mm after 1<sup>st</sup> drop. The numerical modelling predicted the residual bearing strength of bolted joint qualitatively which captured the decrease trend of residual strength after pull-through damage. However, the strength predicted was not accurate enough versus test data due to the simplification of the inherent damage.
