## Autonomous systems thermographic NDT of composite structures

**Keywords:** Thermography, composites, CFRP, UAS, imaging, aerospace.

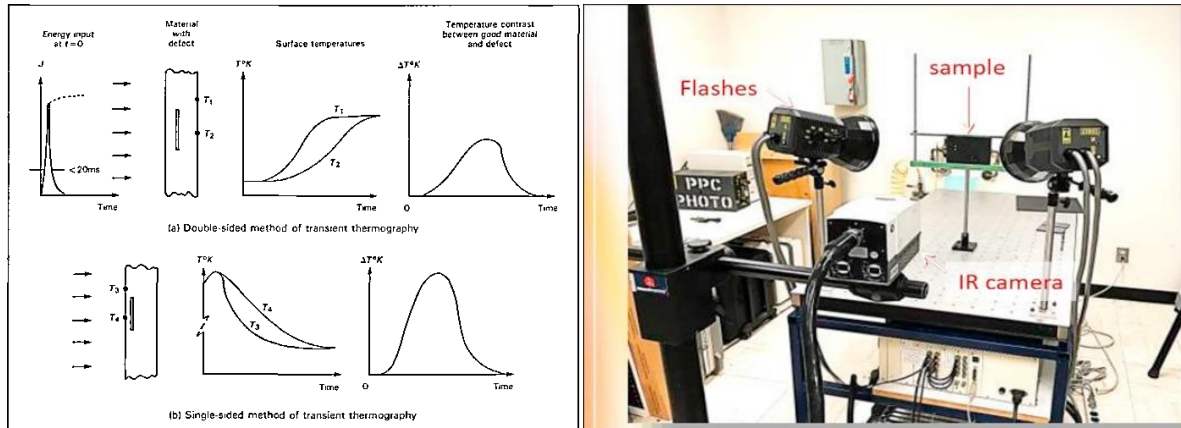
FIGURE 1 (LEFT): THE IMAGE REPRESENTS TRANSIENT THERMOGRAPHY AND HOW THE TEMPERATURE DIFFERS WHEN THERE IS A DEFECT PRESENT. (A) THE TRANSMISSIVE MODE (DOUBLE-SIDED) AND (B) THE REFLECTIVE METHOD (SINGLE-SIDED) [2]. FIGURE 2 (RIGHT): EXPERIMENTAL SET UP [5].

The surface of the specimens were positioned parallel to the camera lens as depicted in Fig. 2. The data was acquired for 40 s with a 1.5 ms integration time, that includes 10 frames before the flashes, plus 1990 frames during cooling a total of 2000 frames were recorded. The software used to acquire the data was RDac from FLIR. For signal processing MATLAB and Ir\_view from Visioimage inc were employed. Two advanced processing techniques were used; PCT (principal component thermography) and PPT (pulsed phase thermography) [5].

The figures below (Figures 3-8) are all the processed results. A reflection test means that the camera and the excitation source are on the same side (as seen in Figure 4). Generally, reflection is more suited to detect defects closer to heated surface. PPT (pulsed phase thermography) was one of the methods used, with the acquired temperature data it varies with time and is transferred to phase data, which varies with frequency, the frequencies which show adequate data are below each image in hertz. PCT (principal component thermography) was the other, method used, the data is re-ordered by variance, this method finds both time series and spatial patterns, most of the variability is contained in the first component: EOF1 (empirical orthogonal function). Usually, EOF1 shows thermal variations related to surface heating. Later EOFs are typically related to surface and subsurface damage. Comparing both techniques, for this specific data set in figure 5 it seems that the PCT technique displays the damage clearer [5].

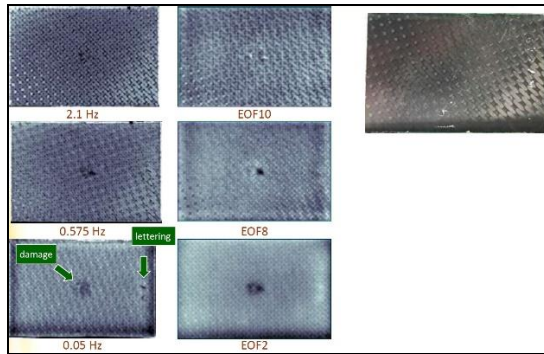
**Figure 3: Sample A4 (15 J woven), front face (impacted side), PPT and PCT.** The damage is barely visible in the original image of the composite (Far right image), the white marks are lettering from labelling the specimen. The 0.05Hz PPT image, shows clear subsurface damage [5].

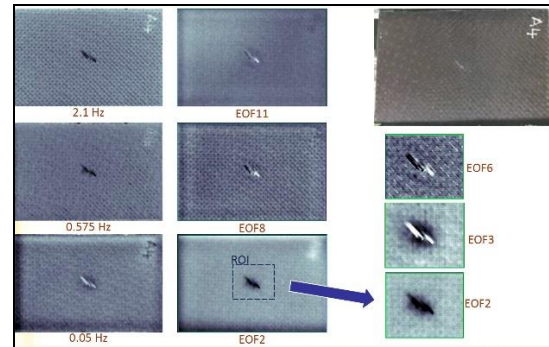
**Figure 4: Sample A4 (15 J), Reflection rear face PPT and PCT.** The rear surface is cracked, this is interesting because this side is significantly more damaged than the impacted side. This is a prime example of barely visible impact damage [5].

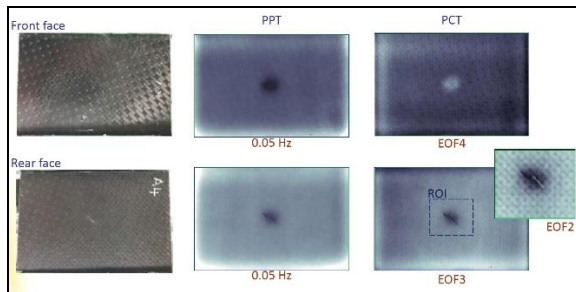
**Figure 5: Sample A4 (15 J).** Transmission is where the one side of the composite is excited, and the other side is observed by the camera and captures the data [5].

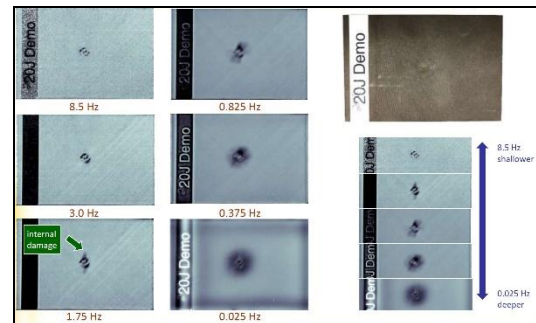
**Figure 6: Sample 20 J Demo, Reflection front face, PPT.** The damage is visible on the front face, how, it's clear that the damage is much worse subsurface and spreads further than the impacted area [5].

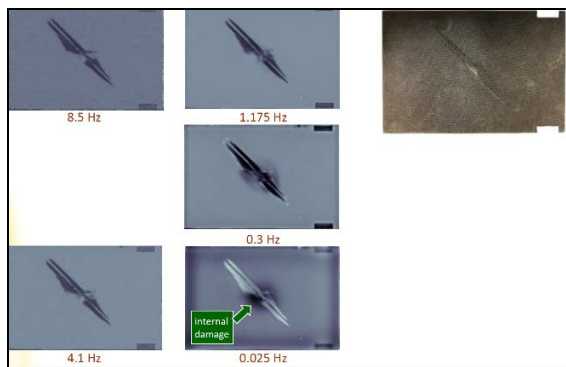
**Figure 7: Sample 20 J Demo, Reflection rear face, PPT.** The rear face has some substantial damage. The PPT locates the surrounding internal damage [5].

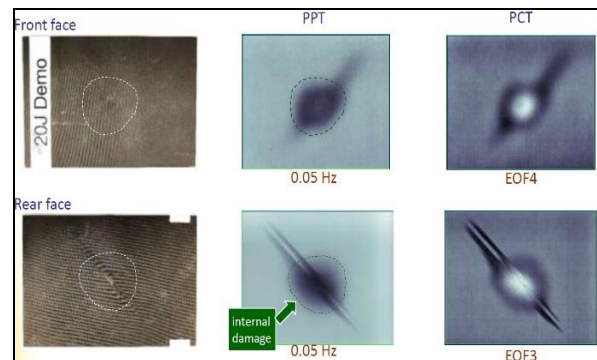
**Figure 8: Sample 20 J Demo, Reflection front face, Transmission.** The test has adequately located the internal damage [5].

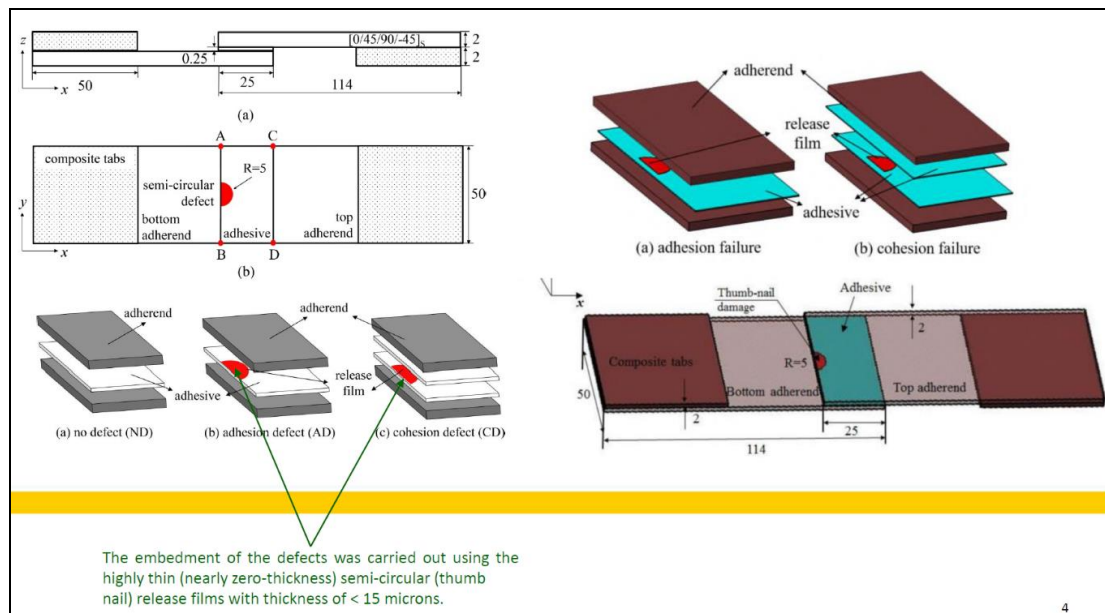
Figure 10: Artificial defects release film kissing bond [17].

The three inspected specimens are all composite material with artificial defects (see fig.10,11,12,13)

- **Specimen N-D-F4P** is composed of one layer of adhesive sandwiched by two layers of adherent (carbon fiber) and contains no defect, it was purposely used for reference only.
- **Specimen W-DA-F4** is similar to N-D-F4P but with an adhesive film release semi-circular ("thumb nail") shape defect, simulating a kissing bond defect.

- **SpecimenW-DC-F2** is similar to W-DA-F4 but with an additional adhesive film on top of the one with the simulated defect.

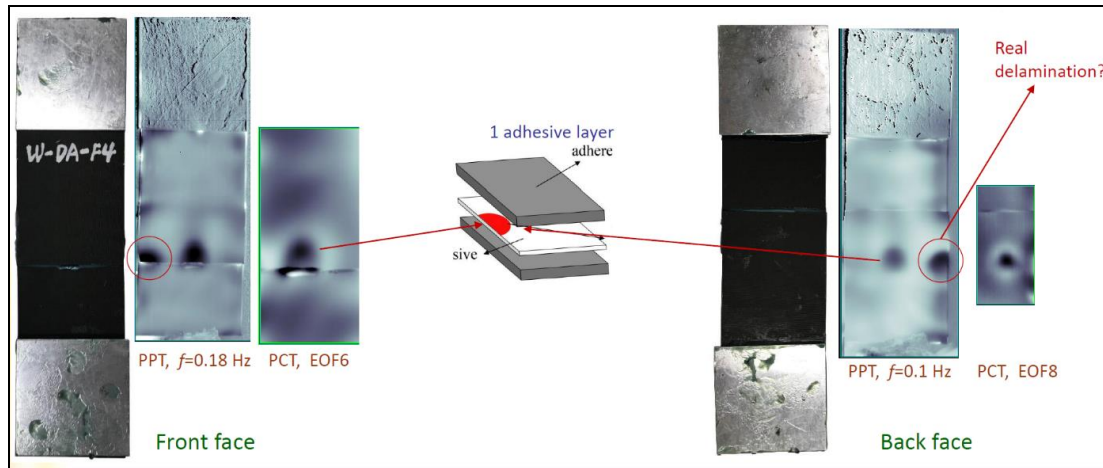
#### Sample W-DA-F4: Vibrothermography:

Figure 11: The processed results from the vibrothermographic inspection on sample W-DA-F4 [5].

Results clearly show the thumb nail shape in all cases, specimens W-DC-F2 and W-DA-F4, from one side and the other (front and back), after processing by PPT and PCT. Additionally, several indications of real defects seem to be observed. For instance, possible delamination's were found and indicated with red circles [5].

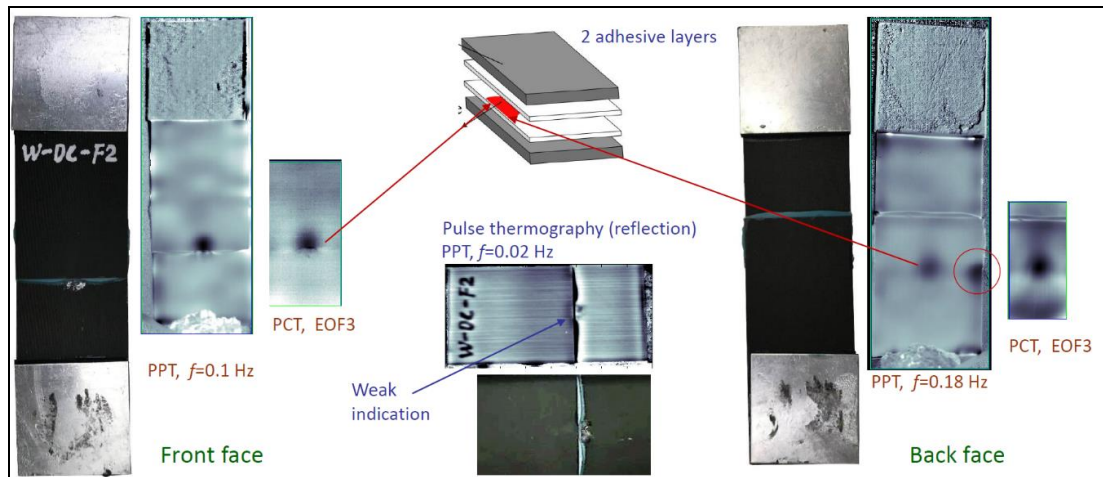
#### Sample W-DC-F2: Vibrothermography:

Figure 12: The processed results from the vibrothermographic inspection on sample W-DC-F2 [5].

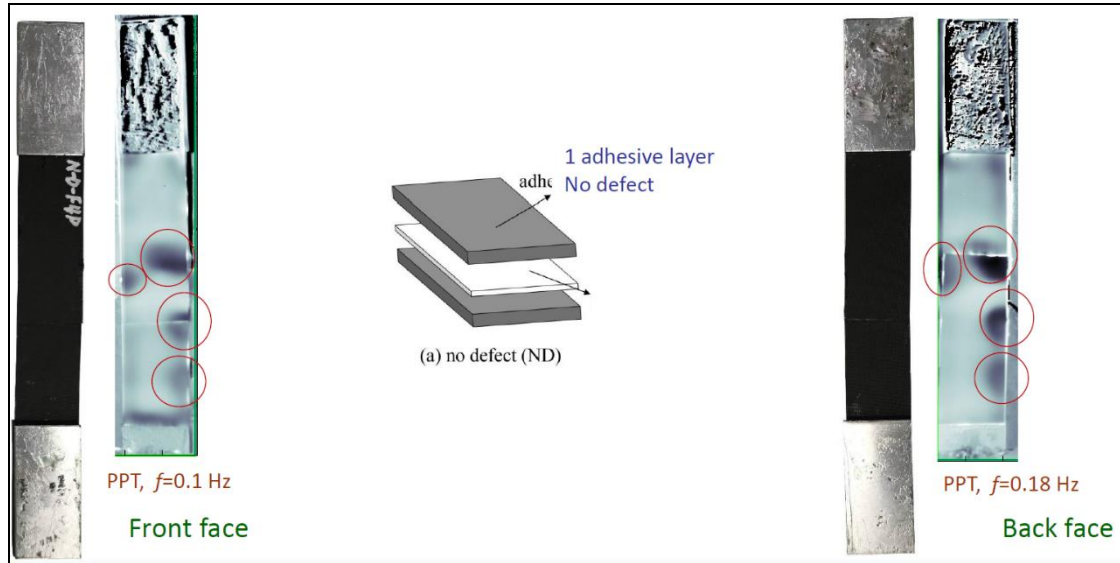
### Sample N-D-F4P: Vibrothermography:

**Figure 13:** The postprocessed results from the vibrothermographic inspection on sample N-D-F4P [5].

There was no kissing bond defect detected in specimen N-D-F4P (as expected) however, delamination-like defects were identified. The vibrothermography results in the two previous samples are promising for the detection of kissing bond
