# Implementation and Demonstration of Autonomous Ultrasonic Track Inspection Using Cloud-based AI Rail Flaw Analyzer

This research successfully demonstrated autonomous rail inspection feasibility up to Technology Readiness Level (TRL) 7. A prototype integrating an autonomous rail vehicle and Sperry's Ultrasound Testing (UT) system was developed at Cranfield University. It was first tested at Cranfield's Railways Innovation Test Area (RITA) at TRL 5 and tested at heritage operational railway, in Idridgehay, Derbyshire, UK achieving TRL 7. Experimental works included a 15-meter track test at RITA and nine rounds demonstration of a 250-meter track inspection at Idridgehay, showcasing inspection, localization, navigation accuracy, and defect location precision. The prototype successfully detected artificial rail defect during the demonstration and promptly communicated to command centre via email. We characterised the vehicle performance by measuring the positional error and detection rate. The positional accuracy measurements, verified through GPS and odometry, revealed an odometry-based error of 0.27-3.2 metres and an 8-metre GPS-associated error. The absence of differential GPS and

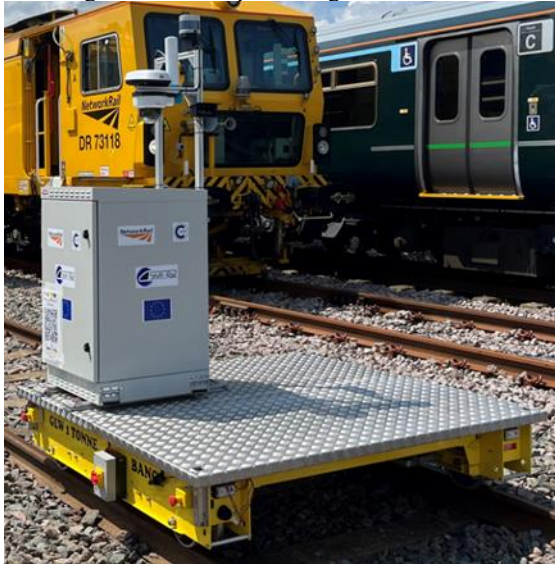
A manual-controlled motorised trolley from BANCE® was procured and upgraded to an autonomous robot platform which supports self-navigation and obstacle avoidance functions as shown in Figure 1. This vehicle is lightweight, battery-powered, and capable of carrying a payload of up to 830 kg while reaching speeds of up to 8 km/h. In order to implement autonomous driving function easily, seven speed levels were pre-defined covering the vehicle speed range.

Fig.1 Autonomous Rail Trolley, equipped with LiDAR, GPS, Encoder and Camera

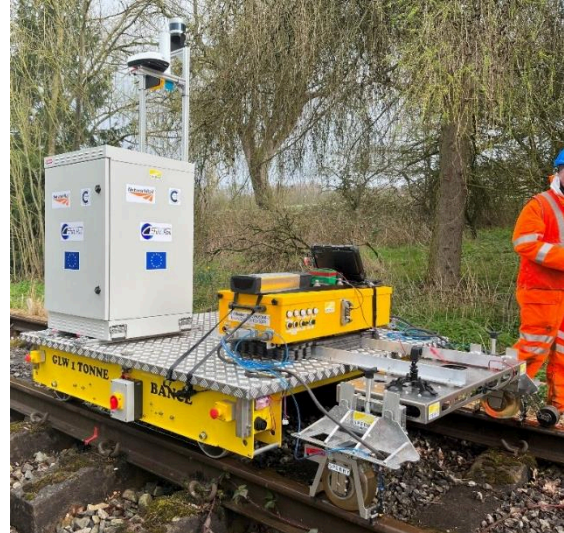
The walking stick and trolley platform are joined using two aluminium angle components as the mechanical integration. The tablet, batteries and water tank are accommodated on the vehicle front platform and secured in place with a foam energy absorber to suppress vibrations. Since the UT system does not inherently possess an autonomous inspection function, the research establishes a serial port communication interface between the vehicle and UT system to facilitate the control of the inspection procedure start and stop functions. Three string commands are employed. Initially, UT system transmitted the 'CTR\_RD' command to the vehicle to indicate that inspection kit is on standby. Subsequently, the vehicle sends the 'CTR\_ST' command to the UT system to initiate the inspection process, while the 'CTR\_SP' command is used to terminate data collection. The integrated prototype is shown in Figure 2.

Fig.2 Integrated autonomous ultrasonic rail inspection system prototype
