CRANFIELD UNIVERSITY

MONITORING OF STRESS CORROSION CRACKING UNDER  
REPRESENTATIVE PIPELINE CONDITIONS

PhD

Academic Year: 2019 - 2023

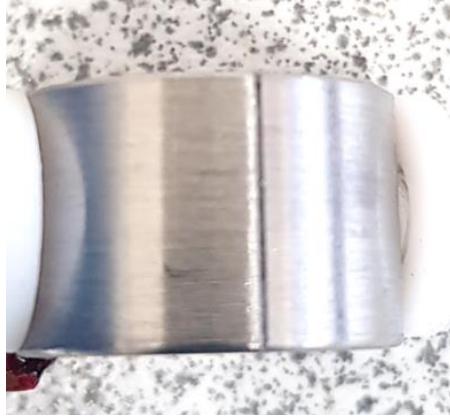
To understand the effect of pre-exposure surface damage on stress corrosion susceptibility of the samples, notched samples were prepared. In addition, mechanically and chemically pre-damage samples were also prepared. The notched samples were prepared by engraving or machining 200  $\mu\text{m}$  V-notches across the top centre of the C-rings. This is carried out in order to create a triaxial stress condition adjacent to the root of the notch on the specimens' surfaces. Figure 3-5 shows an example of a notched sample and position of the engraved notch.

**Figure 3-5 - Example of a notched sample showing the position of the notch.**

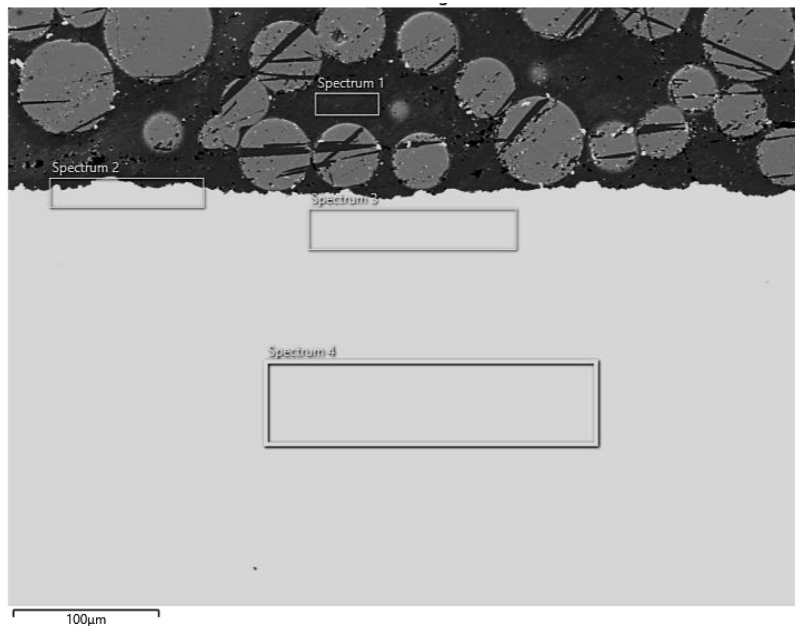
Different elemental compositions (Figure 5-59) were detected from the EDS spectra (Figure 5-58) of the X100 3-point bent-beam sample stressed at 80 % Y.S. exposed at 25 °C, relative to the X100 3-point bent beam sample exposed at 5 °C (Figure 5-56). The percentages of Fe and Mn detected in the EDS spectra of the X100 3-point bent-beam sample exposed at 25 °C are lower, with maximum values of 92.68 wt.% and 1.93 wt.%, respectively, relative to X100 3-point sample exposed at 5 °C (Figure 5-56). Presence of O and Si was also observed in all

spectra in the X100 3-point bent-beam samples exposed at 25 °C, with values of 0.76 wt.% and 0.25 wt.%, respectively observed in spectrum 4 and 3. Traces of Cl was observed in spectrum 4 of the X100 3-point bent-beam sample exposed at 25 °C with a value of 0.03 wt.%. relative to sample exposed at 5 °C.

**Figure 5-58 - SEM backscattered electron image of the exposed X100 3-point bent-beam sample in simulated saltwater solution with CO<sub>2</sub> at 25 °C stressed at 80 % Y.S. Data from the EDS spectra are reported in Figure 5-59.**

In comparison with the X100 C-ring sample exposed at 25 °C (Figure 5-53), percentage of Fe was observed to be higher in the X100 3-point sample exposed at 25 °C. Maximum Fe concentration values of 92.68 wt.% and 92.3 wt.%, respectively, were observed in spectrum 3 of the X100 3-point bent-beam and spectrum 4 of the X100 C-ring samples. The percentage of Mn and Si were observed to be lower in the X100 3-point sample, relative to X100 C-ring sample. Maximum Mn concentration of 2.03 wt.% and 1.93 wt.% at 25 °C, respectively, were detected in spectrum 3 of the X100 C-ring and spectrum 4 of the X100 3-point samples. Highest concentration of Si with a value of 0.25 wt.% was detected in spectrum 3 of the X100 3-point sample, with a maximum value of 0.98 wt.% observed in spectrum 3 of the X100 C-ring sample. Presence of O was detected in all spectra in the X100 3-point sample, relative to X100 C-ring sample.
