# Three-dimensional subsurface defect shape reconstruction and visualisation by pulsed thermography

Defects detected by most thermographic inspection are represented in the form of 2D image, which might limit the understanding of where the defects initiate and how they grow over time. This paper introduces a novel technique to rapidly estimate the defect depth and thickness simultaneously based on one single-side inspection. For the first time, defects are reconstructed and visualised in the form of a 3D image using cost-effective and rapid pulsed thermography technology. The feasibility and effectiveness of the proposed solution is demonstrated through inspecting a composite specimen and a steel specimen with semi-closed airgaps. For the composite specimen, this technique can deliver comparatively low averaged percentage error of the estimated total 3D defect volume of less than 10%.

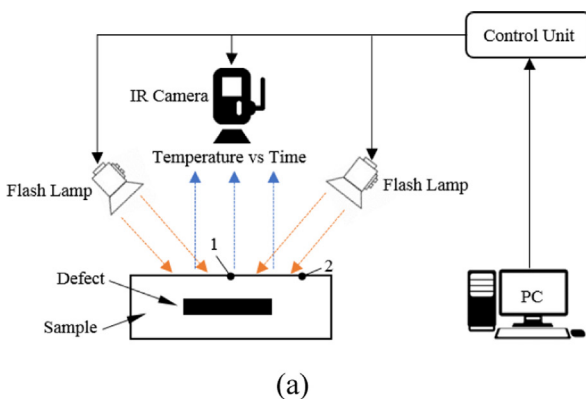
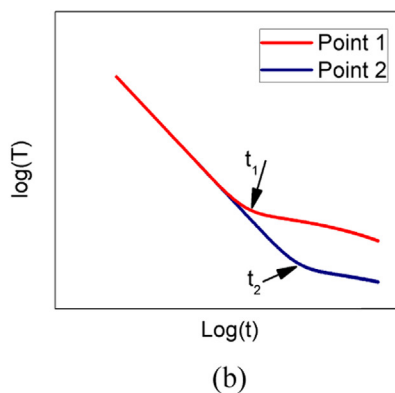
**Fig. 1.** (a) Experimental configuration of the pulsed thermographic inspection under the reflection mode, where point 1 denotes a surface location with a defect underneath and point 2 denotes a location on the sample surface with no defect underneath; (b) Typical observed time-temperature decay curves in the logarithmic domain for the point 1 and 2, respectively, where the time of  $t_1$  and  $t_2$  is the key to measure the thickness of local materials [7].

In a pulsed thermographic inspection in reflection mode, a short and high energy light pulse is projected onto the sample surface through one or two flash lamps (see Fig. 1(a) for typical experimental setup) [33].

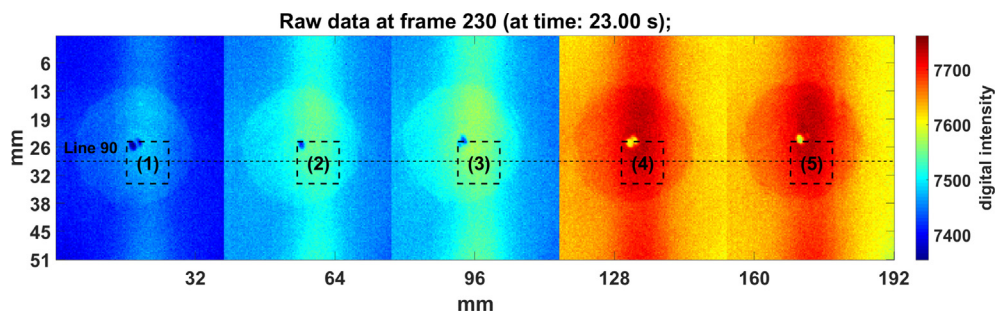
**Fig. 6.** The raw thermal image at the frame 230 for Sample 1 after combining 5 inspections, where the regions of interest are highlighted.

Due to the large width of Sample 1 (230 mm), the defects of this sample suffer non-uniform heating for a single inspection, which could lead to unreliable results [36]. To reduce this effect, in this study the sample has been inspected five times, where each defect was placed on the centre of the camera's view once. An area of the centralised defect with the size of  $160 \times 120$  pixels for five data files was then cropped and merged into one file with a size of  $160 \times 600$  pixels for easier analysis. Fig. 6 shows a snapshot of the raw thermal image at time 23 s. The defects are labelled as “(1)”, “(2)”, “(3)”, “(4)”, and “(5)” to represent the defect thickness of 0.5 mm, 1.0 mm, 2.0 mm, 3.0 mm, and 4.0 mm, respectively. The ROI of each defect is about  $10 \text{ mm} \times 10 \text{ mm}$  (around  $30 \times 30$  pixels), as highlighted in Fig. 6, which are used for evaluating the performance of the proposed technique.

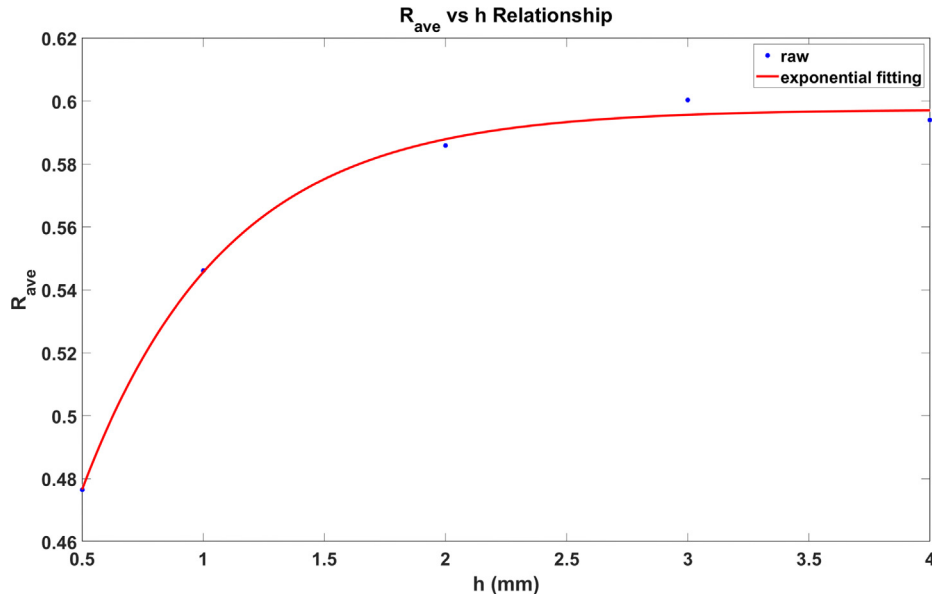
Fig. 7. The plot of  $R_{ave}$ - $h$  curve of Sample 1.

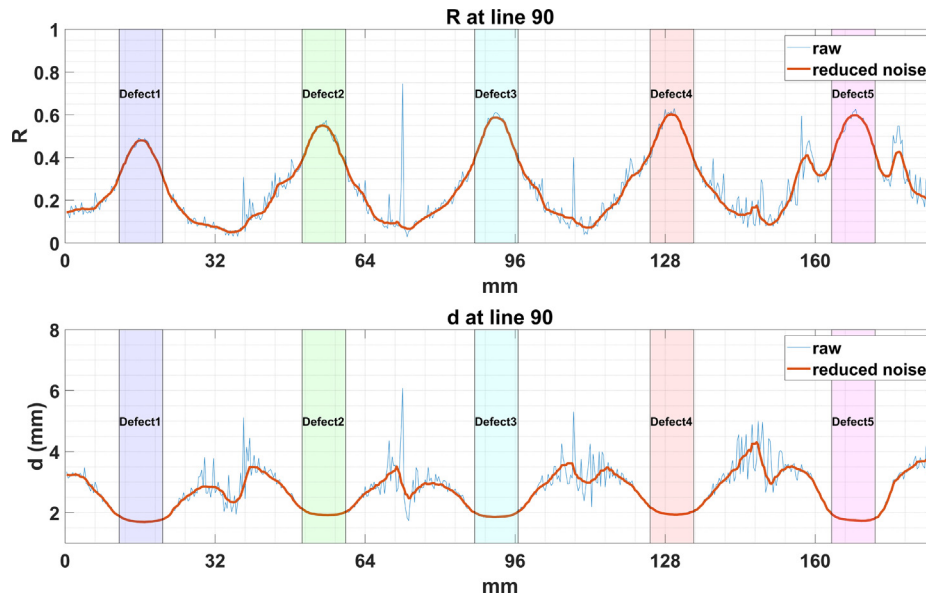
Fig. 8. Plots of estimated  $R$  and  $d$  of the cross-section at line 90.

Fig. 8 shows plots of estimated  $R$  and  $d$  of the cross-section at line 90, where it can be clearly seen that the  $R$  values are not consistent for one defect even though the five defects have a consistent thickness. It indicates that there are some other factors affected the  $R$  value. It is suggested in Fig. 8 that  $R$  value at both sides of defect's boundary is less than the middle region. This observation could be caused by the fact that the heat around the middle of the defect is more difficult to leak than that around the boundary of the defect. This issue must be addressed if the identified model from the regions of  $6 \times 30$  pixels is applied to the ROI of  $30 \times 30$  pixels. To improve the accuracy of  $R$  estimation, the shortest distance from the boundary of the defect to the inspected point ( $D_{dis}$ ), shown in Fig. 2, is taken into account to correct the  $R$  value. The re-calculated  $R$  ( $R_{new}$ ) is a function of  $R$  and  $D_{dis}$

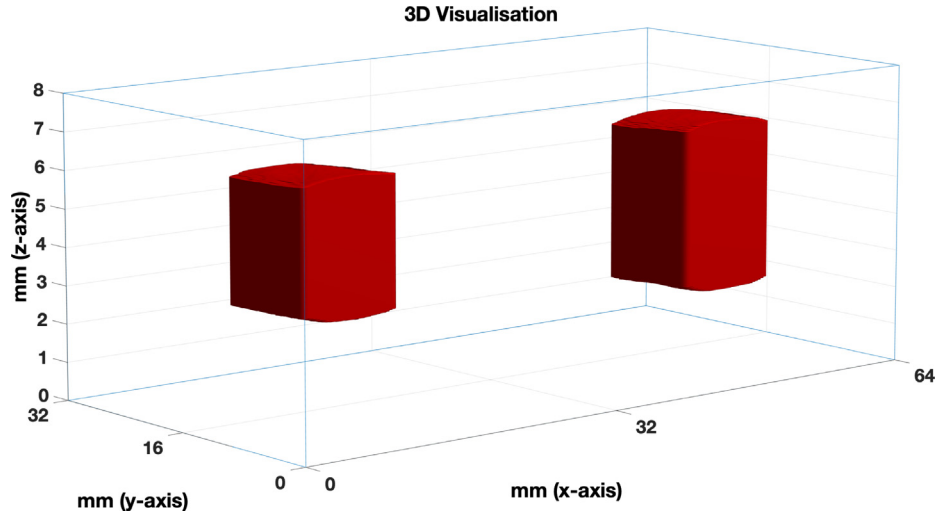
Fig. 11. The 3D visualisation of Sample 1 from the double-side inspection.

volume image and visualised in the form of 3D image, as shown in Fig. 11. It is clearly visible that Defect 5 is thicker than Defect 4, and the estimated 3D volume for both defects is close to the design shown in Fig. 4. It should be noted that the z-axis is scaled up to better visualise the detail of the defect surface.

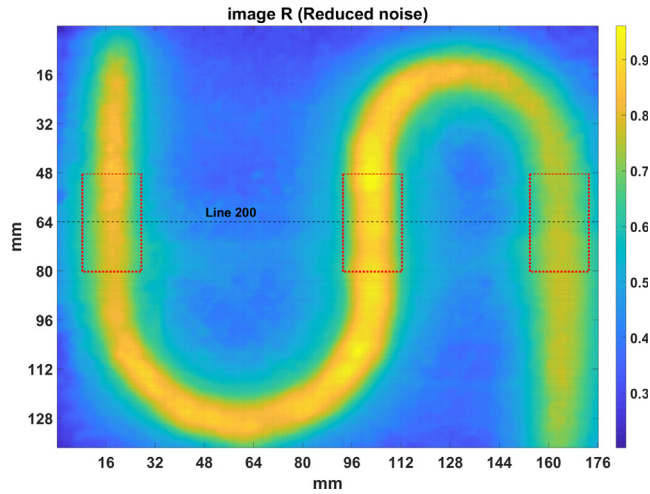
Fig. 12. The averaged  $R$  region over the top side triangle defect area for Sample 2.

$100 \times 60$  pixels were sampled as highlighted in Fig. 12. It should be pointed out that the  $R$  values of 100 vertical pixels were averaged. Fig. 13 plots the cross-section at line 200 of the estimated  $R$  and  $d$ , where the three selected areas are highlighted. It can be observed that the middle area has the highest value of  $R$ , then the left one and the right now. Proven in the experiments of Sample 1, a higher value of  $R$  suggests a thicker defect. As illustrated in Fig. 5, the maximal thickness of the left defect is about 20 mm, and the right one is about 16 mm. Based on the observation of the  $R$  values, the maximum thickness of the middle area is assumed to be 24 mm. A numerical model was then established to represent the relationship between  $R$  and  $h$ , written as

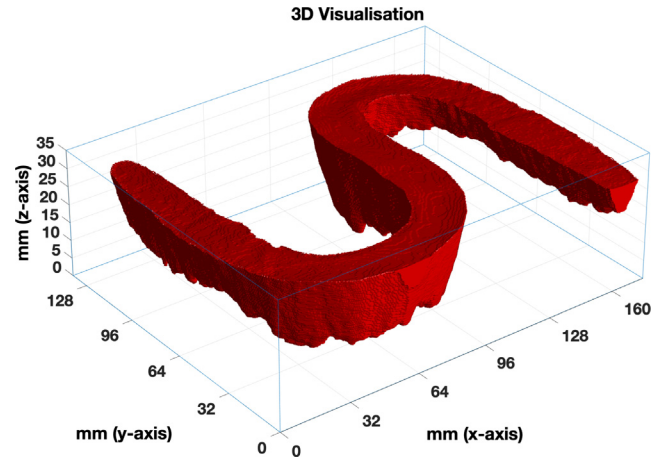
Fig. 14. 3D defect visualisation of Sample 2 defects using the proposed single-side inspection.

As the last step, the 3D volume image was reconstructed by combining the surface dimension (size and thickness of the sample) and subsurface information (defect depth and defect thickness) and result is shown in Fig. 14. The triangular 'S' shape defect can be clearly observed which matches the appearance of the defect shown in in Fig. 5(c) and Fig. 5(d). To validate the result using other NDT methods, Fig. 15 shows the comparison of the 2D image of the defect from pulsed thermography and X-ray. It can be seen that the defect shape of both images is similar. A quantitative comparison between these two imaging modalities in terms of 3D defect reconstruction was not conducted in this paper due to the distortion of thermal images caused by the lens. A further study is required to correct this distortion before conducting a comprehensive comparison.
