# Using High-Resolution Digital Photography and Micro-CT Scanning to Investigate Deathwatch Beetle Damage to an Historic Timber from HMS *Victory*

Fiona Brock<sup>a</sup>, Richard Southwell<sup>a</sup>, Zoë Hazell<sup>b</sup>, Roland Wessling<sup>a</sup>, Matthew Green<sup>c</sup> and Diana Davis<sup>d</sup>

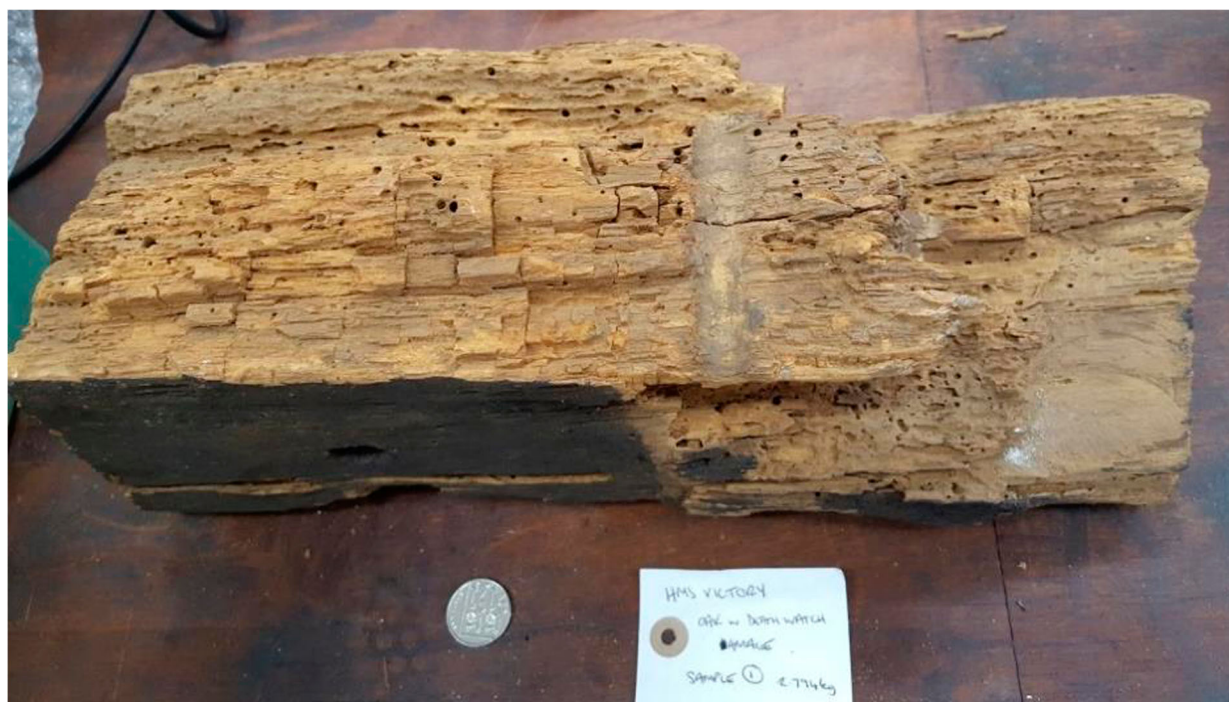
**Figure 1.** The investigated oak timber (previously removed from *Victory*) before subsampling. Note the original, darker and smoother, outer surface. Image taken by R Southwell.

A single timber of *Quercus* sp. (oak) from *Victory* was used for this study (Figure 1); it had been removed from the ship's hull between 1955 and 2000 during routine, on-going restoration work, because it showed evidence of damage by *X. rufovillosus*. There is no secure record of its original *in situ* position or orientation, although it is thought to be from a futtock (part of one of the ship's 'rib' frames), thereby dating to between 1759 and 1816. Since its removal, it has been kept in storage at the Royal Navy dockyard, then by a private owner, and since 2012 by the NMRN. It is most likely to be heartwood, as sapwood tended to be (though not always) removed by shipwrights during conversion, but this was not checked prior to the destructive analysis of the blocks following this study. The smooth, even faces are inferred to be

original outer edges of the timber, with the darker colour resulting from factors associated with ageing and/or exposure. It is not thought to have been topically treated, as futtocks are located within the double skin of a ship's structural frame. This timber was selected as it did not contain any high-density materials (such as copper nails or lead-painted surfaces) that would have affected the imaging.

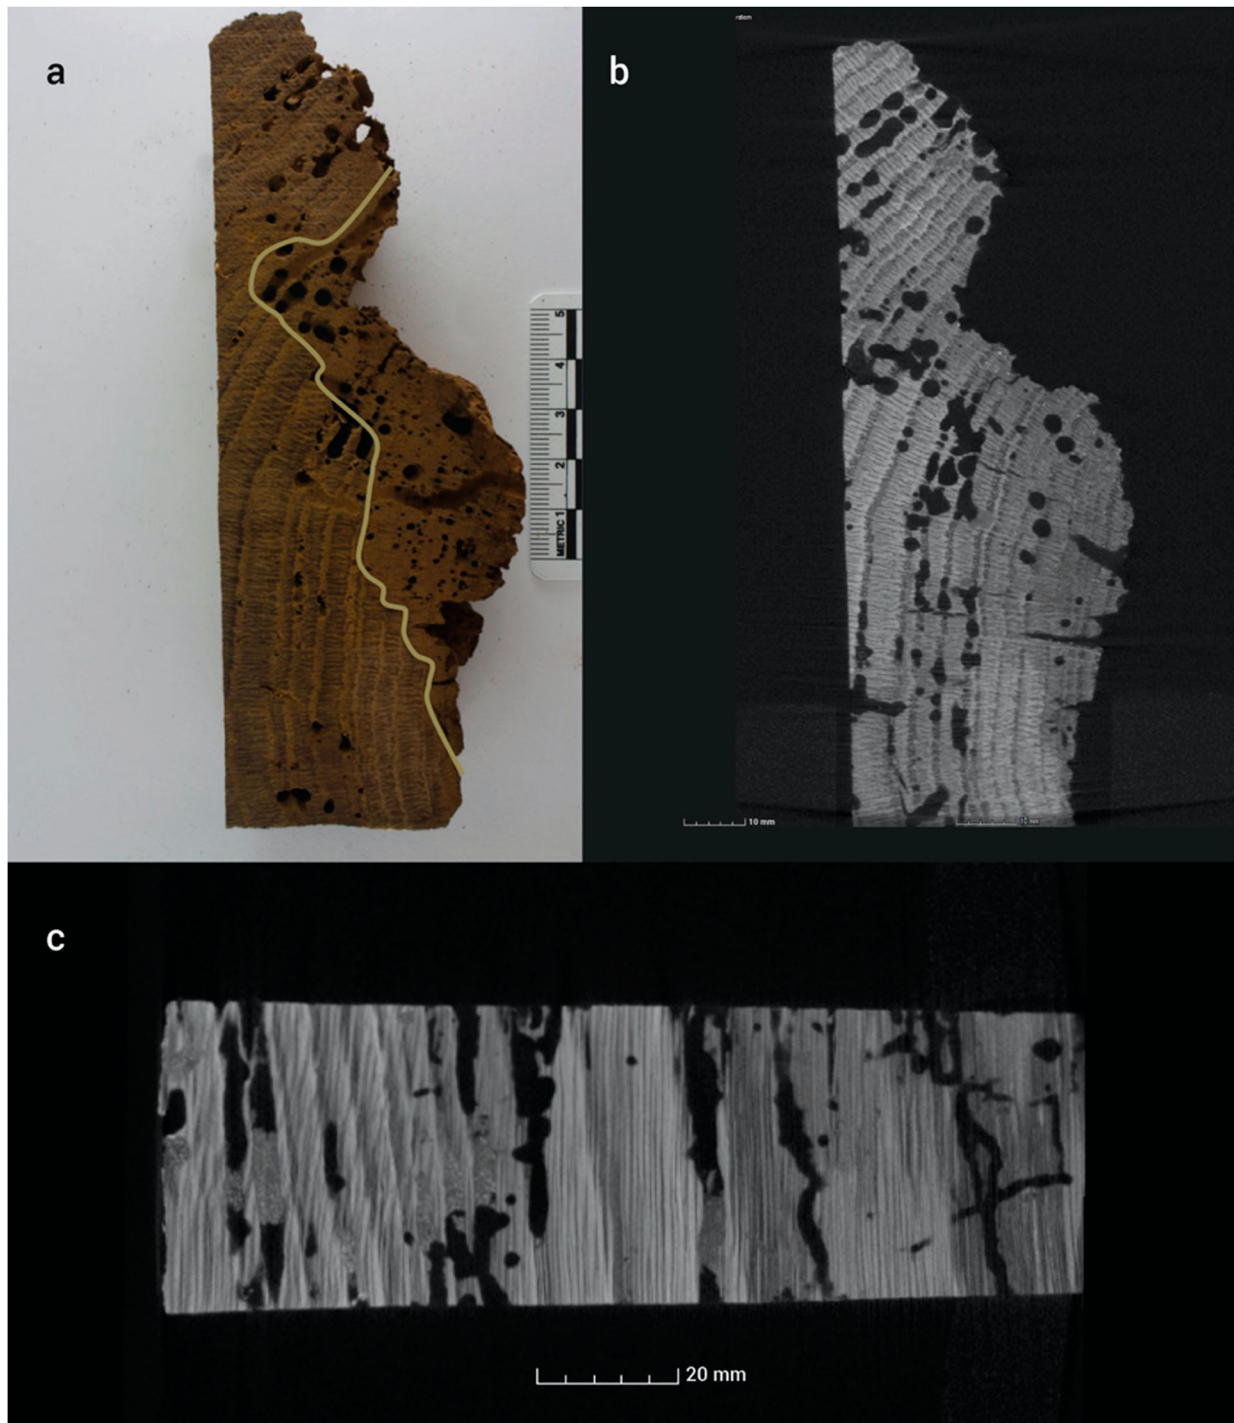
**Figure 6.** Images of Block 1b (surface photograph and CT slices). In Figure 6(a), the boundary has been drawn on (by eye), distinguishing (i) the area of degrading wood, lacking some structure (here, the right-hand side of the block) from (ii) the better condition, sound wood (here, the left-hand side of the block). Note that Figure 6(b) is a 'slice' from within Block 1b, and hence the holes are not identical to those observed in the surface image.

The X-radiograph showing the transverse section of the wood (Figure 5(b)) shows characteristics of the wood itself (i.e. the growth rings) as well as some insect damage manifest as tunnels, including holes of different diameters. An area of wood along some of the uneven, degraded edge of the fragment appears to be paler in appearance on the X-radiograph (i.e. with a lighter greyscale value) than the rest of the sample. Close inspection of the wood block itself (Figure 6(a)) appears to show the same area being

slightly darker in colour than the rest of the sample and to have lost some of its structural definition. The same region of wood also appears to have a slightly darker greyscale value than the rest of the wood on the corresponding micro-CT slices (Figure 6(b,c)). This difference in appearance within Block 1b could be due to some other form of degradation (see below for further discussion).

The micro-CT slices of Block 1b in Figure 6(b,c) also clearly show extensive internal damage in both

the longitudinal and transverse planes. The tunnels are mostly empty of frass and most commonly occurring in the earlywood (visible in *Quercus* by the ring porous large vessels), indicating a dietary preference for this part of the growth ring; reason(s) for which are outlined later.

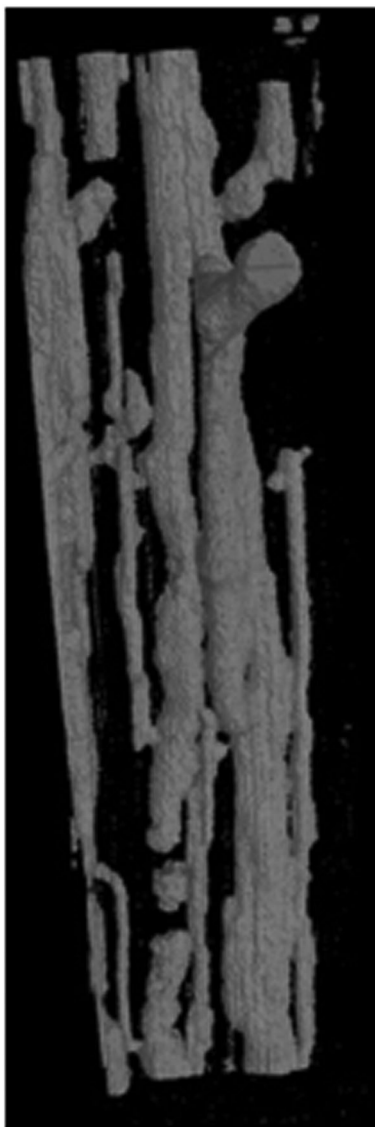
**Figure 9.** Model of the tunnel voids from Block 6a. Total height of block is ca. 90 mm.

Isolating and inverting the tunnel volumes from the wood matrix helps to visualise their form (e.g. Figure 9), particularly the prevalence of longitudinally-aligned linear tunnels. It should be noted that some tunnels are 'lost' during this process or appear as patches of noise on the images due to the difficulty in digitally isolating the frass from the wood matrix (see further discussion, below).

When zooming in as far as possible to the voxel limit on the isolated tunnel volumes (Figure 9) using the VG StudioMax software, a semi-regular, characteristic pattern appears to be visible along the length of the tunnels. Images are not presented here as the resolution is not sufficiently high to provide confidence that these are an actual feature, rather than an artefact of imaging. However, such patterns should not be unexpected, due to the tunnelling physics of the larval stage of wood-boring insects, which exert hydrostatic pressure against the walls with the front end of their bodies to get purchase on the face of the tunnel. Once the larva has eaten all the timber within reach, it deflates, shuffles forward, inflates at a tunnel face, and begins again. Such activity can only be seen using X-radiographic techniques, as once a tunnel is sectioned open, it loses pressure. Micro-CT-scanning smaller

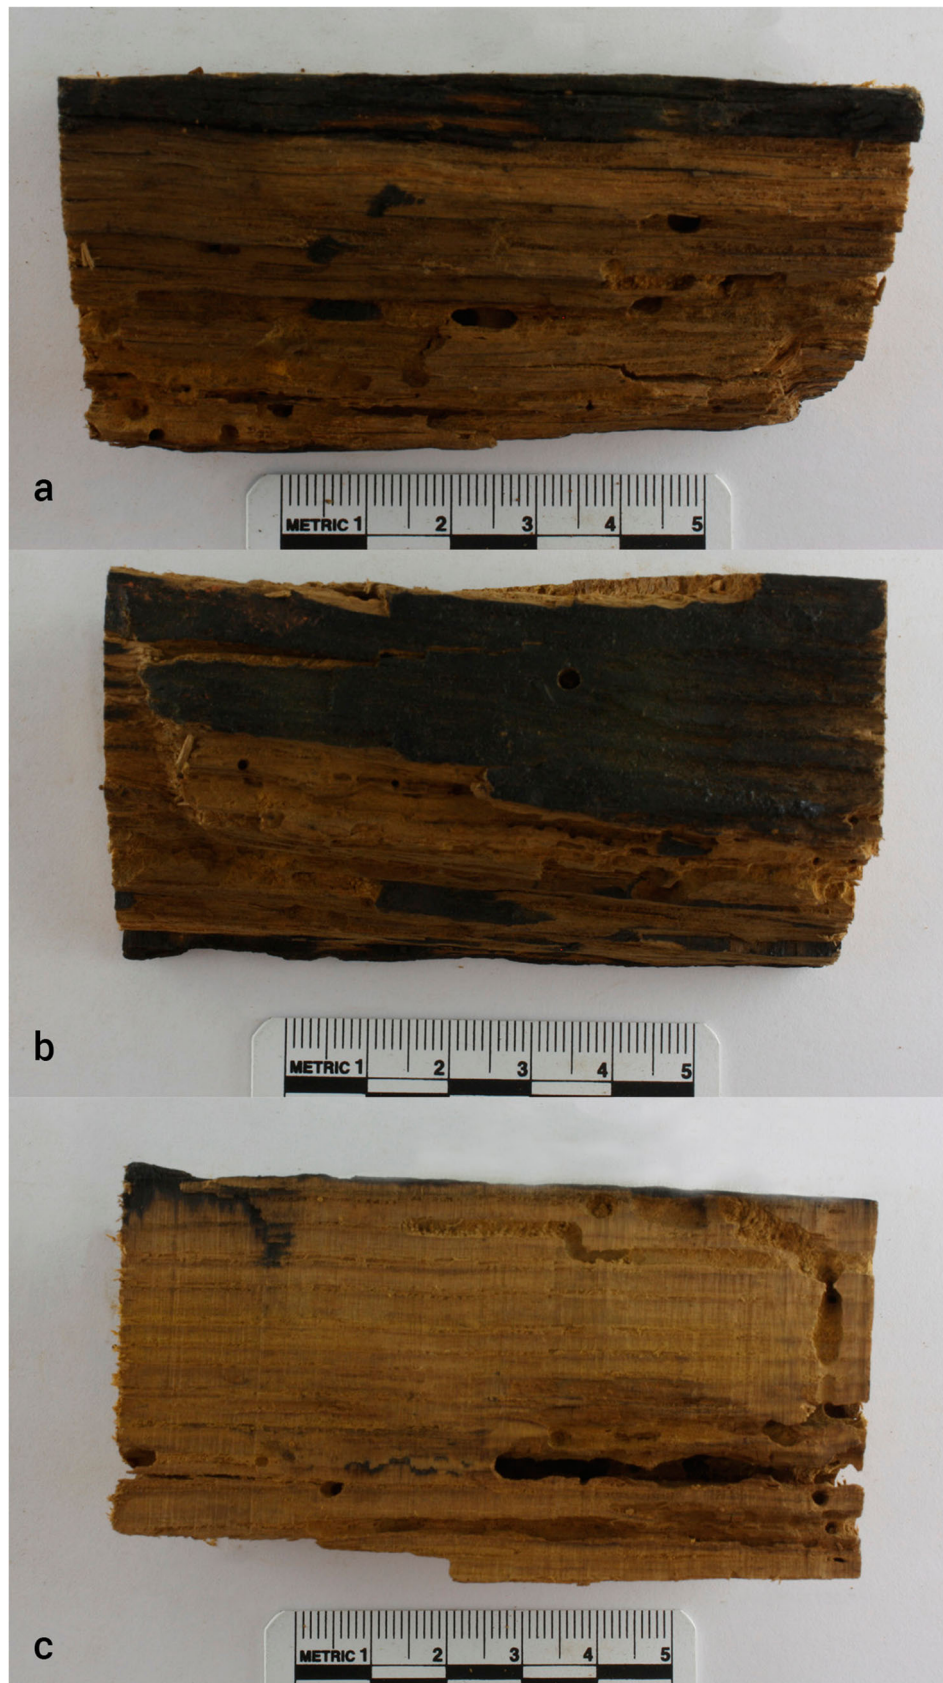
**Figure 10.** Block 7a (image of the fourth surface not available).

Further difficulties were experienced in calculating the total area of flight holes for samples that had significant damage resulting in uneven surfaces (e.g. Block 7a, Figure 10). Unfortunately, these difficulties could not be overcome by calculating the flight hole area from the micro-CT images using the same
