# Assessment of Coating Performance on Waterwalls and Superheaters in a Pulverised Fuel-Fired Power Station

**Abstract** Protective coatings offer one route to increase the lives of heat exchangers in pulverised fuel power plants. A range of candidate coatings have been exposed on the waterwall and superheaters of a 500 MWe UK power station unit for periods of up to ~4 years (24,880 operating hours), during which time this unit was fired on a mixture of UK and world-traded coals. Both nickel- and iron-based candidate coatings were included, applied using high velocity oxy-fuel or arc-wire process; a selection of these also had a surface sealant applied to investigate its effectiveness. Dimensional metrology was used to evaluate coating performances, with SEM/EDX examinations used to investigate the various degradation mechanisms found. Both the waterwall and superheater environments generated their characteristic corrosion damage morphologies which depended on the radial positions around the tube. Coating performances were found to depend on the initial coating quality rather than composition, and were not improved by the use of a sealant.

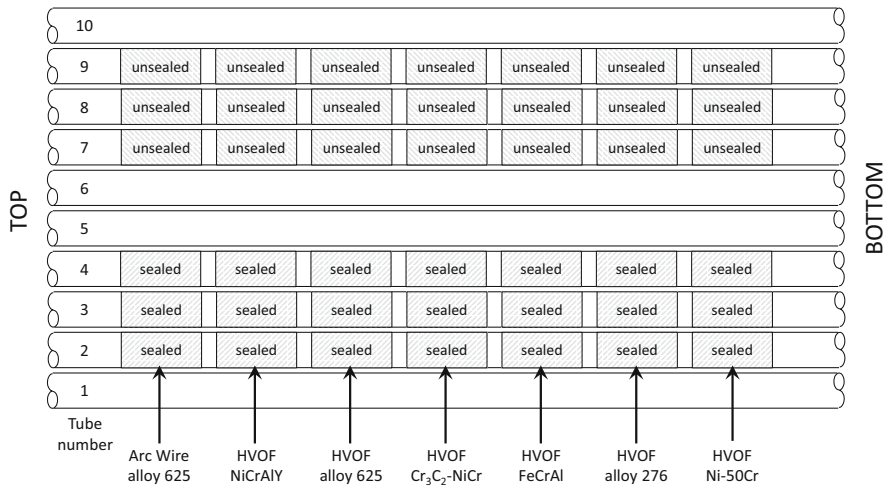
Tubes 2/3/4 and 7/8/9 of the furnace wall panel were externally coated with approximately 200-mm long bands of alloy 625 (arc-wire sprayed), NiCrAlY, alloy 625,  $\text{Cr}_3\text{C}_2$  in Ni–Cr matrix, FeCrAl, alloy 276 and Ni-50Cr (Fig. 2). With the exception of the alloy 625 applied by arc-wire spraying, all coatings were applied using HVOF. Tubes 2/3/4 also had the seal coating applied on top of the bands of coating. Tubes 1, 5, 6 and 10 were not coated. It should be noted that the tubes had already been assembled into a section of furnace wall panel, and so this restricted access for the coating processes and resulted in coatings that were thicker at the tube crowns (see Results).

**Fig. 2** Coating distribution on waterwall panel—all applied by HVOF except one by arc-wire spray

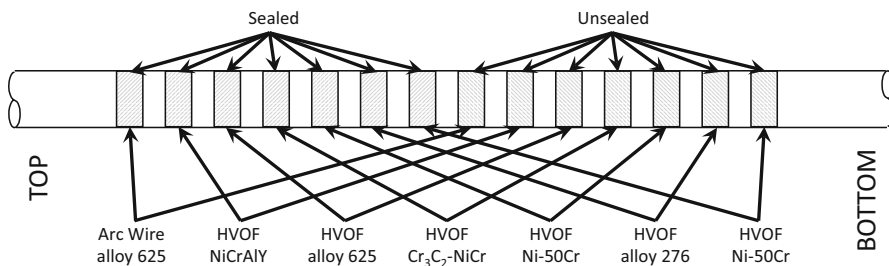
The tubes for installation in the primary platen superheater, outlet leg, and the secondary convection superheater, outlet bank, inlet leg, were externally coated with bands approximately 100 mm long of arc-wire sprayed alloy 625, NiCrAlY, HVOF alloy 625,  $\text{Cr}_3\text{C}_2$  in a Ni–Cr matrix, Ni-50Cr, alloy 276 and Ni-50Cr which were repeated once along the length of the tube (Fig. 3). These coatings were applied evenly around the individual tubes. One set of coatings had an additional seal coat (Fig. 3).

**Fig. 3** Coating distribution on the primary platen superheater outlet leg and secondary convection superheater outlet bank inlet leg
