## **Detection of shaft-seal rubbing in large-scale power generation turbines with Acoustic Emissions; Case study**

**D. Mba<sup>1</sup>, A. Cooke<sup>2</sup>, D. Roby<sup>3</sup>, G. Hewitt<sup>3</sup>**

### **Abstract**

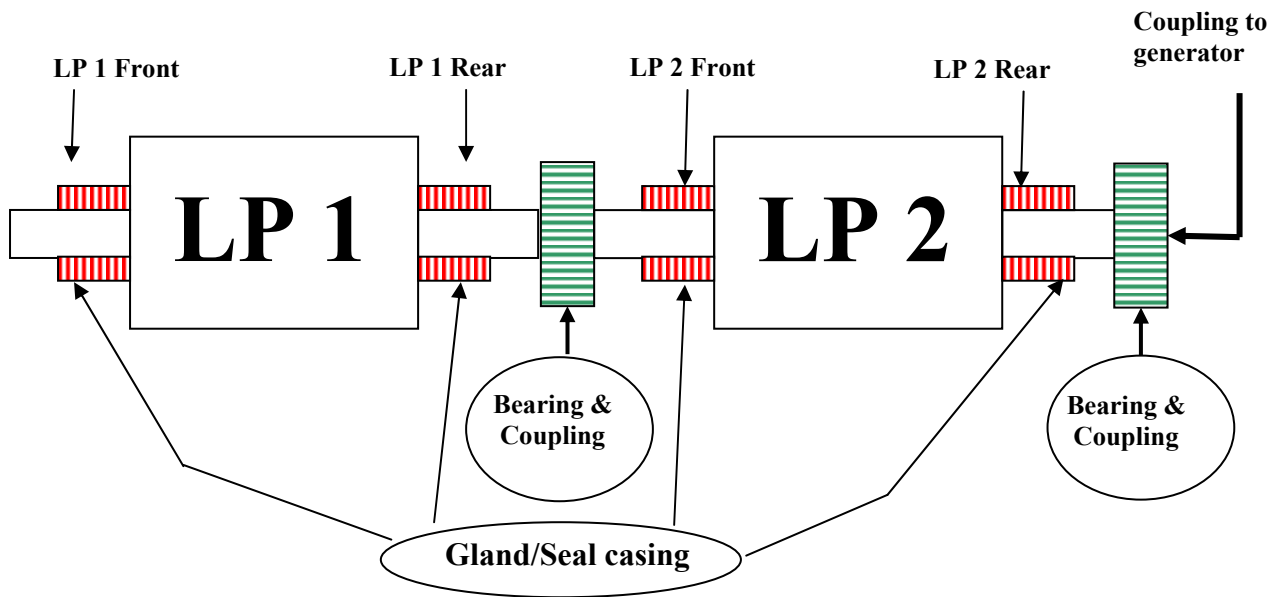
**Figure 2 Schematic of part of the Steam turbine unit**

A brief summary of the investigation into the applicability of AE as a detection tool for shaft seal rubbing on a specific steam turbine is presented. During operation high levels of shaft displacement were noted across the low-pressure turbine cylinders (designated 'LP' in figure 2) and the generator. A rub was suspected as the cause for such high displacement levels. These displacements were observed with permanently positioned eddy current probes. The operational performance of the unit during this condition included a steam exhaust temperature of 18<sup>0</sup>C and a maximum load of 80MW. The rotational speed of the unit was 3000 rpm (50Hz). Acoustic Emission recordings were undertaken at 'LP2 Rear', 'LP2 Front', 'LP1 Front' and 'LP1 Rear', see figure 2.
