# Experimental observations of an 8 m/s drop test of a metallic helicopter underfloor structure onto a hard surface: part 1

**Abstract:** This is the first part of a two-part paper that describes the experimental observations for two similar sections of floor that were dropped onto both hard and water surfaces at 8 m/s, as a part of one experimental campaign. The current paper provides an assessment of a simple box-beam underfloor structure typically found in metallic helicopters and provides an overview of the failure modes and the collapse mechanism observed when dropped onto a hard surface. All findings are supported by quantitative measurements and extensive photographic evidence.

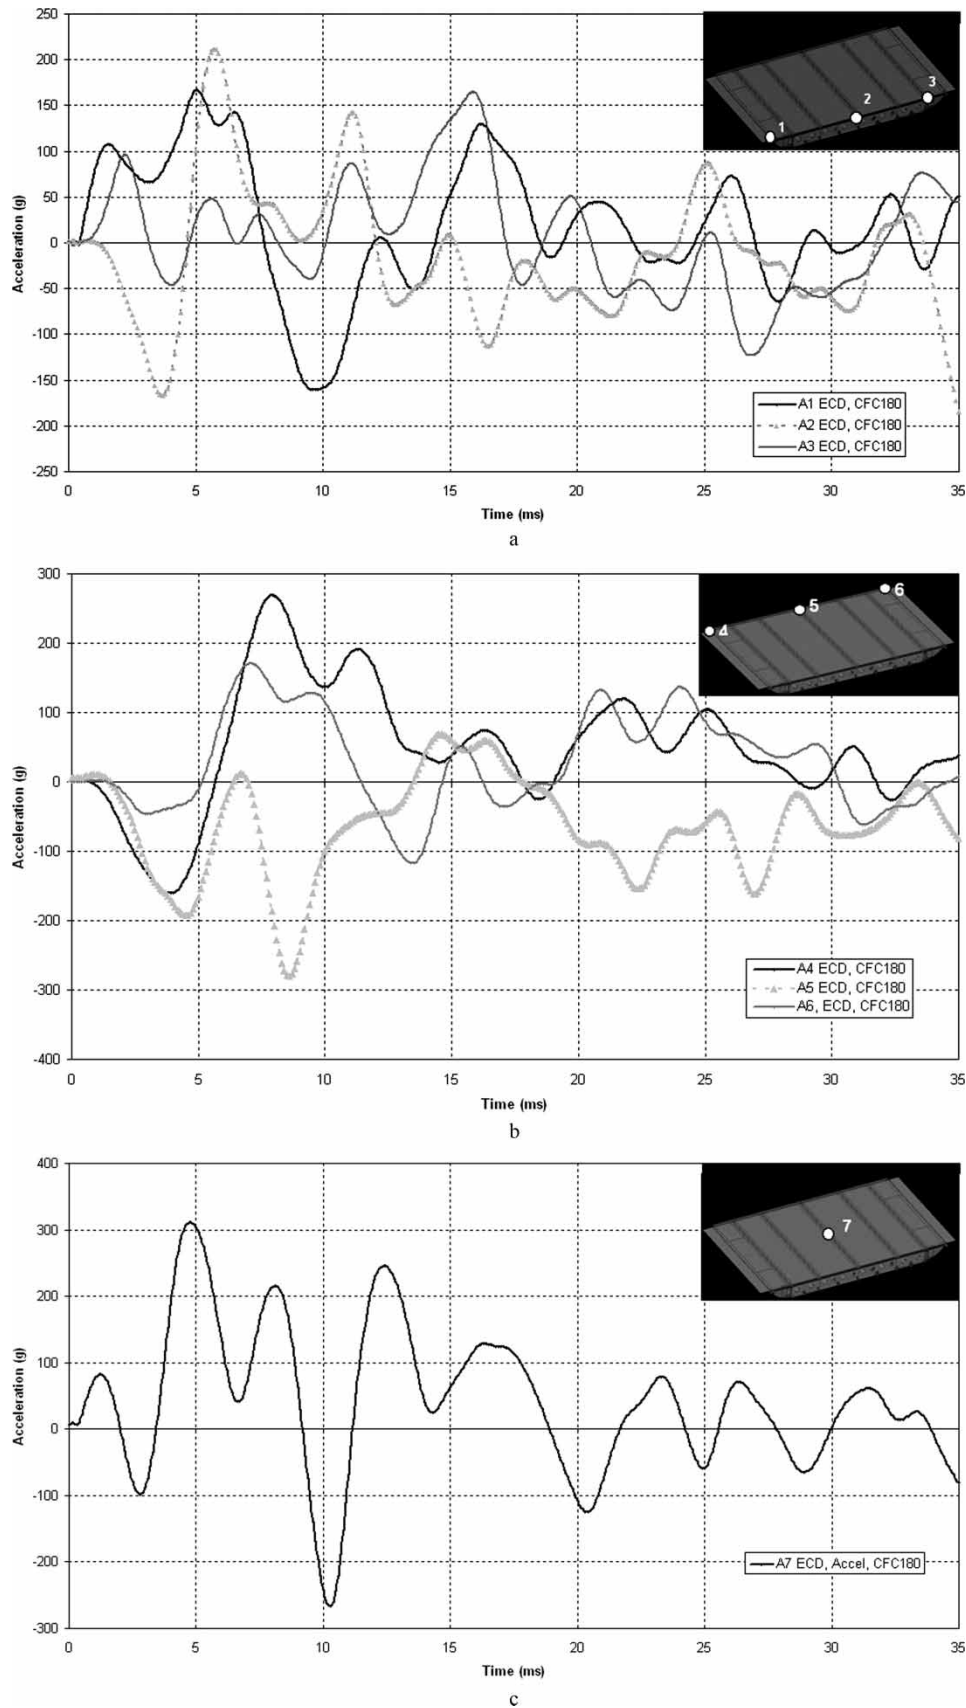
**Fig. 19** Experimental acceleration-time histories for A1 through A7

STN450F, V0, and STN1710F. During setup however, the accelerometers were directly attached to the top surface of the steel plate, presumably out of ease from an experimental point of view. The time histories in Fig. 19 shows that there appears to be no consistency between traces, as the signals are extremely noisy, even when low frequency CFC60 filters are applied.
