# Experimental observations of an 8 m/s drop test of a metallic helicopter underfloor structure onto water: part 2

K Hughes\*, R Vignjevic, and J Campbell

Crashworthiness, Impacts and Structural Mechanics Group, School of Engineering (CISM), Cranfield University, Cranfield, Bedfordshire, UK

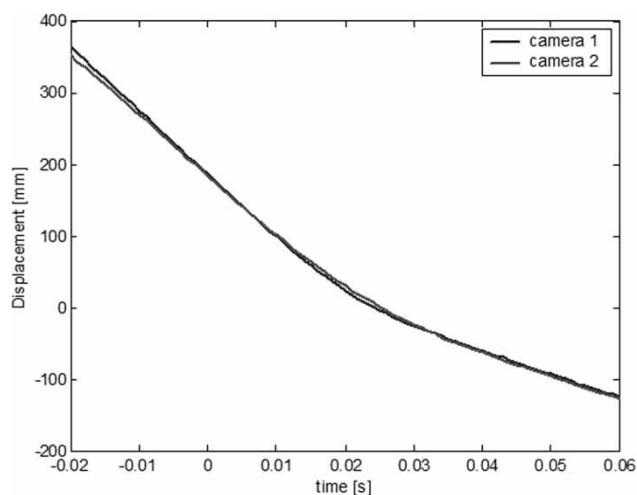
**Fig. 17** The vertical displacement of the guided trolley assembly determined from the high-speed camera images

After the drop test had been performed, it was found that the accelerations exceeded the range of the data acquisition system, as this was set to be sensitive to a maximum of 50 g. Therefore, no accurate data exists regarding the acceleration pulse shape, duration, or magnitude along any of the seat rails.

In order to provide an estimation for the whole body deceleration experienced by the guided trolley assembly, the displacement measurements shown in Fig. 17, were obtained from the two high-speed cameras located 20 and 5 m away from the drop tower, respectively. The images were calibrated against a fixed

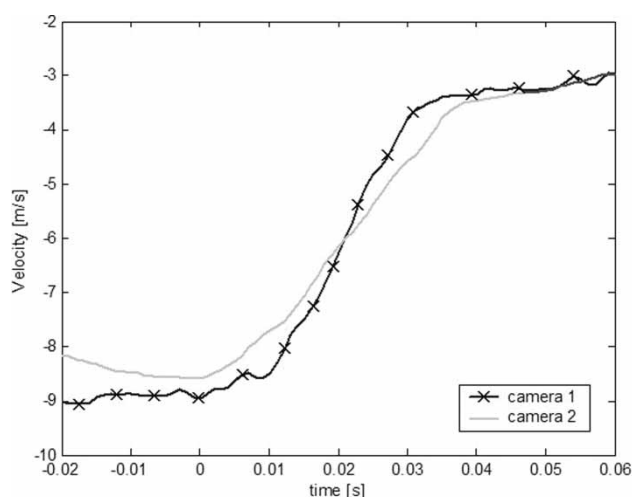
**Fig. 18** The velocity time history of the trolley assembly was obtained by differentiating the displacement data obtained from the high-speed cameras

datum, where the velocity and acceleration time histories were obtained by discrete differentiation of the displacement data in Figs 18 and 19, respectively.

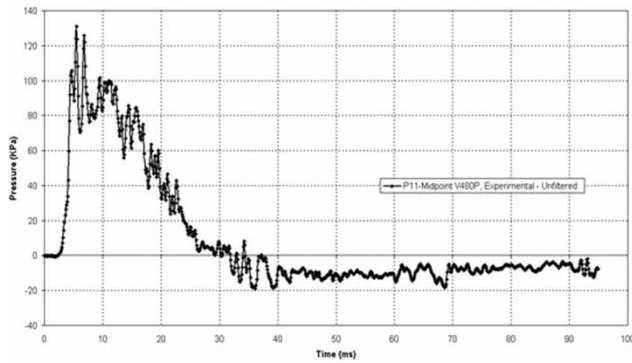
**Fig. 20** Experimental pressure time history for P11 situated underneath the midpoint of V480P

For example, Fig. 20 shows the results obtained for a pressure transducer located under the midpoint of V480P. As can be seen, the pressure rises to approximately 120 kPa, before going negative after 30 ms. The negative region is not an indication of cavitation, as it is an artificial effect caused by the inertial properties of the transducer. The oscillation of the sensor provokes this false reading, which can result in misinterpretation if the analyst is not aware of this effect. Removing this noise is difficult to achieve in practice and raises questions as to the validity of the results in this region.

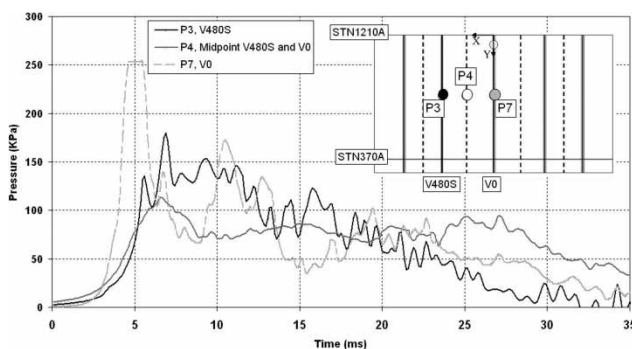
**Fig. 21** Experimental pressure time histories for three different strength locations of the floor, namely V480S, V0 and the midpoint

The results presented in Fig. 21 provide a comparison between the pressure results obtained along the midpoint of V480P and V0, which represents 'hard' locations where little frame deformation occurs, together with the flexible skin section located in between these two frames where significant inward deflections occur and is termed a 'soft' location. The pressures recorded underneath the frames of P3 and P7, results in high pressures of approximately 179 and 253 kPa, respectively. The hard results are higher than those at the soft location, as a peak pressure of only 113 kPa is recorded. This is expected and can be explained by the differences in stiffness between the two locations, as the more deformable locations are better able to counteract the sudden increase in pressure due to yielding, resulting in the lower pressures being recorded.
