# Dynamic investigation on the Mirandola bell tower in post-earthquake scenarios

**Abstract** After the seismic events of the 20th and 29th of May 2012 in Emilia (Italy), most of the monumental and historic buildings of the area were severely damaged. In a few structures, partial collapse mechanisms were observed (e.g. façade tilting, out-of-plane overturning of panels...). This paper presents the case-study of the bell tower of the Santa Maria Maggiore cathedral, located in Mirandola (Italy). The dynamic response of the structure was evaluated through operational modal analysis using ambient vibrations, a consolidated non-destructive procedure that estimates the dynamic parameters of the bell-tower. The dynamic tests were carried out in pre-intervention and post-intervention conditions in order to understand the sensitivity of dynamic measurements to safety interventions. Furthermore, a comparative study is made with similar cases of undamaged masonry towers up to the 6th mode. Finally, an investigation on the state of connections and of the building itself is carried out via FE model updating.

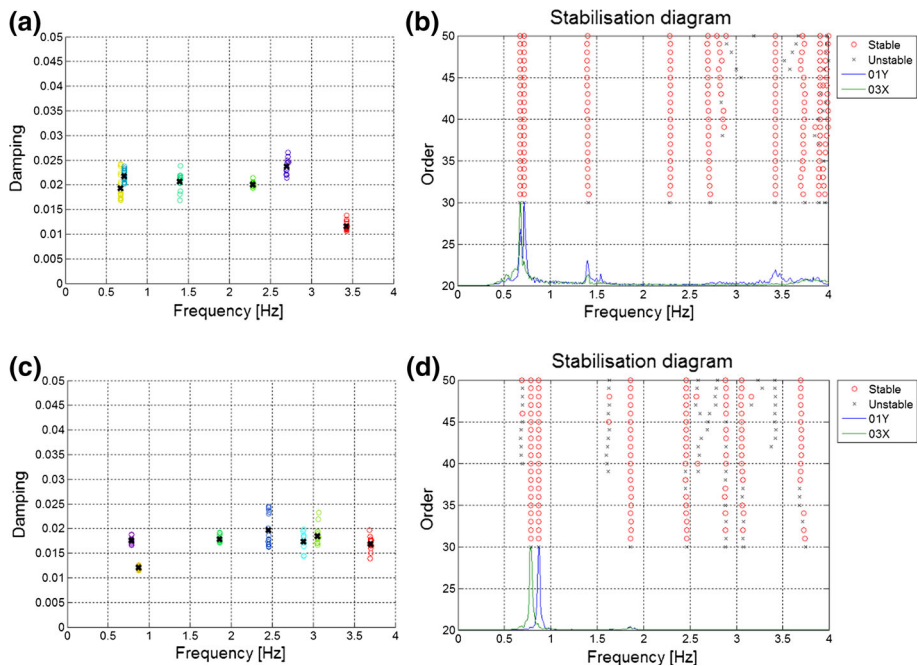
From the modal frequencies and from  $\Delta f$  it can be clearly noticed how the installation of the safety interventions mitigated the effects of the extensive damage suffered by the bell-tower (De Stefano and Ceravolo 2007). In fact, the first two bending modes (Table 1) increased of the 16 and 21 %, from 0.68 and 0.72 to 0.79 and 0.87 Hz; whereas the first torsional mode had an increase of 32 %, from 1.41 to 1.86 Hz. For what concerns the damping ratios, the trend is not as clear. Anyhow, 6 out of the 8 modes listed in Table 1 show an increase in the damping ratios after the interventions.

**Fig. 7** Bell-tower modal identification results (frequency-damping clustering and stabilisation diagram): **a**, **b** PR-I, **c**, **d** PS-I. The stabilisation parameters chosen for the graph were:  $\delta f = 0.005$ ,  $\delta \zeta = 0.1$ ,  $MAC = 0.95$

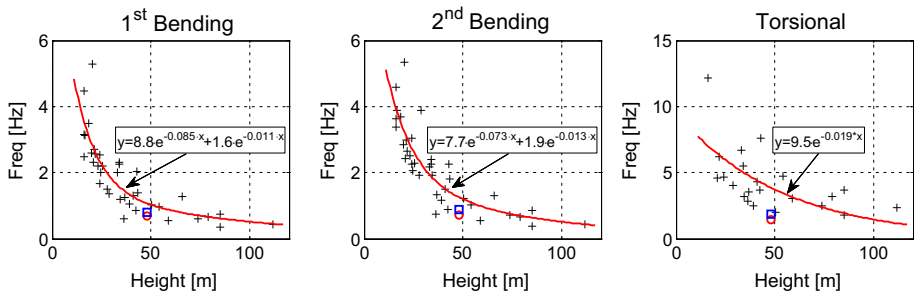
**Fig. 8** Frequency dependency of the first 2 bending and the torsional mode with respect to height of the building from literature data. The red circle and the blue square represents the Mirandola bell-tower frequencies in the PR-I and PS-I configuration respectively, whilst the regression line is obtained with a generic exponential law

height represented by the lines in Fig. 8. This is most probably a symptom of a severely damaged structure, where box-like behaviour has been strongly affected. In fact, stiffness along the plane of the masonry walls is relatively less affected by the presence of cracks than torsional stiffness, which is influenced by the state of the connections between orthogonal wall panels. The full list of bell tower modes, up to the sixth, can be found in Table 2.

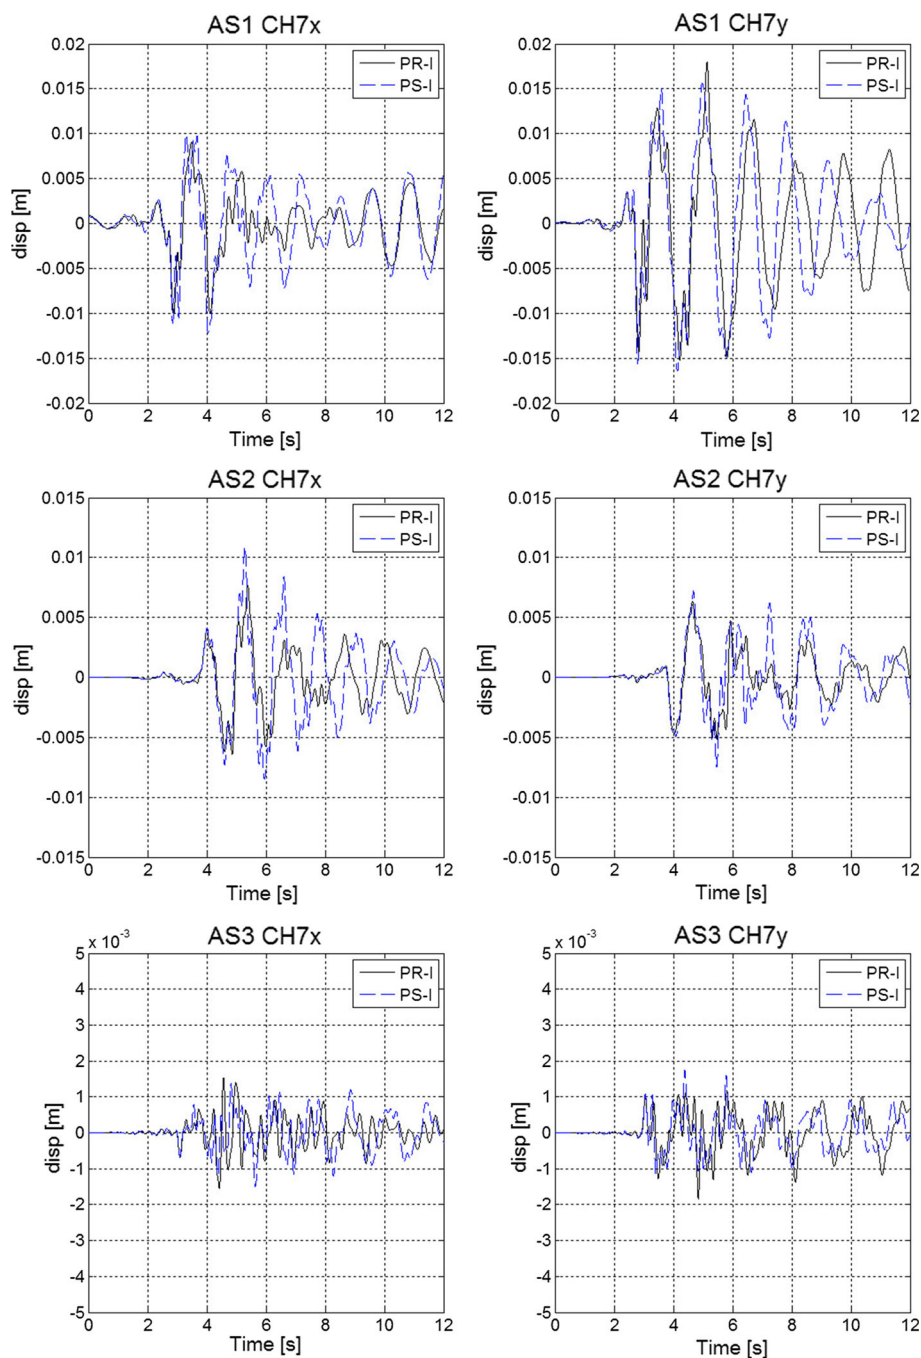
**Fig. 16** Comparison between the displacement responses related to CH7-position (direction  $x$ —first column, direction  $y$ —second column) in the pre (red line) and post (blue line) condition

The maximum displacements values are obtained for the CH-7 position, located in a higher, thus more flexible region of the tower, where the most severe damages were assessed (see Fig. 2). Observing the time-history responses in Fig. 16 and the results in Table 6 it is possible to notice how the amplitude of the response in the PR-I and PS-I configurations is quite similar with all the three aftershocks. As shown in Fig. 16, the response in the direction of the x and y reveals quite similar results between PR-I and PS-I differing only by the time of occurrence of the peak displacement. Only the responses to AS1 and AS3 aftershocks show an improvement of global behaviour when considering the maximum response in terms of displacement.
