# Profiling Corrosion Rates for Offshore Wind Turbines with Depth in the North Sea

**Abstract:** Corrosion in the marine environment is a complex and expensive form of damage. It is commonly studied by the deployment of coupons that reflect the marine corrosion a structure will experience, thus allowing design and maintenance prevention strategies to be developed accordingly. This study stems from the lack of information in the literature regarding the profiling of corrosion with respect to marine depth in the North Sea where important wind farm developments have been undertaken. To address such issue a field experiment has been designed and carried out in the vicinity of the Westernmost Rough Windfarm in the North Sea. The field experiment consists of deploying steel S355 coupons below the tidal area and capturing the effects of corrosion, the mass loss from which the corrosion rate is derived and the chemical products that makes up the rust with water depth. The study involves proper planning and logistics to ensure that the field experiment survives the rough conditions of the North Sea for a duration of 111 days. A high corrosion rate of 0.83 mm/year has been observed in this

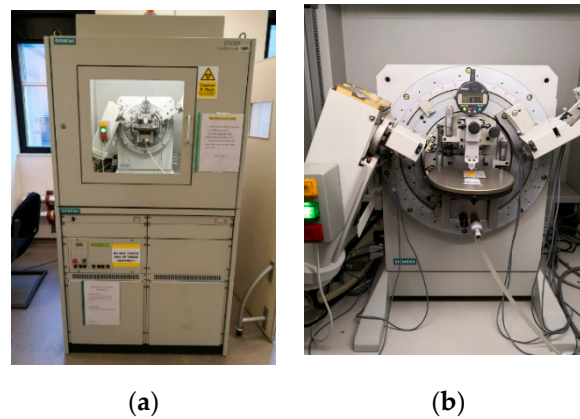
The chemical products formed due to corrosion were determined using the XRD technique. The rust formed was iron oxide-hydroxide. The equipment is shown in Figure 14.

Figure 14. (a–b) XRD equipment with rust sample being tested.
