# The effects of crossbow impacts onto a common automotive vehicle side window—a preliminary study

## Abstract

In recent times, the number of criminal incidents involving crossbows in the UK has increased with many incidents resulting in either injuries or fatalities. Whilst the effects of crossbow bolts on the body are well understood, there is a limited understanding on how these projectiles interact with the wider environment. One area of particular interest is the interaction between common vehicle side windows and bolts. In this study, the penetrability of two distinct bolts using an off-the-shelf crossbow against a common automotive side window was explored, where velocity loss up to 25 m/s post impact was recorded. All windows failed through radial glass fracture at a rate up to 1600 m/s, whilst bolt damage varied from tip holder decoupling, shaft damage, and traumatic fletching removal. No distinct relationship between bolt type, velocity, and window damage was identified.

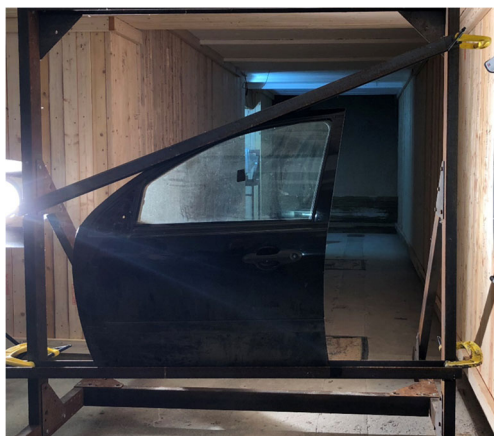
**Fig. 1** Target door secured in mount

Six Ford Fiesta (Fifth generation model, year 2002 to 2008) front doors containing tempered glass were procured from Haynes of Challow, Oxfordshire to represent a common car type within the UK. Prior to use, each door window was visibly checked for damage before being hand cleaned with soap and warm water to remove any visible dirt or blemishes before placed in a metal target frame (Fig. 1). Doors were positioned with the external face facing towards the crossbow.

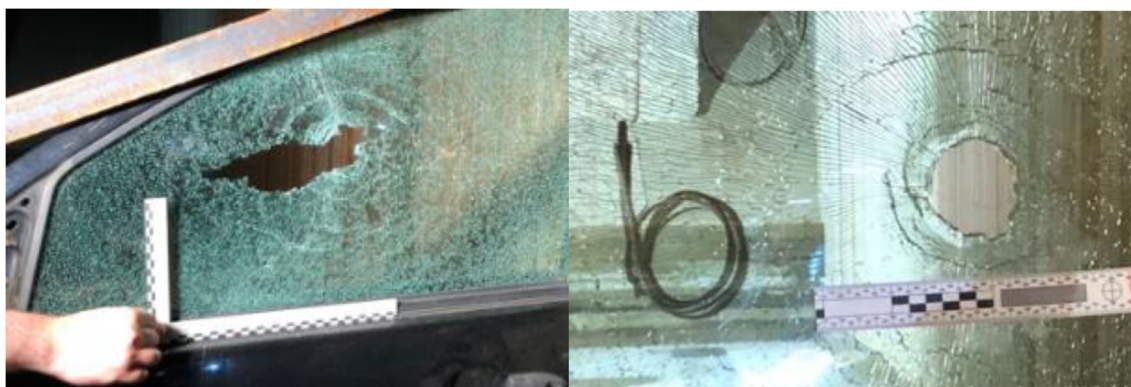
**Fig. 6** Fracture pattern post impact by a 2219 bolt and EK Bolt in to window 1 and 6, respectively

In all tests, window damage occurred at the point of contact between the bolt and window, resulting in glass shatter (Fig. 6). Damage initiation was radial in geometry, which propagated outwards to the window boundaries at a rate up to 1600 m/s as measured by HSV. At the contact point the glass shards were eroded, leaving a circular hole, whilst the shattered glass remained in place the more distal from the impact. Due to the irregular geometry of the holes five diameter measurements were taken and averaged. Analysis of the circular holes indicated a mean width of  $48.6 \pm 2.86$  mm,  $60.9 \pm 4.8$  mm, and  $51.2 \pm 4.1$  mm for shot numbers 1, 5, and 6, respectively. Raw data is presented in Table 2. No relationship between width and bolt type and velocity was notable. For all other shots, the shattered glass fell away under the mass of the window, resulting in non-measurable holes. Analysis of the HSV found that the local glass erosion was the product of the bolt tip translating through the glass and displaced in a conical pattern (Fig. 7) in the direction of bolt travel.

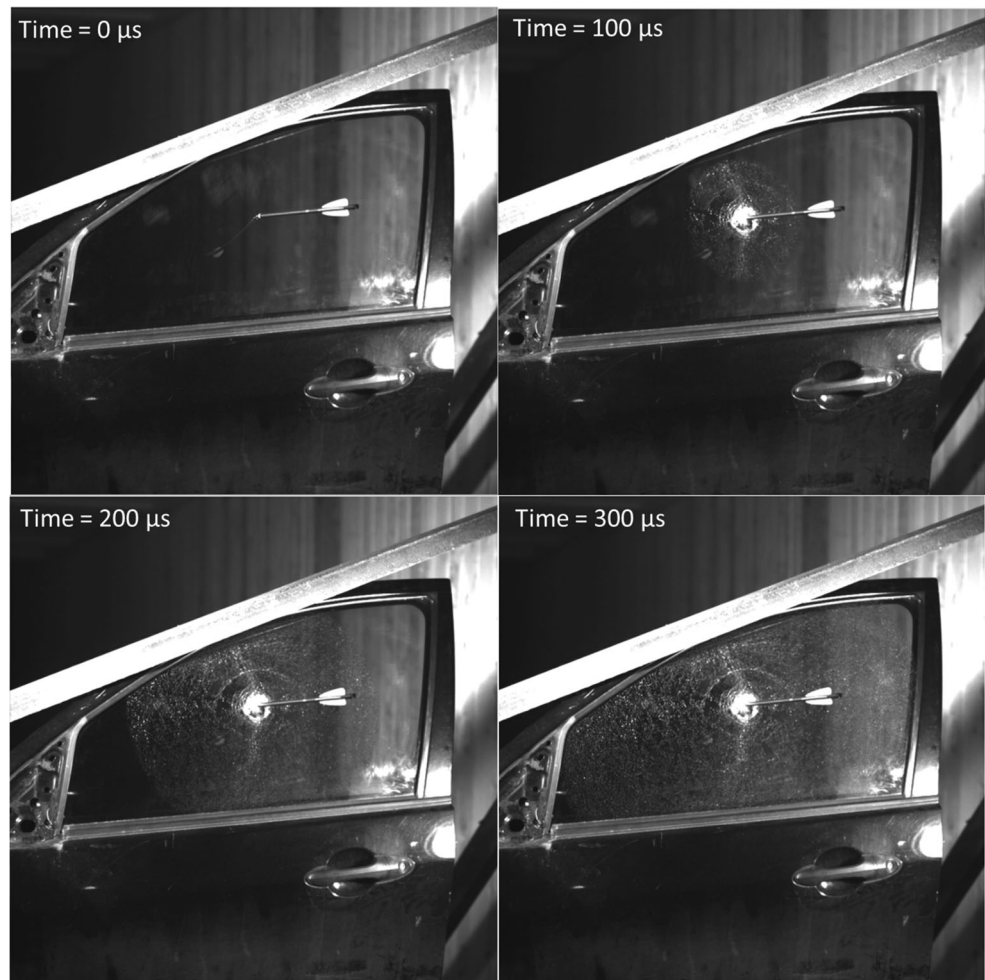
**Fig. 7** Glass failure during impact with crossbow bolt between 0 to 300  $\mu$ s during test 1

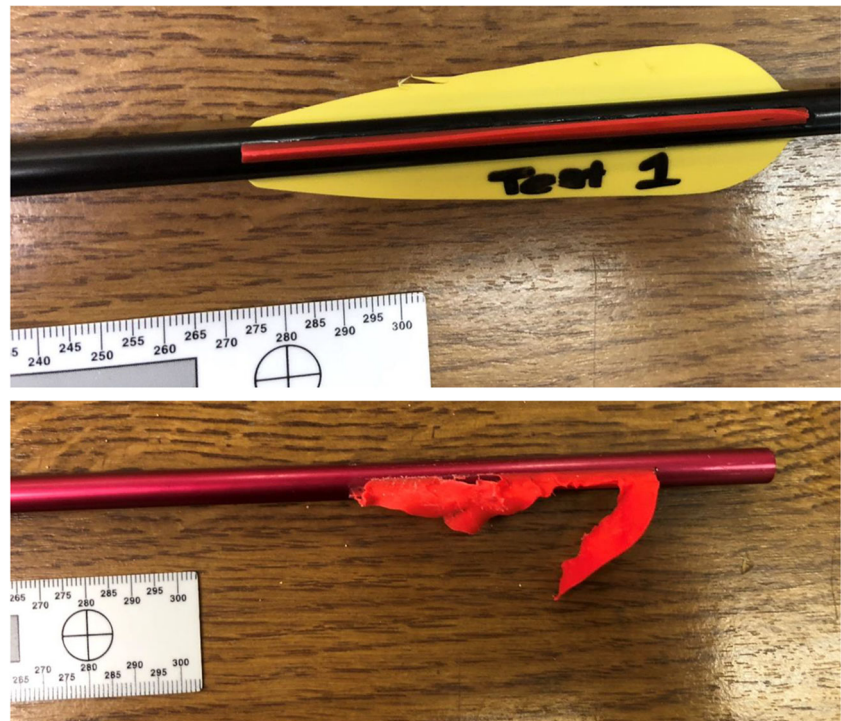
**Fig. 8** Examples of fletching damage

Fletching damage was the most common with damage ranging from minor tears to traumatic removal (Fig. 8). The cause of this damage is currently unknown; however, HSV suggests that the damage comes from the passing through the windows and interaction with the shattered glass.
