Title: The response of aluminium/GLARE hybrid materials to impact and to in-plane fatigue

To appear in: *Materials Science and Engineering A*

# The response of aluminium/GLARE hybrid materials to impact and to in-plane fatigue

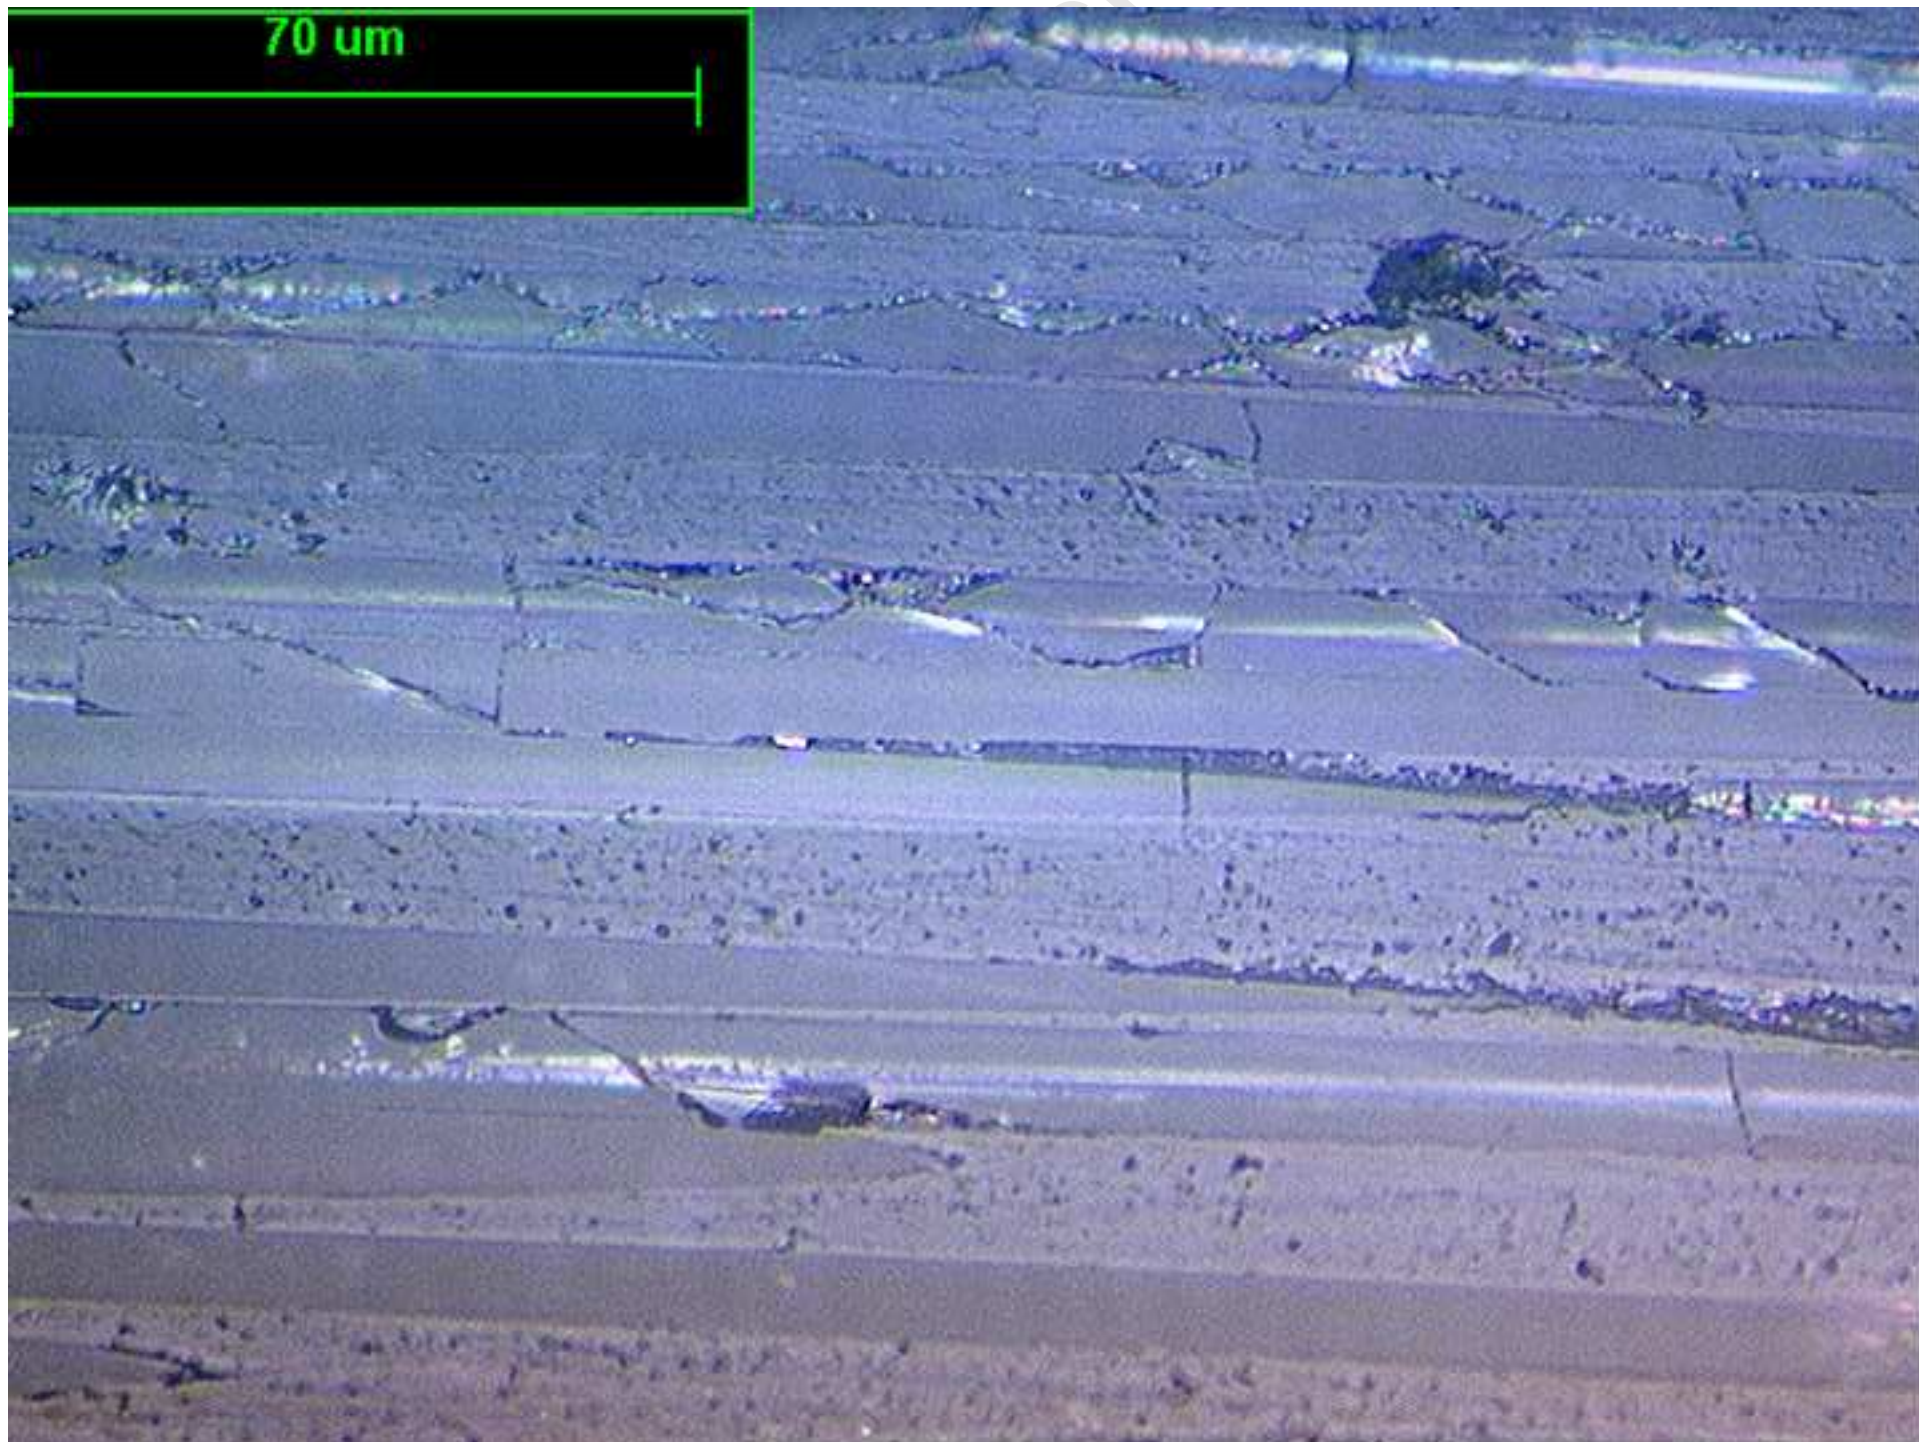
figure 12

Figure 12 Optical micrograph showing cracks in the glass fibres at 45° (see arrows) with respect to the fibre axis in second glass layer within GLARE after 50 J impact on the substrate.
