## Fireside performance of different coatings in biomass power plant

The energy sector will need to employ novel strategies to reduce greenhouse gas emissions, such as the increase of steam temperatures/pressures or the use of low carbon fuels (i.e. biomass). Both cause heat exchanger materials' degradation issues, due to the formation of more/different corrosive deposits, which requires the use of expensive nickel-based materials or coatings. This paper focuses on the behaviour of three different coatings (HVOF NiCrFeSi, laser clad FeCrAl and Laser Clad NiCrFeSi) deposited on TP347HFG, at 700°C (up to 1000 h exposure). Tests were performed using the 'deposit recoat' method (KCl deposit) in simulated biomass combustion environments. Cross-sections were analysed using dimensional metrology, to determine distributions of metal loss and internal damage. Intergranular damage and pits were identified using SEM/EDX. A 'diffusion cell' behaviour was observed, which led to depletion of alloying elements from the coating and consequent increase in damage. The results suggested a severe degradation of all coatings.

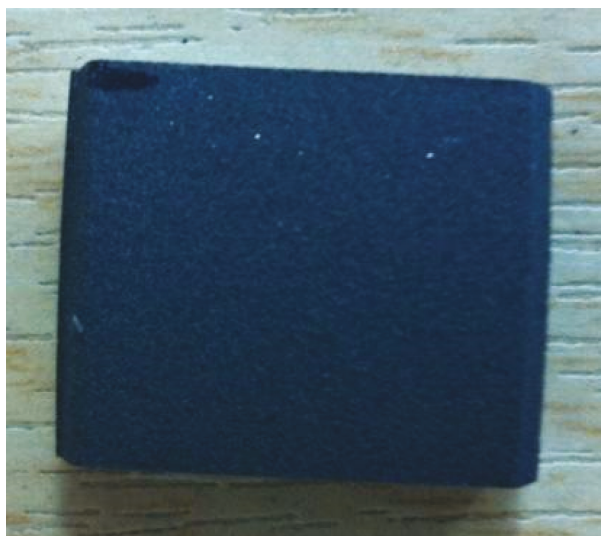
**Figure 1.** Examples of tube segments used for corrosion exposures, the samples are about 15 mm x 15 mm, with 4 mm thickness.

which were subsequently cut into specimens (Figure 1). The typical dimensions of specimens were ~15 mm long and wide with a ~4 mm wall thickness.
